**Flood Control Project Maintenance  
Levee Inspections**

**Fall 2011 Levee Maintenance Deficiency Summary Report**

**Reclamation District No. 2101 Blewett**

<b>Waterway</b>		<b>Bank</b>	<b>Unit Miles</b>
Unit No. 01 San Joaquin River		Left	3.20

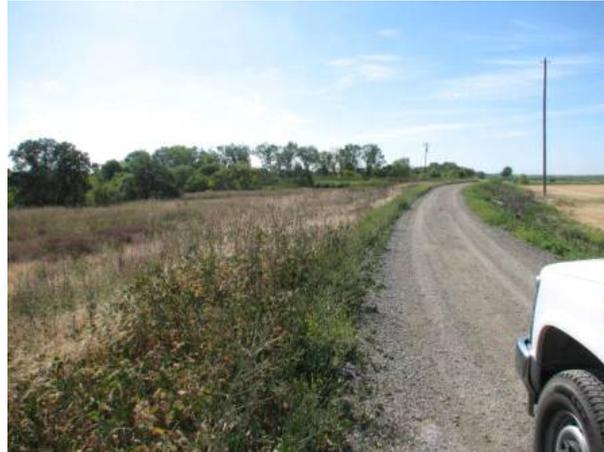
Levee Mile Report Line	2
Start Levee Mile	0.02
End Levee Mile	1.49
Location	Water Side
Category	Earthen Levee
Item	Vegetation
<p>05/26/2011 Vegetation growth is typical for waterside slopes for the entire length of the unit. LMA has stated that DFG restrictions will not allow him to spray or perform proper vegetation control on the waterside of the levee.</p>	
<p>jeto_f_20110923_441.jpg</p>

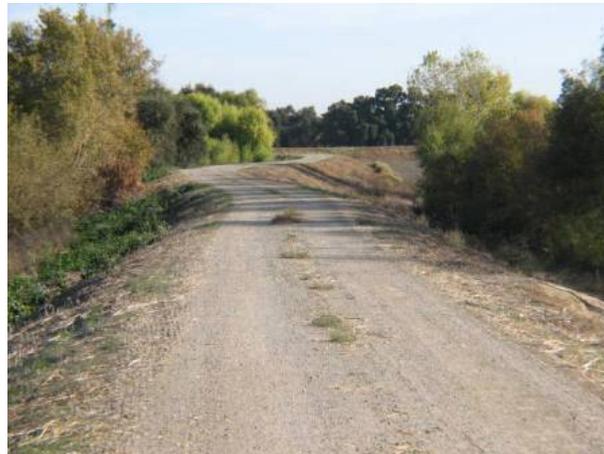
Levee Mile Report Line	2
Start Levee Mile	0.02
End Levee Mile	1.49
Location	Water Side
Category	Earthen Levee
Item	Vegetation
<p>11/02/2011 Photo shows vegetation management.</p>	
<p>jeto_f_20111109_533.jpg</p>

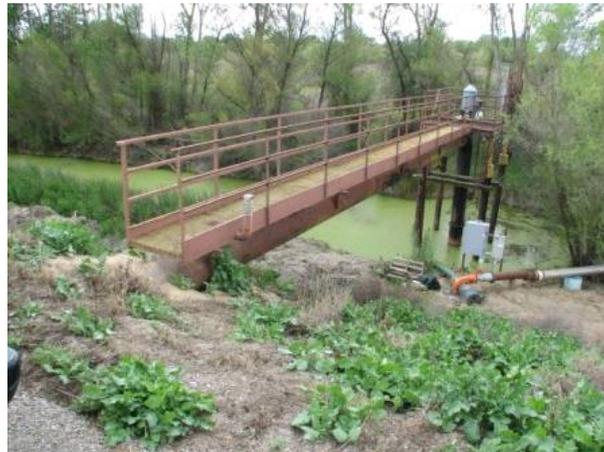
Levee Mile Report Line	5
Start Levee Mile	0.19
End Levee Mile	0.19
Location	Crown
Category	Earthen Levee
Item	Encroachments
<p>Drainage discharge under levee crown.</p>	
<p>jeto_f_20110923_443.jpg</p>

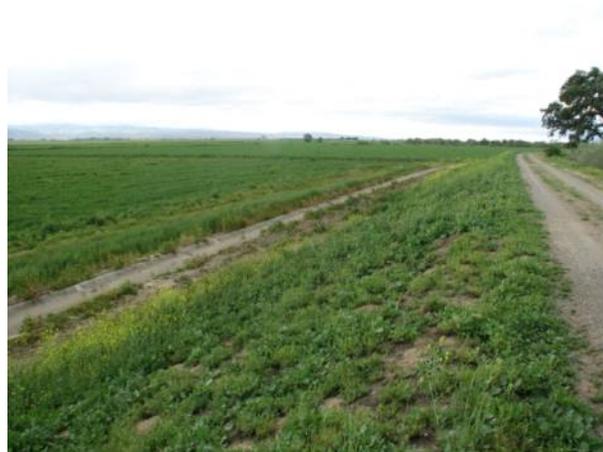
Levee Mile Report Line	10
Start Levee Mile	0.76
End Levee Mile	1.80
Location	Land Side
Category	Earthen Levee
Item	Encroachments
Concrete ditch near landside toe.	
jeto_f_20110923_457.jpg

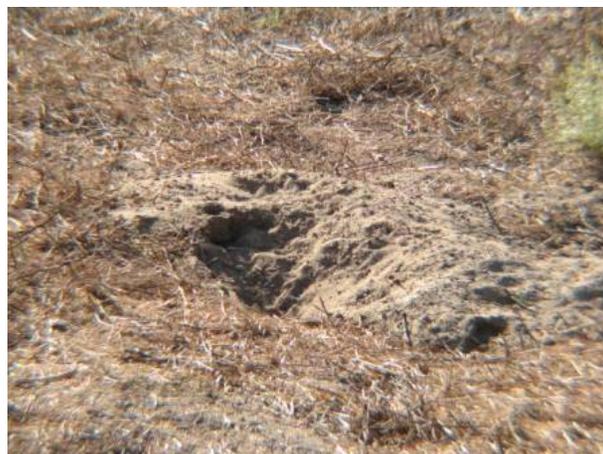
Levee Mile Report Line	13
Start Levee Mile	0.88
End Levee Mile	0.88
Location	Land Side
Category	Earthen Levee
Item	Animal Control
11/02/2011 Active rodent burrow.	
jeto_f_20111109_535.jpg

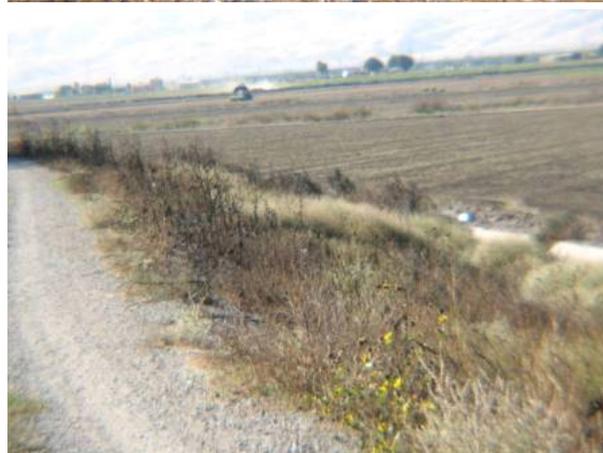
Levee Mile Report Line	15
Start Levee Mile	1.03
End Levee Mile	2.74
Location	Land Side
Category	Earthen Levee
Item	Vegetation
11/02/2011 Typical vegetation on the landside slope for the remainder of the levee. Crews have not reached this point yet. Active crews were working on vegetation control during the inspection.	
jeto_f_20111109_537.jpg

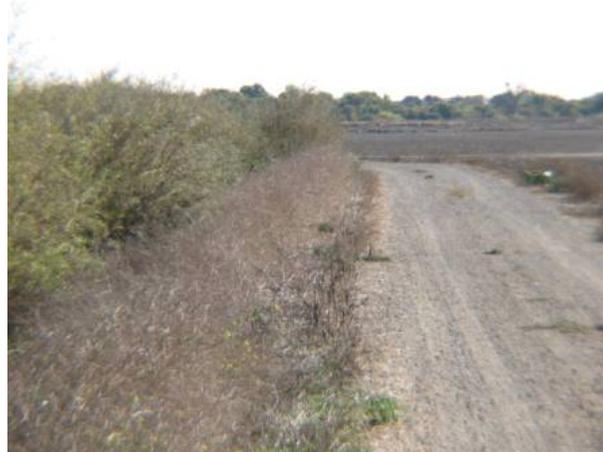
Levee Mile Report Line	17
Start Levee Mile	1.49
End Levee Mile	2.74
Location	Water Side
Category	Earthen Levee
Item	Vegetation
<p>11/02/2011 Typical vegetation for the remainder of the levee. Crews were performing vegetation control during the inspection.</p>	
<p>jeto_f_20111109_538.jpg</p>

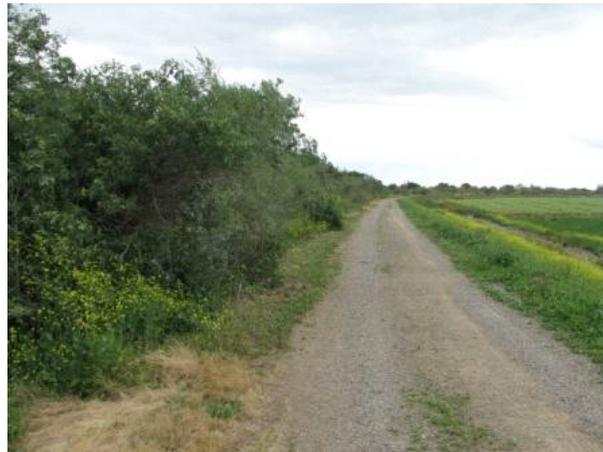
Levee Mile Report Line	19
Start Levee Mile	1.62
End Levee Mile	1.84
Location	Water Side
Category	Earthen Levee
Item	Trim / Thin Trees
<p>Trees on top 20' of waterside slope obstruct access and visibility.</p>	
<p>jeto_f_20110923_449.jpg</p>

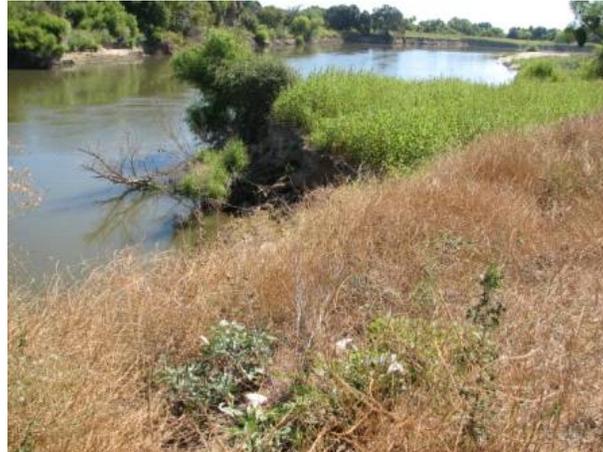
SJR2011\_RD2101U01RM73.92\_1.jpg

LMIR No.	Levee Mile		Category	Item	Location *	Rating **	Action/Comment	GPS Latitude/Longitude		Issue No. Photo
	Start	End						Start	End	
21	1.91	2.00	Supplemental	DWR Erosion Survey	WS	U	Inspector Comments: 08/18/2011: Erosion progressed significantly during the past flood season. The levee toe along the erosion site was washed away, and the erosion has cut the levee structure up to the point about 1/3 of the levee slope. The scarp height is approximately 17 feet. Very dense vegetation on the site. Trees visible.  10/19/2010: No significant changes observed on site. Remaining levee berm topsoil is of silty sand mixture. Erosion is near the downstream transition. An eddy has formed, and has scoured away a 100-foot section of the bank, possibly encroaching into the levee prism. Vegetation on site includes willows, oak, and cotton wood located from the bench to the toe. On the landside are rows of corn crop.08/05/2010: Recommended for Repair, per CLRO.2009: Site recommended as annual assessment and monitoring if critical erosion site, per CLRO CES Evaluation 2008 Report; an eddy has formed, eroding bank and intruding into the levee prism; Site # is the same as RM76.3,LM1.89; previously rated "U".08/30/2007: Recommended for short list of immediate repair sites; silty sand levee material. [2011 Site ID:RD2101U01RM73.92]	37.650259 ° -121.228961 °	37.650259 ° -121.228961 °	1 Y

Levee Mile Report Line	21
Start Levee Mile	1.91
End Levee Mile	2.00
Location	Water Side
Category	Supplemental
Item	DWR Erosion Survey

Looking upstream from levee top. The tree at the water edge is the visible starting point of the erosion.

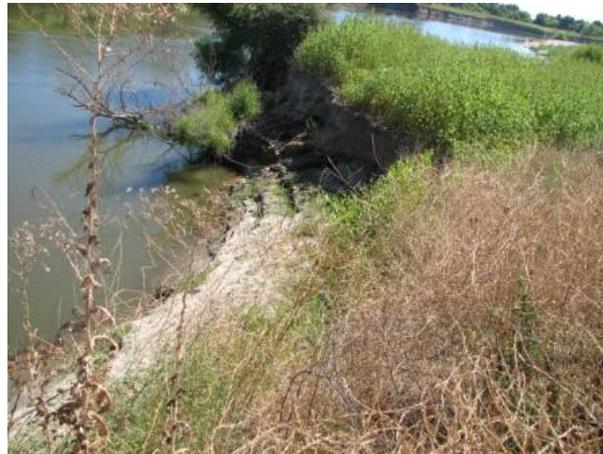
SJR2011\_RD2101U01RM73.92\_2.jpg

Levee Mile Report Line	21
Start Levee Mile	1.91
End Levee Mile	2.00
Location	Water Side
Category	Supplemental
Item	DWR Erosion Survey

A close look at the erosion. The viewing point is about half of the levee slope.

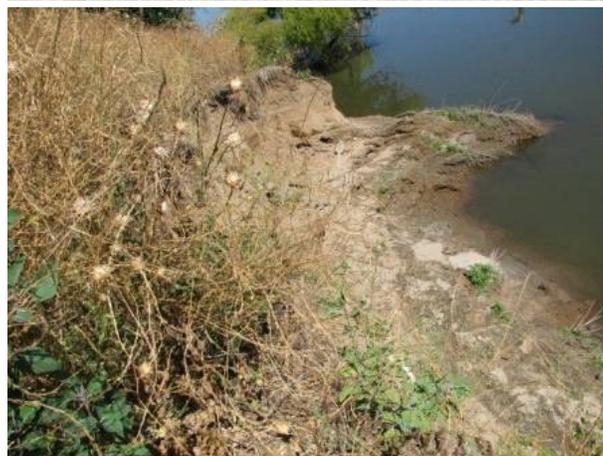
SJR2011\_RD2101U01RM73.92\_3.jpg

Levee Mile Report Line	21
Start Levee Mile	1.91
End Levee Mile	2.00
Location	Water Side
Category	Supplemental
Item	DWR Erosion Survey

Looking downstream at the scour site. The erosion has developed to about 1/3 of the levee slope. The levee toe has been washed away.

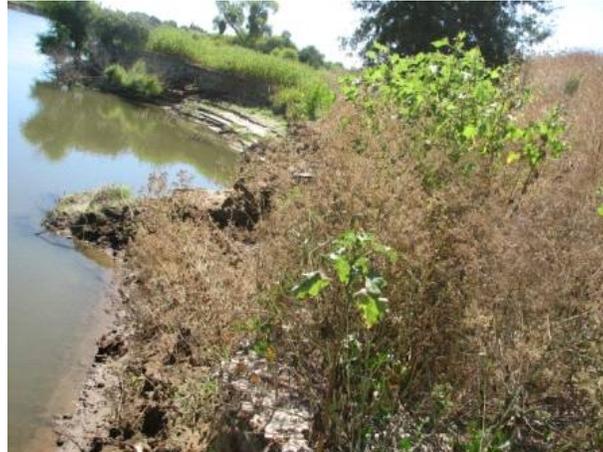
Levee Mile Report Line	21
Start Levee Mile	1.91
End Levee Mile	2.00
Location	Water Side
Category	Supplemental
Item	DWR Erosion Survey
Looking upstream at the scour site. The dense vegetation visible.	
SJR2011_RD2101U01RM73.92_4.jpg

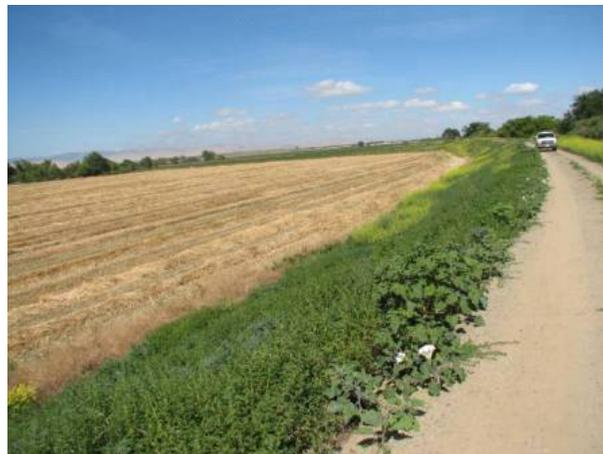
22	1.91	2.00	Earthen Levee	Seepage / Sandboils	LS	A	Inspector Comments: 05/26/2011: LMA reports that seepage was occurring through erosion survey site, causing damage to adjacent field.	37.650259 ° -121.228961 °	37.650259 ° -121.228961 °	8 Y
23	2.06	2.06	Earthen Levee	Animal Control	CR	M	No rodents visible, but rodent burrows visible; need to backfill and compact or grout burrows.	37.649382 ° -121.226997 °	37.649382 ° -121.226997 °	955 Y
24	2.74	2.74	Earthen Levee	Encroachments	WS	W	Pipe	37.642005 ° -121.229742 °	37.642005 ° -121.229742 °	21 Y
25	2.88	2.88	Earthen Levee	Animal Control	WS	U	No rodents visible, but rodent burrows visible; need to backfill and compact or grout burrows. Inspector Comments: Active burrows with squirrels observed. Burrows on both sides of levee.	37.640305 ° -121.230095 °	37.640305 ° -121.230095 °	27 Y
26	2.89	2.89	Earthen Levee	Encroachments	WS	W	Pipe	37.640133 ° -121.230037 °	37.640133 ° -121.230037 °	25 Y

Levee Mile Report Line	22
Start Levee Mile	1.91
End Levee Mile	2.00
Location	Land Side
Category	Earthen Levee
Item	Seepage / Sandboils
05/26/2011 Field which had crop damage due to sitting water from seepage through erosion site.	
jeto_f_20110923_444.jpg

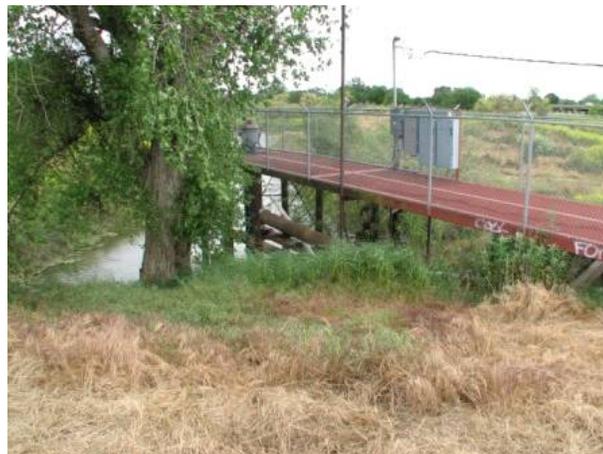
Levee Mile Report Line	24
Start Levee Mile	2.74
End Levee Mile	2.74
Location	Water Side
Category	Earthen Levee
Item	Encroachments
Irrigation intake near Maze Blvd.	
jeto_f_20110923_446.jpg

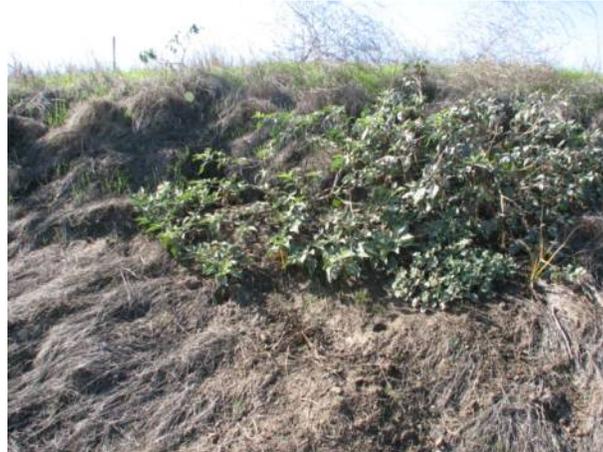
Levee Mile Report Line	25
Start Levee Mile	2.88
End Levee Mile	2.88
Location	Water Side
Category	Earthen Levee
Item	Animal Control
Rodent holes on levee slope hidden by vegetation.	
jeto_f_20110923_450.jpg

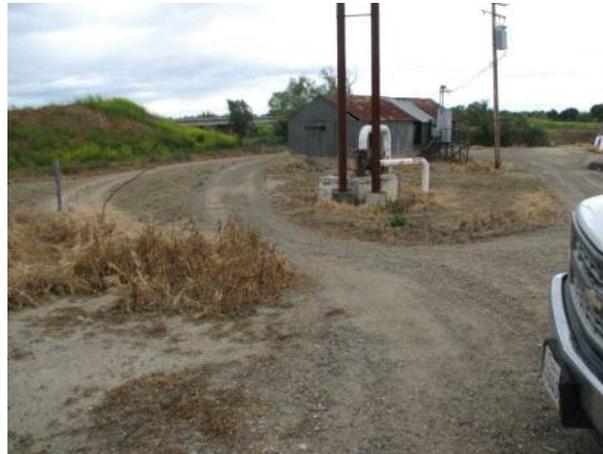
Levee Mile Report Line	26
Start Levee Mile	2.89
End Levee Mile	2.89
Location	Water Side
Category	Earthen Levee
Item	Encroachments
Risers on waterside berm and risers along road leading to levee indicate presence of pipe penetration.	
jeto_f_20110923_448.jpg

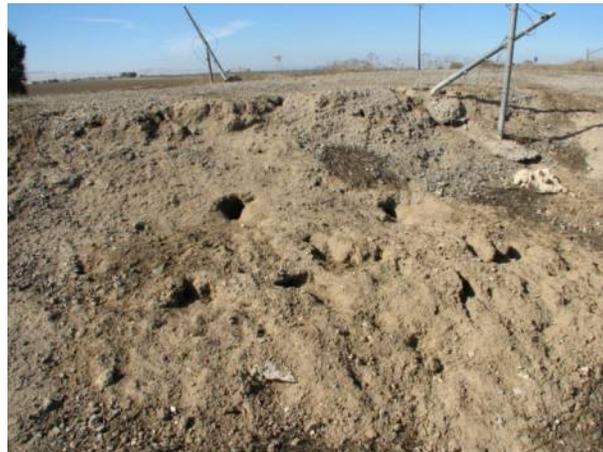
27	2.89	2.89	Earthen Levee	Animal Control	LS	U	No rodents visible, but rodent burrows visible; need to backfill and compact or grout burrows. Inspector Comments: Numerous rodent holes throughout levee slope.	37.640134 ° -121.230019 °	37.640134 ° -121.230019 °	28 Y
28	2.91	2.91	Earthen Levee	Erosion / Bank Caving	WS	M	Schedule repair of erosion site prior to the next inspection.	37.639852 ° -121.229980 °	37.639852 ° -121.229980 °	29 Y

Levee Mile Report Line	27
Start Levee Mile	2.89
End Levee Mile	2.89
Location	Land Side
Category	Earthen Levee
Item	Animal Control
Rodent holes on levee slope.	
jeto_f_20110923_451.jpg

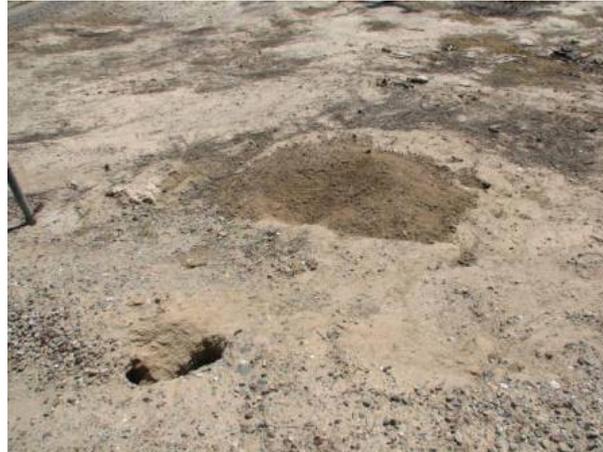
Levee Mile Report Line	27
Start Levee Mile	2.89
End Levee Mile	2.89
Location	Land Side
Category	Earthen Levee
Item	Animal Control
05/26/2011 Updated photo of animal control issue noted in Fall 2010 inspection, fresh rodent burrow present.	
jeto_f_20110923_452.jpg

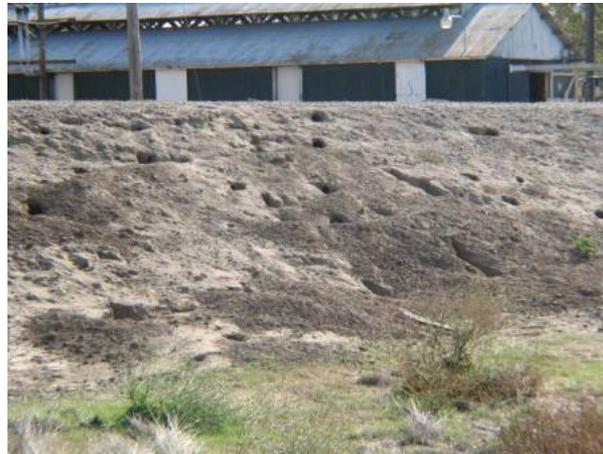
Levee Mile Report Line	27
Start Levee Mile	2.89
End Levee Mile	2.89
Location	Land Side
Category	Earthen Levee
Item	Animal Control
11/02/2011 Numerous burrows on levee slope.	
jeto_f_20111109_543.jpg

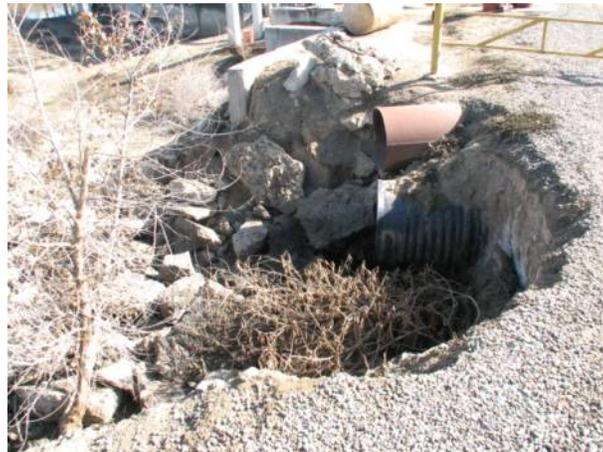
Levee Mile Report Line	28
Start Levee Mile	2.91
End Levee Mile	2.91
Location	Water Side
Category	Earthen Levee
Item	Erosion / Bank Caving
Levee slope is being eroded at this location. Repair needed to preserve access road.	
jeto_f_20110923_453.jpg

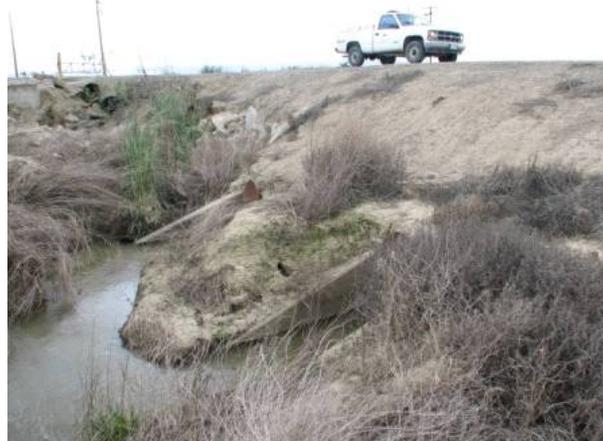
Levee Mile Report Line	29
Start Levee Mile	2.91
End Levee Mile	2.91
Location	Water Side
Category	Earthen Levee
Item	Encroachments
Drainage discharge to San Joaquin River.	
jeto_f_20110923_447.jpg

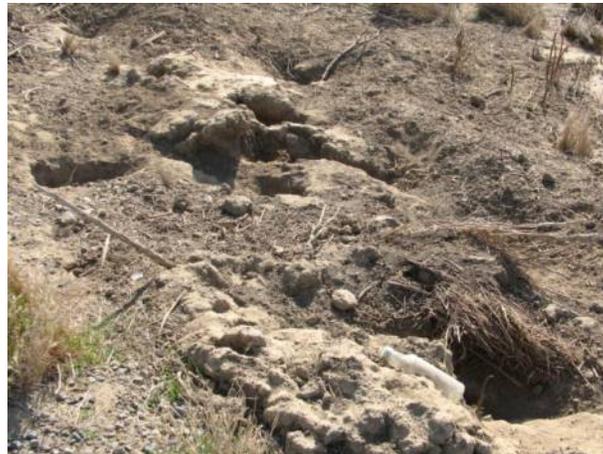
Levee Mile Report Line	31
Start Levee Mile	3.02
End Levee Mile	3.20
Location	Land Side
Category	Earthen Levee
Item	Animal Control
11/02/2011 Numerous burrows present, some already caving in, others are active.	
jeto_f_20111109_544.jpg

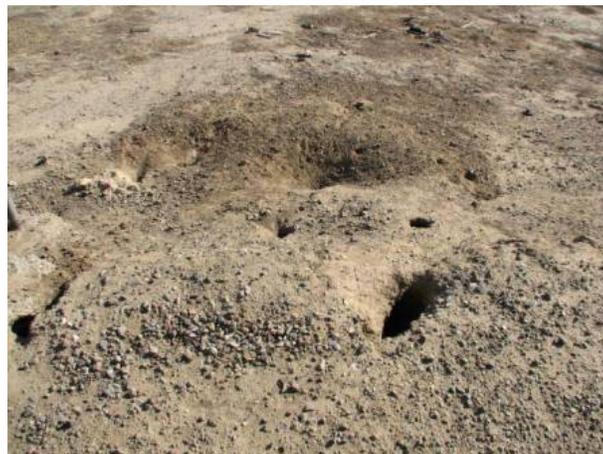
Levee Mile Report Line	31
Start Levee Mile	3.02
End Levee Mile	3.20
Location	Land Side
Category	Earthen Levee
Item	Animal Control
11/02/2011 Many active burrows present.	
jeto_f_20111109_545.jpg

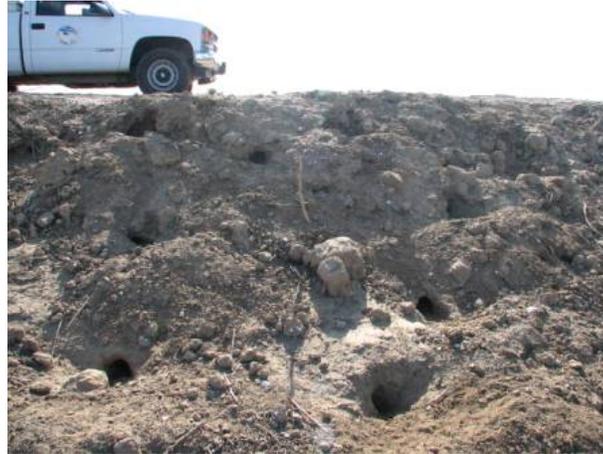
Levee Mile Report Line	31
Start Levee Mile	3.02
End Levee Mile	3.20
Location	Land Side
Category	Earthen Levee
Item	Animal Control
11/02/2011 Many burrows present throughout the levee slope.	
jeto_f_20111109_546.jpg

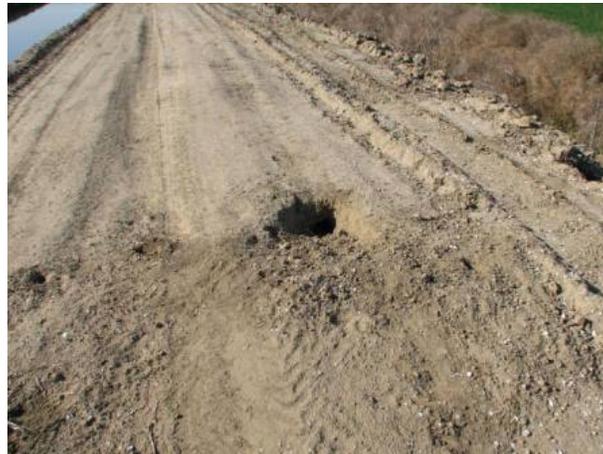
Levee Mile Report Line	32
Start Levee Mile	3.11
End Levee Mile	3.11
Location	Crown
Category	Earthen Levee
Item	Animal Control
11/02/2011 Large burrow in crown.	
jeto_f_20111109_547.jpg

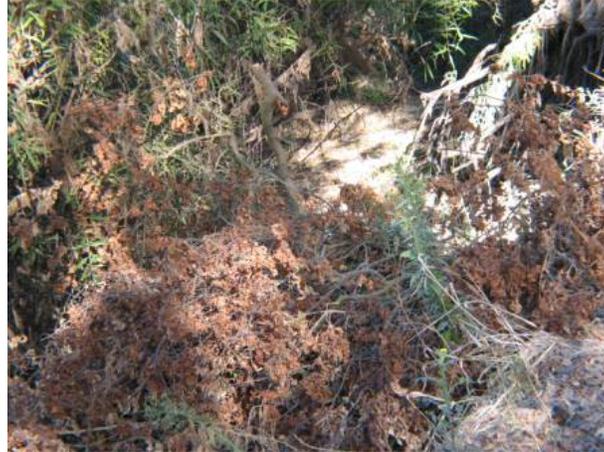
Levee Mile Report Line	3
Start Levee Mile	0.31
End Levee Mile	0.31
Location	Water Side
Category	Earthen Levee
Item	Erosion / Bank Caving
<p>11/02/2011 Updated photo of the scouring occurring at the end of the spur levee.</p>	
<p>jeto_f_20111109_534.jpg</p>
