**Flood Control Project Maintenance
Levee Inspections**

Fall 2014 Levee Maintenance Deficiency Summary Report

Reclamation District No. 2101 Blewett

Levee Inspection Report By Mile - Fall 2014

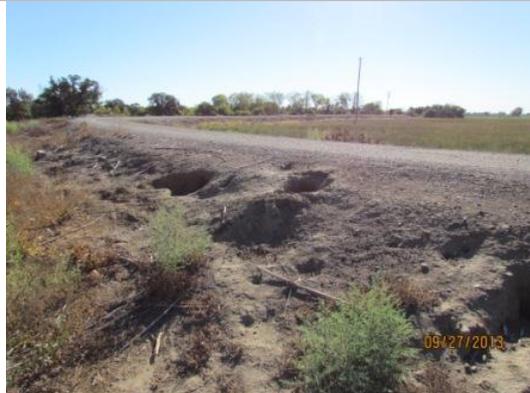
Photo 1 of 1 : FA_2014_RD2101_326_12_20141001_00005.jpg

LM Start	0.04	Rating **	M	Issue No.	12
LM End	0.04	Issue Type +	Ma	Location *	WS
Category	Earthen Levee		GPS Latitude/Longitude		
			Start	End	
Item	Animal Control		37.657648 °	37.657648 °	
			-121.253812 °	-121.253812 °	
DWR ID	DWR_RD2101_01_s_2012_12				
Action/Comments					
No rodents visible, but rodent burrows visible; need to backfill and compact or grout burrows.

View of rodent holes on waterward slope, facing upstream.

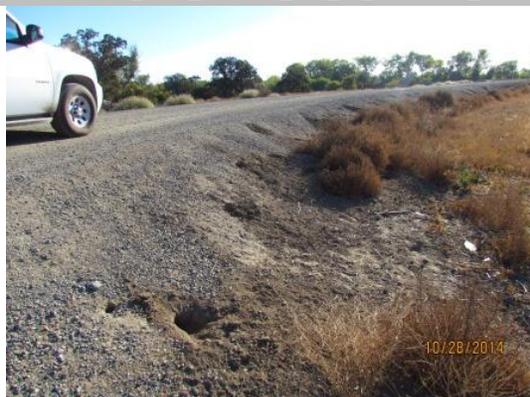
Photo 1 of 1 : FA_2014_RD2101_326_16_20141029_00031.jpg

LM Start	0.07	Rating **	M	Issue No.	16
LM End	0.07	Issue Type +	Ma	Location *	LS
Category	Earthen Levee		GPS Latitude/Longitude		
			Start	End	
Item	Animal Control		37.657811 °	37.657811 °	
			-121.253269 °	-121.253269 °	
DWR ID	DWR_RD2101_01_s_2013_16				
Action/Comments					
No rodents visible, but rodent burrows visible; need to backfill and compact or grout burrows. Inspector Comments: Continue rodent extermination and backfilling the rodent burrows.

View of rodent burrows on the landside levee slope.

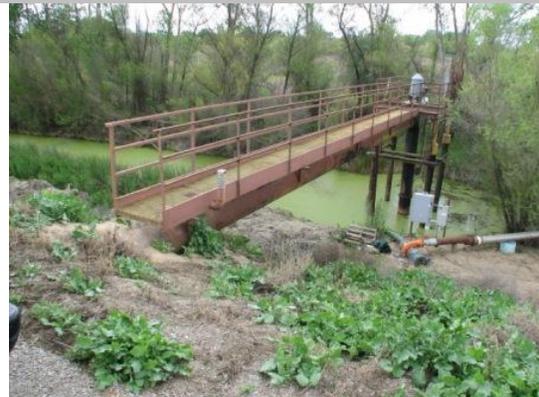
Photo 1 of 1 : FA_2014_RD2101_326_7_20141001_00003.jpg

LM Start	0.19	Rating **	A/W	Issue No.	7
LM End	0.19	Issue Type +	En	Location *	CR
Category	Earthen Levee		GPS Latitude/Longitude		
			Start	End	
Item	Encroachments		37.657128 °	37.657128 °	
			-121.251692 °	-121.251692 °	
DWR ID	DWR_RD2101_01_s_2012_7				
Action/Comments					
Pipe

Drainage discharge under levee crown.

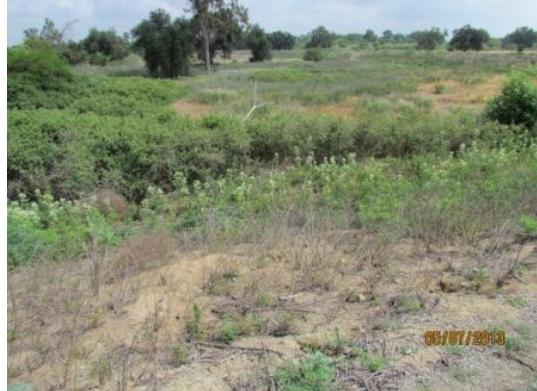
Photo 1 of 1 : FA_2014_RD2101_326_26_20141001_00015.jpg

LM Start	0.70	Rating **	U	Issue No.	26
LM End	0.70	Issue Type +	Ma	Location *	WS
Category	Earthen Levee		GPS Latitude/Longitude		
			Start	End	
Item	Animal Control		37.659907 °	37.659907 °	
			-121.244219 °	-121.244219 °	
DWR ID	DWR_RD2101_01_s_2013_26				
Action/Comments					
Exterminate rodents and backfill and compact or grout burrows.

View of the rodent burrows on the waterside levee slope.

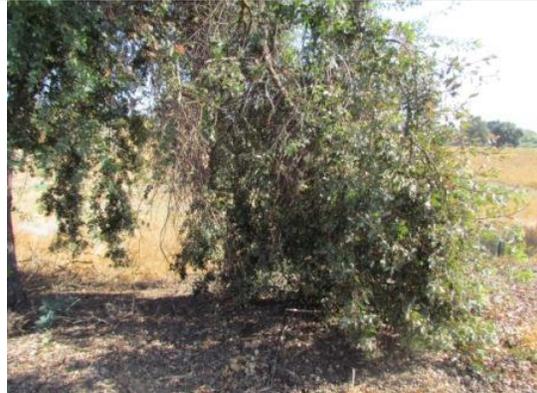
Photo 1 of 1 : FA_2014_RD2101_326_11_20141001_00004.jpg

LM Start	0.75	Rating **	M	Issue No.	11
LM End	0.75	Issue Type +	Ma	Location *	WS
Category	Earthen Levee		GPS Latitude/Longitude		
			Start	End	
Item	Trim / Thin Trees		37.659705 °	37.659705 °	
			-121.243306 °	-121.243306 °	
DWR ID	DWR_RD2101_01_f_2012_11				
Action/Comments					
Trim trees to at least five feet above ground level. Inspector Comments: Trim tree to allow access and visibility.

View of tree branches obstructing waterside slope.

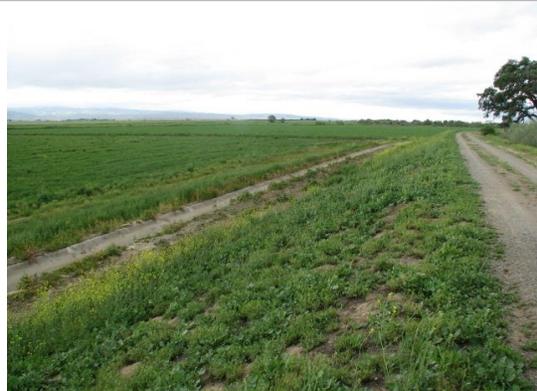
Photo 1 of 1 : FA_2014_RD2101_326_944_20141001_00024.jpg

LM Start	0.76	Rating **	M	Issue No.	944
LM End	1.80	Issue Type +	En	Location *	LS
Category	Earthen Levee		GPS Latitude/Longitude		
			Start	End	
Item	Encroachments		37.659827 °	37.651049 °	
			-121.243675 °	-121.231475 °	
DWR ID	DWR_RD2101_01_s_2012_944				
Action/Comments					
Ditch

Concrete ditch near landside toe.

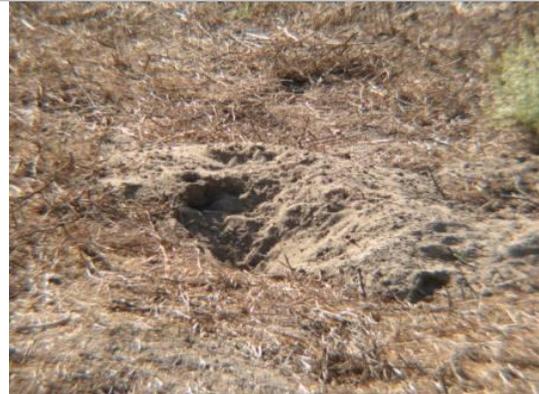
Photo 1 of 1 : FA_2014_RD2101_326_3_20141001_00002.jpg

LM Start	0.88	Rating **	M	Issue No.	3
LM End	0.88	Issue Type +	Ma	Location *	LS
Category	Earthen Levee		GPS Latitude/Longitude		
			Start	End	
Item	Animal Control		37.658663 °	37.658663 °	
			-121.241750 °	-121.241750 °	
DWR ID	DWR_RD2101_01_s_2012_3				
Action/Comments					
No rodents visible, but rodent burrows visible; need to backfill and compact or grout burrows.

11/02/2011 Active rodent burrow.

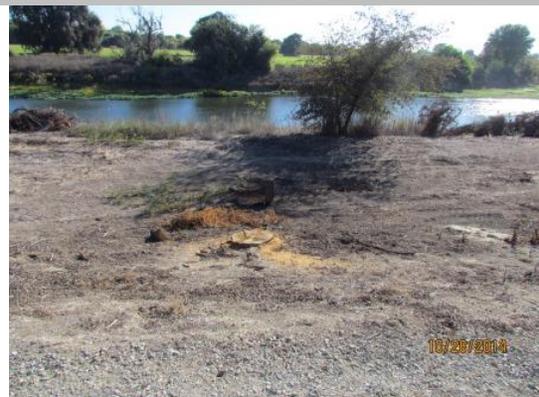
Photo 1 of 1 : FA_2014_RD2101_326_33_20141029_00033.jpg

LM Start	1.03	Rating **	N	Issue No.	33
LM End	1.03	Issue Type +	Ma	Location *	WS
Category	Earthen Levee		GPS Latitude/Longitude		
			Start	End	
Item	Trim / Thin Trees		37.656745 °	37.656745 °	
			-121.241104 °	-121.241104 °	
DWR ID	DWR_RD2101_01_f_2014_33				
Action/Comments					
Tree stumps.

View of the tree stump at the waterside levee toe.

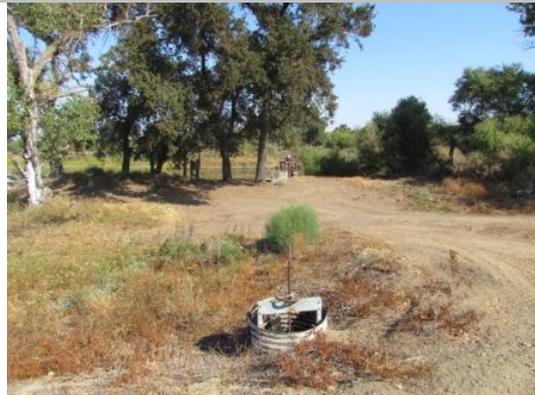
Photo 1 of 1 : FA_2014_RD2101_326_13_20141001_00006.jpg

LM Start	1.62	Rating **	A/W	Issue No.	13
LM End	1.62	Issue Type +	Ma	Location *	WS
Category	Earthen Levee		GPS Latitude/Longitude		
			Start	End	
Item	Encroachments		37.651555 °	37.651555 °	
			-121.234319 °	-121.234319 °	
DWR ID	DWR_RD2101_01_s_2012_13				
Action/Comments					
Pipe Inspector Comments: Pipe penetrates through levee. Closure valve on water side slope.

Photo of pump in background and CMP riser with valve in foreground.

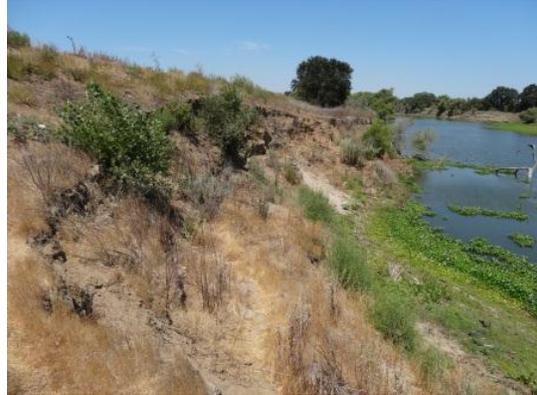
Photo 1 of 1 : SJR2014_RD2101U01RM73.92_1.jpg

LM Start	1.91	Rating **	U	Issue No.	1	
LM End	2.00	Issue Type +	Ma	Location *	WS	
Category	Supplemental			GPS Latitude/Longitude		
			Start	End		
Item	DWR Erosion Survey			37.650259 °	37.650259 °	
				-121.228961 °	-121.228961 °	
DWR ID						
Action/Comments						
<p>Inspector Comments: 07/17/2014: No significant change observed. 09/20/2013: Site has been visited. There are signs of further erosion development along the levee slope and toe. 07/18/2012: The erosion has further developed toward levee crown. Vegetation has been removed. 08/18/2011: The erosion progressed significantly during the past flood season. The levee toe along the erosion site was washed away, and the erosion has cut the levee structure up to the point about 1/3 of the levee slope. The scarp height is approximately 17 feet. Very dense vegetation and trees are visible. 10/19/2010: No significant change observed on site. Remaining levee berm topsoil is of silty sand mixture. The erosion is near the downstream transition. An eddy has formed, and has scoured away a 100-foot section of the bank, possibly encroaching into the levee prism. Vegetation on site includes willows, oak, and cotton wood located from the bench to the toe. On the landside are rows of corn crop. 08/05/2010: Recommended for Repair, per CLRO. 2009: Site recommended as annual assessment and monitoring if critical erosion site, per CLRO CES Evaluation 2008 Report; an eddy has formed, eroding bank and intruding into the levee prism; Site # is the same as RM76.3, LM1.89; previously rated "U". 08/30/2007: Recommended for short list of immediate repair sites; silty sand levee material. [2014 Site ID:RD2101U01RM73.92]</p>

Upstream view of the erosion.

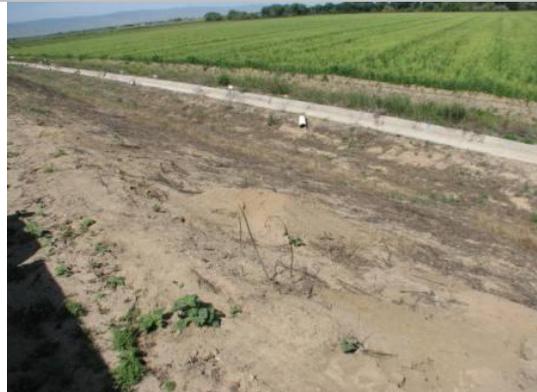
Photo 1 of 1 : FA_2014_RD2101_326_30_20141001_00023.jpg

LM Start	2.39	Rating **	M	Issue No.	30	
LM End	2.39	Issue Type +	Ma	Location *	LS	
Category	Earthen Levee			GPS Latitude/Longitude		
			Start	End		
Item	Animal Control			37.645785 °	37.645785 °	
				-121.226337 °	-121.226337 °	
DWR ID	DWR_RD2101_01_s_2012_30					
Action/Comments						
Exterminate rodents and backfill and compact or grout burrows.

View of levee material removed by rodent activity on landside slope, facing upstream. 05/02/2012

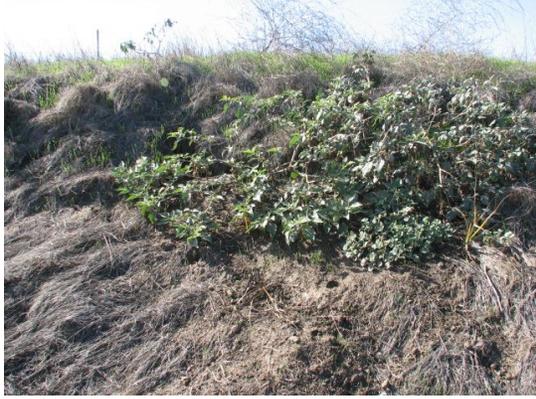
Photo 1 of 1 : FA_2014_RD2101_326_27_20141001_00016.jpg

LM Start	2.88	Rating **	U	Issue No.	27
LM End	2.88	Issue Type +	Ma	Location *	WS
Category	Earthen Levee		GPS Latitude/Longitude		
			Start	End	
Item	Animal Control		37.640305 °	37.640305 °	
			-121.230095 °	-121.230095 °	
DWR ID	DWR_RD2101_01_s_2012_27				
Action/Comments					
No rodents visible, but rodent burrows visible; need to backfill and compact or grout burrows. Inspector Comments: Active burrows with squirrels observed. Burrows on both sides of levee.

Rodent holes on levee slope hidden by vegetation.

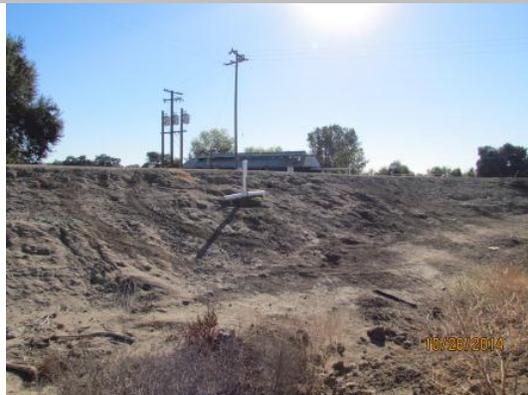
Photo 1 of 1 : FA_2014_RD2101_326_28_20141029_00032.jpg

LM Start	2.89	Rating **	U	Issue No.	28
LM End	2.89	Issue Type +	Ma	Location *	LS
Category	Earthen Levee		GPS Latitude/Longitude		
			Start	End	
Item	Animal Control		37.640134 °	37.640134 °	
			-121.230019 °	-121.230019 °	
DWR ID	DWR_RD2101_01_s_2012_28				
Action/Comments					
No rodents visible, but rodent burrows visible; need to backfill and compact or grout burrows. Inspector Comments: Numerous rodent holes throughout levee slope.

View of numerous rodent holes with bait stations present.

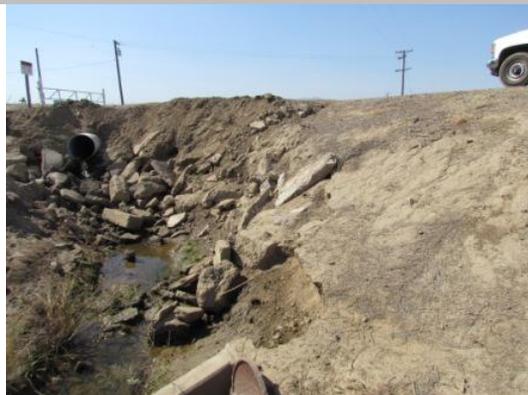
Photo 1 of 2 : FA_2014_RD2101_326_29_20141001_00021.jpg

LM Start	2.91	Rating **	M	Issue No.	29
LM End	2.91	Issue Type +	Ma	Location *	WS
Category	Earthen Levee		GPS Latitude/Longitude		
			Start	End	
Item	Erosion / Bank Caving		37.639852 °	37.639852 °	
			-121.229980 °	-121.229980 °	
DWR ID	DWR_RD2101_01_s_2012_29				
Action/Comments					
Schedule repair of erosion site prior to the next inspection.

View of repaired site, but it appears that erosion is still occurring.
09/25/2012

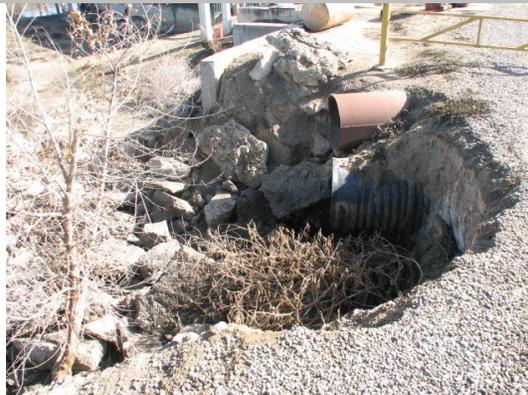
Photo 2 of 2 : FA_2014_RD2101_326_29_20141001_00022.jpg

LM Start	2.91	Rating **	M	Issue No.	29 (cont)
LM End	2.91	Issue Type +	Ma	Location *	WS

Levee slope is being eroded at this location. Repair needed to preserve access road.

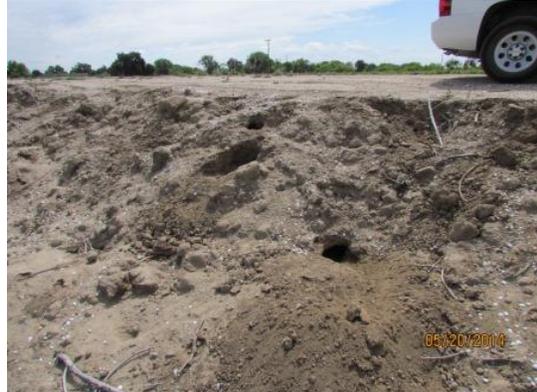
Photo 1 of 1 : FA_2014_RD2101_326_17_20141001_00009.jpg

LM Start	3.02	Rating **	M	Issue No.	17
LM End	3.20	Issue Type +	Ma	Location *	LS
Category	Earthen Levee		GPS Latitude/Longitude		
			Start	End	
Item	Animal Control		37.638760 °	37.638760 °	
			-121.231341 °	-121.231341 °	
DWR ID	DWR_RD2101_01_s_2012_17				
Action/Comments					
Exterminate rodents and backfill and compact or grout burrows. Inspector Comments: Active burrows with rodents present.

Numerous burrows present, some already caving in, others are active.

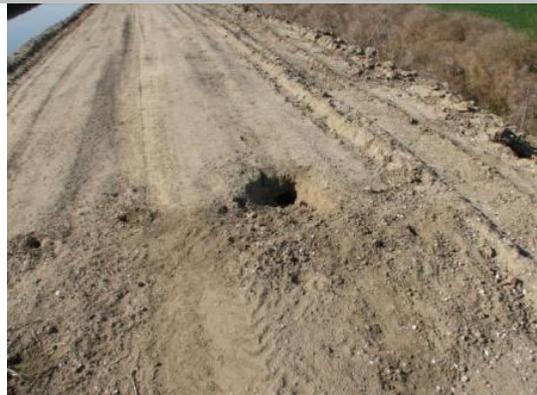
Photo 1 of 3 : FA_2014_RD2101_326_18_20141001_00010.jpg

LM Start	3.11	Rating **	M	Issue No.	18
LM End	3.11	Issue Type +	Ma	Location *	CR
Category	Earthen Levee		GPS Latitude/Longitude		
			Start	End	
Item	Animal Control		37.637943 °	37.637943 °	
			-121.232620 °	-121.232620 °	
DWR ID	DWR_RD2101_01_s_2012_18				
Action/Comments					
No rodents visible, but rodent burrows visible; need to backfill and compact or grout burrows. Inspector Comments: Large burrow in crown with no rodents present at time of inspection.

11/02/2011 Large burrow in crown.

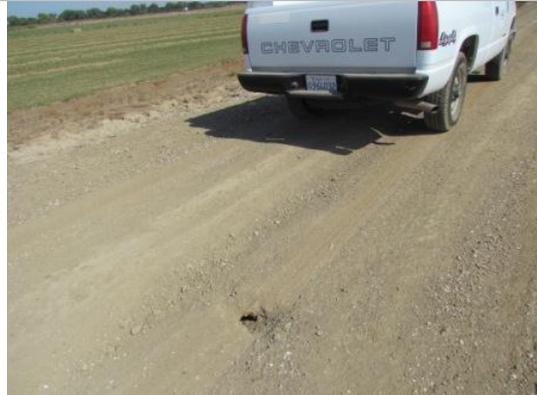
Photo 2 of 3 : FA_2014_RD2101_326_18_20141001_00011.jpg

LM Start	3.11	Rating **	M	Issue No.	18 (cont)
LM End	3.11	Issue Type +	Ma	Location *	CR
Category	Earthen Levee		GPS Latitude/Longitude		
			Start	End	
Item	Animal Control		37.637943 °	37.637943 °	
			-121.232620 °	-121.232620 °	
DWR ID	DWR_RD2101_01_s_2012_18				
Action/Comments					
No rodents visible, but rodent burrows visible; need to backfill and compact or grout burrows. Inspector Comments: Large burrow in crown with no rodents present at time of inspection.

View of the rodent hole in the levee crown. Smaller holes were covered due to crown regrading. 09/25/2012

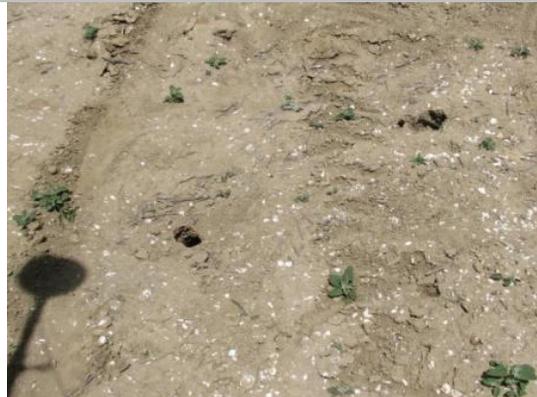
Photo 3 of 3 : FA_2014_RD2101_326_18_20141001_00012.jpg

LM Start	3.11	Rating **	M	Issue No.	18 (cont)
LM End	3.11	Issue Type +	Ma	Location *	CR

05/02/2012 Rodent holes in the levee crown.

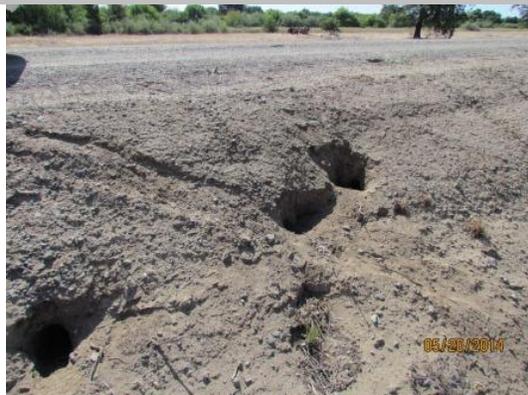
Photo 1 of 1 : FA_2014_RD2101_327_2_20141001_00001.jpg

LM Start	0.23	Rating **	M	Issue No.	2
LM End	0.23	Issue Type +	Ma	Location *	WS
Category	Earthen Levee		GPS Latitude/Longitude		
			Start	End	
Item	Animal Control		37.662968 °	37.662968 °	
			-121.242674 °	-121.242674 °	
DWR ID	DWR_RD2101_02_f_2013_2				
Action/Comments					
No rodents visible, but rodent burrows visible; need to backfill and compact or grout burrows.

View of the rodent burrows on waterside levee slope.

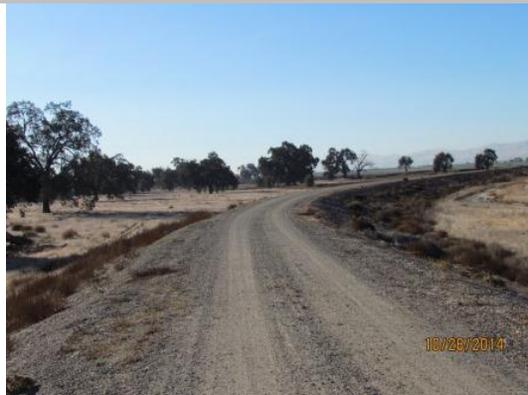
Photo 1 of 1 : FA_2014_RD2101_327_1_20141029_00003.jpg

LM Start	0.28	Rating **	M	Issue No.	1
LM End	0.28	Issue Type +	Ma	Location *	WS
Category	Earthen Levee		GPS Latitude/Longitude		
			Start	End	
Item	Vegetation		37.663593 °	37.663593 °	
			-121.242807 °	-121.242807 °	
DWR ID	DWR_RD2101_02_f_2014_1				
Action/Comments					
Remove the wild growth other than native grasses from the levee slopes.

View of the vegetation on the waterside levee slope.
