**Flood Control Project Maintenance
Levee Inspections**
LMA District Cover Sheet
Spring 2016 Levee Inspection Results

Reclamation District No. 2101 Blewett

Levee Inspection Report By Mile - Spring 2016

Waterway	Bank	Unit Miles	Inspection Start/End	Inspector
Unit No. 01 San Joaquin River	Left	3.16	03/24/2016 03/24/2016	Maksim Khashchuk

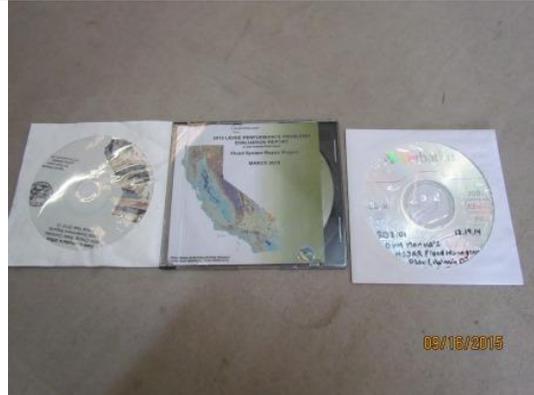
Photo 1 of 1 : SP_2016_RD2101_326_2_20160229_00004.jpg

LM Start		Rating **	A	Issue No.	2
LM End		Issue Type +	Ma	Location *	N/A
Category	Earthen Levee		GPS Latitude/Longitude		
			Start	End	
Item	Operations & Maintenance Manuals			o	o
DWR ID	DWR_RD2101_01_s_2013_2			o	o
Comment Code					
Inspector Comment					
The LMA has the O&M Manual available electronically.

View of the O&M manual and other documentation.

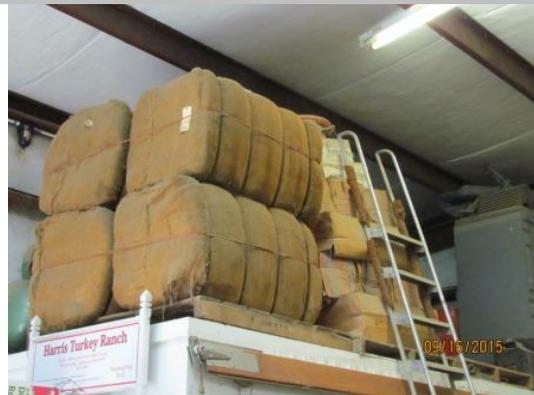
Photo 1 of 1 : SP_2016_RD2101_326_4_20160229_00005.jpg

LM Start		Rating **	A	Issue No.	4
LM End		Issue Type +	Ma	Location *	N/A
Category	Earthen Levee		GPS Latitude/Longitude		
			Start	End	
Item	Emergency Supplies & Equipment			o	o
DWR ID	DWR_RD2101_01_s_2013_4			o	o
Comment Code					
Inspector Comment					
LMA has emergency supplies on site at the warehouse.

View of the emergency flood fight supplies in the shop.

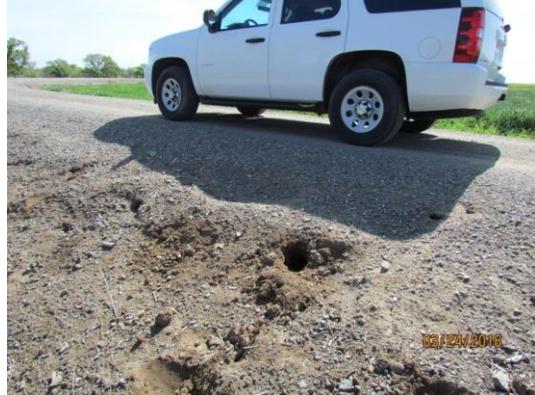
Photo 1 of 1 : SP_2016_RD2101_326_12_20160412_00039.jpg

LM Start	0.04	Rating **	M	Issue No.	12
LM End	0.04	Issue Type +	Ma	Location *	WS
Category	Earthen Levee		GPS Latitude/Longitude		
			Start	End	
Item	Animal Control		37.657648 °	37.657648 °	
			-121.253812 °	-121.253812 °	
DWR ID	DWR_RD2101_01_s_2012_12				
Comment Code					
A3 : No rodents visible, but rodent burrows visible; need to backfill and compact or grout burrows.					
Inspector Comment					
LMA is actively exterminating rodents in this area.

View of the rodent holes on the waterside levee slope, facing upstream.

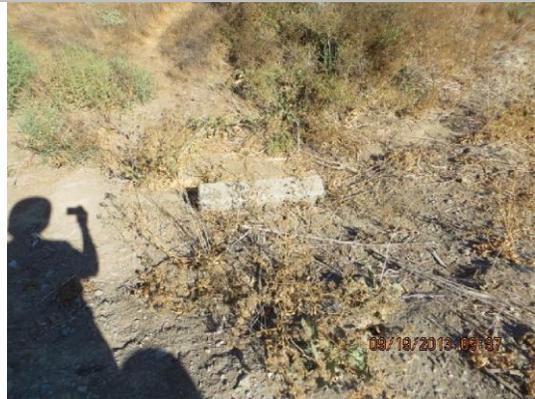
Photo 1 of 2 : UCIP_SP_2016_26403_47962.jpg

LM Start	0.05	Rating **	U	Issue No.	951
LM End	0.05	Issue Type +	En	Location *	WS
Category	Supplemental		GPS Latitude/Longitude		
			Start	End	
Item	DWR UCIP Field Study		37.657801 °	37.657801 °	
			-121.253745 °	-121.253745 °	
DWR ID					
Comment Code					
Inspector Comment					
FS_ID:26403 DS_ID:20699 EP_NO: N/A Repair Type: Urgent Crossing Status: Found UCIP Comments: Slide gate missing from WS toe. Pipe has heavy sediment buildup. FIELD_STRUCT_DESC: 18-inch corrugated metal pipe through levee 3-feet below crown. Concrete headwall on both ends. Slide gate at headwall on the waterward end. Originally included in the 1968 O&M manual. FS Date: 9/17/2013

Headwall on WS toe.

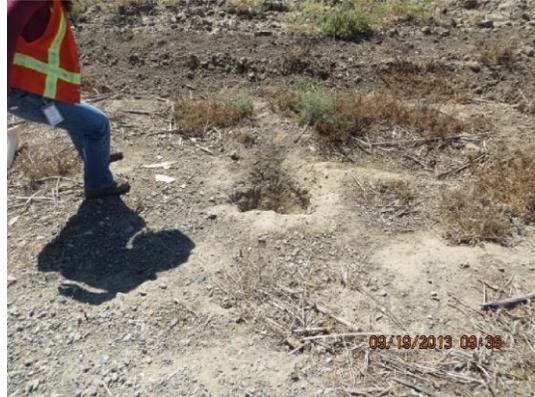
Photo 2 of 2 : UCIP_SP_2016_26403_47961.jpg

LM Start	0.05	Rating **	U	Issue No.	951 (cont)
LM End	0.05	Issue Type +	En	Location *	WS
Category	Supplemental			GPS Latitude/Longitude	
				Start	End
Item	DWR UCIP Field Study			37.657801 °	37.657801 °
				-121.253745 °	-121.253745 °
DWR ID					
Comment Code					
Inspector Comment					
FS_ID:26403 DS_ID:20699 EP_NO: N/A Repair Type: Urgent Crossing Status: Found UCIP Comments: Slide gate missing from WS toe. Pipe has heavy sediment buildup. FIELD_STRUCT_DESC: 18-inch corrugated metal pipe through levee 3-feet below crown. Concrete headwall on both ends. Slide gate at headwall on the waterward end. Originally included in the 1968 O&M manual. FS Date: 9/17/2013

Pipe and headwall visible on LS toe.

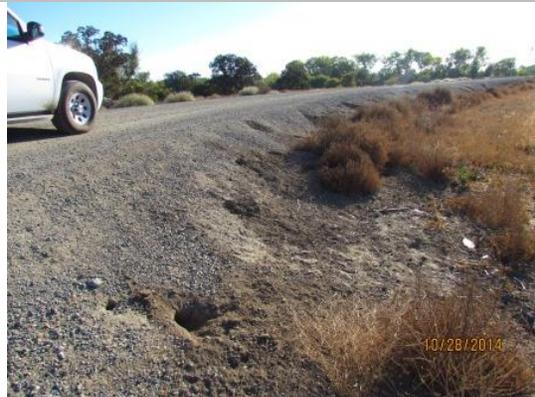
Photo 1 of 1 : SP_2016_RD2101_326_16_20160229_00010.jpg

LM Start	0.08	Rating **	M	Issue No.	16
LM End	0.08	Issue Type +	Ma	Location *	LS
Category	Earthen Levee			GPS Latitude/Longitude	
				Start	End
Item	Animal Control			37.657811 °	37.657811 °
				-121.253269 °	-121.253269 °
DWR ID	DWR_RD2101_01_s_2013_16				
Comment Code					
A3 : No rodents visible, but rodent burrows visible; need to backfill and compact or grout burrows.					
Inspector Comment					
Continue rodent extermination and backfilling the rodent burrows.

View of rodent burrows on the landside levee slope.

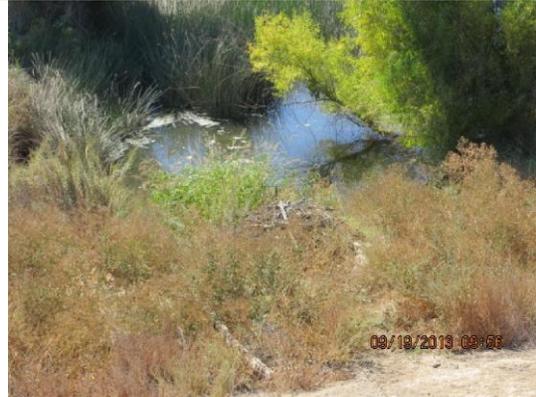
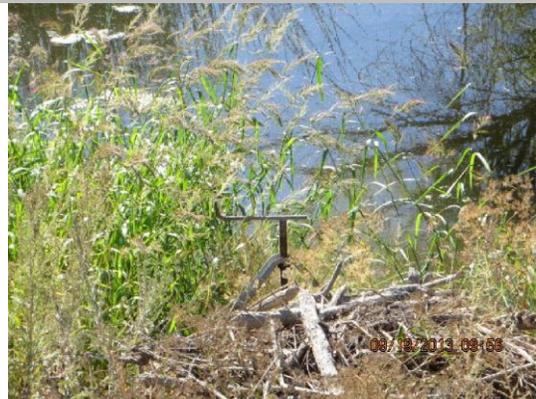
LM Start	0.31	Rating **	M	Issue No.	945
LM End	0.31	Issue Type +	En	Location *	LS
Category	Supplemental			GPS Latitude/Longitude	
				Start	End
Item	DWR UCIP Field Study			37.658142 °	37.658142 °
				-121.250047 °	-121.250047 °
DWR ID					
Comment Code					
Inspector Comment					
FS_ID:20785 DS_ID:20701 EP_NO: N/A Repair Type: Non-Urgent Crossing Status: Found UCIP Comments: Inlet blocked by soil from beaver activity. Outlet covered in soil. FIELD_STRUCT_DESC: 24-inch corrugated metal pipe through levee 21.0 feet below crown. Headwall and slide gate on the landward end. Concrete "U" headwall and flap gate on the waterward end. Originally included in the 1968 O&M manual. FS Date: 9/19/2013

Slide gate at concrete headwall on LS toe.

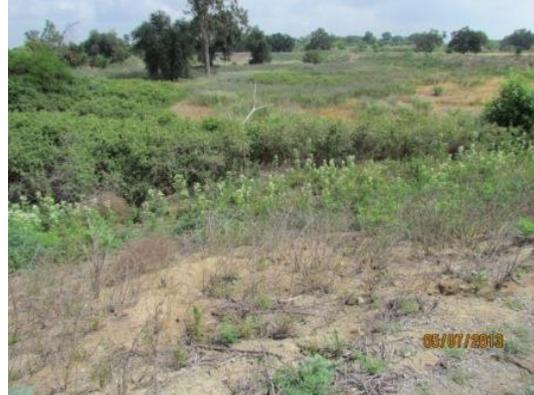
Photo 1 of 1 : SP_2016_RD2101_326_26_20160229_00012.jpg

LM Start	0.70	Rating **	A/W	Issue No.	26
LM End	0.70	Issue Type +	Ma	Location *	WS
Category	Earthen Levee			GPS Latitude/Longitude	
				Start	End
Item	Animal Control			37.659907 °	37.659907 °
				-121.244219 °	-121.244219 °
DWR ID	DWR_RD2101_01_s_2013_26				
Comment Code					
A1 : Exterminate rodents and backfill and compact or grout burrows.					
Inspector Comment

View of the rodent burrows on the waterside levee slope.

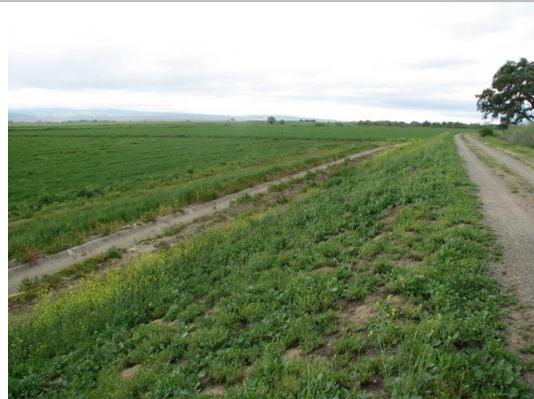
Photo 1 of 1 : SP_2016_RD2101_326_944_20160229_00018.jpg

LM Start	0.73	Rating **	M	Issue No.	944
LM End	1.76	Issue Type +	En	Location *	LS
Category	Earthen Levee			GPS Latitude/Longitude	
				Start	End
Item	Encroachments			37.659827 °	37.651049 °
				-121.243675 °	-121.231475 °
DWR ID	DWR_RD2101_01_s_2012_944				
Comment Code					
DT : Ditch					
Inspector Comment

Concrete ditch near landside toe.

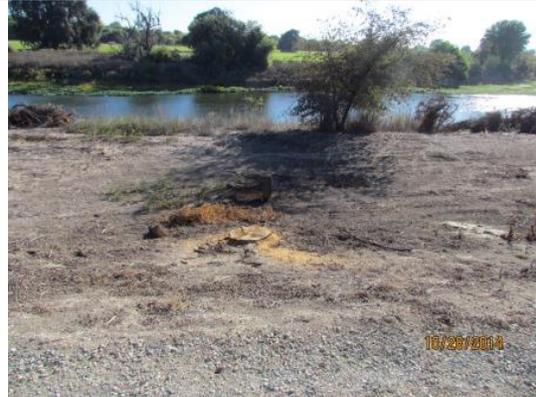
Photo 1 of 1 : SP_2016_RD2101_326_33_20160229_00017.jpg

LM Start	1.02	Rating **	N	Issue No.	33
LM End	1.02	Issue Type +	Ma	Location *	WS
Category	Earthen Levee		GPS Latitude/Longitude		
			Start	End	
Item	Trim / Thin Trees		37.656745 °	37.656745 °	
			-121.241104 °	-121.241104 °	
DWR ID	DWR_RD2101_01_f_2014_33				
Comment Code					
T5 : Tree stumps.					
Inspector Comment

View of the tree stump at the waterside levee toe.

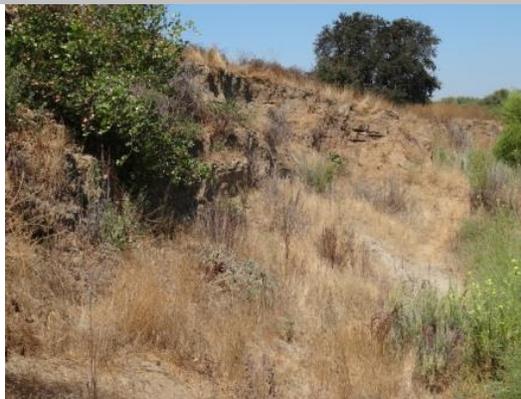
Photo 3 of 3 : SP_2016_RD2101_326_1_20160229_00003.jpg

LM Start	1.86	Rating **	U	Issue No.	1 (cont)
LM End	1.95	Issue Type +	Ma	Location *	WS
Category	Supplemental			GPS Latitude/Longitude	
				Start	End
Item	DWR Erosion Survey			37.650259 °	37.650259 °
				-121.228961 °	-121.228961 °
DWR ID	DWR_RD2101_01_s_2016_1

Comment Code					
Inspector Comment					
<p>08/19/2015: No significant change observed. 07/17/2014: No significant change observed. 09/20/2013: Site has been visited. There are signs of further erosion development along the levee slope and toe. 07/18/2012: The erosion has further developed toward levee crown. Vegetation has been removed. 08/18/2011: The erosion progressed significantly during the past flood season. The levee toe along the erosion site was washed away, and the erosion has cut the levee structure up to the point about 1/3 of the levee slope. The scarp height is approximately 17 feet. Very dense vegetation and trees are visible. 10/19/2010: No significant change observed on site. Remaining levee berm topsoil is of silty sand mixture. The erosion is near the downstream transition. An eddy has formed, and has scoured away a 100-foot section of the bank, possibly encroaching into the levee prism. Vegetation on site includes willows, oak, and cotton wood located from the bench to the toe. On the landside are rows of corn crop. 08/05/2010: Recommended for Repair, per CLRO. 2009: Site recommended as annual assessment and monitoring if critical erosion site, per CLRO CES Evaluation 2008 Report; an eddy has formed, eroding bank and intruding into the levee prism; Site # is the same as RM76.3, LM1.89; previously rated "U". 08/30/2007: Recommended for short list of immediate repair sites; silty sand levee material. [2015 Site ID:RD2101U01RM73.92]</p>

Close view of the erosion. Levee crest is approximately 8 feet above the erosion.

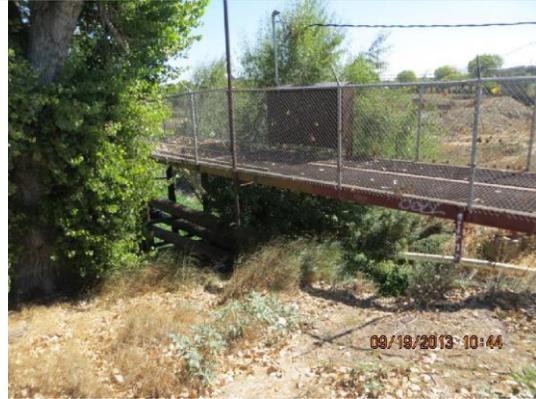
Photo 1 of 2 : UCIP_SP_2016_20865_35110.jpg

LM Start	2.71	Rating **	M	Issue No.	946
LM End	2.71	Issue Type +	En	Location *	CR
Category	Supplemental			GPS Latitude/Longitude	
				Start	End
Item	DWR UCIP Field Study			37.641976°	37.641976°
				-121.229745°	-121.229745°
DWR ID					
Comment Code					
Inspector Comment					
FS_ID:20865 DS_ID:20711 EP_NO: N/A Repair Type: Non-Urgent Crossing Status: Found UCIP Comments: Pipe leaking at pipe/concrete connection on WS slope. FIELD_STRUCT_DESC: 2 of 3: 20-inch steel pipe through levee 10.0-feet below crown encased in concrete. Pump on steel pier on WS. Gate valve in 16'X7' concrete vault on WS shoulder. Pipes discharge into concrete canal on LS toe. Originally included in the 1968 O&M manual. FS Date: 9/19/2013

Pump on metal pier on WS.

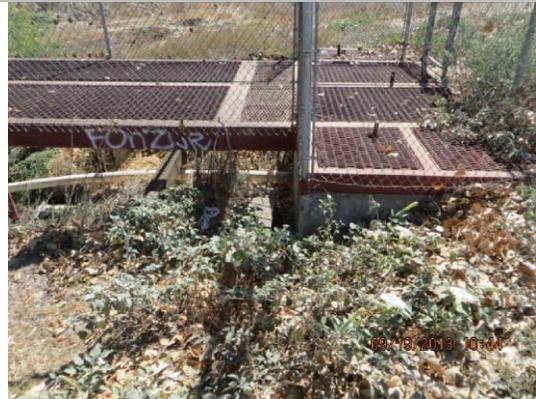
Photo 2 of 2 : UCIP_SP_2016_20865_35109.jpg

Gate valve in concrete vault on WS shoulder.

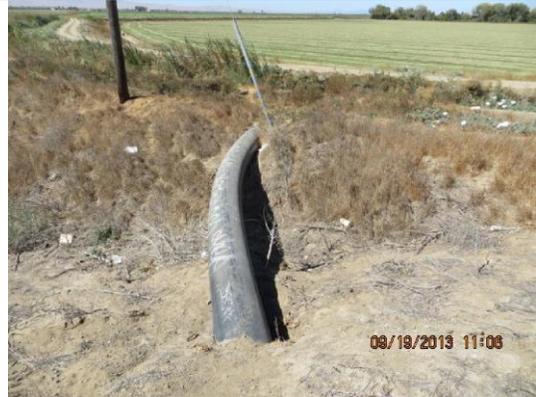
Photo 1 of 2 : UCIP_SP_2016_22915_39043.jpg

LM Start	2.72	Rating **	M	Issue No.	950
LM End	2.72	Issue Type +	En	Location *	CR
Category	Supplemental			GPS Latitude/Longitude	
				Start	End
Item	DWR UCIP Field Study			37.641798 °	37.641798 °
				-121.229714 °	-121.229714 °
DWR ID					
Comment Code					
Inspector Comment					
FS_ID:22915 DS_ID:24679 EP_NO: N/A Repair Type: Non-Urgent Crossing Status: Found UCIP Comments: No permit identified for this crossing. FIELD_STRUCT_DESC: 18-inch PVC irrigation pipe through the levee 3.5-feet below the crown. No pump or other appurtances visible. FS Date: 9/19/2013

18-inch PVC pipe visible at LS slope.

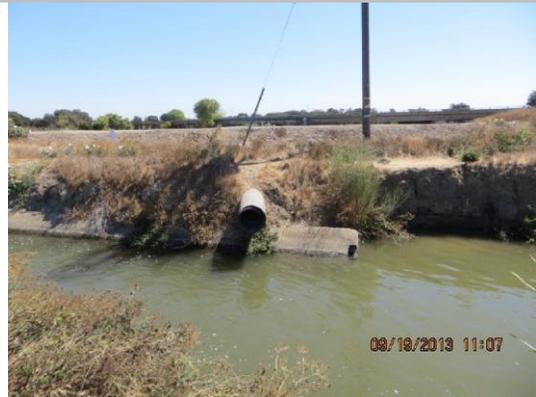
Photo 2 of 2 : UCIP_SP_2016_22915_39042.jpg

18-inch PVC pipe visible at outlet to irrigation canal on LS slope.

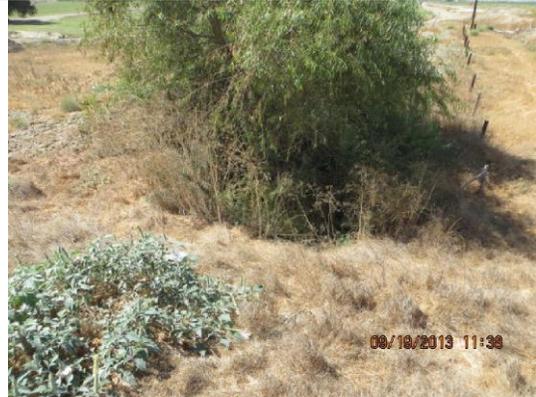
Photo 1 of 2 : UCIP_SP_2016_20872_35142.jpg

LM Start	2.82	Rating **	U	Issue No.	947
LM End	2.82	Issue Type +	En	Location *	CR
Category	Supplemental			GPS Latitude/Longitude	
				Start	End
Item	DWR UCIP Field Study			37.640566 °	37.640566 °
				-121.230216 °	-121.230216 °
DWR ID					
Comment Code					
Inspector Comment					
FS_ID:20872 DS_ID:20705 EP_NO: N/A Repair Type: Urgent Crossing Status: Found UCIP Comments: Flap gate missing from WS headwall. FIELD_STRUCT_DESC: 24-inch corrugated metal drain pipe through levee 11.0 feet below crown. Concrete "U" headwall on both ends. Flap gate on waterward end. Originally included in the 1968 O&M manual. FS Date: 9/19/2013

Concrete headwall visible at LS toe in ditch.

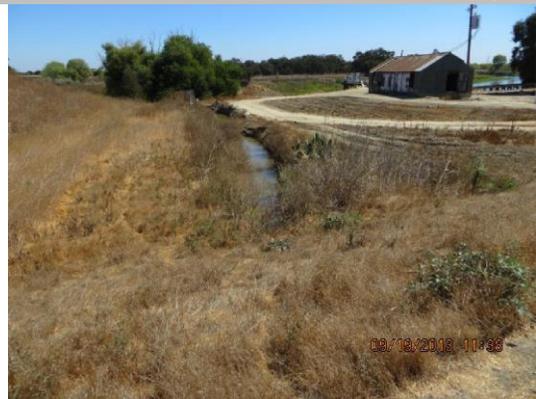
Photo 2 of 2 : UCIP_SP_2016_20872_35141.jpg

Concrete headwall visible on WS toe at canal.

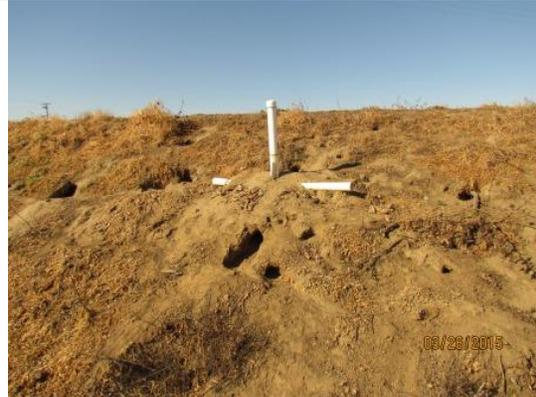
Photo 1 of 1 : SP_2016_RD2101_326_27_20160229_00013.jpg

LM Start	2.83	Rating **	U	Issue No.	27
LM End	2.83	Issue Type +	Ma	Location *	WS
Category	Earthen Levee		GPS Latitude/Longitude		
			Start	End	
Item	Animal Control		37.640425°	37.640425°	
			-121.230139°	-121.230139°	
DWR ID	DWR_RD2101_01_s_2012_27				
Comment Code					
A3 : No rodents visible, but rodent burrows visible; need to backfill and compact or grout burrows.					
Inspector Comment					
Burrows on both sides of levee. Backfill the burrows to restore the levee to original condition.

View of multiple rodent holes on the levee slope.

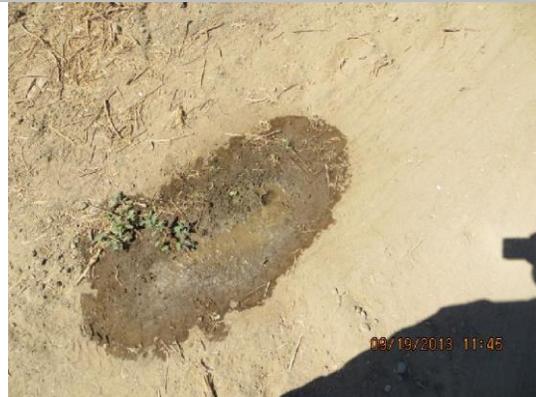
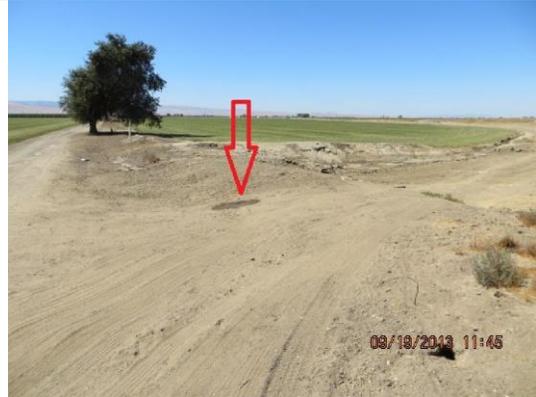
LM Start	2.85	Rating **	M	Issue No.	948
LM End	2.85	Issue Type +	En	Location *	WS
Category	Supplemental		GPS Latitude/Longitude		
			Start	End	
Item	DWR UCIP Field Study		37.640185°	37.640185°	
			-121.230067°	-121.230067°	
DWR ID					
Comment Code					
Inspector Comment					
FS_ID:20873 DS_ID:20706 EP_NO: N/A Repair Type: Non-Urgent Crossing Status: Found UCIP Comments: Leaks off LS toe may indicate internal failure. Good candidate for video inspection. FIELD_STRUCT_DESC: 1 of 2: 24-inch concrete irrigation pipe through levee 11.0 feet below crown. Pump on metal pier at WS berm. Screw gates in 6'X10.5' concrete box on waterward side. 12-inch steel riser next to concrete box with slide gates. Abandoned pump house on waterward side. Originally included in the 1968 O&M manual. FS Date: 9/19/2013

Leak in pipe off LS toe.

LM Start	2.85	Rating **	M	Issue No.	948 (cont)
LM End	2.85	Issue Type +	En	Location *	WS
Category	Supplemental			GPS Latitude/Longitude	
				Start	End
Item	DWR UCIP Field Study			37.640185 °	37.640185 °
				-121.230067 °	-121.230067 °
DWR ID					
Comment Code					
Inspector Comment					
FS_ID:20873 DS_ID:20706 EP_NO: N/A Repair Type: Non-Urgent Crossing Status: Found UCIP Comments: Leaks off LS toe may indicate internal failure. Good candidate for video inspection. FIELD_STRUCT_DESC: 1 of 2: 24-inch concrete irrigation pipe through levee 11.0 feet below crown. Pump on metal pier at WS berm. Screw gates in 6'X10.5' concrete box on waterward side. 12-inch steel riser next to concrete box with slide gates. Abandoned pump house on waterward side. Originally included in the 1968 O&M manual. FS Date: 9/19/2013

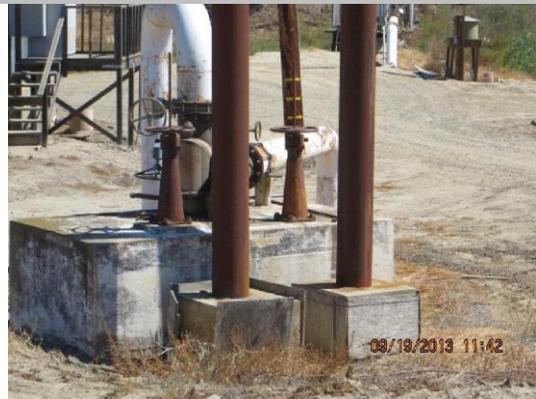
Photo 1 of 2 : UCIP_SP_2016_20874_35151.jpg

LM Start	2.85	Rating **	M	Issue No.	949
LM End	2.85	Issue Type +	En	Location *	WS
Category	Supplemental			GPS Latitude/Longitude	
				Start	End
Item	DWR UCIP Field Study			37.640185 °	37.640185 °
				-121.230067 °	-121.230067 °
DWR ID					
Comment Code					
Inspector Comment					
FS_ID:20874 DS_ID:20712 EP_NO: N/A Repair Type: Non-Urgent Crossing Status: Found UCIP Comments: Leak off LS toe may indicate internal failure. Good candidate for video inspection. FIELD_STRUCT_DESC: 2 of 2: 30-inch concrete pipe through levee 11.0 feet below crown. Pump on metal pier on waterside berm. 12-inch steel riser next to 6'X10.5' concrete box with Screw gate inside on waterward side. Abandoned Pump house on waterward side. Originally included in the 1968 O&M manual. FS Date: 9/19/2013

Gatevalve in concrete vault with standpipe off WS toe.

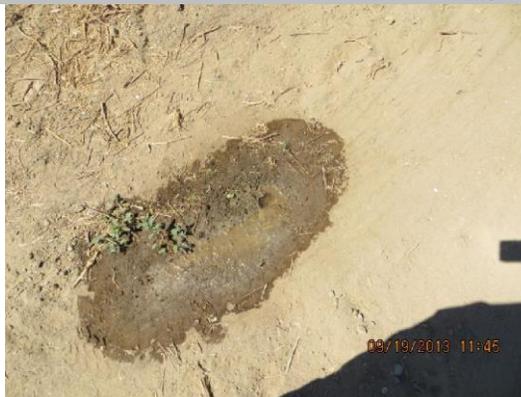
Photo 2 of 2 : UCIP_SP_2016_20874_35150.jpg

LM Start	2.85	Rating **	M	Issue No.	949 (cont)
LM End	2.85	Issue Type +	En	Location *	WS
Category	Supplemental			GPS Latitude/Longitude	
				Start	End
Item	DWR UCIP Field Study			37.640185 °	37.640185 °
				-121.230067 °	-121.230067 °
DWR ID					
Comment Code					
Inspector Comment					
FS_ID:20874 DS_ID:20712 EP_NO: N/A Repair Type: Non-Urgent Crossing Status: Found UCIP Comments: Leak off LS toe may indicate internal failure. Good candidate for video inspection. FIELD_STRUCT_DESC: 2 of 2: 30-inch concrete pipe through levee 11.0 feet below crown. Pump on metal pier on waterside berm. 12-inch steel riser next to 6'X10.5' concrete box with Screw gate inside on waterward side. Abandoned Pump house on waterward side. Originally included in the 1968 O&M manual. FS Date: 9/19/2013

Leak in pipe off LS toe.

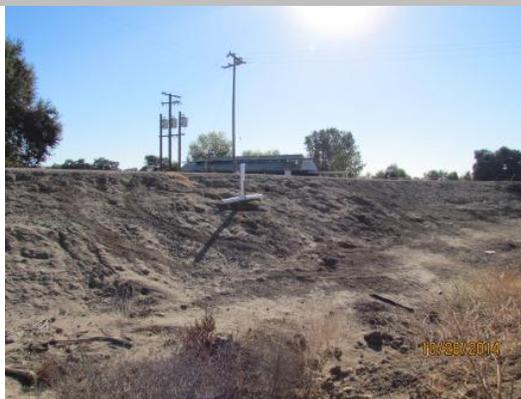
Photo 1 of 1 : SP_2016_RD2101_326_28_20160229_00014.jpg

LM Start	2.85	Rating **	A/W	Issue No.	28
LM End	2.85	Issue Type +	Ma	Location *	LS
Category	Earthen Levee			GPS Latitude/Longitude	
				Start	End
Item	Animal Control			37.640134 °	37.640134 °
				-121.230019 °	-121.230019 °
DWR ID	DWR_RD2101_01_s_2012_28				
Comment Code					
A3 : No rodents visible, but rodent burrows visible; need to backfill and compact or grout burrows.					
Inspector Comment					
Rodent holes were backfilled. Continue to monitor the area and exterminate the rodents.

View of numerous rodent holes with bait stations present.

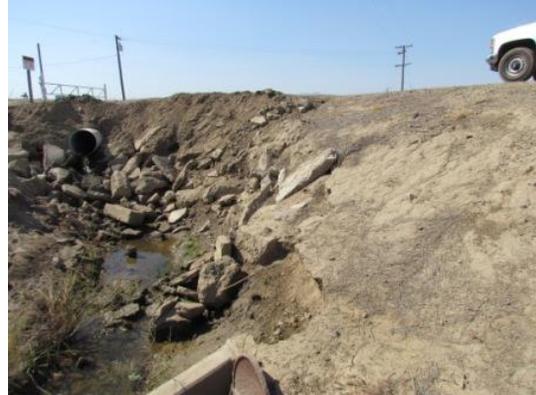
Photo 1 of 2 : SP_2016_RD2101_326_29_20160229_00015.jpg

LM Start	2.87	Rating **	M	Issue No.	29
LM End	2.87	Issue Type +	Ma	Location *	WS
Category	Earthen Levee			GPS Latitude/Longitude	
				Start	End
Item	Erosion / Bank Caving			37.639852 °	37.639852 °
				-121.229980 °	-121.229980 °
DWR ID	DWR_RD2101_01_s_2012_29				
Comment Code					
E1 : Note and monitor erosion site.					
Inspector Comment

View of repaired site, but it appears that erosion is still occurring. 09/25/2012

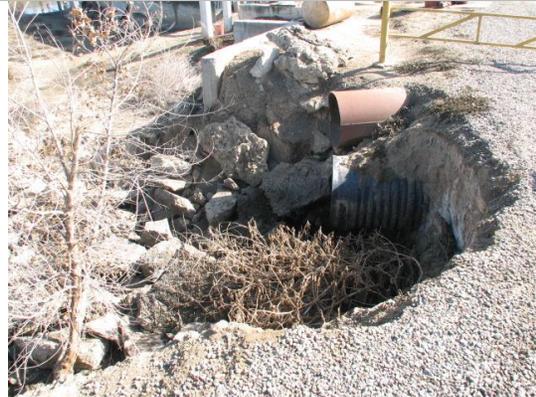
Photo 2 of 2 : SP_2016_RD2101_326_29_20160229_00016.jpg

Levee slope is being eroded at this location. Repair needed to preserve access road.

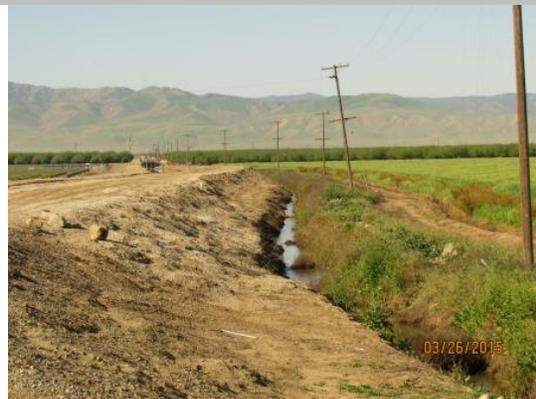
Photo 1 of 1 : SP_2016_RD2101_326_8_20160229_00006.jpg

LM Start	2.88	Rating **	M	Issue No.	8
LM End	3.15	Issue Type +	En	Location *	LS
Category	Earthen Levee			GPS Latitude/Longitude	
				Start	End
Item	Encroachments			37.639780 °	37.637167 °
				-121.230008 °	-121.233715 °
DWR ID	DWR_RD2101_01_f_2013_8				
Comment Code					
DT : Ditch					
Inspector Comment

View of the ditch at the landside levee toe.

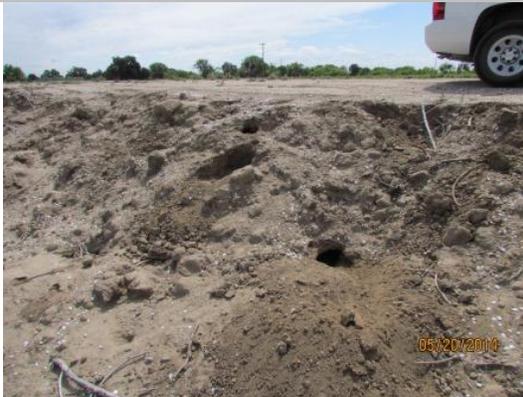
Photo 1 of 1 : SP_2016_RD2101_326_17_20160229_00011.jpg

LM Start	2.98	Rating **	M	Issue No.	17
LM End	2.98	Issue Type +	Ma	Location *	LS
Category	Earthen Levee		GPS Latitude/Longitude		
			Start	End	
Item	Animal Control		37.638760 °	37.638760 °	
			-121.231341 °	-121.231341 °	
DWR ID	DWR_RD2101_01_s_2012_17				
Comment Code					
A1 : Exterminate rodents and backfill and compact or grout burrows.					
Inspector Comment					
Active burrows with rodents present.

Numerous burrows present, some already caving in, others are active.

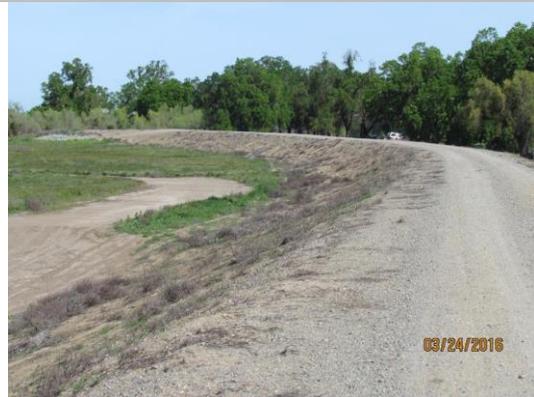
Photo 1 of 1 : SP_2016_RD2101_327_2_20160412_00002.jpg

View of the acceptable vegetation on the waterside levee slope.
