**Flood Control Project Maintenance  
Levee Inspections**

**Maintenance Issue Types Only, Levee Inspection Report By Mile - Fall 2015**

**Reclamation District No. 2101 Blewett**

Waterway	Bank	Unit Miles	Inspection Start/End	Inspector
Unit No. 01 San Joaquin River	Left	3.16	09/16/2015 09/16/2015	Maksim Khashchuk

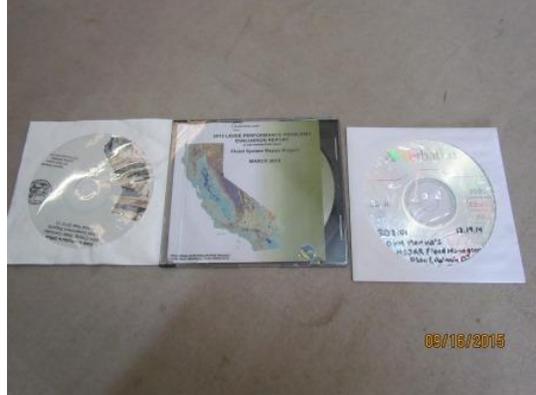
Photo 1 of 1 : FA\_2015\_RD2101\_326\_2\_20150921\_00025.jpg

LM Start		Rating **	A	Issue No.	2
LM End		Issue Type +	Ma	Location *	N/A
Category	Earthen Levee		GPS Latitude/Longitude		
			Start		End
Item	Operations & Maintenance Manuals			o	o
DWR ID	DWR_RD2101_01_s_2013_2				
Action/Comments					
Inspector Comments: The LMA has the O&M Manual available electronically.

View of the O&M manual and other documentation.

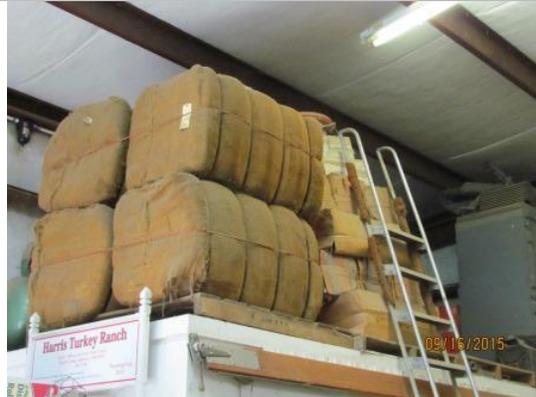
Photo 1 of 1 : FA\_2015\_RD2101\_326\_4\_20150921\_00024.jpg

LM Start		Rating **	A	Issue No.	4
LM End		Issue Type +	Ma	Location *	N/A
Category	Earthen Levee		GPS Latitude/Longitude		
			Start		End
Item	Emergency Supplies & Equipment			o	o
DWR ID	DWR_RD2101_01_s_2013_4				
Action/Comments					
Inspector Comments: LMA has emergency supplies on site at the warehouse.

View of the emergency flood fight supplies in the shop.

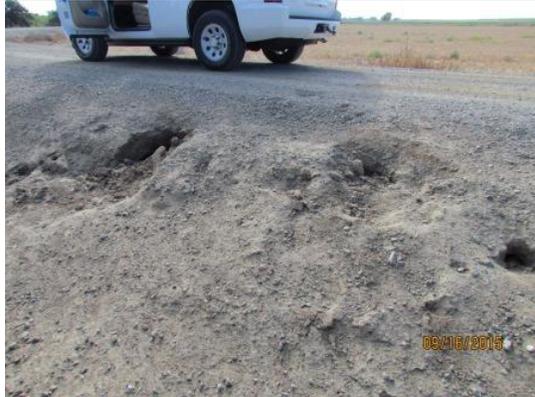
Photo 1 of 1 : FA\_2015\_RD2101\_326\_12\_20150921\_00026.jpg

LM Start	<b>0.04</b>	Rating **	U	Issue No.	<b>12</b>
LM End	<b>0.04</b>	Issue Type +	Ma	Location *	WS
Category	Earthen Levee		GPS Latitude/Longitude		
			Start	End	
Item	Animal Control		37.657648 °	37.657648 °	
			-121.253812 °	-121.253812 °	
DWR ID	DWR_RD2101_01_s_2012_12				
Action/Comments					
No rodents visible, but rodent burrows visible; need to backfill and compact or grout burrows.

View of the rodent holes on the waterside levee slope, facing upstream.

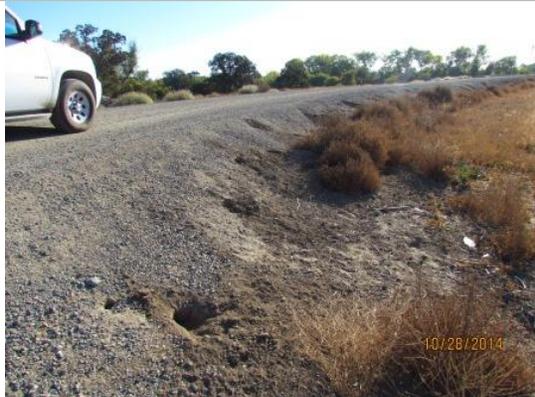
Photo 1 of 1 : FA\_2015\_RD2101\_326\_16\_20150910\_00008.jpg

LM Start	<b>0.08</b>	Rating **	M	Issue No.	<b>16</b>
LM End	<b>0.08</b>	Issue Type +	Ma	Location *	LS
Category	Earthen Levee		GPS Latitude/Longitude		
			Start	End	
Item	Animal Control		37.657811 °	37.657811 °	
			-121.253269 °	-121.253269 °	
DWR ID	DWR_RD2101_01_s_2013_16				
Action/Comments					
No rodents visible, but rodent burrows visible; need to backfill and compact or grout burrows. Inspector Comments: Continue rodent extermination and backfilling the rodent burrows.

View of rodent burrows on the landside levee slope.

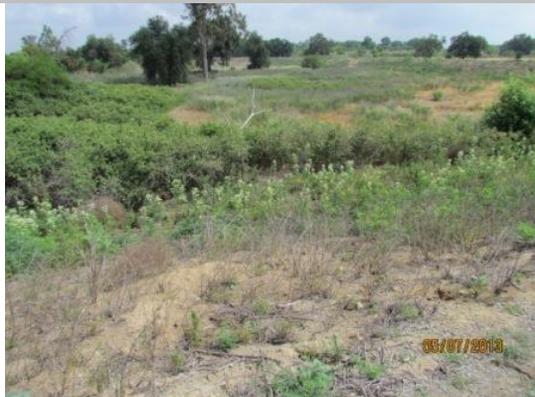
Photo 1 of 1 : FA\_2015\_RD2101\_326\_26\_20150910\_00010.jpg

LM Start	<b>0.70</b>	Rating **	A/W	Issue No.	<b>26</b>
LM End	<b>0.70</b>	Issue Type +	Ma	Location *	WS
Category	Earthen Levee		GPS Latitude/Longitude		
			Start	End	
Item	Animal Control		37.659907 °	37.659907 °	
			-121.244219 °	-121.244219 °	
DWR ID	DWR_RD2101_01_s_2013_26				
Action/Comments					
Exterminate rodents and backfill and compact or grout burrows.

View of the rodent burrows on the waterside levee slope.

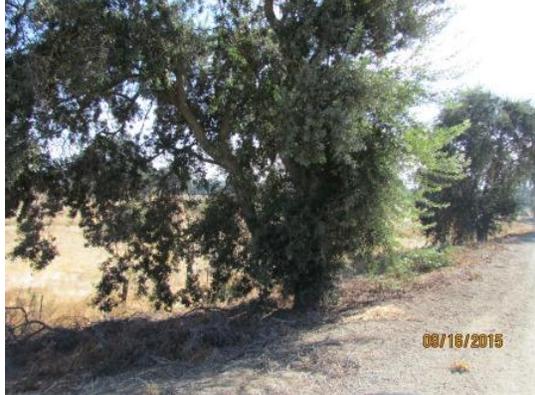
Photo 1 of 1 : FA\_2015\_RD2101\_326\_11\_20150921\_00027.jpg

LM Start	<b>0.75</b>	Rating **	M	Issue No.	<b>11</b>
LM End	<b>0.75</b>	Issue Type +	Ma	Location *	WS
Category	Earthen Levee		GPS Latitude/Longitude		
			Start	End	
Item	Trim / Thin Trees		37.659705 °	37.659705 °	
			-121.243306 °	-121.243306 °	
DWR ID	DWR_RD2101_01_f_2012_11				
Action/Comments					
Trim trees to at least five feet above ground level. Inspector Comments: Trim tree to allow access and visibility.

View of tree branches obstructing waterside slope.

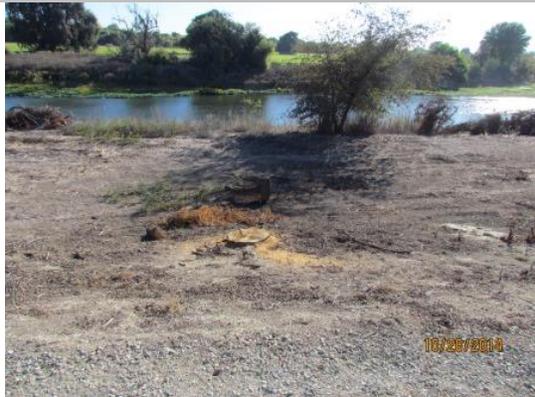
Photo 1 of 1 : FA\_2015\_RD2101\_326\_33\_20150910\_00016.jpg

LM Start	<b>1.02</b>	Rating **	N	Issue No.	<b>33</b>
LM End	<b>1.02</b>	Issue Type +	Ma	Location *	WS
Category	Earthen Levee		GPS Latitude/Longitude		
			Start	End	
Item	Trim / Thin Trees		37.656745 °	37.656745 °	
			-121.241104 °	-121.241104 °	
DWR ID	DWR_RD2101_01_f_2014_33				
Action/Comments					
Tree stumps.

View of the tree stump at the waterside levee toe.

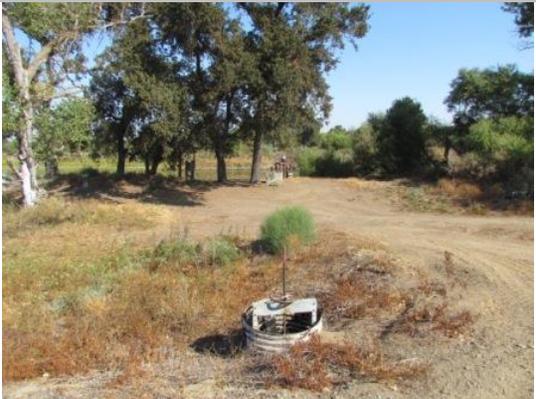
Photo 1 of 1 : FA\_2015\_RD2101\_326\_13\_20150910\_00007.jpg

LM Start	<b>1.59</b>	Rating **	A/W	Issue No.	<b>13</b>
LM End	<b>1.59</b>	Issue Type +	Ma	Location *	WS
Category	Earthen Levee		GPS Latitude/Longitude		
			Start	End	
Item	Encroachments		37.651555 °	37.651555 °	
			-121.234319 °	-121.234319 °	
DWR ID	DWR_RD2101_01_s_2012_13				
Action/Comments					
Pipe Inspector Comments: Pipe penetrates through levee. Closure valve on water side slope.

Photo of pump in background and CMP riser with valve in foreground.

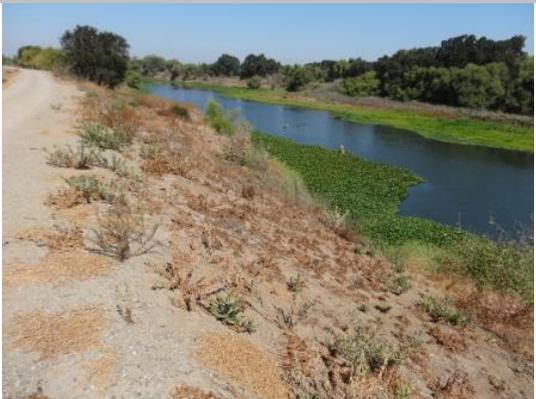
Photo 1 of 3 : SJR2015\_RD2101U01RM73.92\_1.jpg

LM Start	<b>1.86</b>	Rating **	U	Issue No.	<b>1</b>
LM End	<b>1.95</b>	Issue Type +	Ma	Location *	WS
Category	Supplemental		GPS Latitude/Longitude		
			Start	End

Item	DWR Erosion Survey		37.650259 °	37.650259 °	
			-121.228961 °	-121.228961 °	
DWR ID					
Action/Comments					
Inspector Comments: 08/19/2015: No significant change observed. 07/17/2014: No significant change observed. 09/20/2013: Site has been visited. There are signs of further erosion development along the levee slope and toe. 07/18/2012: The erosion has further developed toward levee crown. Vegetation has been removed. 08/18/2011: The erosion progressed significantly during the past flood season. The levee toe along the erosion site was washed away, and the erosion has cut the levee structure up to the point about 1/3 of the levee slope. The scarp height is approximately 17 feet. Very dense vegetation and trees are visible. 10/19/2010: No significant change observed on site. Remaining levee berm topsoil is of silty sand mixture. The erosion is near the downstream transition. An eddy has formed, and has scoured away a 100-foot section of the bank, possibly encroaching into the levee prism. Vegetation on site includes willows, oak, and cotton wood located from the bench to the toe. On the landside are rows of corn crop. 08/05/2010: Recommended for Repair, per CLRO. 2009: Site recommended as annual assessment and monitoring if critical erosion site, per CLRO CES Evaluation 2008 Report; an eddy has formed, eroding bank and intruding into the levee prism; Site # is the same as RM76.3, LM1.89; previously rated "U". 08/30/2007: Recommended for short list of immediate repair sites; silty sand levee material. [2015 Site ID:RD2101U01RM73.92]

Upstream view of the erosion.

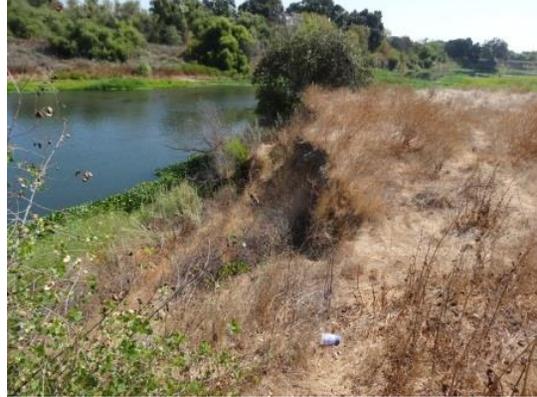
Photo 2 of 3 : SJR2015\_RD2101U01RM73.92\_3.jpg

Inspector Comments: 08/19/2015: No significant change observed.  
 07/17/2014: No significant change observed.  
 09/20/2013: Site has been visited. There are signs of further erosion development along the levee slope and toe.  
 07/18/2012: The erosion has further developed toward levee crown. Vegetation has been removed.  
 08/18/2011: The erosion progressed significantly during the past flood season. The levee toe along the erosion site was washed away, and the erosion has cut the levee structure up to the point about 1/3 of the levee slope. The scarp height is approximately 17 feet. Very dense vegetation and trees are visible.  
 10/19/2010: No significant change observed on site. Remaining levee berm topsoil is of silty sand mixture. The erosion is near the downstream transition. An eddy has formed, and has scoured away a 100-foot section of the bank, possibly encroaching into the levee prism. Vegetation on site includes willows, oak, and cotton wood located from the bench to the toe. On the landside are rows of corn crop.

08/05/2010: Recommended for Repair, per CLRO.  
 2009: Site recommended as annual assessment and monitoring if critical erosion site, per CLRO CES Evaluation 2008 Report; an eddy has formed, eroding bank and intruding into the levee prism; Site # is the same as RM76.3, LM1.89; previously rated "U".  
 08/30/2007: Recommended for short list of immediate repair sites; silty sand levee material. [2015 Site ID:RD2101U01RM73.92]

Downstream view of the erosion.

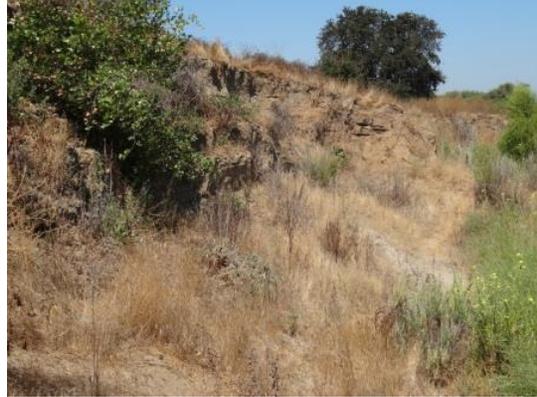
Photo 3 of 3 : SJR2015\_RD2101U01RM73.92\_8.jpg

LM Start	1.86	Rating **	U	Issue No.	1 (cont)
LM End	1.95	Issue Type +	Ma	Location *	WS
Category	Supplemental			GPS Latitude/Longitude	
				Start	End
Item	DWR Erosion Survey			37.650259 °	37.650259 °
DWR ID				-121.228961 °	-121.228961 °
Action/Comments					
<p>Inspector Comments: 08/19/2015: No significant change observed. 07/17/2014: No significant change observed. 09/20/2013: Site has been visited. There are signs of further erosion development along the levee slope and toe. 07/18/2012: The erosion has further developed toward levee crown. Vegetation has been removed. 08/18/2011: The erosion progressed significantly during the past flood season. The levee toe along the erosion site was washed away, and the erosion has cut the levee structure up to the point about 1/3 of the levee slope. The scarp height is approximately 17 feet. Very dense vegetation and trees are visible. 10/19/2010: No significant change observed on site. Remaining levee berm topsoil is of silty sand mixture. The erosion is near the downstream transition. An eddy has formed, and has scoured away a 100-foot section of the bank, possibly encroaching into the levee prism. Vegetation on site includes willows, oak, and cotton wood located from the bench to the toe. On the landside are rows of corn crop. 08/05/2010: Recommended for Repair, per CLRO. 2009: Site recommended as annual assessment and monitoring if critical erosion site, per CLRO CES Evaluation 2008 Report; an eddy has formed, eroding bank and intruding into the levee prism; Site # is the same as RM76.3, LM1.89; previously rated "U". 08/30/2007: Recommended for short list of immediate repair sites; silty sand levee material. [2015 Site ID:RD2101U01RM73.92]</p>

Close view of the erosion. Levee crest is approximately 8 feet above the erosion.

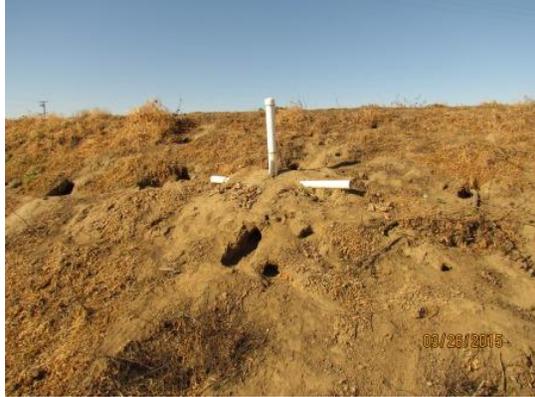
Photo 1 of 1 : FA\_2015\_RD2101\_326\_27\_20150910\_00011.jpg

LM Start	<b>2.83</b>	Rating **	U	Issue No.	<b>27</b>
LM End	<b>2.83</b>	Issue Type +	Ma	Location *	WS
Category	Earthen Levee		GPS Latitude/Longitude		
			Start	End	
Item	Animal Control		37.640425 °	37.640425 °	
			-121.230139 °	-121.230139 °	
DWR ID	DWR_RD2101_01_s_2012_27				
Action/Comments					
No rodents visible, but rodent burrows visible; need to backfill and compact or grout burrows. Inspector Comments: Burrows on both sides of levee. Backfill the burrows to restore the levee to original condition.

View of multiple rodent holes on the levee slope.

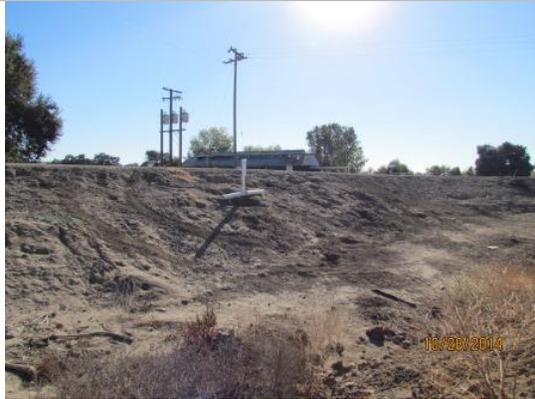
Photo 1 of 1 : FA\_2015\_RD2101\_326\_28\_20150910\_00012.jpg

LM Start	<b>2.85</b>	Rating **	A/W	Issue No.	<b>28</b>
LM End	<b>2.85</b>	Issue Type +	Ma	Location *	LS
Category	Earthen Levee		GPS Latitude/Longitude		
			Start	End	
Item	Animal Control		37.640134 °	37.640134 °	
			-121.230019 °	-121.230019 °	
DWR ID	DWR_RD2101_01_s_2012_28				
Action/Comments					
No rodents visible, but rodent burrows visible; need to backfill and compact or grout burrows. Inspector Comments: Rodent holes were backfilled. Continue to monitor the area and exterminate the rodents.

View of numerous rodent holes with bait stations present.

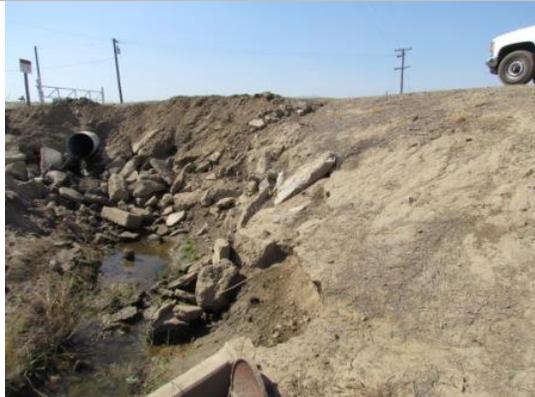
Photo 1 of 2 : FA\_2015\_RD2101\_326\_29\_20150910\_00013.jpg

LM Start	<b>2.87</b>	Rating **	M	Issue No.	<b>29</b>
LM End	<b>2.87</b>	Issue Type +	Ma	Location *	WS
Category	Earthen Levee		GPS Latitude/Longitude		
			Start	End	
Item	Erosion / Bank Caving		37.639852 °	37.639852 °	
			-121.229980 °	-121.229980 °	
DWR ID	DWR_RD2101_01_s_2012_29				
Action/Comments					
Note and monitor erosion site.

View of repaired site, but it appears that erosion is still occurring.  
09/25/2012

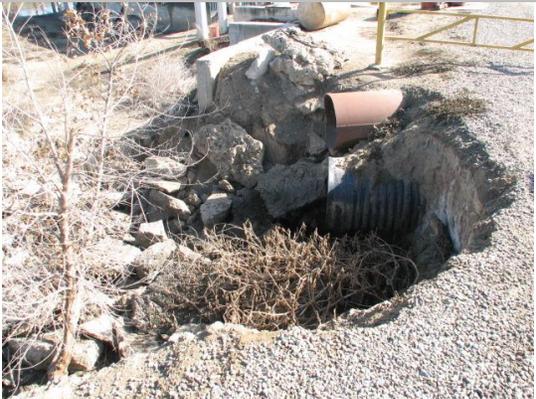
Photo 2 of 2 : FA\_2015\_RD2101\_326\_29\_20150910\_00014.jpg

LM Start	<b>2.87</b>	Rating **	M	Issue No.	<b>29 (cont)</b>
LM End	<b>2.87</b>	Issue Type +	Ma	Location *	WS
Category	Earthen Levee			GPS Latitude/Longitude	
				Start	End
Item	Erosion / Bank Caving			37.639852 °	37.639852 °
				-121.229980 °	-121.229980 °
DWR ID	DWR_RD2101_01_s_2012_29				
Action/Comments					
Note and monitor erosion site.

Levee slope is being eroded at this location. Repair needed to preserve access road.

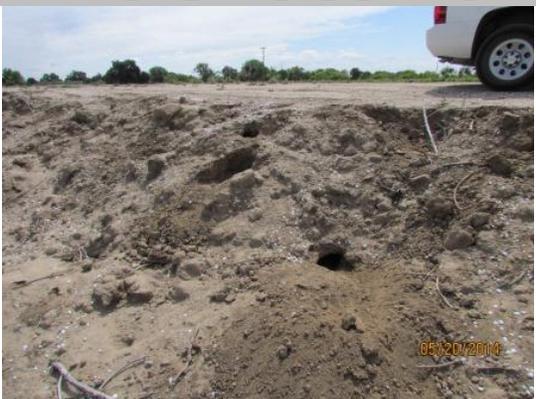
Photo 1 of 1 : FA\_2015\_RD2101\_326\_17\_20150910\_00009.jpg

LM Start	<b>2.98</b>	Rating **	M	Issue No.	<b>17</b>
LM End	<b>2.98</b>	Issue Type +	Ma	Location *	LS
Category	Earthen Levee			GPS Latitude/Longitude	
				Start	End
Item	Animal Control			37.638760 °	37.638760 °
				-121.231341 °	-121.231341 °
DWR ID	DWR_RD2101_01_s_2012_17				
Action/Comments					
Exterminate rodents and backfill and compact or grout burrows. Inspector Comments: Active burrows with rodents present.

Numerous burrows present, some already caving in, others are active.

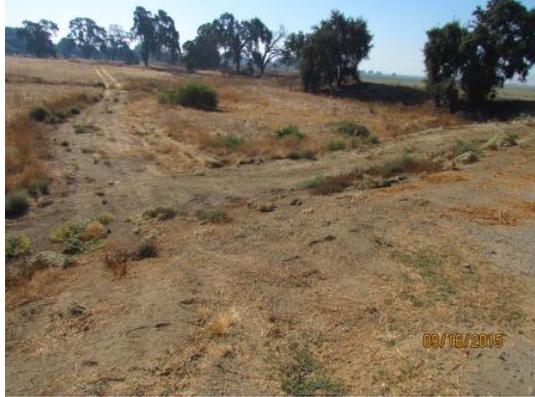
Photo 1 of 1 : FA\_2015\_RD2101\_327\_1\_20150921\_00002.jpg

LM Start	<b>0.03</b>	Rating **	A/W	Issue No.	<b>1</b>
LM End	<b>0.03</b>	Issue Type +	Ma	Location *	WS
Category	Earthen Levee		GPS Latitude/Longitude		
			Start	End	
Item	Slope Stability		37.660251 °	37.660251 °	
			-121.243372 °	-121.243372 °	
DWR ID	DWR_RD2101_02_f_2015_1				
Action/Comments					
Repair the levee slope damaged by vehicle traffic and prevent access where possible. Inspector Comments: Monitor the slope for potential further erosion. Repair as needed.

View of the vehicle tracks on the levee slope.
