**Flood Control Project Maintenance
Levee Inspections**

Maintenance Issue Types Only, Levee Inspection Report By Mile - Spring 2016

Reclamation District No. 2101 Blewett

Waterway	Bank	Unit Miles	Inspection Start/End	Inspector
Unit No. 01 San Joaquin River	Left	3.16	03/24/2016 03/24/2016	Maksim Khashchuk

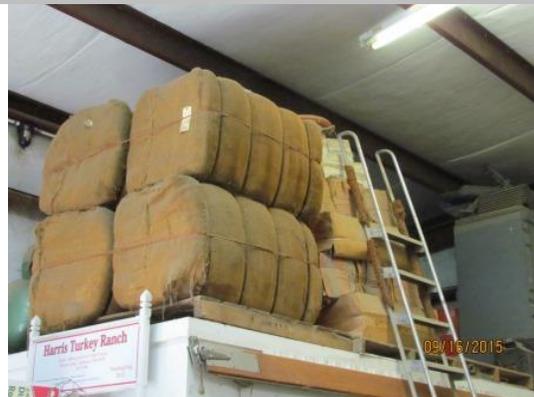
Photo 1 of 1 : SP_2016_RD2101_326_4_20160229_00005.jpg

LM Start		Rating **	A	Issue No.	4
LM End		Issue Type +	Ma	Location *	N/A
Category	Earthen Levee		GPS Latitude/Longitude		
			Start	End	
Item	Emergency Supplies & Equipment			o	o
DWR ID	DWR_RD2101_01_s_2013_4			o	o
Comment Code					
Inspector Comment					
LMA has emergency supplies on site at the warehouse.

View of the emergency flood fight supplies in the shop.

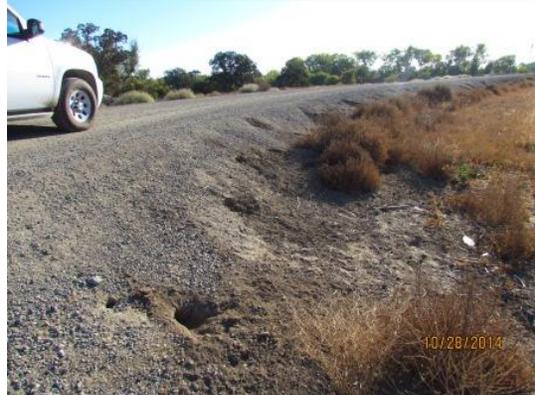
Photo 1 of 1 : SP_2016_RD2101_326_16_20160229_00010.jpg

LM Start	0.08	Rating **	M	Issue No.	16
LM End	0.08	Issue Type +	Ma	Location *	LS
Category	Earthen Levee		GPS Latitude/Longitude		
			Start	End	
Item	Animal Control		37.657811 °	37.657811 °	
			-121.253269 °	-121.253269 °	
DWR ID	DWR_RD2101_01_s_2013_16				
Comment Code					
A3 : No rodents visible, but rodent burrows visible; need to backfill and compact or grout burrows.					
Inspector Comment					
Continue rodent extermination and backfilling the rodent burrows.

View of rodent burrows on the landside levee slope.

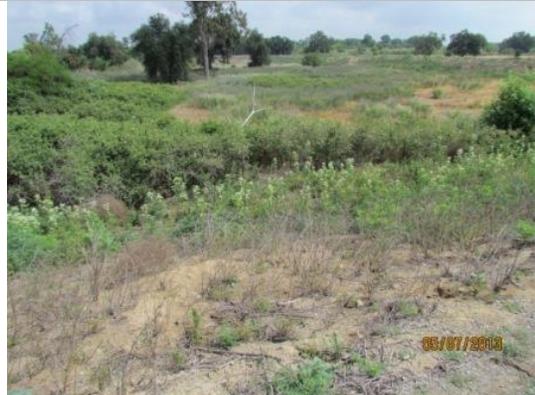
Photo 1 of 1 : SP_2016_RD2101_326_26_20160229_00012.jpg

LM Start	0.70	Rating **	A/W	Issue No.	26
LM End	0.70	Issue Type +	Ma	Location *	WS
Category	Earthen Levee		GPS Latitude/Longitude		
			Start	End	
Item	Animal Control		37.659907 °	37.659907 °	
			-121.244219 °	-121.244219 °	
DWR ID	DWR_RD2101_01_s_2013_26				
Comment Code					
A1 : Exterminate rodents and backfill and compact or grout burrows.					
Inspector Comment

View of the rodent burrows on the waterside levee slope.

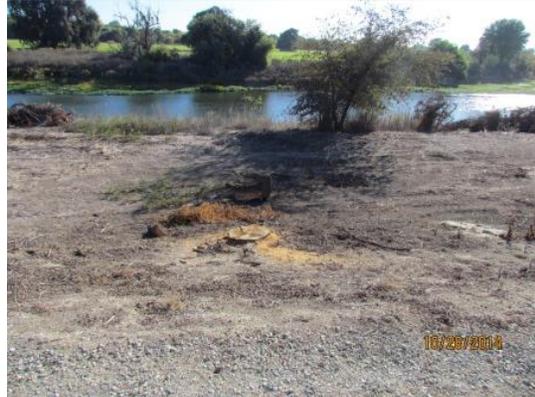
Photo 1 of 1 : SP_2016_RD2101_326_33_20160229_00017.jpg

LM Start	1.02	Rating **	N	Issue No.	33
LM End	1.02	Issue Type +	Ma	Location *	WS
Category	Earthen Levee		GPS Latitude/Longitude		
			Start	End	
Item	Trim / Thin Trees		37.656745 °	37.656745 °	
			-121.241104 °	-121.241104 °	
DWR ID	DWR_RD2101_01_f_2014_33				
Comment Code					
T5 : Tree stumps.					
Inspector Comment

View of the tree stump at the waterside levee toe.

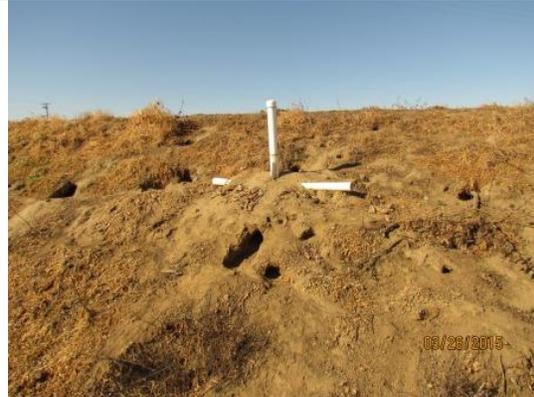
Photo 1 of 1 : SP_2016_RD2101_326_27_20160229_00013.jpg

LM Start	2.83	Rating **	U	Issue No.	27
LM End	2.83	Issue Type +	Ma	Location *	WS
Category	Earthen Levee		GPS Latitude/Longitude		
			Start	End	
Item	Animal Control		37.640425 °	37.640425 °	
			-121.230139 °	-121.230139 °	
DWR ID	DWR_RD2101_01_s_2012_27				
Comment Code					
A3 : No rodents visible, but rodent burrows visible; need to backfill and compact or grout burrows.					
Inspector Comment					
Burrows on both sides of levee. Backfill the burrows to restore the levee to original condition.

View of multiple rodent holes on the levee slope.

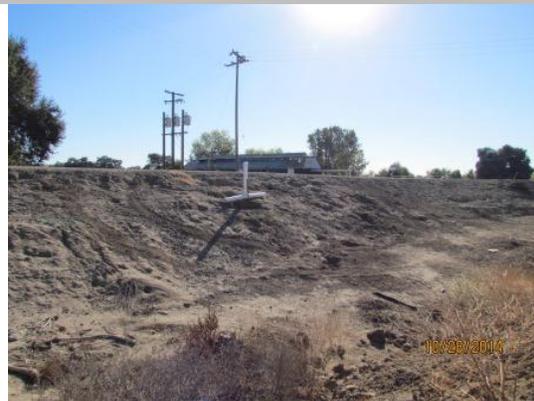
Photo 1 of 1 : SP_2016_RD2101_326_28_20160229_00014.jpg

LM Start	2.85	Rating **	A/W	Issue No.	28
LM End	2.85	Issue Type +	Ma	Location *	LS
Category	Earthen Levee		GPS Latitude/Longitude		
			Start	End	
Item	Animal Control		37.640134 °	37.640134 °	
			-121.230019 °	-121.230019 °	
DWR ID	DWR_RD2101_01_s_2012_28				
Comment Code					
A3 : No rodents visible, but rodent burrows visible; need to backfill and compact or grout burrows.					
Inspector Comment					
Rodent holes were backfilled. Continue to monitor the area and exterminate the rodents.

View of numerous rodent holes with bait stations present.

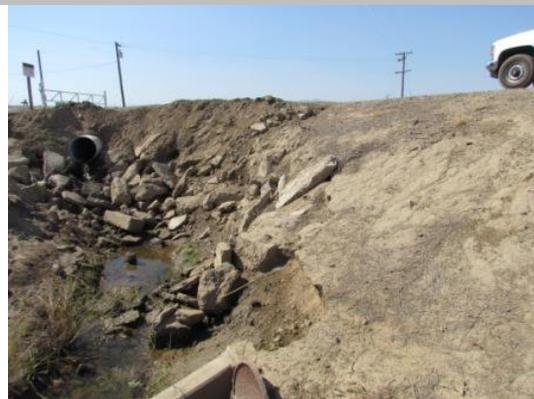
Photo 1 of 2 : SP_2016_RD2101_326_29_20160229_00015.jpg

LM Start	2.87	Rating **	M	Issue No.	29
LM End	2.87	Issue Type +	Ma	Location *	WS
Category	Earthen Levee		GPS Latitude/Longitude		
			Start	End	
Item	Erosion / Bank Caving		37.639852 °	37.639852 °	
			-121.229980 °	-121.229980 °	
DWR ID	DWR_RD2101_01_s_2012_29				
Comment Code					
E1 : Note and monitor erosion site.					
Inspector Comment

View of repaired site, but it appears that erosion is still occurring.
09/25/2012

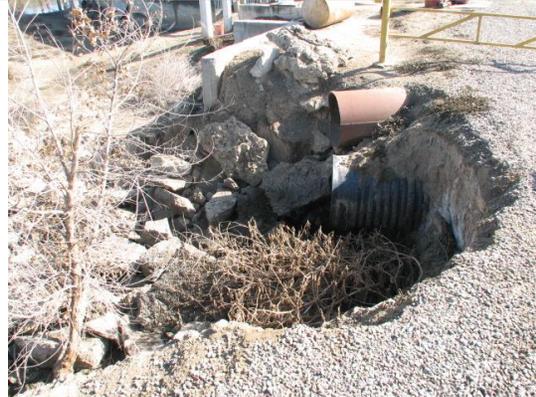
Photo 2 of 2 : SP_2016_RD2101_326_29_20160229_00016.jpg

LM Start	2.87	Rating **	M	Issue No.	29 (cont)
LM End	2.87	Issue Type +	Ma	Location *	WS
Category	Earthen Levee			GPS Latitude/Longitude	
				Start	End
Item	Erosion / Bank Caving			37.639852 °	37.639852 °
				-121.229980 °	-121.229980 °
DWR ID	DWR_RD2101_01_s_2012_29				
Comment Code					
E1 : Note and monitor erosion site.					
Inspector Comment

Levee slope is being eroded at this location. Repair needed to preserve access road.

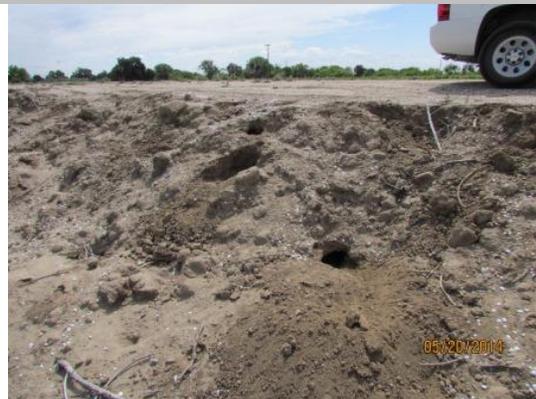
Photo 1 of 1 : SP_2016_RD2101_326_17_20160229_00011.jpg

LM Start	2.98	Rating **	M	Issue No.	17
LM End	2.98	Issue Type +	Ma	Location *	LS
Category	Earthen Levee			GPS Latitude/Longitude	
				Start	End
Item	Animal Control			37.638760 °	37.638760 °
				-121.231341 °	-121.231341 °
DWR ID	DWR_RD2101_01_s_2012_17				
Comment Code					
A1 : Exterminate rodents and backfill and compact or grout burrows.					
Inspector Comment					
Active burrows with rodents present.

Numerous burrows present, some already caving in, others are active.

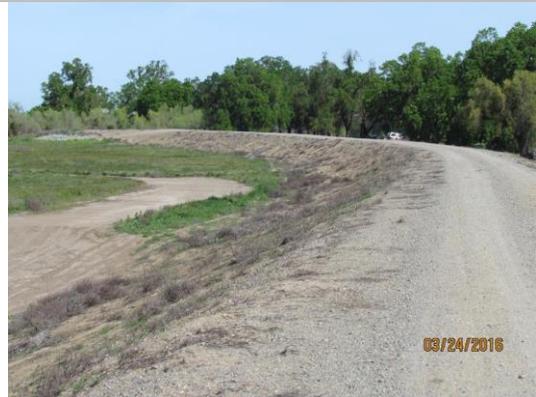
Photo 1 of 1 : SP_2016_RD2101_327_2_20160412_00002.jpg

LM Start	0.13	Rating **	A	Issue No.	2
LM End	0.13	Issue Type +	Ma	Location *	WS
Category	Earthen Levee		GPS Latitude/Longitude		
			Start	End	
Item	Vegetation		37.661612 °	37.661612 °	
			-121.242976 °	-121.242976 °	
DWR ID	DWR_RD2101_02_s_2016_2				
Comment Code					
V1 : Control annual grass and weeds on the levee slopes and easements.					
Inspector Comment

View of the acceptable vegetation on the waterside levee slope.
