**Flood Control Project Maintenance
Levee Inspections**

Fall 2012 Levee Maintenance Deficiency Summary Report

Sacramento River Basin

Reclamation District No. 2103 Wheatland Vicinity

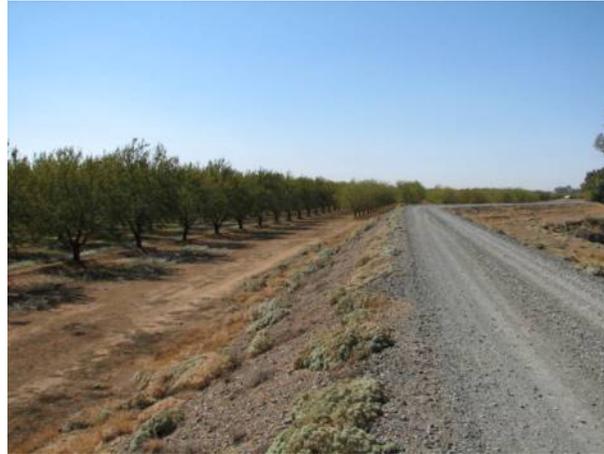
cathom_f_20121106_228.JPG

Levee Mile Report Line	4
Start Levee Mile	0.09
End Levee Mile	4.62
Location	Land Side
Category	Earthen Levee
Item	Vegetation

This photo shows the landside levee slope at levee mile 2.68.

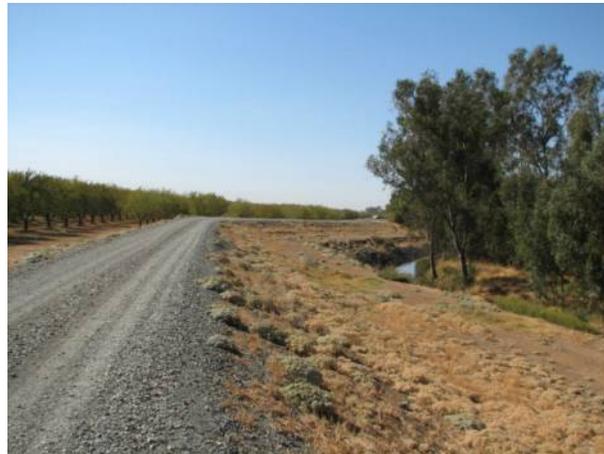
cathom_f_20121106_229.JPG

Levee Mile Report Line	5
Start Levee Mile	0.09
End Levee Mile	4.62
Location	Water Side
Category	Earthen Levee
Item	Vegetation

This photo shows the waterside slope at levee mile 2.68.

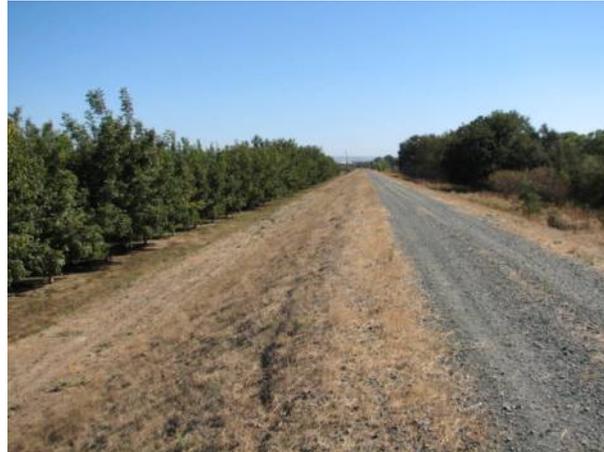
cathom_f_20121106_226.JPG

Levee Mile Report Line	1
Start Levee Mile	0.05
End Levee Mile	4.84
Location	Land Side
Category	Earthen Levee
Item	Vegetation

This photo shows the landside slope of the levee at levee mile 0.00.

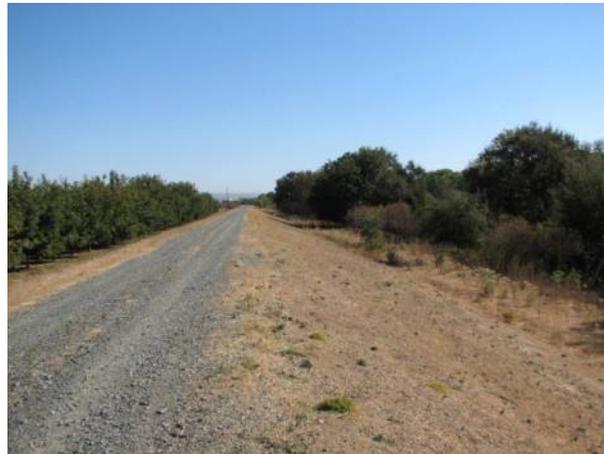
cathom_f_20121106_227.JPG

Levee Mile Report Line	2
Start Levee Mile	0.05
End Levee Mile	4.84
Location	Water Side
Category	Earthen Levee
Item	Vegetation

This photo shows the waterside slope of the levee at levee mile 0.00.

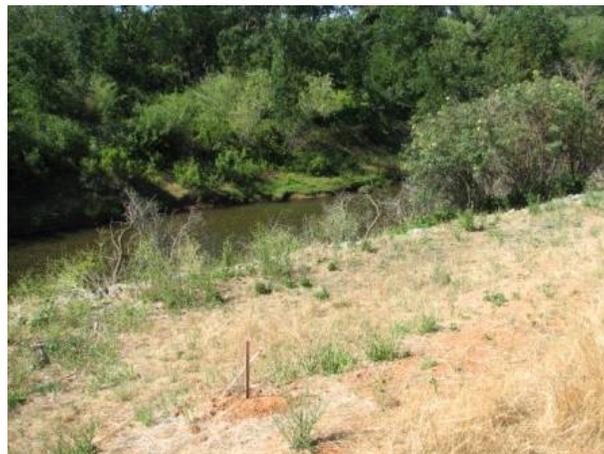
cathom_f_20120912_202.jpg

Levee Mile Report Line	3
Start Levee Mile	0.30
End Levee Mile	0.30
Location	Water Side
Category	Earthen Levee
Item	Riprap Revetments

Trees at waters edge in the rip rap levee mile 0.30.

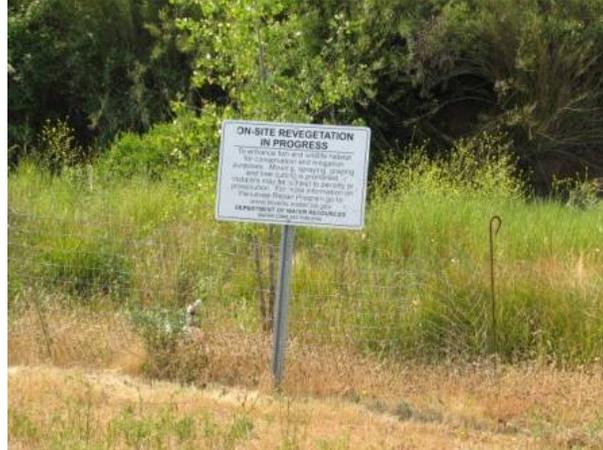
cathom_f_20120912_201.jpg

Levee Mile Report Line	4
Start Levee Mile	0.33
End Levee Mile	0.50
Location	Water Side
Category	Earthen Levee
Item	Vegetation

Levee mile 0.33, this photo is looking at the landscaping, vegetation on the waterside slope
