**Flood Control Project Maintenance
Levee Inspections**

Fall 2015 Levee Maintenance Deficiency Summary Report

Reclamation District No. 2103 Wheatland Vicinity

Waterway		Bank	Unit Miles
Unit No. 01 South Dry Creek		Left	4.64

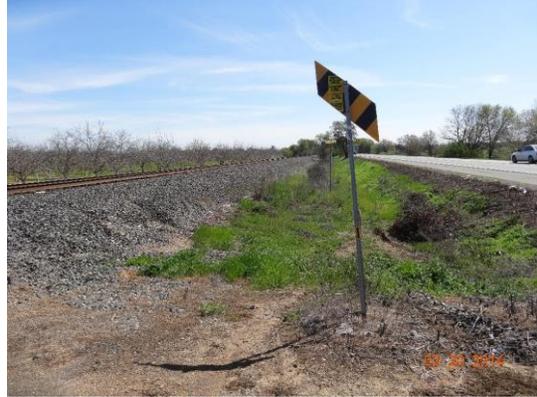
Photo 1 of 3 : UCIP_FA_2015_6582.jpg

Inspector Comments: FS_ID:39985
 DS_ID:19468
 EP_NO: 3659
 FS_HLM: 0.561
 Repair Type: Non-Urgent
 Crossing Status: Indicator Found
 UCIP Comments: Need to contact owner to determine status of crossing. Need date of last inspection and confirmation that crossing is still in operable condition. It appears this is the same line as the next entry however, permit calls for Southern Pacific Pipe Lines, Inc as the owner and the sign found in the field indicates Kinder Morgan as owner. Need to contact owner to clarify if 2 crossings exist or if crossing is same owner will need to update permit information.
 FIELD_STRUCT_DESC: 8-5/8-inch steel fuel line through the levee, 3.0 feet below the crown. Cutoff wall around pipe at centerline of levee. Pipe extends through overflow area. (Permit No. 3569-1961). This entry matches the Drainage or Irrigation Structure referenced in O&M manual (HLM 0.55). Markers visible on both sides.

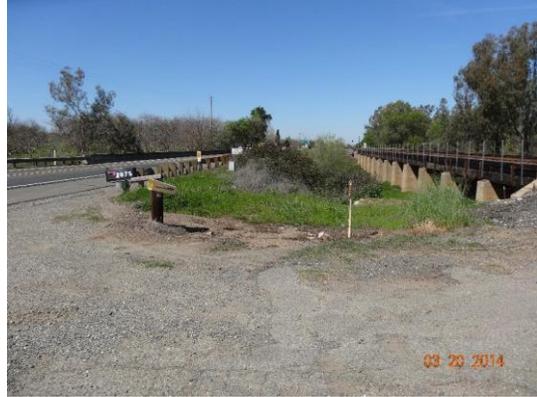
Photo 2 of 3 : UCIP_FA_2015_6583.jpg

Inspector Comments: FS_ID:39985
 DS_ID:19468
 EP_NO: 3659
 FS_HLM: 0.561
 Repair Type: Non-Urgent
 Crossing Status: Indicator Found
 UCIP Comments: Need to contact owner to determine status of crossing. Need date of last inspection and confirmation that crossing is still in operable condition. It appears this is the same line as the next entry however, permit calls for Southern Pacific Pipe Lines, Inc as the owner and the sign found in the field indicates Kinder Morgan as owner. Need to contact owner to clarify if 2 crossings exist or if crossing is same owner will need to update permit information.
 FIELD_STRUCT_DESC: 8-5/8-inch steel fuel line through the levee, 3.0 feet below the crown. Cutoff wall around pipe at centerline of levee. Pipe extends through overflow area. (Permit No. 3569-1961). This entry matches the Drainage or Irrigation Structure referenced in O&M manual (HLM 0.55). Markers visible on both sides.

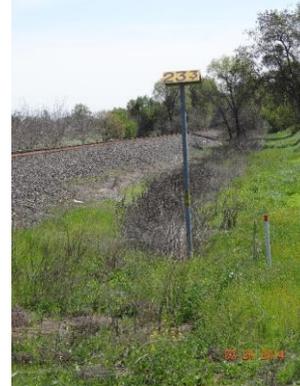
Photo 3 of 3 : UCIP_FA_2015_6584.jpg

LM Start	0.54	Rating **	M	Issue No.	28 (cont)
LM End	0.54	Issue Type +	En	Location *	LS
Category	Supplemental			GPS Latitude/Longitude	
	Start		End		
Item	DWR UCIP Field Study			39.022513 °	39.022513 °
				-121.444813 °	-121.444813 °
DWR ID					
Action/Comments					
Inspector Comments: FS_ID:39985 DS_ID:19468 EP_NO: 3659 FS_HLM: 0.561 Repair Type: Non-Urgent Crossing Status: Indicator Found UCIP Comments: Need to contact owner to determine status of crossing. Need date of last inspection and confirmation that crossing is still in operable condition. It appears this is the same line as the next entry however, permit calls for Southern Pacific Pipe Lines, Inc as the owner and the sign found in the field indicates Kinder Morgan as owner. Need to contact owner to clarify if 2 crossings exist or if crossing is same owner will need to update permit information. FIELD_STRUCT_DESC: 8-5/8-inch steel fuel line through the levee, 3.0 feet below the crown. Cutoff wall around pipe at centerline of levee. Pipe extends through overflow area. (Permit No. 3569-1961). This entry matches the Drainage or Irrigation Structure referenced in O&M manual (HLM 0.55). Markers visible on both sides. FS Date: 03/20/2014

Marker visible on toe in between railroad tracks and highway (south).

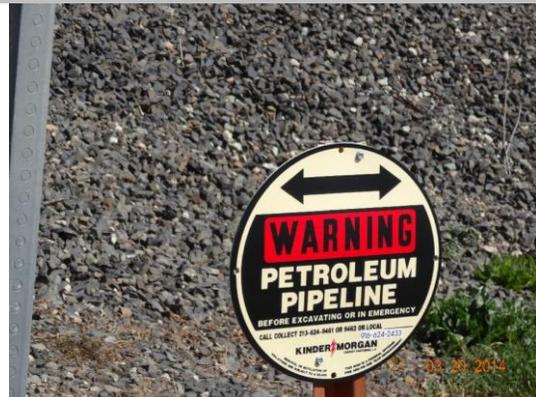
Photo 1 of 3 : UCIP_FA_2015_6309.jpg

LM Start	0.54	Rating **	M	Issue No.	29
LM End	0.54	Issue Type +	En	Location *	LS
Category	Supplemental			GPS Latitude/Longitude	
	Start		End		
Item	DWR UCIP Field Study			39.022514 °	39.022514 °
				-121.444814 °	-121.444814 °
DWR ID					
Action/Comments					
Inspector Comments: FS_ID:39986 DS_ID:24878 EP_NO: N/A FS_HLM: 0.556 Repair Type: Non-Urgent Crossing Status: Indicator Found UCIP Comments: It appears this is the same line as the next entry however, permit calls for Southern Pacific Pipe Lines, Inc as the owner and the sign found in the field indicates Kinder Morgan as owner. Need to contact owner to clarify if 2 crossings exist or if crossing is same owner will need to update permit information. Also need to contact owner to determine status of crossing. Need date of last inspection and confirmation that crossing is still in operable condition. FIELD_STRUCT_DESC: Kinder Morgan line through levee. Markers visible on both banks. FS Date: 03/04/2014

Petroleum Pipeline owned by Kinder Morgan.

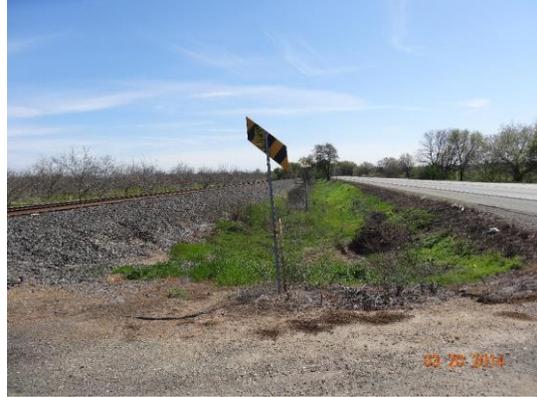
Photo 2 of 3 : UCIP_FA_2015_6310.jpg

Markers visible on landward side.

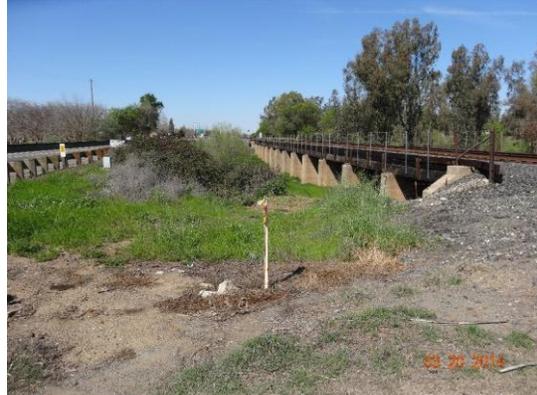
Photo 3 of 3 : UCIP_FA_2015_6311.jpg

View of marker visible on waterward side (between HWY 65 and railroad).

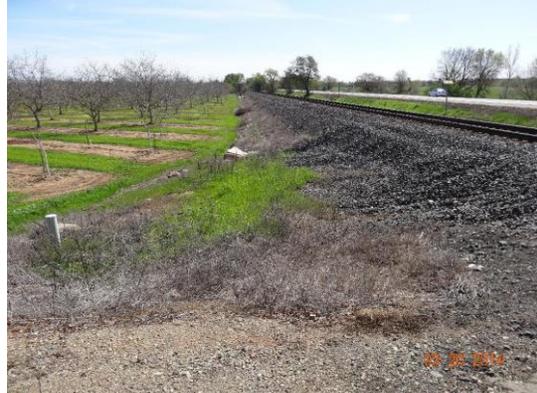
Photo 1 of 1 : UCIP_FA_2015_6032.jpg

LM Start	0.55	Rating **	M	Issue No.	31
LM End	0.55	Issue Type +	En	Location *	LS
Category	Supplemental			GPS Latitude/Longitude	
				Start	End
Item	DWR UCIP Field Study			39.022654 °	39.022654 °
				-121.444665 °	-121.444665 °
DWR ID					
Action/Comments					
Inspector Comments: FS_ID:43823 DS_ID:19467 EP_NO: 16041 FS_HLM: 0.57 Repair Type: Non-Urgent Crossing Status: Indicator Found

Junction box visible on LS toe (at lower left of photo).

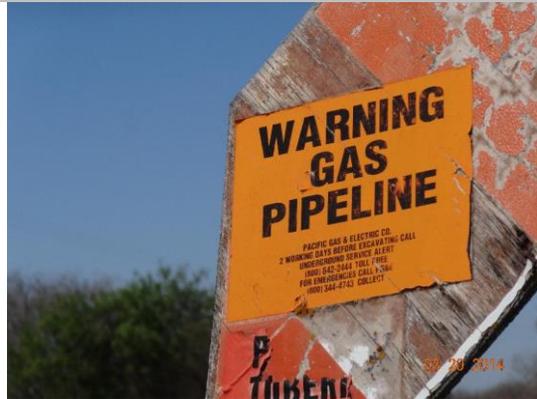
Photo 1 of 3 : UCIP_FA_2015_6624.jpg

LM Start	0.56	Rating **	M	Issue No.	32
LM End	0.56	Issue Type +	En	Location *	LS
Category	Supplemental			GPS Latitude/Longitude	
				Start	End
Item	DWR UCIP Field Study			39.022733 °	39.022733 °
				-121.444626 °	-121.444626 °
DWR ID					
Action/Comments					
Inspector Comments: FS_ID:38323 DS_ID:19469 EP_NO: 2098 FS_HLM: 0.58 Repair Type: Non-Urgent Crossing Status: Indicator Found UCIP Comments: Need to contact owner to determine status of crossing. Need date of last inspection and confirmation that crossing is still in operable condition. FIELD_STRUCT_DESC: 16-inch steel gas line through the levee, 3.0 feet below the crown. Marker on waterward slope. (Permit No. 2098-1955). This entry matches the Drainage or Irrigation Structure referenced in O&M manual (HLM 0.56). FS Date: 03/20/2014

Contact information of owner.

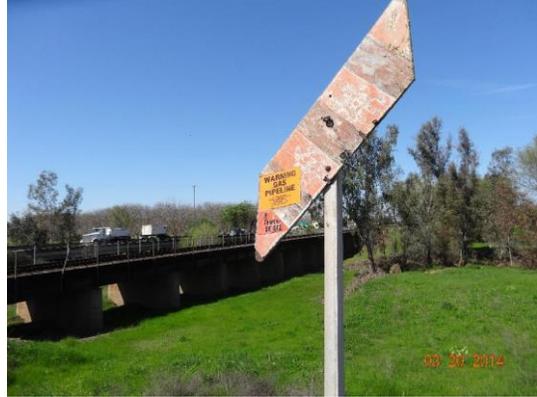
Photo 2 of 3 : UCIP_FA_2015_6625.jpg

Marker visible waterward side.

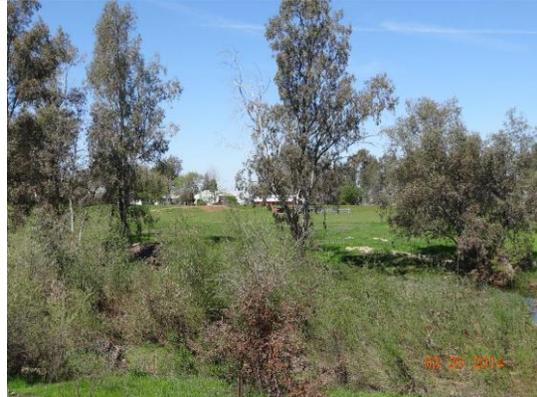
Photo 1 of 3 : UCIP_FA_2015_6627.jpg

LM Start	0.62	Rating **	M	Issue No.	33
LM End	0.62	Issue Type +	En	Location *	LS
Category	Supplemental			GPS Latitude/Longitude	
				Start	End
Item	DWR UCIP Field Study			39.023513 °	39.023513 °
				-121.444168 °	-121.444168 °
DWR ID					
Action/Comments					
Inspector Comments: FS_ID:38324 DS_ID:19470 EP_NO: 789 FS_HLM: 0.64 Repair Type: Non-Urgent Crossing Status: Indicator Found

Overview of gas marker visible on opposite bank.

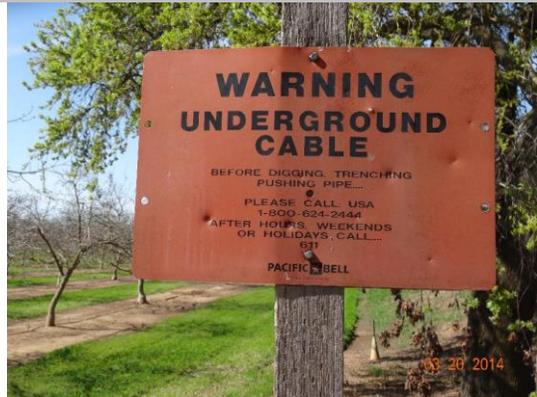
Photo 2 of 3 : UCIP_FA_2015_6382.jpg

LM Start	0.81	Rating **	M	Issue No.	34
LM End	0.81	Issue Type +	En	Location *	CR
Category	Supplemental			GPS Latitude/Longitude	
				Start	End
Item	DWR UCIP Field Study			39.024725 °	39.024725 °
				-121.440978 °	-121.440978 °
DWR ID					
Action/Comments					
Inspector Comments: FS_ID:39988 DS_ID:24880 EP_NO: N/A FS_HLM: 0.81 Repair Type: Non-Urgent Crossing Status: Indicator Found UCIP Comments: No marker found on waterward side--need to confirm with owner if crossing goes through levee. If so, need depth of crossing through levee. Also need to obtain permit number used to authorize crossing. FIELD_STRUCT_DESC: Conduit line through levee. Marker visible on landward side. FS Date: 03/04/2014

Marker is for underground cable line owned by Pacific Bell.

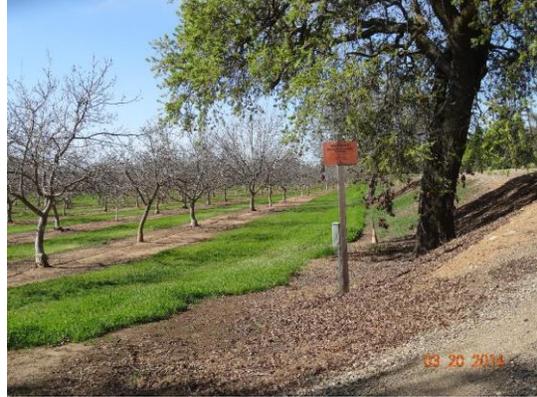
Photo 3 of 3 : UCIP_FA_2015_6383.jpg

Underground cable line marker visible on landward side toe.

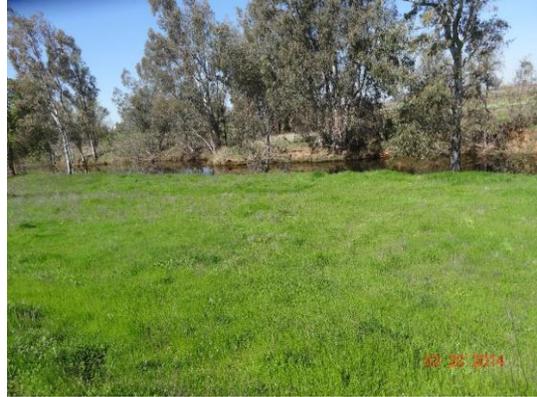
Photo 2 of 3 : UCIP_FA_2015_5243.jpg

Action/Comments
 Inspector Comments: FS_ID:41183
 DS_ID:19473
 EP_NO: 1886
 FS_HLM: 1.853
 Repair Type: Non-Urgent
 Crossing Status: Indicator Found
 UCIP Comments: Need to coordinate with owner. Severely corroded section of steel pipe present on waterward side--no other evidence present at this location. Owner will need to coordinate with CVFPB and DWR-Inspector to determine proper action to abandon crossing.
 FIELD_STRUCT_DESC: Abandoned 12-inch steel irrigation pipe through the levee, 3.1 feet below the crown. Siphon breaker on the waterward slope. Concrete standpipe at the landward toe. Vertical pump on waterward side. Open on waterward end. Permit includes gravel dam through channel of Dry Creek. (Permit No. 1886-1959). This entry matches the Drainage or Irrigation Structure referenced in O&M manual (HLM 1.86). Crossing is angled 45 degrees.
 FS Date: 03/20/2014

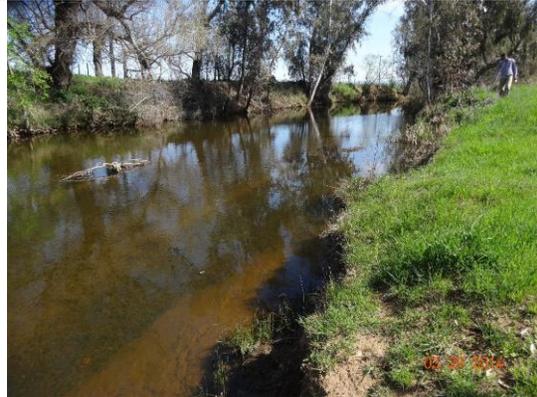
Photo 1 of 3 : UCIP_FA_2015_5189.jpg

LM Start	1.86	Rating **	M	Issue No.	36
LM End	1.86	Issue Type +	En	Location *	CR
Category	Supplemental			GPS Latitude/Longitude	
				Start	End
Item	DWR UCIP Field Study			39.029694 °	39.029694 °
				-121.423946 °	-121.423946 °
DWR ID					
Action/Comments					
Inspector Comments: FS_ID:38327 DS_ID:19512 EP_NO: N/A FS_HLM: 1.913 Repair Type: Non-Urgent Crossing Status: Indicator Found

No crossing visible on waterward side.

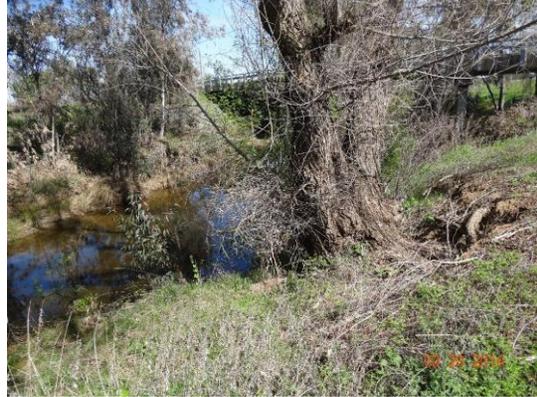
Photo 2 of 3 : UCIP_FA_2015_5193.jpg

LM Start	2.63	Rating **	M	Issue No.	37 (cont)
LM End	2.63	Issue Type +	En	Location *	CR
Category	Supplemental			GPS Latitude/Longitude	
				Start	End
Item	DWR UCIP Field Study			39.031590 °	39.031590 °
				-121.409870 °	-121.409870 °
DWR ID					
Action/Comments					
Inspector Comments: FS_ID:38331 DS_ID:19477 EP_NO: N/A FS_HLM: 2.715 Repair Type: Non-Urgent Crossing Status: Found UCIP Comments: Need to contact owner to determine status. FIELD_STRUCT_DESC: 8-inch steel irrigation pipe through the levee, 3.1 feet below the crown. Siphon breaker on the waterward slope. Pump on the landward side. Pipe crosses creek to orchard on north side (Permit No. 1887, 1954. (USACE-1962). This entry matches the Drainage or Irrigation Structure referenced in O&M manual (HLM 2.68). FS Date: 03/20/2014

Crossing was not visible on waterward side.

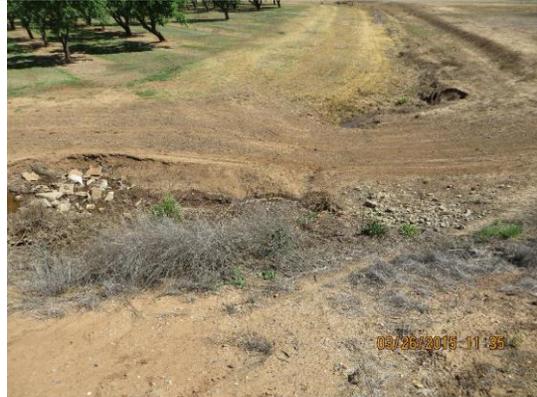
Photo 1 of 3 : UCIP_FA_2015_5781.jpg

LM Start	3.59	Rating **	U	Issue No.	38
LM End	3.59	Issue Type +	En	Location *	CR
Category	Supplemental			GPS Latitude/Longitude	
				Start	End
Item	DWR UCIP Field Study			39.033074 °	39.033074 °
				-121.400434 °	-121.400434 °
DWR ID					
Action/Comments					
Inspector Comments: FS_ID:43954 DS_ID:19478 EP_NO: N/A FS_HLM: 3.702 Repair Type: Urgent Crossing Status: Found

Pipe visible at LS toe.

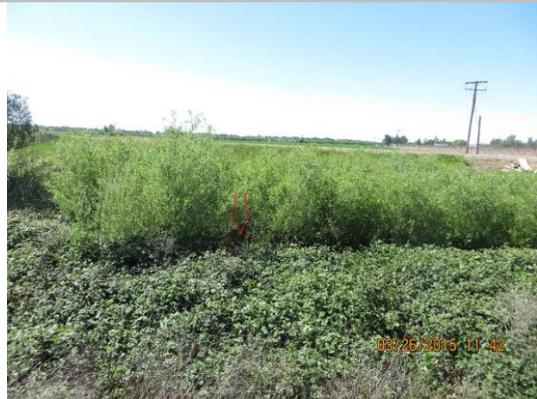
Photo 2 of 3 : UCIP_FA_2015_5782.jpg

Location of pipe and Flapgate on WS berm.

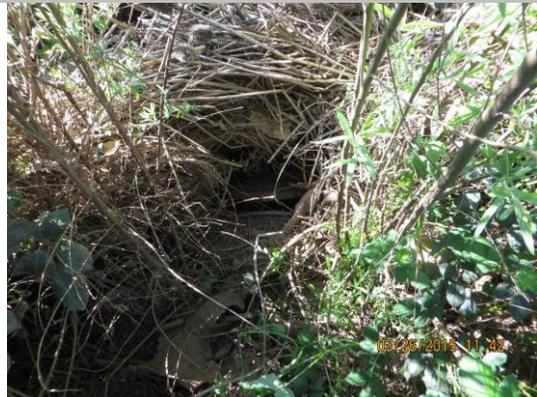
Photo 3 of 3 : UCIP_FA_2015_5783.jpg

Flapgate at WS berm blocked by soil and vegetation buildup.

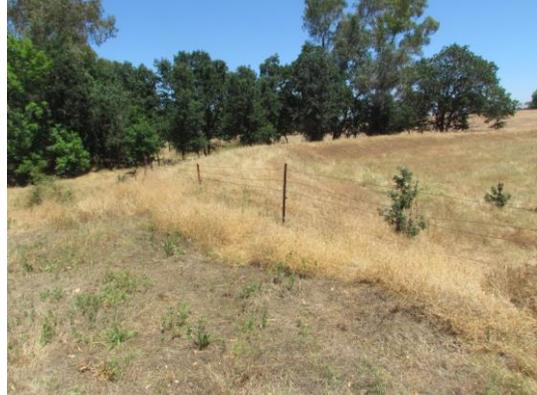
Photo 1 of 1 : FA_2015_RD2103_10_20_20151030_00004.jpg

View of the fence blocking access to the crown of the levee. View is from the crown facing upstream.

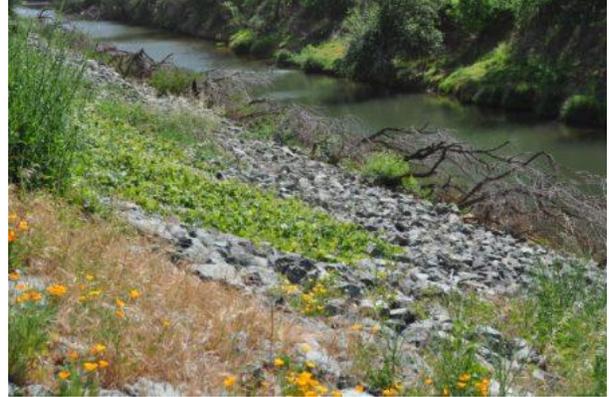
Photo 1 of 2 : FA_2015_RD2103_11_4_20151030_00001.jpg

View of revetment with dead trees, Spring 2013.

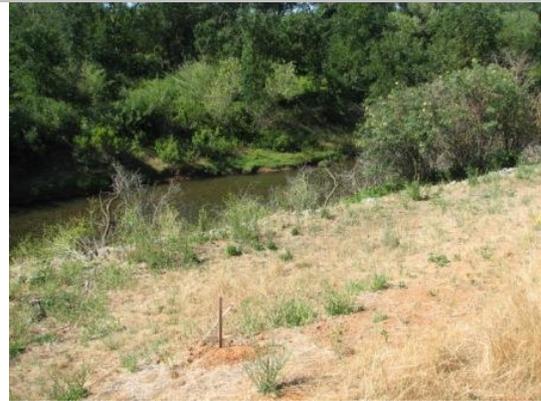
Photo 2 of 2 : FA_2015_RD2103_11_4_20151030_00002.jpg

Trees at waters edge in the rip rap levee mile 0.30.

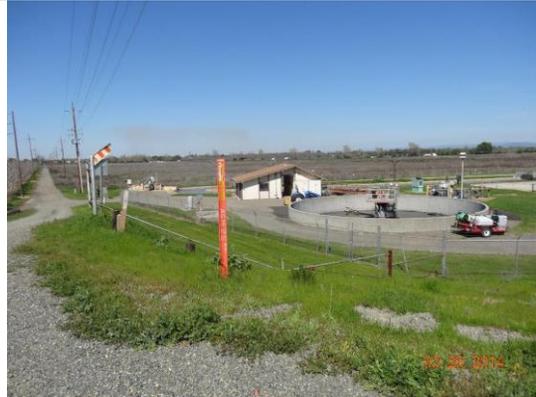
Photo 1 of 2 : UCIP_FA_2015_5240.jpg

LM Start	1.26	Rating **	M	Issue No.	28
LM End	1.26	Issue Type +	En	Location *	LS
Category	Supplemental			GPS Latitude/Longitude	
				Start	End
Item	DWR UCIP Field Study			38.998301 °	38.998301 °
				-121.415296 °	-121.415296 °
DWR ID					
Action/Comments					
Inspector Comments: FS_ID:39992 DS_ID:19484 EP_NO: 1613 FS_HLM: 1.3079 Repair Type: Non-Urgent Crossing Status: Indicator Found UCIP Comments: Need to contact owner to determine status of crossing. Need date of last inspection and confirmation that crossing is still in operable condition. FIELD_STRUCT_DESC: 16-inch steel gas line through the levee, 3.0 feet below the crown. (Permit No. 1613-1951). This entry matches the Drainage or Irrigation Structure referenced in O&M manual (HLM 1.30). FS Date: 03/20/2014

Marker visible on landward side.

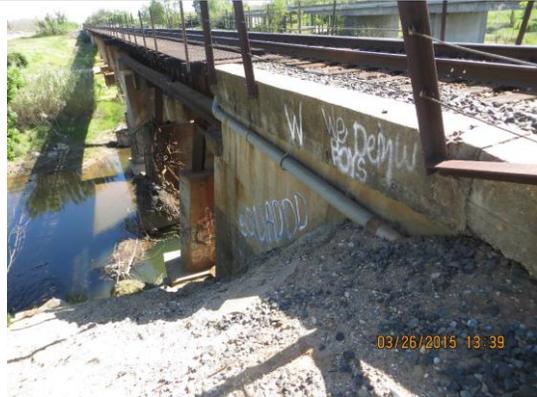
Photo 1 of 3 : UCIP_FA_2015_5834.jpg

LM Start	1.73	Rating **	U	Issue No.	31
LM End	1.73	Issue Type +	En	Location *	LS
Category	Supplemental			GPS Latitude/Longitude	
				Start	End
Item	DWR UCIP Field Study			39.000226 °	39.000226 °
				-121.406865 °	-121.406865 °
DWR ID					
Action/Comments					
Inspector Comments: FS_ID:40006 DS_ID:19462 EP_NO: 4148 FS_HLM: 1.79 Repair Type: Urgent Crossing Status: Not Found

6-inch steel conduit visible on upstream side of railroad bridge.

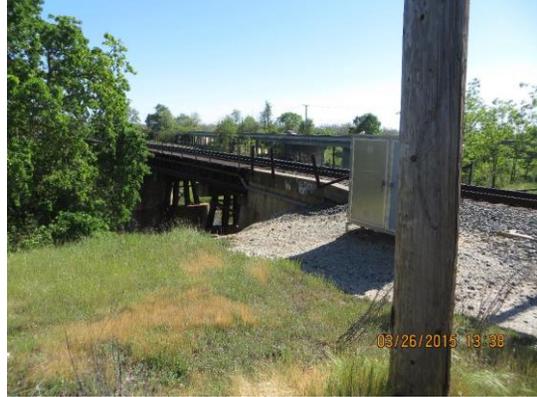
Photo 2 of 3 : UCIP_FA_2015_5835.jpg

6-inch steel conduit visible on upstream side of railroad bridge.

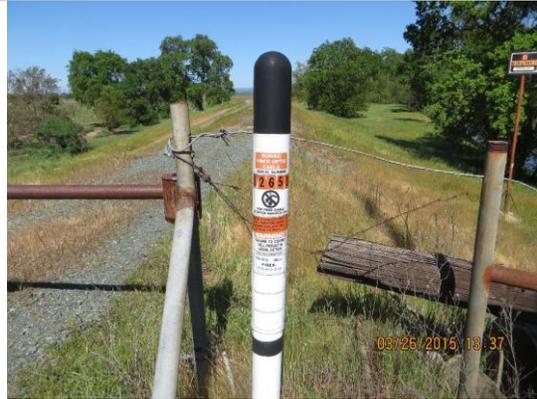
Photo 3 of 3 : UCIP_FA_2015_5836.jpg

Fiberoptic line marker on crown of levee

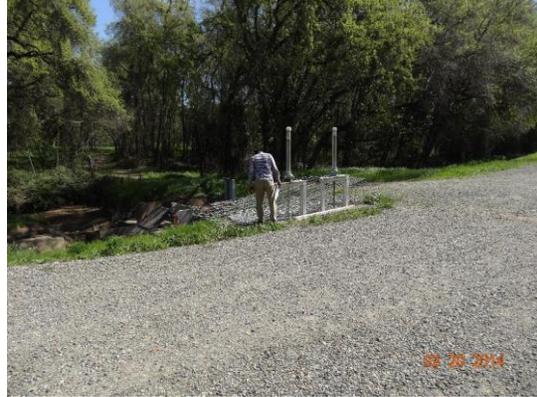
Photo 1 of 3 : UCIP_FA_2015_6386.jpg

Slide gates visible located on landward side.

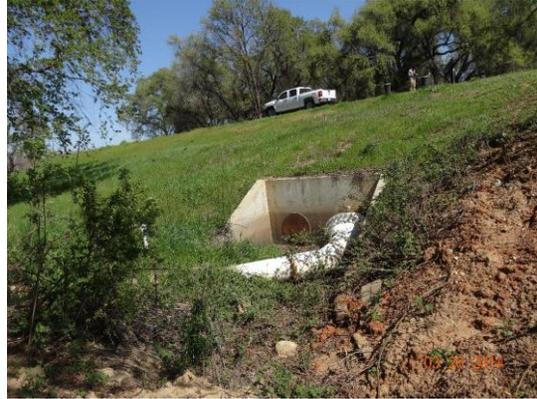
Photo 3 of 3 : UCIP_FA_2015_6411.jpg

Concrete headwall visible on waterward side--white pipe attached to crossing at headwall.

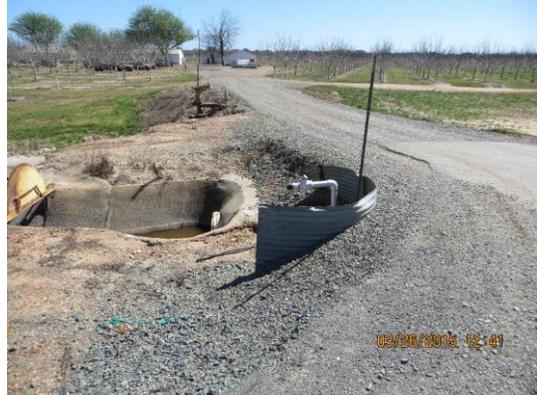
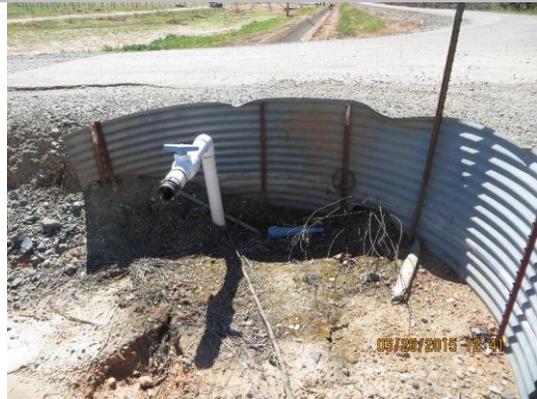
Service connection and ball valve visible on LS shoulder.

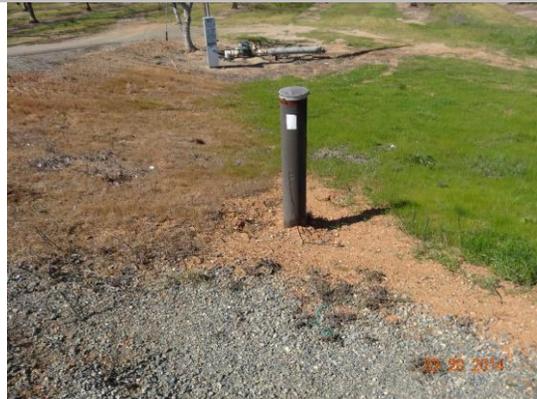
Photo 2 of 3 : UCIP_FA_2015_6413.jpg

Riser located on landward slope.

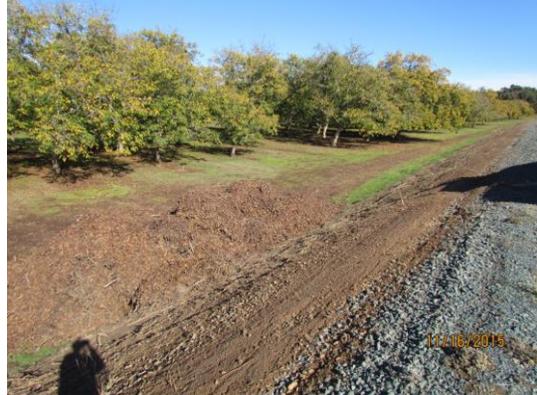
Photo 1 of 1 : FA_2015_RD2103_11_21_20151117_00006.jpg

View of the pile of leaves on the landward side of the levee looking upstream. Fall 2015.

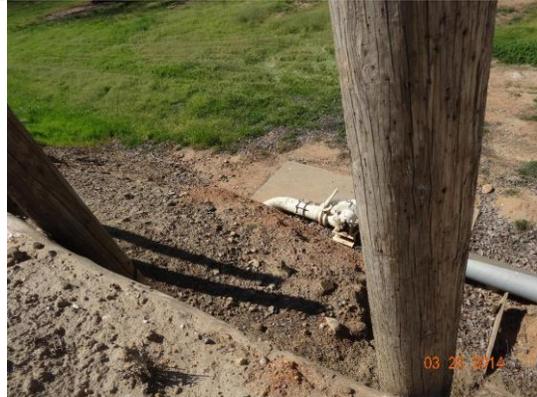
Photo 2 of 3 : UCIP_FA_2015_6416.jpg

Pipe visible on waterward side.

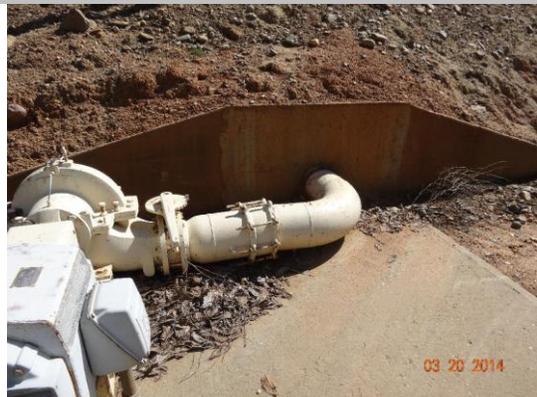
Photo 3 of 3 : UCIP_FA_2015_6417.jpg

Pipe connection at crossing.

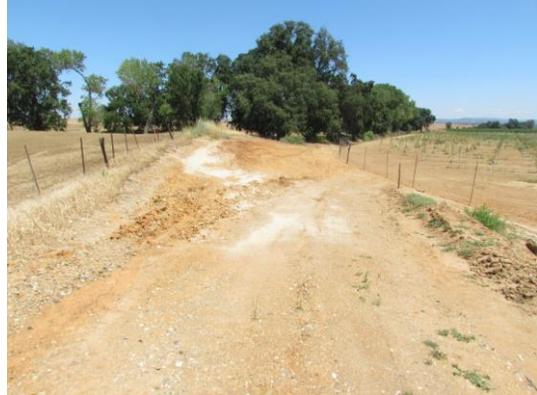
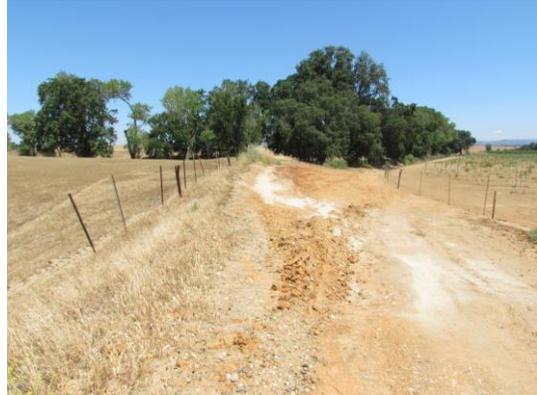
View of material on levee crown from the crown facing upstream.
