**Flood Control Project Maintenance  
Levee Inspections**  
**LMA District Cover Sheet**  
**Spring 2015 Levee Inspection Results**

**Reclamation District No. 2103 Wheatland Vicinity**

**Levee Inspection Report By Mile - Spring 2015**

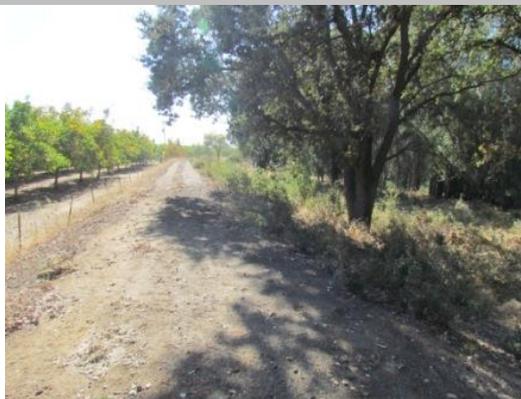
Photo 1 of 1 : SP\_2015\_RD2103\_10\_8\_20150318\_00003.jpg

LM Start	<b>4.41</b>	Rating **	M	Issue No.	<b>8</b>
LM End	<b>4.49</b>	Issue Type +	Ma	Location *	WS
Category	Earthen Levee			GPS Latitude/Longitude	
				Start	End
Item	Vegetation			39.041051 °	39.041810 °
				-121.394931 °	-121.393951 °
DWR ID	DWR_RD2103_01_f_2013_8				
Action/Comments					
Remove the wild growth other than native grasses from the levee slopes.

This photo was taken from the crown of the levee facing west looking at the vegetation on the waterward slope of the levee.

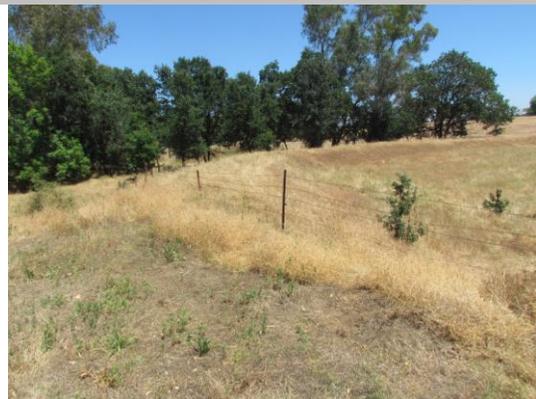
Photo 1 of 1 : SP\_2015\_RD2103\_10\_20\_20150529\_00004.jpg

LM Start	<b>4.52</b>	Rating **	M	Issue No.	<b>20</b>
LM End	<b>4.52</b>	Issue Type +	En	Location *	CR
Category	Earthen Levee		GPS Latitude/Longitude		
			Start	End	
Item	Encroachments		39.042220 °	39.042220 °	
			-121.393577 °	-121.393577 °	
DWR ID	DWR_RD2103_01_s_2015_20				
Action/Comments					
Fence

View of the fence blocking access to the crown of the levee. View is from the crown facing upstream.

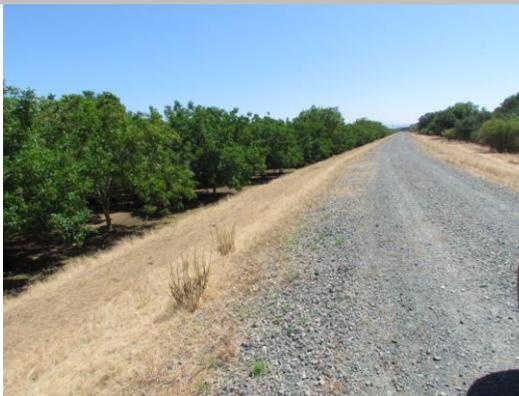
Photo 1 of 1 : SP\_2015\_RD2103\_11\_20\_20150529\_00004.jpg

LM Start	<b>0.01</b>	Rating **	A/W	Issue No.	<b>20</b>
LM End	<b>2.95</b>	Issue Type +	Ma	Location *	LS
Category	Earthen Levee		GPS Latitude/Longitude		
			Start	End	
Item	Vegetation		38.993442 °	39.012376 °	
			-121.437253 °	-121.392299 °	
DWR ID	DWR_RD2103_02_s_2015_20				
Action/Comments					
Control annual grass and weeds on the levee slopes and easements.

View of the vegetation on the landside of the levee facing upstream.

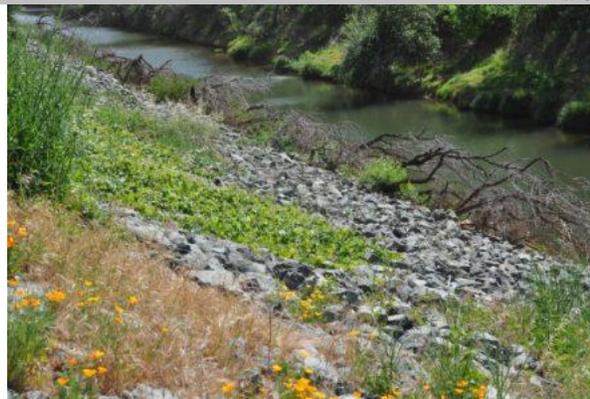
Photo 1 of 2 : SP\_2015\_RD2103\_11\_4\_20150401\_00001.jpg

LM Start	<b>0.29</b>	Rating **	A/W	Issue No.	<b>4</b>
LM End	<b>0.50</b>	Issue Type +	Ma	Location *	WS
Category	Earthen Levee		GPS Latitude/Longitude		
			Start	End	
Item	Riprap Revetments		38.994660 °	38.995537 °	
			-121.432170 °	-121.428535 °	
DWR ID	DWR_RD2103_02_s_2012_4				
Action/Comments					
Inspector Comments: The District has a concern with dead trees placed in the rip rap that may not stay in place during a high water event.

View of revetment with dead trees, Spring 2013.

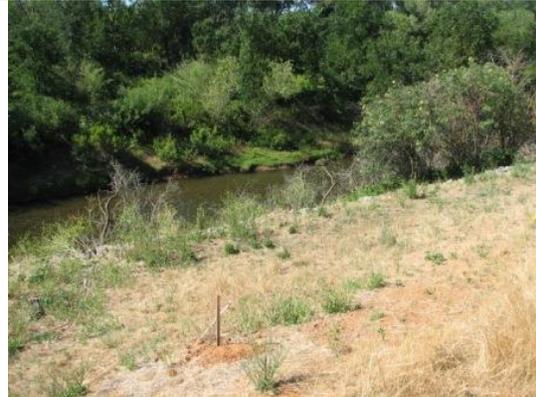
Photo 2 of 2 : SP\_2015\_RD2103\_11\_4\_20150401\_00002.jpg

LM Start	<b>0.29</b>	Rating **	A/W	Issue No.	<b>4 (cont)</b>
LM End	<b>0.50</b>	Issue Type +	Ma	Location *	WS
Category	Earthen Levee		GPS Latitude/Longitude		
			Start	End	
Item	Riprap Revetments		38.994660 °	38.995537 °	
			-121.432170 °	-121.428535 °	
DWR ID	DWR_RD2103_02_s_2012_4				
Action/Comments					
Inspector Comments: The District has a concern with dead trees placed in the rip rap that may not stay in place during a high water event.

Trees at waters edge in the rip rap levee mile 0.30.

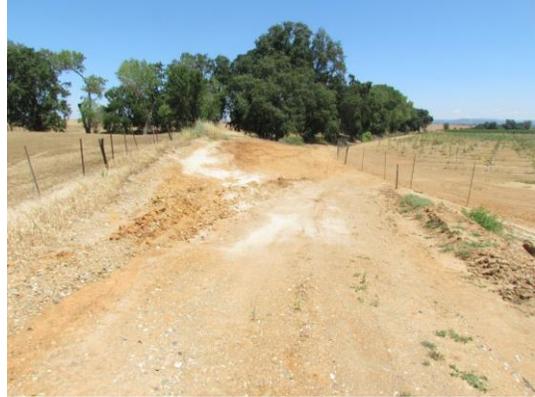
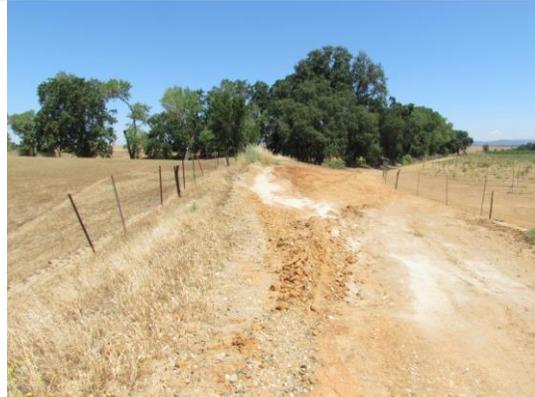
LM Start	<b>4.86</b>	Rating **	U	Issue No.	<b>27</b>
LM End	<b>4.86</b>	Issue Type +	En	Location *	CR
Category	Earthen Levee		GPS Latitude/Longitude		
			Start	End	
Item	Encroachments		39.031568 °	39.031568 °	
			-121.366981 °	-121.366981 °	
DWR ID	DWR_RD2103_02_s_2015_27				
Action/Comments					
Material Inspector Comments: It appears that the farmer cut into the levee, and pushed earthen material on levee crown.

View of material on levee crown from the crown facing upstream.
