**Flood Control Project Maintenance
Levee Inspections**

Maintenance Issue Types Only, Levee Inspection Report By Mile - Fall 2014

Reclamation District No. 2103 Wheatland Vicinity

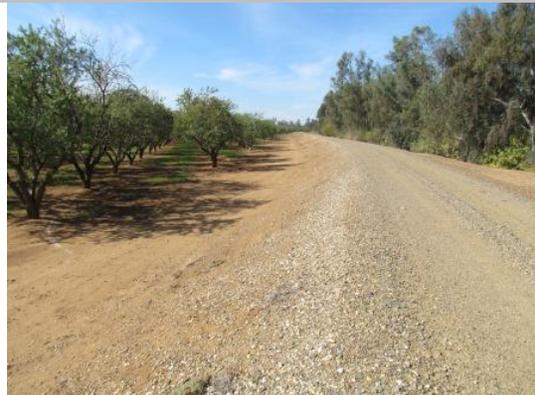
Photo 1 of 1 : FA_2014_RD2103_10_23_20141017_00006.jpg

LM Start	2.26	Rating **	A	Issue No.	23
LM End	2.26	Issue Type +	Ma	Location *	LS
Category	Earthen Levee		GPS Latitude/Longitude		
			Start	End	
Item	Vegetation		39.030460 °	39.030460 °	
			-121.417276 °	-121.417276 °	
DWR ID	DWR_RD2103_01_f_2014_23				
Action/Comments					
Control annual grass and weeds on the levee slopes and easements.

This photo was taken from the crown facing west looking down the landward levee slope at acceptable vegetation maintenance. Fall 2014.

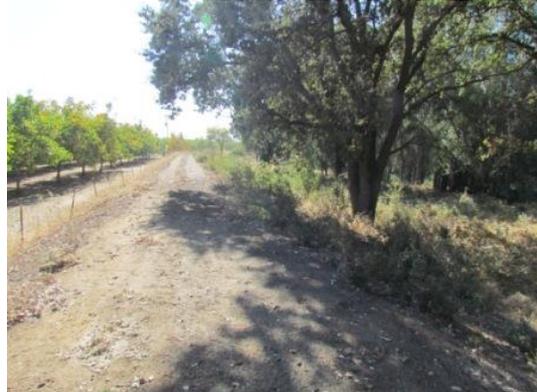
Photo 1 of 1 : FA_2014_RD2103_10_8_20141013_00004.jpg

LM Start	4.52	Rating **	M	Issue No.	8
LM End	4.58	Issue Type +	Ma	Location *	WS
Category	Earthen Levee		GPS Latitude/Longitude		
			Start	End	
Item	Vegetation		39.041051 °	39.041810 °	
			-121.394931 °	-121.393951 °	
DWR ID	DWR_RD2103_01_f_2013_8				
Action/Comments					
Remove the wild growth other than native grasses from the levee slopes.

This photo was taken from the crown of the levee facing west looking at the vegetation on the waterward slope of the levee.

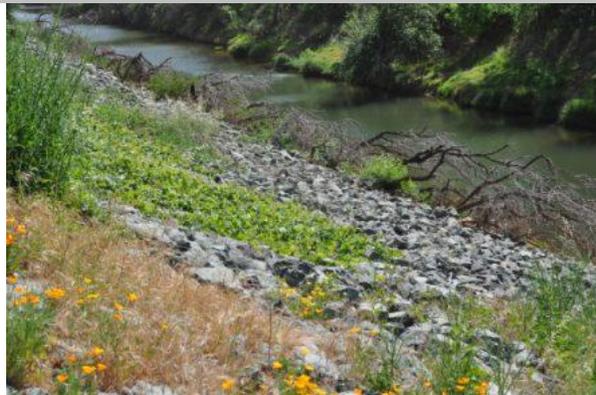
Photo 1 of 2 : FA_2014_RD2103_11_4_20141013_00002.jpg

LM Start	0.30	Rating **	A/W	Issue No.	4
LM End	0.51	Issue Type +	Ma	Location *	WS
Category	Earthen Levee		GPS Latitude/Longitude		
			Start	End	
Item	Riprap Revetments		38.994660 °	38.995537 °	
			-121.432170 °	-121.428535 °	
DWR ID	DWR_RD2103_02_s_2012_4				
Action/Comments					
Inspector Comments: The District has a concern with dead trees placed in the rip rap that may not stay in place during a high water event.

View of revetment with dead trees, Spring 2013.

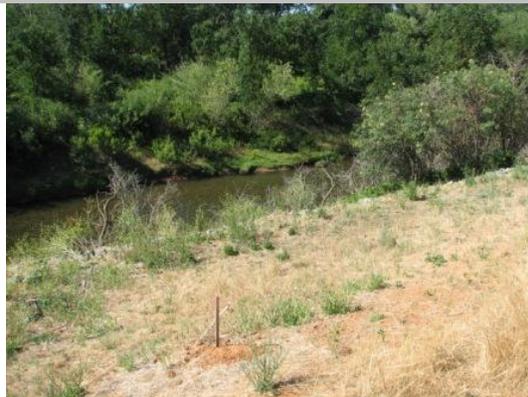
Photo 2 of 2 : FA_2014_RD2103_11_4_20141013_00003.jpg

Trees at waters edge in the rip rap levee mile 0.30.

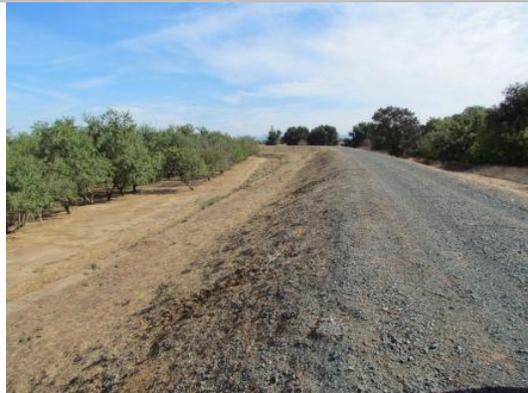
Photo 1 of 1 : FA_2014_RD2103_11_22_20141017_00006.jpg

LM Start	0.74	Rating **	A	Issue No.	22
LM End	0.74	Issue Type +	Ma	Location *	LS
Category	Earthen Levee		GPS Latitude/Longitude		
			Start	End	
Item	Vegetation		38.996588 °	38.996588 °	
			-121.424209 °	-121.424209 °	
DWR ID	DWR_RD2103_02_f_2014_22				
Action/Comments					
Control annual grass and weeds on the levee slopes and easements.

This photo was taken from the crown facing east looking down the landward levee slope at acceptable vegetation maintenance. Fall 2014.
