**Flood Control Project Maintenance
Levee Inspections**

Maintenance Issue Types Only, Levee Inspection Report By Mile - Fall 2015

Reclamation District No. 2103 Wheatland Vicinity

Waterway	Bank	Unit Miles	Inspection Start/End	Inspector
Unit No. 01 South Dry Creek	Left	4.64	11/16/2015 11/16/2015	Jai Lor

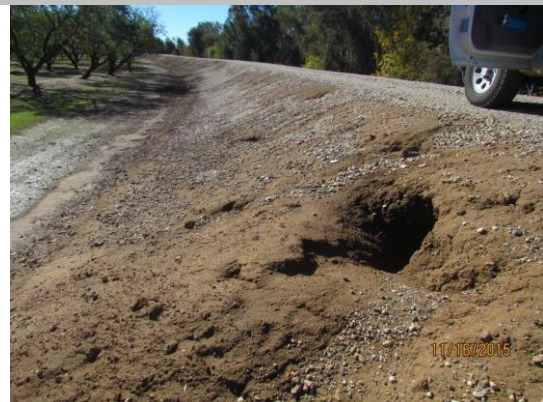
Photo 1 of 1 : FA_2015_RD2103_10_17_20151117_00005.jpg

LM Start	3.92	Rating **	U	Issue No.	17
LM End	3.92	Issue Type +	Ma	Location *	LS
Category	Earthen Levee			GPS Latitude/Longitude	
				Start	End
Item	Animal Control			39.037402 °	39.037402 °
				-121.401417 °	-121.401417 °
DWR ID	DWR_RD2103_01_f _ 2015_17				
Action/Comments					
No rodents visible, but rodent burrows visible; need to backfill and compact or grout burrows.

View of the rodent burrow on the landward side of the levee looking downstream. Fall 2015.

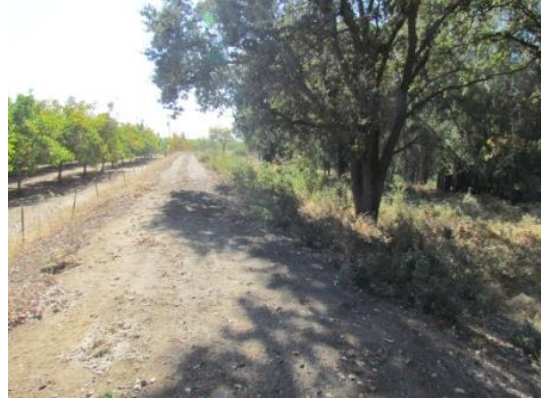
Photo 1 of 1 : FA_2015_RD2103_10_8_20151030_00003.jpg

LM Start	4.41	Rating **	M	Issue No.	8
LM End	4.49	Issue Type +	Ma	Location *	WS
Category	Earthen Levee			GPS Latitude/Longitude	
				Start	End
Item	Vegetation			39.041051 °	39.041810 °
				-121.394931 °	-121.393951 °
DWR ID	DWR_RD2103_01_f_2013_8				
Action/Comments					
Remove the wild growth other than native grasses from the levee slopes.

This photo was taken from the crown of the levee facing west looking at the vegetation on the waterward slope of the levee.

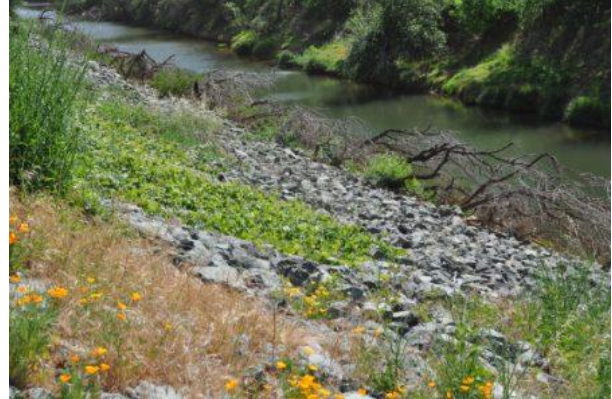
Photo 1 of 2 : FA_2015_RD2103_11_4_20151030_00001.jpg

LM Start	0.29	Rating **	A/W	Issue No.	4
LM End	0.50	Issue Type +	Ma	Location *	WS
Category	Earthen Levee			GPS Latitude/Longitude	
				Start	End
Item	Riprap Revetments			38.994660 °	38.995537 °
				-121.432170 °	-121.428535 °
DWR ID	DWR_RD2103_02_s _ 2012_4				
Action/Comments					
Inspector Comments: The District has a concern with dead trees placed in the rip rap that may not stay in place during a high water event.

View of revetment with dead trees, Spring 2013.

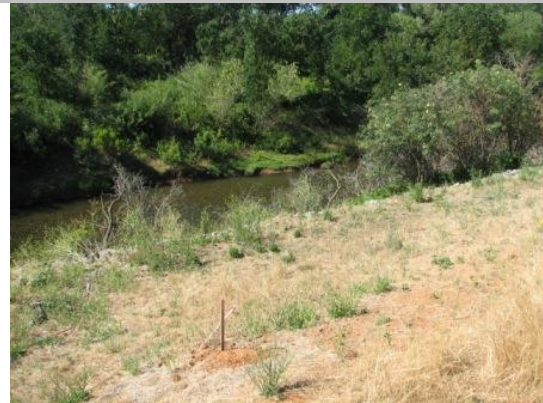
Photo 2 of 2 : FA_2015_RD2103_11_4_20151030_00002.jpg

Trees at waters edge in the rip rap levee mile 0.30.
