**Flood Control Project Maintenance
Levee Inspections**

Maintenance Issue Types Only, Levee Inspection Report By Mile - Fall 2016

Reclamation District No. 2103 Wheatland Vicinity

Waterway	Bank	Unit Miles	Inspection Start/End	Inspector
Unit No. 01 South Dry Creek	Left	4.64	10/19/2016 10/19/2016	Sterling York

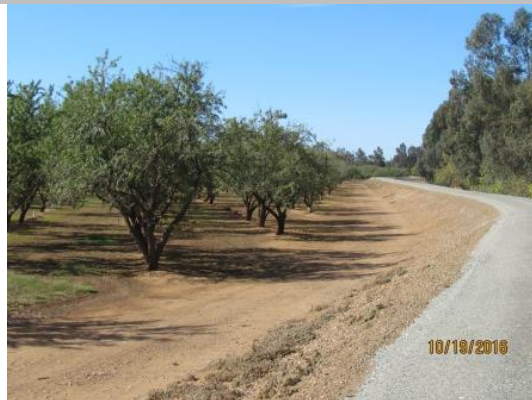
Photo 1 of 1 : FA_2016_RD2103_10_19_20161025_00037.jpg

LM Start	0.01	Rating **	A	Issue No.	19
LM End	3.53	Issue Type +	Ma	Location *	LS
Category	Earthen Levee			GPS Latitude/Longitude	
				Start	End
Item	Vegetation			39.019834 °	39.030231 °
				-121.453868 °	-121.400977 °
DWR ID	DWR_RD2103_01_f_2016_19				
Comment Code					
V1 : Control annual grass and weeds on the levee slopes and easements.					
Inspector Comment					
Well maintained annual vegetation. Fall 2016.

View of well maintained vegetation on the landside looking upstream.
Fall 2016.

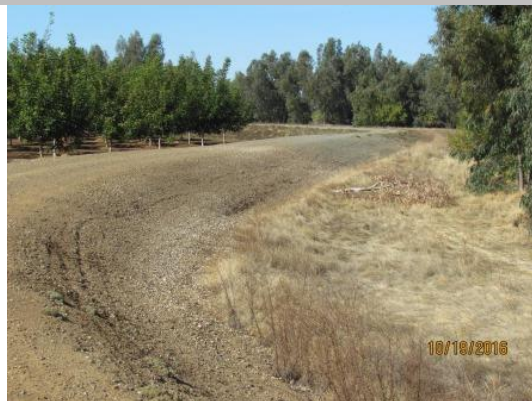
Photo 1 of 1 : FA_2016_RD2103_10_21_20161025_00038.jpg

LM Start	0.01	Rating **	A	Issue No.	21
LM End	3.53	Issue Type +	Ma	Location *	WS
Category	Earthen Levee			GPS Latitude/Longitude	
				Start	End
Item	Vegetation			39.019835 °	39.030231 °
				-121.453866 °	-121.400978 °
DWR ID	DWR_RD2103_01_f_2016_21				
Comment Code					
V1 : Control annual grass and weeds on the levee slopes and easements.					
Inspector Comment					
Well maintained annual vegetation. Fall 2016.

View of well maintained vegetation on the waterside looking upstream. Fall 2016.

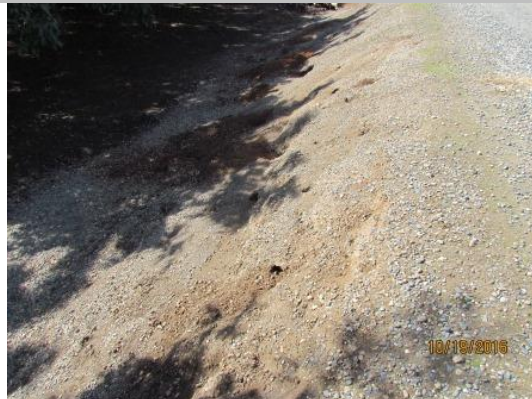
Photo 1 of 1 : FA_2016_RD2103_10_23_20161025_00042.jpg

LM Start	0.20	Rating **	M	Issue No.	23
LM End	0.22	Issue Type +	Ma	Location *	LS
Category	Earthen Levee			GPS Latitude/Longitude	
				Start	End
Item	Animal Control			39.020856 °	39.020938 °
				-121.450629 °	-121.450237 °
DWR ID	DWR_RD2103_01_f_2015_23				
Comment Code					
A3 : No rodents visible, but rodent burrows visible; need to backfill and compact or grout burrows.					
Inspector Comment					
Squirrel holes need to be backfilled. Fall 2016.

View of squirrel holes on the waterside looking downstream. Fall 2016.

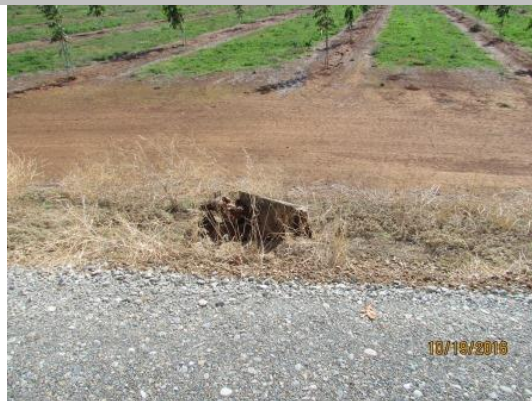
Photo 1 of 1 : FA_2016_RD2103_10_26_20161025_00039.jpg

LM Start	1.27	Rating **	N	Issue No.	26
LM End	1.27	Issue Type +	Ma	Location *	LS
Category	Earthen Levee			GPS Latitude/Longitude	
				Start	End
Item	Trim / Thin Trees			39.027261 °	39.027261 °
				-121.433269 °	-121.433269 °
DWR ID	DWR_RD2103_01_s_2016_26				
Comment Code					
T5 : Tree stumps.					
Inspector Comment					
Stump needs to be removed fom slope. Fall 2016.

View of tree stump on lanside levee slope. Fall 2016.

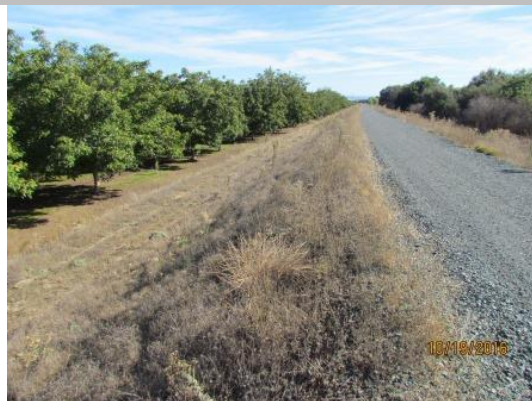
Photo 1 of 1 : FA_2016_RD2103_11_14_20161025_00029.jpg

LM Start	0.01	Rating **	M	Issue No.	14
LM End	0.86	Issue Type +	Ma	Location *	LS
Category	Earthen Levee			GPS Latitude/Longitude	
				Start	End
Item	Vegetation			38.993483°	38.997690°
				-121.437133°	-121.422511°
DWR ID	DWR_RD2103_02_f_2016_14				
Comment Code					
V1 : Control annual grass and weeds on the levee slopes and easements.					
Inspector Comment					
Annual vegetation needs to be maintained, Fall 2016.

View of annual vegetation that needs to be maintained on the landside looking upstream. Fall 2016.

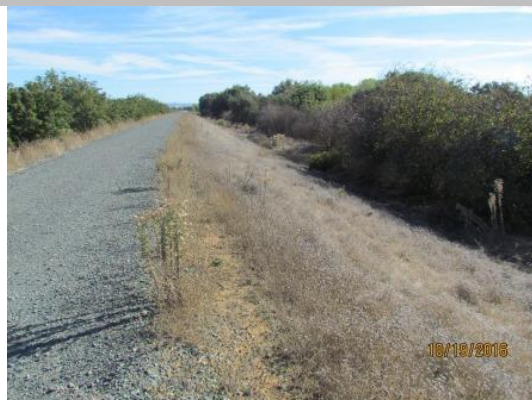
Photo 1 of 1 : FA_2016_RD2103_11_15_20161025_00030.jpg

LM Start	0.01	Rating **	M	Issue No.	15
LM End	0.87	Issue Type +	Ma	Location *	WS
Category	Earthen Levee			GPS Latitude/Longitude	
				Start	End
Item	Vegetation			38.993483°	38.997801°
				-121.437133°	-121.422373°
DWR ID	DWR_RD2103_02_f_2016_15				
Comment Code					
V1 : Control annual grass and weeds on the levee slopes and easements.					
Inspector Comment					
Annual vegetation needs to be maintained, Fall 2016.

View of annual vegetation that needs to be maintained on the waterside looking upstream. Fall 2016.

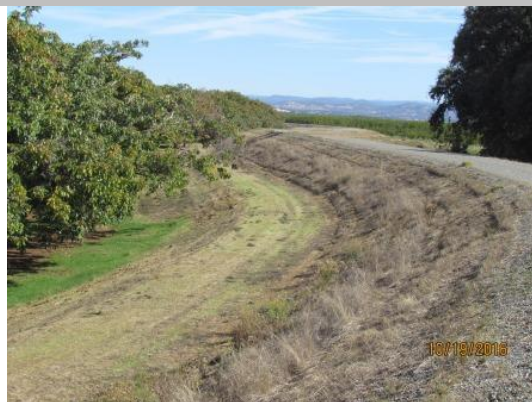
Photo 1 of 1 : FA_2016_RD2103_11_3_20161025_00037.jpg

LM Start	0.87	Rating **	A	Issue No.	3
LM End	4.88	Issue Type +	Ma	Location *	LS
Category	Earthen Levee			GPS Latitude/Longitude	
				Start	End
Item	Vegetation			38.997801 °	39.031787 °
				-121.422373 °	-121.366800 °
DWR ID	DWR_RD2103_02_f_2016_3				
Comment Code					
V1 : Control annual grass and weeds on the levee slopes and easements.					
Inspector Comment					
Well maintained vegetation, Fall 2016.

View of well maintained vegetation on landside looking upstream. Fall 2016.

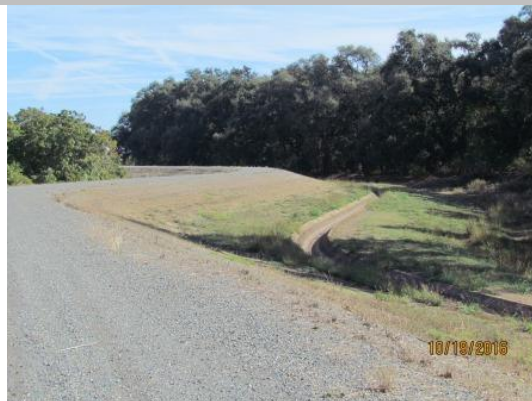
Photo 1 of 1 : FA_2016_RD2103_11_16_20161025_00033.jpg

LM Start	0.87	Rating **	A	Issue No.	16
LM End	4.88	Issue Type +	Ma	Location *	WS
Category	Earthen Levee			GPS Latitude/Longitude	
				Start	End
Item	Vegetation			38.997801°	39.031787°
				-121.422372°	-121.366800°
DWR ID	DWR_RD2103_02_f_2016_16				
Comment Code					
V1 : Control annual grass and weeds on the levee slopes and easements.					
Inspector Comment					
Well maintained vegetation, Fall 2016.

View of well maintained vegetation on waterside looking upstream. Fall 2016.
