**Flood Control Project Maintenance
Levee Inspections**

Maintenance Issue Types Only, Levee Inspection Report By Mile - Fall 2017

Reclamation District No. 2103 Wheatland Vicinity

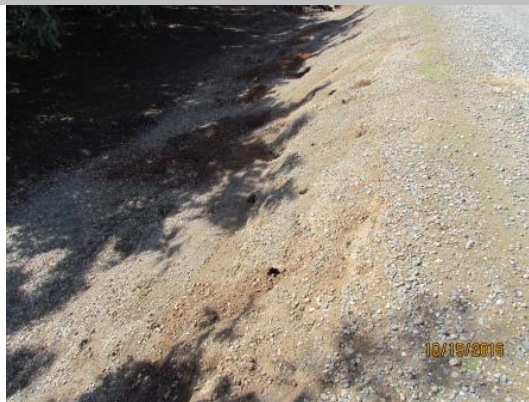
Photo 1 of 1 : FA_2017_RD2103_10_23_20170911_00007.jpg

LM Start	0.20	Rating **	M	Issue No.	23
LM End	0.22	Issue Type +	Ma	Location *	LS
Category	Earthen Levee			GPS Latitude/Longitude	
				Start	End
Item	Animal Control			39.020856 °	39.020938 °
				-121.450629 °	-121.450237 °
DWR ID	DWR_RD2103_01_f_2015_23				
Comment Code					
A3 : No rodents visible, but rodent burrows visible; need to backfill and compact or grout burrows.					
Inspector Comment

View of squirrel holes on the waterside looking downstream but no evidence of animal activity during Fall 2017 inspection.

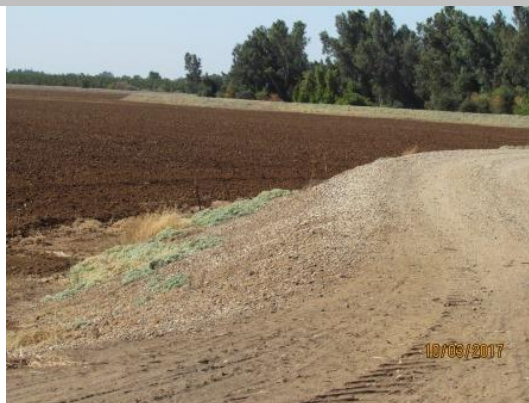
Photo 1 of 1 : FA_2017_RD2103_10_19_20171011_00049.jpg

LM Start	0.56	Rating **	A	Issue No.	19
LM End	4.51	Issue Type +	Ma	Location *	LS
Category	Earthen Levee			GPS Latitude/Longitude	
				Start	End
Item	Vegetation			39.022644 °	39.042024 °
				-121.444628 °	-121.393752 °
DWR ID	DWR_RD2103_01_f_2017_19				
Comment Code					
V1 : Control annual grass and weeds on the levee slopes and easements.					
Inspector Comment					
The annual vegetation is well maintained, Fall 2017.

View looking downstream landside of well maintained annual vegetation, Fall 2017.

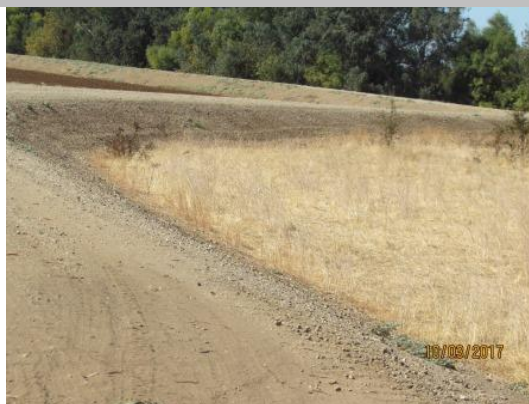
Photo 1 of 1 : FA_2017_RD2103_10_21_20171011_00050.jpg

LM Start	0.56	Rating **	A	Issue No.	21
LM End	4.51	Issue Type +	Ma	Location *	WS
Category	Earthen Levee			GPS Latitude/Longitude	
				Start	End
Item	Vegetation			39.022644 °	39.042131 °
				-121.444628 °	-121.393653 °
DWR ID	DWR_RD2103_01_f_2017_21				
Comment Code					
V1 : Control annual grass and weeds on the levee slopes and easements.					
Inspector Comment					
The annual vegetation is well maintained, Fall 2017.

View looking downstream waterside of well maintained annual vegetation, Fall 2017.

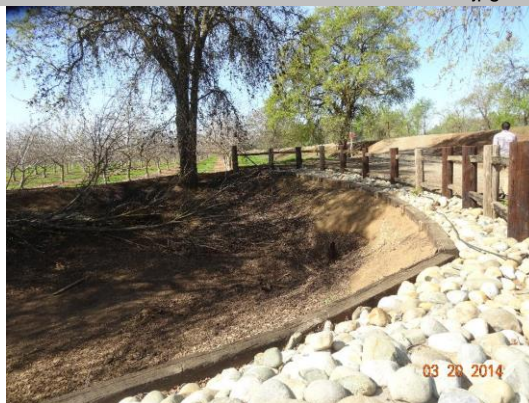
Photo 1 of 3 : UCIP_FA_2017_38325_69869.jpg

LM Start	0.82	Rating **	A/W	Issue No.	36
LM End	0.82	Issue Type +	Ma	Location *	
Category	Supplemental			GPS Latitude/Longitude	
				Start	End
Item	DWR UCIP LMA Responsibility			39.024811 °	39.024811 °
				-121.440750 °	-121.440750 °
DWR ID					
Comment Code					
Inspector Comment					
FS_ID:38325					
DS_ID:19471					
EP_NO: N/A					
Repair Type: No Action Needed					
Crossing Status: Found					
UCIP Comments:					
FIELD_STRUCT_DESC: 36-inch CM drainpipe through the levee, 14.4 feet below the crown. Concrete headwall, flap-gate and 3x6-foot concrete splash apron at waterward toe. Outfall drain from old Grasshopper Slough. (USACE-1962). This entry matches the Drainage or Irrigation Structure referenced in O&M manual (HLM 0.83).					
FS Date: 3/20/2014

View of CMP crossing located on landward side.

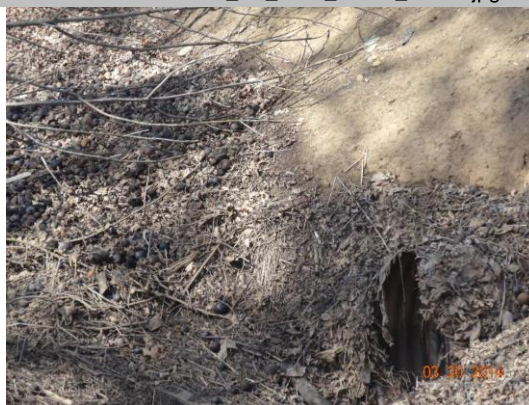
Photo 2 of 3 : UCIP_FA_2017_38325_69868.jpg

Close up view of crossing from landward side.

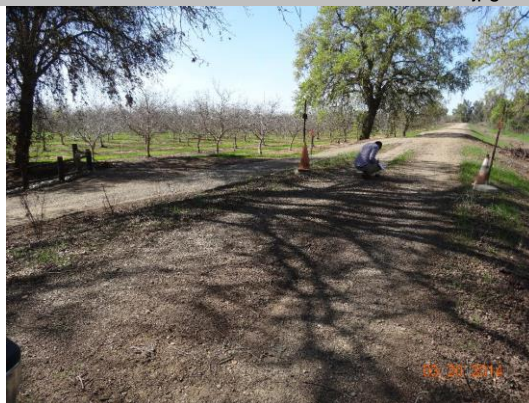
Photo 3 of 3 : UCIP_FA_2017_38325_69873.jpg

View of levee crown at crossing.

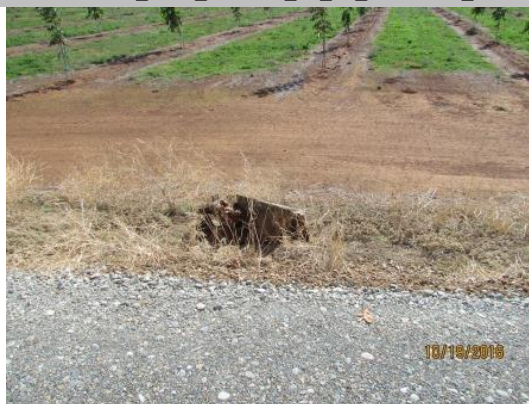
Photo 1 of 1 : FA_2017_RD2103_10_26_20170911_00008.jpg

LM Start	1.27	Rating **	N	Issue No.	26
LM End	1.27	Issue Type +	Ma	Location *	LS
Category	Earthen Levee			GPS Latitude/Longitude	
				Start	End
Item	Trim / Thin Trees			39.027261 °	39.027261 °
				-121.433269 °	-121.433269 °
DWR ID	DWR_RD2103_01_s_2016_26				
Comment Code					
T5 : Tree stumps.					
Inspector Comment					
Stump needs to be removed fom slope. Fall 2016.

View of tree stump on landside levee slope. Fall 2016, still exist as of Fall 2017.

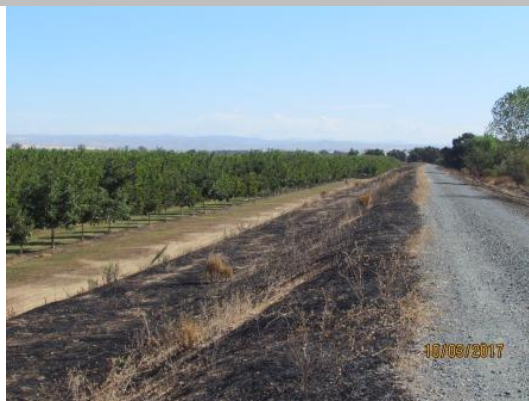
Photo 1 of 2 : FA_2017_RD2103_11_13_20171011_00031.jpg

LM Start	0.16	Rating **	A	Issue No.	13
LM End	1.19	Issue Type +	Ma	Location *	LS
Category	Earthen Levee			GPS Latitude/Longitude	
				Start	End
Item	Vegetation			38.994109 °	38.998316 °
				-121.434590 °	-121.416505 °
DWR ID	DWR_RD2103_02_f_2017_13				
Comment Code					
V1 : Control annual grass and weeds on the levee slopes and easements.					
Inspector Comment					
The annual vegetation is well maintained through this section, Fall 2017.

View looking upstream landside of well maintained vegetation, Fall 2017.

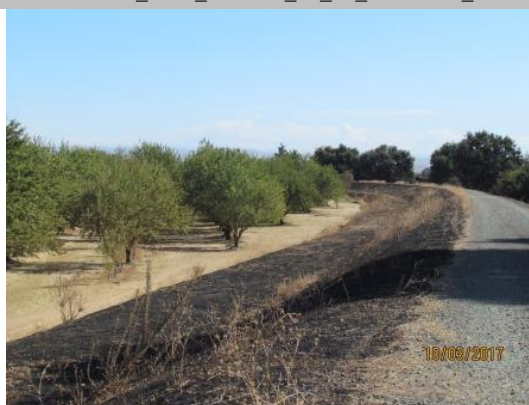
Photo 2 of 2 : FA_2017_RD2103_11_13_20171011_00032.jpg

Second view looking upstream landside of well maintained vegetation, Fall 2017.

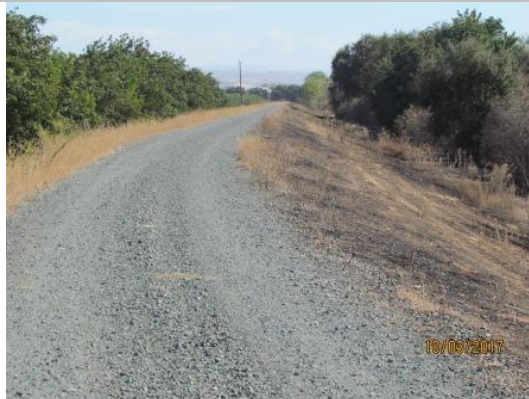
Photo 1 of 2 : FA_2017_RD2103_11_14_20171011_00029.jpg

LM Start	0.16	Rating **	A	Issue No.	14
LM End	1.20	Issue Type +	Ma	Location *	WS
Category	Earthen Levee			GPS Latitude/Longitude	
				Start	End
Item	Vegetation			38.994109 °	38.998319 °
				-121.434590 °	-121.416319 °
DWR ID	DWR_RD2103_02_f_2017_14				
Comment Code					
V1 : Control annual grass and weeds on the levee slopes and easements.					
Inspector Comment					
The annual vegetation is well maintained through this section, Fall 2017.

View looking upstream waterside of well maintained vegetation, Fall 2017.

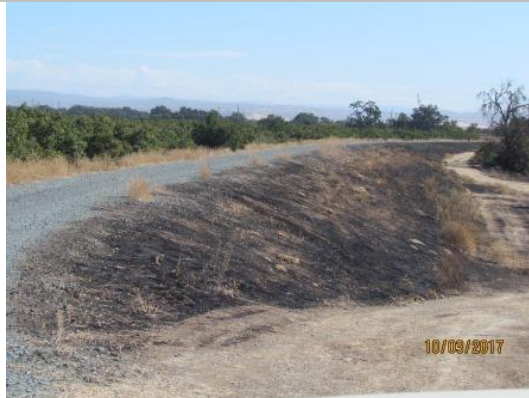
Photo 2 of 2 : FA_2017_RD2103_11_14_20171011_00030.jpg

Second view looking upstream waterside of well maintained vegetation, Fall 2017.

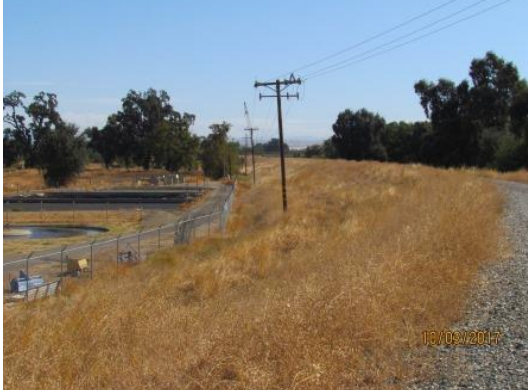
Photo 1 of 1 : FA_2017_RD2103_11_15_20171011_00033.jpg

View looking upstream landside of the annual vegetation that needs to be maintained, Fall 2017.

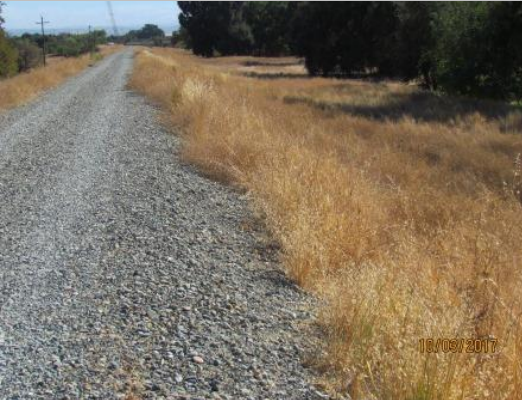
Photo 1 of 1 : FA_2017_RD2103_11_16_20171011_00034.jpg

View looking upstream waterside of the annual vegetation that needs to be maintained, Fall 2017.

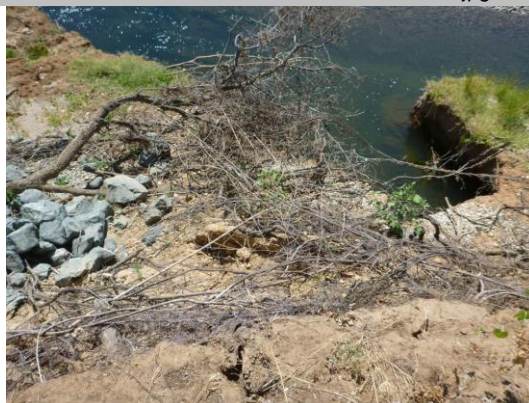
Photo 5 of 5 : LEVAL_FA_2017_488_1812.jpg

Comment Code						
Inspector Comment						
Levee Evaluation Comments						
Description:2017 Flood Fight Emergency Repair - 200 feet of site repaired in March 2017. Additional 50 feet requires repair after water receded. \$220,000 estimated total for completion and post project permits and mitigation						
Site ID No:488						
Site Designation:LMA-326						
Repair Type: Erosion						
Rating:Area of Concern						
Field Date:7/27/2017						
Notes: Site will likely degrade quickly due to lack of RSP along the lower portion of the bank slope and downstream end of site. At time of field visit, site does not appear to be any imminent threat of failure.

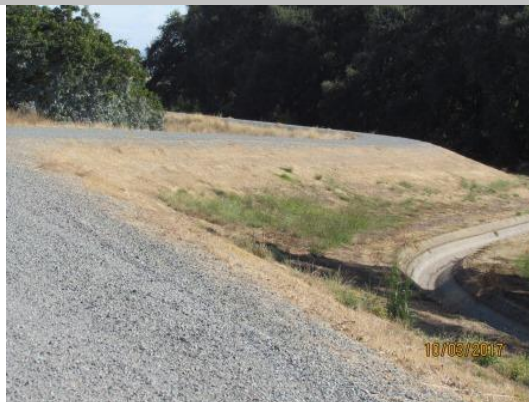
Photo 1 of 1 : FA_2017_RD2103_11_17_20171011_00037.jpg

LM Start	2.56	Rating **	A	Issue No.	17
LM End	4.83	Issue Type +	Ma	Location *	WS
Category	Earthen Levee			GPS Latitude/Longitude	
				Start	End
Item	Vegetation			39.008797 °	39.031172 °
				-121.397328 °	-121.367277 °
DWR ID	DWR_RD2103_02_f_2017_17				
Comment Code					
V1 : Control annual grass and weeds on the levee slopes and easements.					
Inspector Comment					
The annual vegetation is well maintained through this section, Fall 2017.

View looking upstream waterside of well maintained annual vegetation, Fall 2017.

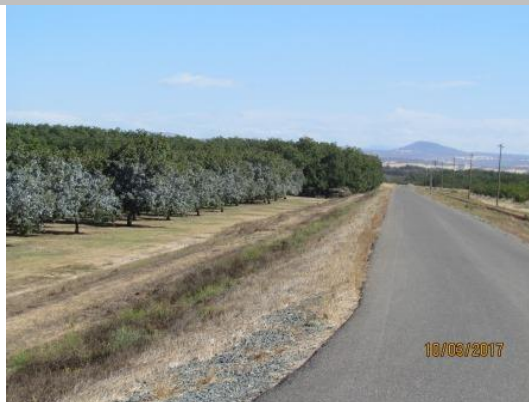
Photo 1 of 1 : FA_2017_RD2103_11_18_20171011_00038.jpg

LM Start	3.42	Rating **	A	Issue No.	18
LM End	4.83	Issue Type +	Ma	Location *	LS
Category	Earthen Levee			GPS Latitude/Longitude	
				Start	End
Item	Vegetation			39.017155 °	39.031179 °
				-121.386272 °	-121.367274 °
DWR ID	DWR_RD2103_02_f_2017_18				
Comment Code					
V1 : Control annual grass and weeds on the levee slopes and easements.					
Inspector Comment					
The annual vegetation is well maintained through this section, Fall 2017.

View looking upstream landside of well maintained annual vegetation, Fall 2017.
