**Flood Control Project Maintenance
Levee Inspections**

Maintenance Issue Types Only, Levee Inspection Report By Mile - Fall 2018

Reclamation District No. 2103 Wheatland Vicinity

Waterway	Bank	Unit Miles	Inspection Start/End	Inspector
Unit No. 01 South Dry Creek	Left	4.64	11/01/2018 11/01/2018	Sterling York

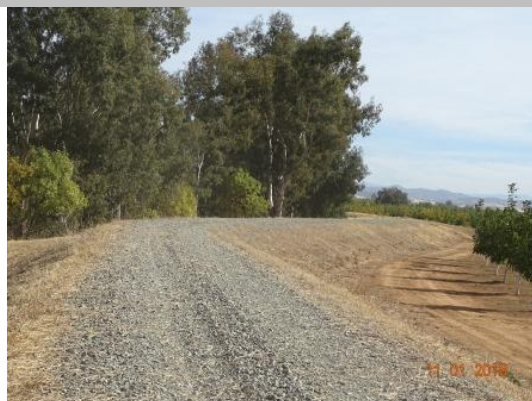
Photo 1 of 1 : FA_2018_RD2103_10_18_20181107_00042.jpg

LM Start	0.00	Rating **	A	Issue No.	18
LM End	4.64	Issue Type +	Ma	Location *	LS
Category	Earthen Levee			GPS Latitude/Longitude	
				Start	End
Item	Vegetation			39.019794 °	39.041396 °
				-121.454006 °	-121.392002 °
DWR ID	DWR_RD2103_01_f_2018_18				
Comment Code					
V1 : Control annual grass and weeds on the levee slopes and easements.					
Inspector Comment					
The annual vegetation is well maintained, Fall 2018.

View looking upstream landside of the annual vegetation that is well maintained, Fall 2018.

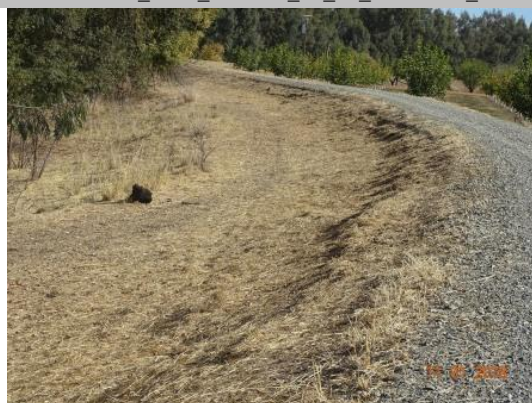
Photo 1 of 1 : FA_2018_RD2103_10_19_20181107_00041.jpg

LM Start	0.00	Rating **	A	Issue No.	19
LM End	4.64	Issue Type +	Ma	Location *	WS
Category	Earthen Levee			GPS Latitude/Longitude	
				Start	End
Item	Vegetation			39.019794 °	39.041396 °
				-121.454006 °	-121.392002 °
DWR ID	DWR_RD2103_01_f_2018_19				
Comment Code					
V1 : Control annual grass and weeds on the levee slopes and easements.					
Inspector Comment					
The annual vegetation is well maintained, Fall 2018.

View looking upstream waterside of the annual vegetation that is well maintained, Fall 2018.

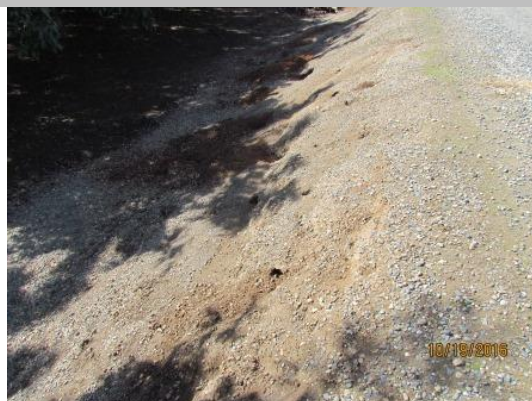
Photo 1 of 1 : FA_2018_RD2103_10_23_20180918_00004.jpg

LM Start	0.20	Rating **	M	Issue No.	23
LM End	0.22	Issue Type +	Ma	Location *	LS
Category	Earthen Levee			GPS Latitude/Longitude	
				Start	End
Item	Animal Control			39.020856 °	39.020938 °
				-121.450629 °	-121.450237 °
DWR ID	DWR_RD2103_01_f_2015_23				
Comment Code					
A3 : No rodents visible, but rodent burrows visible; need to backfill and compact or grout burrows.					
Inspector Comment

View of squirrel holes on the waterside looking downstream but no evidence of animal activity during Fall 2018 inspection.

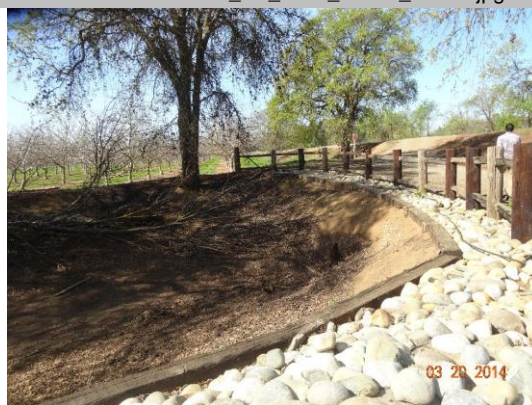
Photo 1 of 3 : UCIP_FA_2018_38325_69869.jpg

LM Start	0.82	Rating **	A/W	Issue No.	36
LM End	0.82	Issue Type +	Ma	Location *	
Category	Supplemental			GPS Latitude/Longitude	
				Start	End
Item	DWR UCIP LMA Responsibility			39.024811 °	39.024811 °
				-121.440750 °	-121.440750 °
DWR ID	19471				
Comment Code					
Inspector Comment					
FS_ID:38325 DS_ID:19471 EP_NO: N/A Repair Type: No Action Needed Crossing Status: Found UCIP Comments: FIELD_STRUCT_DESC: 36-inch corrugated metal drainage pipe through the levee, 14.4 feet below the crown. Concrete headwall, flap-gate, and 3-foot by 6-foot concrete splash apron located on the waterside (WS) toe. Outfall drain from old Grasshopper Slough. [Additional Reference(s): DWR Levee Logs, 2005. USACE Sacramento O&M Manual Unit No. 146, November 1962, (HLM 0.83)] FS Date: 3/20/2014

View of CMP crossing located on landward side.

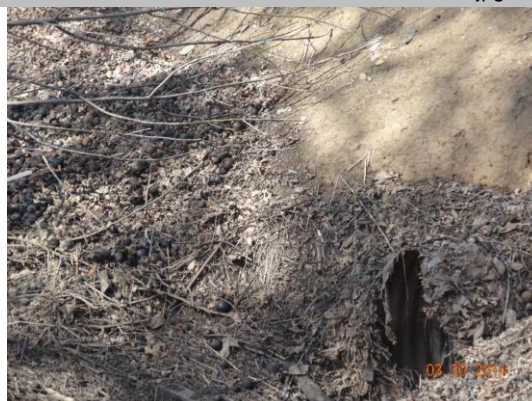
Photo 2 of 3 : UCIP_FA_2018_38325_69868.jpg

Close up view of crossing from landward side.

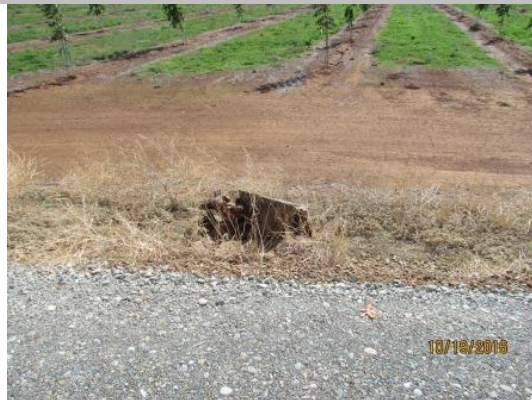
Photo 1 of 1 : FA_2018_RD2103_10_26_20180918_00005.jpg

LM Start	1.27	Rating **	N	Issue No.	26
LM End	1.27	Issue Type +	Ma	Location *	LS
Category	Earthen Levee			GPS Latitude/Longitude	
				Start	End
Item	Trim / Thin Trees			39.027261 °	39.027261 °
				-121.433269 °	-121.433269 °
DWR ID	DWR_RD2103_01_s_2016_26				
Comment Code					
T5 : Tree stumps.					
Inspector Comment					
Stump needs to be removed fom slope.

View of tree stump on lanside levee slope. Fall 2016, still exist as of Fall 2018.

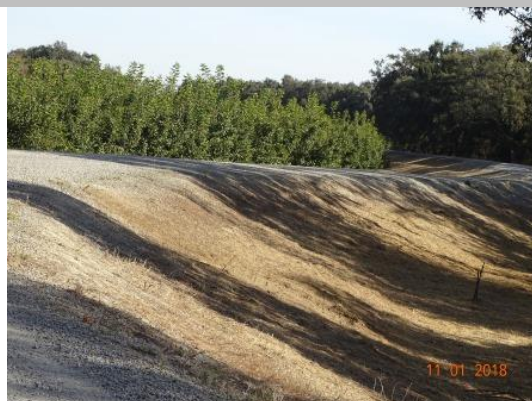
Photo 1 of 1 : FA_2018_RD2103_11_13_20181107_00032.jpg

LM Start	0.00	Rating **	A	Issue No.	13
LM End	4.72	Issue Type +	Ma	Location *	WS
Category	Earthen Levee			GPS Latitude/Longitude	
				Start	End
Item	Vegetation			38.993416 °	39.030162 °
				-121.437338 °	-121.368826 °
DWR ID	DWR_RD2103_02_f_2018_13				
Comment Code					
V1 : Control annual grass and weeds on the levee slopes and easements.					
Inspector Comment					
The annual vegetation is well maintained, Fall 2018.

View looking upstream waterside of the annual vegetation that is well maintained, Fall 2018.

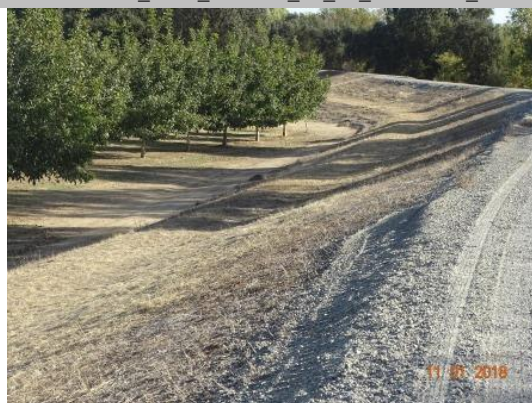
Photo 1 of 1 : FA_2018_RD2103_11_11_20181107_00033.jpg

LM Start	0.00	Rating **	A	Issue No.	11
LM End	4.72	Issue Type +	Ma	Location *	LS
Category	Earthen Levee			GPS Latitude/Longitude	
				Start	End
Item	Vegetation			38.993416 °	39.030162 °
				-121.437338 °	-121.368825 °
DWR ID	DWR_RD2103_02_f_2018_11				
Comment Code					
V1 : Control annual grass and weeds on the levee slopes and easements.					
Inspector Comment					
The annual vegetation is well maintained, Fall 2018.

View looking upstream landside of the annual vegetation that is well maintained, Fall 2018.

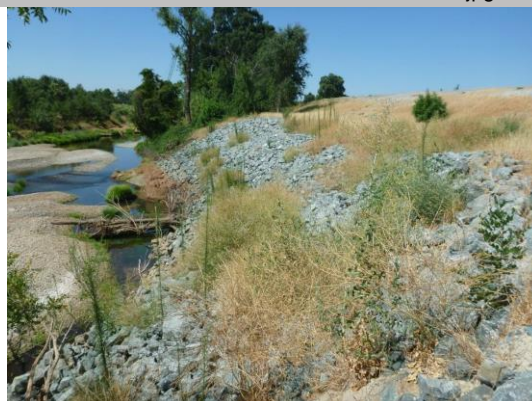
Photo 3 of 5 : LEVAL_FA_2018_488_1808.jpg

Comment Code						
Inspector Comment						
Levee Evaluation Comments						
Description:2017 Flood Fight Emergency Repair - 200 feet of site repaired in March 2017. Additional 50 feet requires repair after water receded. \$220,000 estimated total for completion and post project permits and mitigation						
Site ID No:488						
Site Designation:LMA-326						
Repair Type: Erosion						
Rating:Area of Concern						
Field Date:7/27/2017						
Notes: Site will likely degrade quickly due to lack of RSP along the lower portion of the bank slope and downstream end of site. At time of field visit, site does not appear to be any imminent threat of failure.

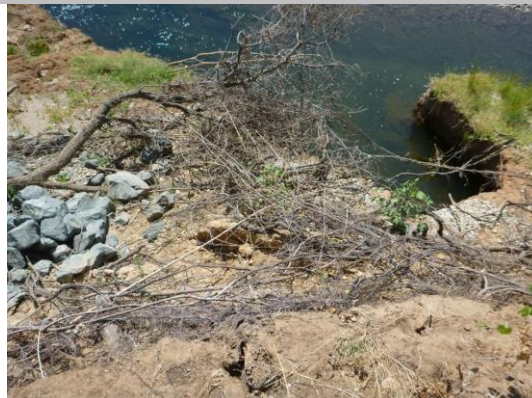
Photo 5 of 5 : LEVAL_FA_2018_488_1812.jpg

Item	2017 Storm Damage			39.002378 °	°					
				-121.403611 °	°					
DWR ID	DWR_RD2103_02_f_2017_12									
Comment Code										
Inspector Comment										
Levee Evaluation Comments Description: 2017 Flood Fight Emergency Repair - 200 feet of site repaired in March 2017. Additional 50 feet requires repair after water receded. \$220,000 estimated total for completion and post project permits and mitigation Site ID No: 488 Site Designation: LMA-326 Repair Type: Erosion Rating: Area of Concern Field Date: 7/27/2017 Notes: Site will likely degrade quickly due to lack of RSP along the lower portion of the bank slope and downstream end of site. At time of field visit, site does not appear to be any imminent threat of failure.
