**Flood Control Project Maintenance  
Levee Inspections**

**Maintenance Issue Types Only, Levee Inspection Report By Mile - Fall 2019**

**Reclamation District No. 2103 Wheatland Vicinity**

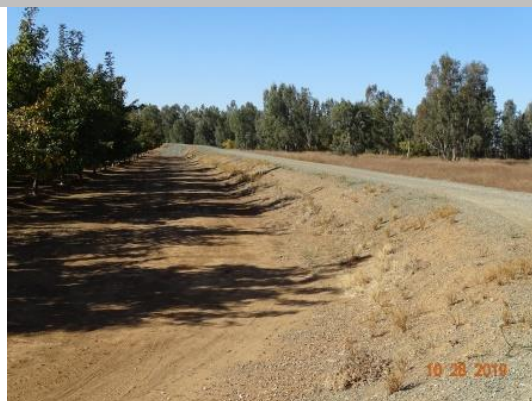
Photo 1 of 1 : FA\_2019\_RD2103\_10\_19\_20191030\_00041.jpg

LM Start	0.02	Rating **	A	Issue No.	19
LM End	3.32	Issue Type +	Ma	Location *	LS
Category	Earthen Levee			GPS Latitude/Longitude	
				Start	End
Item	Vegetation			39.019652 °	39.032921 °
				-121.453446 °	-121.401024 °
DWR ID	DWR_RD2103_01_f_2019_19				
Comment Code					
V1 : Control annual grass and weeds on the levee slopes and easements.					
Inspector Comment					
The annual vegetation is well maintained, Fall 2019.

View looking downstream landside at the well maintained annual vegetation, Fall 2019.

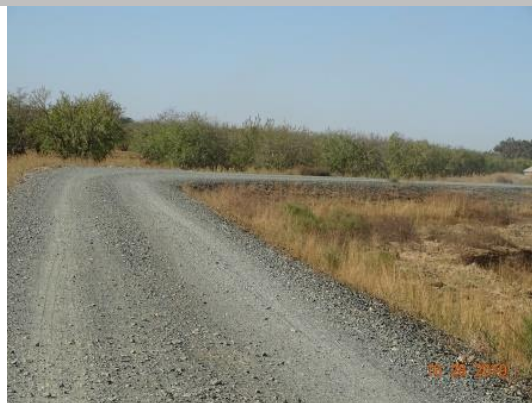
Photo 1 of 1 : FA\_2019\_RD2103\_10\_20\_20191030\_00042.jpg

LM Start	0.02	Rating **	A	Issue No.	20
LM End	3.32	Issue Type +	Ma	Location *	WS
Category	Earthen Levee			GPS Latitude/Longitude	
				Start	End
Item	Vegetation			39.019652 °	39.032882 °
				-121.453446 °	-121.401100 °
DWR ID	DWR_RD2103_01_f_2019_20				
Comment Code					
V1 : Control annual grass and weeds on the levee slopes and easements.					
Inspector Comment					
The annual vegetation is well maintained, Fall 2019.

View looking downstream waterside at the well maintained annual vegetation, Fall 2019.

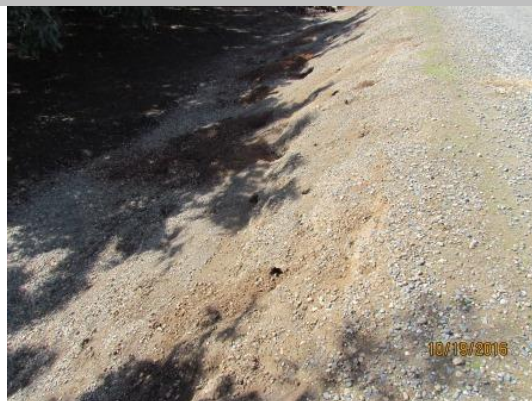
Photo 1 of 1 : FA\_2019\_RD2103\_10\_23\_20190904\_00004.jpg

LM Start	0.20	Rating **	M	Issue No.	23
LM End	0.22	Issue Type +	Ma	Location *	LS
Category	Earthen Levee			GPS Latitude/Longitude	
				Start	End
Item	Animal Control			39.020856 °	39.020938 °
				-121.450629 °	-121.450237 °
DWR ID	DWR_RD2103_01_f_2015_23				
Comment Code					
A3 : No rodents visible, but rodent burrows visible; need to backfill and compact or grout burrows.					
Inspector Comment					
Rodent holes in the levee slope need to be backfilled.

View of squirrel holes on the landside looking downstream but no evidence of animal activity.

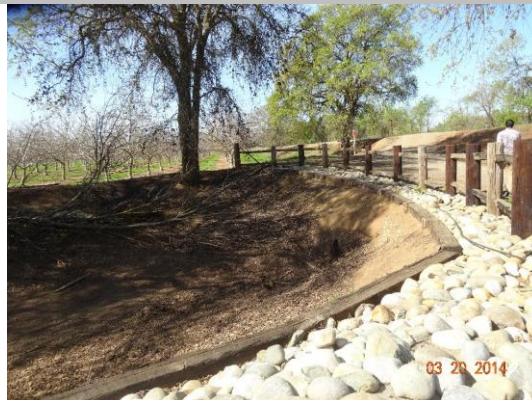
Photo 1 of 3 : UCIP\_FA\_2019\_38325\_69869.jpg

LM Start	0.82	Rating **	A/W	Issue No.	36	
LM End	0.82	Issue Type +	Ma	Location *		
Category	Supplemental			GPS Latitude/Longitude		
				Start		End
Item	DRAFT DWR UCIP LMA Responsibility			39.024811 °		39.024811 °
				-121.440750 °		-121.440750 °
DWR ID	19471					
Comment Code						
Inspector Comment						
DS_ID:19471 FS_ID:38325 EP_NO: N/A Repair Type: No Action Needed Crossing Status: Found UCIP Comments: FIELD_STRUCT_DESC: 36-inch corrugated metal drainage pipe through the levee, 14.4 feet below the crown. Concrete headwall, flap-gate, and 3-foot by 6-foot concrete splash apron located on the waterside (WS) toe. Outfall drain from old Grasshopper Slough. [Additional Reference(s): DWR Levee Logs, 2005. USACE Sacramento O&M Manual Unit No. 146, November 1962, (HLM 0.83)] FS Date: 3/20/2014

View of CMP crossing located on landward side.

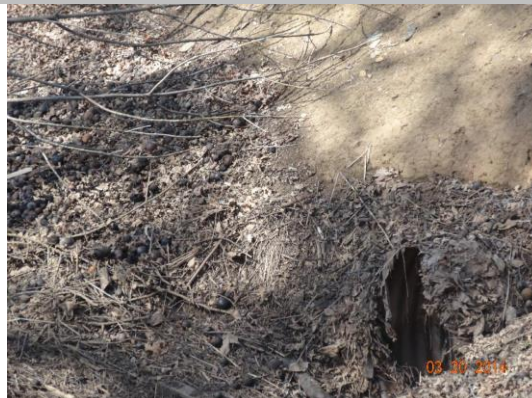
Photo 2 of 3 : UCIP\_FA\_2019\_38325\_69868.jpg

Close up view of crossing from landward side.

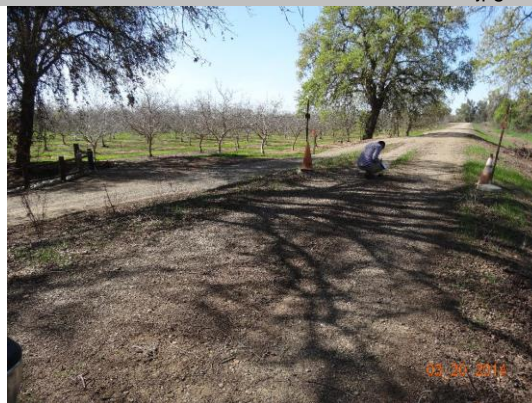
Photo 3 of 3 : UCIP\_FA\_2019\_38325\_69873.jpg

View of levee crown at crossing.

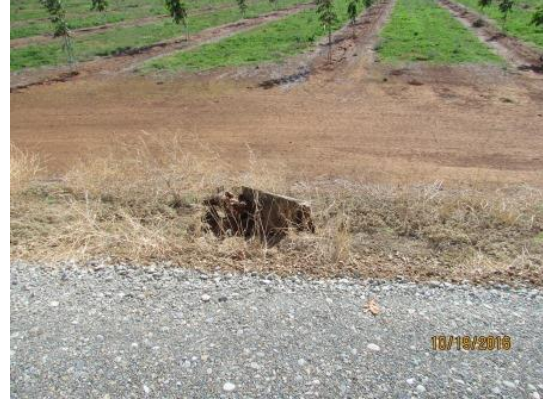
Photo 1 of 1 : FA\_2019\_RD2103\_10\_26\_20190904\_00005.jpg

LM Start	1.27	Rating **	N	Issue No.	26
LM End	1.27	Issue Type +	Ma	Location *	LS
Category	Earthen Levee			GPS Latitude/Longitude	
				Start	End
Item	Trim / Thin Trees			39.027261 °	39.027261 °
				-121.433269 °	-121.433269 °
DWR ID	DWR_RD2103_01_s_2016_26				
Comment Code					
T5 : Tree stumps.					
Inspector Comment					
Stump needs to be removed from slope.

View of tree stump on landside levee slope, Fall 2016. It still exists as of Fall 2019.

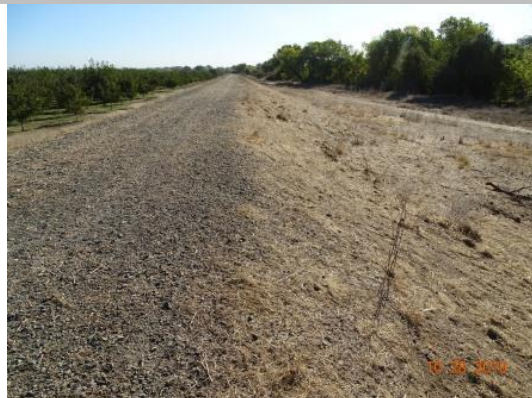
Photo 1 of 1 : FA\_2019\_RD2103\_11\_12\_20191030\_00029.jpg

LM Start	0.00	Rating **	A	Issue No.	12
LM End	4.83	Issue Type +	Ma	Location *	WS
Category	Earthen Levee			GPS Latitude/Longitude	
				Start	End
Item	Vegetation			38.993410 °	39.031167 °
				-121.437352 °	-121.367266 °
DWR ID	DWR_RD2103_02_f_2019_12				
Comment Code					
V1 : Control annual grass and weeds on the levee slopes and easements.					
Inspector Comment					
The annual vegetation is well maintained, Fall 2019.

View looking upstream waterside at the well maintained annual vegetation, Fall 2019.

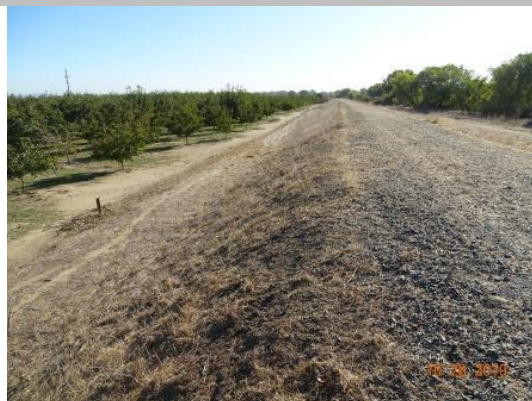
Photo 1 of 1 : FA\_2019\_RD2103\_11\_11\_20191030\_00028.jpg

LM Start	0.00	Rating **	A	Issue No.	11
LM End	4.83	Issue Type +	Ma	Location *	LS
Category	Earthen Levee			GPS Latitude/Longitude	
				Start	End
Item	Vegetation			38.993410 °	39.031168 °
				-121.437352 °	-121.367268 °
DWR ID	DWR_RD2103_02_f_2019_11				
Comment Code					
V1 : Control annual grass and weeds on the levee slopes and easements.					
Inspector Comment					
The annual vegetation is well maintained, Fall 2019.

View looking upstream landside at the well maintained annual vegetation, Fall 2019.

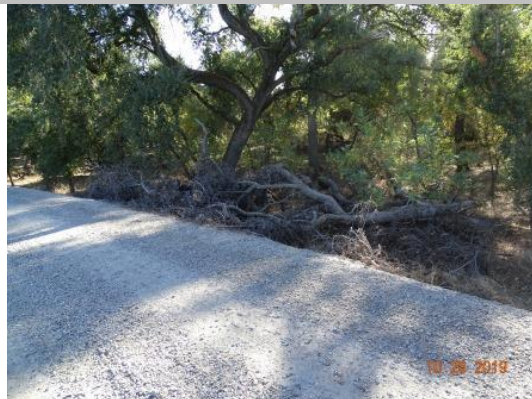
Photo 1 of 1 : FA\_2019\_RD2103\_11\_13\_20191030\_00030.jpg

LM Start	2.44	Rating **	M	Issue No.	13
LM End	2.44	Issue Type +	Ma	Location *	WS
Category	Earthen Levee			GPS Latitude/Longitude	
				Start	End
Item	Encroachments			39.007394 °	39.007394 °
				-121.398112 °	-121.398112 °
DWR ID	DWR_RD2103_02_f_2019_13				
Comment Code					
TR : Tree or limb					
Inspector Comment					
Remove downed tree from levee slope, Fall 2019.

View looking upstream waterside at a downed tree on the levee slope.
