**Flood Control Project Maintenance
Levee Inspections**

Maintenance Issue Types Only, Levee Inspection Report By Mile - Fall 2020

Reclamation District No. 2103 Wheatland Vicinity

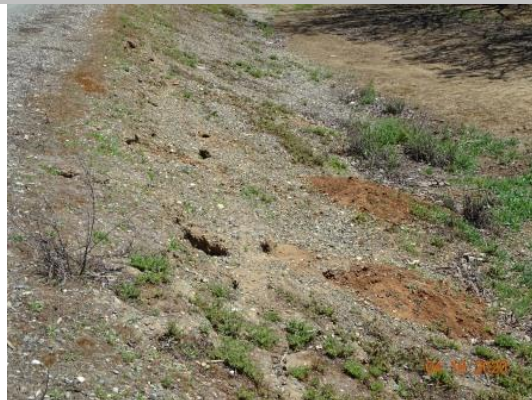
Photo 1 of 1 : FA_2020_RD2103_10_23_20201022_00005.jpg

LM Start	0.20	Rating **	M	Issue No.	23
LM End	0.22	Issue Type +	Ma	Location *	LS
Category	Earthen Levee			GPS Latitude/Longitude	
				Start	End
Item	Animal Control			39.020856 °	39.020938 °
				-121.450629 °	-121.450237 °
DWR ID	DWR_RD2103_01_f_2015_23				
Comment Code					
A3 : No rodents visible, but rodent burrows visible; need to backfill and compact or grout burrows.					
Inspector Comment					
Rodents need to be eradicated and holes in the levee slope need to be backfilled, Fall 2020.

View of active squirrel holes on the landside looking upstream, Spring 2020.

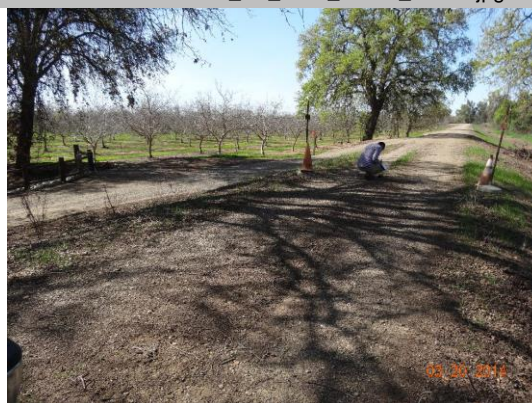
Photo 3 of 3 : UCIP_FA_2020_38325_69873.jpg

View of levee crown at crossing.

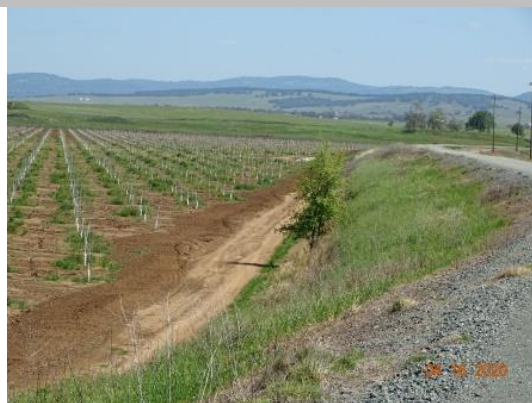
Photo 1 of 1 : FA_2020_RD2103_11_15_20201022_00001.jpg

LM Start	4.05	Rating **	M	Issue No.	15
LM End	4.05	Issue Type +	Ma	Location *	LS
Category	Earthen Levee			GPS Latitude/Longitude	
				Start	End
Item	Trim / Thin Trees			39.023654 °	39.023654 °
				-121.377906 °	-121.377906 °
DWR ID	DWR_RD2103_02_s_2020_15				
Comment Code					
T2 : Thin trees to allow visibility of the ground and room to flood fight.					
Inspector Comment					
Remove small tree from levee toe that is less than 4" in diameter, Fall 2020.

View looking upstream landside at a small tree at the levee toe less than 4" in diameter, Spring 2020.
