**Flood Control Project Maintenance
Levee Inspections**

Maintenance Issue Types Only, Levee Inspection Report By Mile - Fall 2021

Reclamation District No. 2103 Wheatland Vicinity

Waterway	Bank	Unit Miles	Inspection Start/End	Inspector
Unit No. 01 South Dry Creek	Left	4.64	10/18/2021 10/18/2021	Brooks Weisser

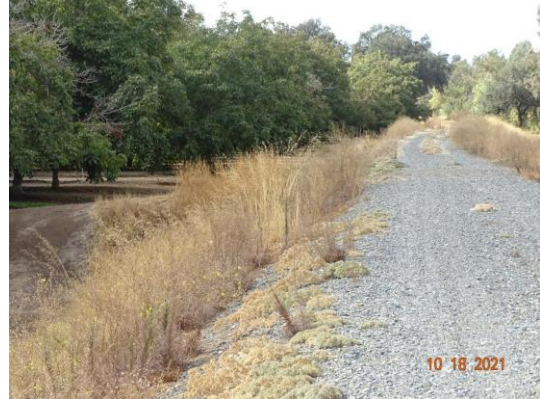
Photo 1 of 1 : FA_2021_RD2103_10_28_20211020_00053.jpg

LM Start	0.01	Rating **	M	Issue No.	28
LM End	1.03	Issue Type +	Ma	Location *	LS
Category	Earthen Levee			GPS Latitude/Longitude	
				Start	End
Item	Vegetation			39.021775 °	39.025961 °
				-121.453871 °	-121.437175 °
DWR ID	DWR_RD2103_01_f_2021_28				
Comment Code					
V1 : Control annual grass and weeds on the levee slopes and easements.					
Inspector Comment					
Annual vegetation on the landside slope needs to be maintained, Fall 2021.

View of annual vegetation on the landside slope, Fall 2021.

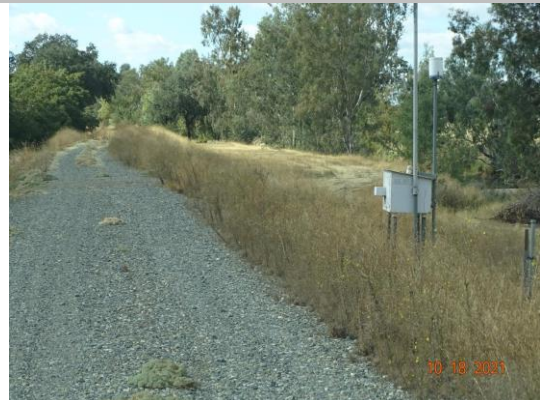
Photo 1 of 1 : FA_2021_RD2103_10_29_20211020_00054.jpg

LM Start	0.01	Rating **	M	Issue No.	29
LM End	1.03	Issue Type +	Ma	Location *	WS
Category	Earthen Levee			GPS Latitude/Longitude	
				Start	End
Item	Vegetation			39.021775 °	39.025959 °
				-121.453871 °	-121.437173 °
DWR ID	DWR_RD2103_01_f_2021_29				
Comment Code					
V1 : Control annual grass and weeds on the levee slopes and easements.					
Inspector Comment					
Annual vegetation on the waterside slope needs to be maintained to 20 feet from the levee crown, Fall 2021.

View of annual vegetation on the waterside slope, Fall 2021.

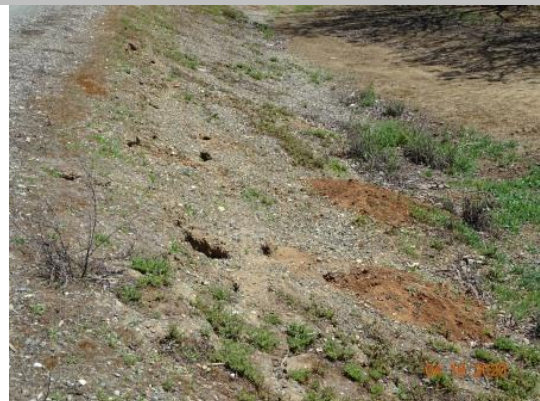
Photo 1 of 1 : FA_2021_RD2103_10_23_20210901_00005.jpg

LM Start	0.20	Rating **	M	Issue No.	23
LM End	0.22	Issue Type +	Ma	Location *	LS
Category	Earthen Levee			GPS Latitude/Longitude	
				Start	End
Item	Animal Control			39.020856 °	39.020938 °
				-121.450629 °	-121.450237 °
DWR ID	DWR_RD2103_01_f_2015_23				
Comment Code					
A3 : No rodents visible, but rodent burrows visible; need to backfill and compact or grout burrows.					
Inspector Comment					
No rodent activity noticed due to tall vegetation, will check again in fall when vegetation is removed, Fall 2021.

View of active squirrel holes on the landside looking upstream, Spring 2020.

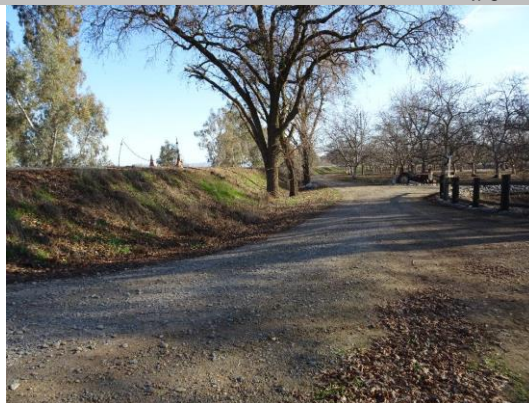
Photo 1 of 3 : UCIP_FA_2021_66323_98695.jpg

Comment Code						
Inspector Comment						
DS_ID:19471 FS_ID:66323 EP_NO: N/A Repair Type: Urgent EVAL Issue: Pipe Integrity Crossing Status: Found UCIP Comments: 01/21/2021 Record has been updated from No Action Needed to Urgent. DWR DMP has found integrity issues, LOF between 5 and 6. Recommend monitoring crossing until funding becomes available to address. No permit was found authorizing this encroachment. CVFPB will need to review crossing to determine owner. (O. Magana - DWR UCIP) FIELD_STRUCT_DESC: 36-inch corrugated metal drainage pipe through the levee, 14.4 feet below the crown. Concrete headwall, flap-gate, and 3-foot by 6-foot concrete splash apron located on the waterside (WS) toe. Outfall drain from old Grasshopper Slough. [Additional Reference(s): DWR Levee Logs, 2005. USACE Sacramento O&M Manual Unit No. 146, November 1962, (HLM 0.83)] FS Date: 1/21/2021

LS view: overview of private access road on the LS toe.

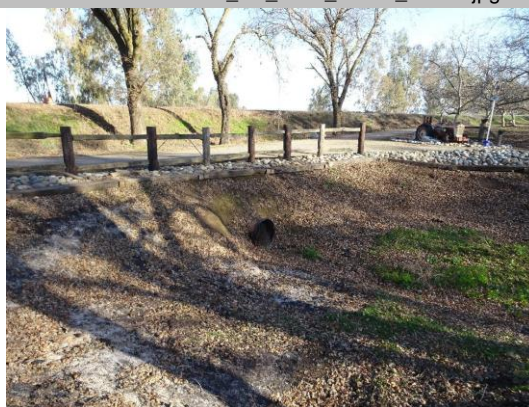
Photo 2 of 3 : UCIP_FA_2021_66323_98696.jpg

LS view: pipe inlet visible on the LS

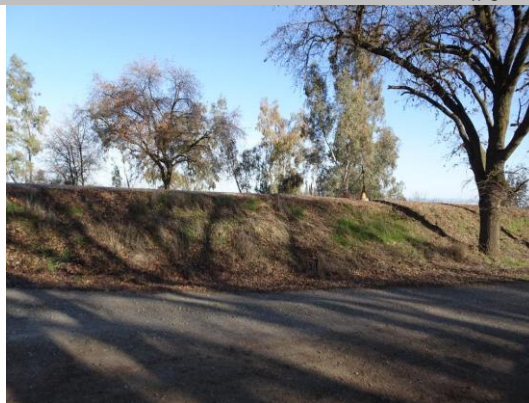
Photo 3 of 3 : UCIP_FA_2021_66323_98697.jpg

LS view: overview of LS slope

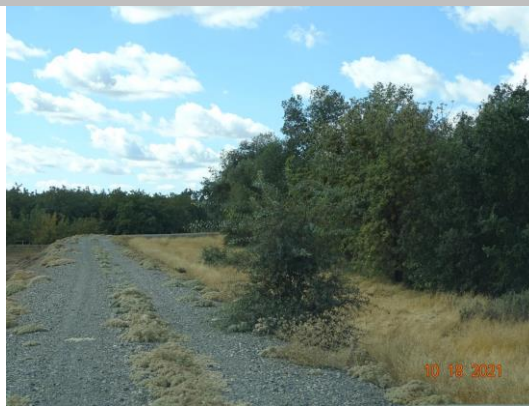
Photo 1 of 1 : FA_2021_RD2103_10_26_20211020_00052.jpg

LM Start	1.14	Rating **	M	Issue No.	26
LM End	1.14	Issue Type +	Ma	Location *	WS
Category	Earthen Levee			GPS Latitude/Longitude	
				Start	End
Item	Trim / Thin Trees			39.026820 °	39.026820 °
				-121.435614 °	-121.435614 °
DWR ID	DWR_RD2103_01_f_2021_26				
Comment Code					
T1 : Trim trees to at least five feet above ground level.					
Inspector Comment					
Remove small starter tree on the water side hinge, Fall 2021.

View of starter tree on the waterside hinge, Fall 2021.

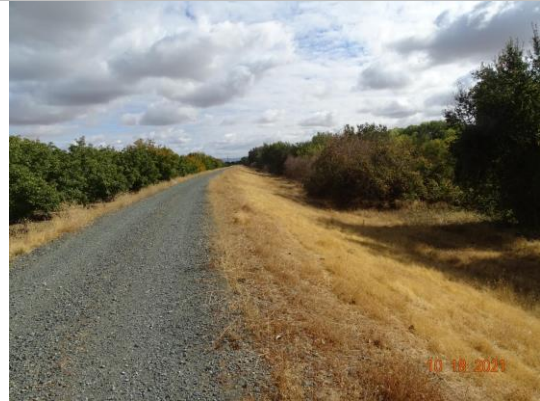
Photo 1 of 1 : FA_2021_RD2103_11_25_20211020_00043.jpg

LM Start	0.00	Rating **	M	Issue No.	25
LM End	1.88	Issue Type +	Ma	Location *	WS
Category	Earthen Levee			GPS Latitude/Longitude	
				Start	End
Item	Vegetation			38.993413 °	39.001807 °
				-121.437343 °	-121.405132 °
DWR ID	DWR_RD2103_02_f_2021_25				
Comment Code					
V1 : Control annual grass and weeds on the levee slopes and easements.					
Inspector Comment					
Annual vegetation on the waterside slope needs to be maintained to 20 feet from the levee crown, Fall 2021.

View of annual vegetation on the waterside slope, Fall 2021.

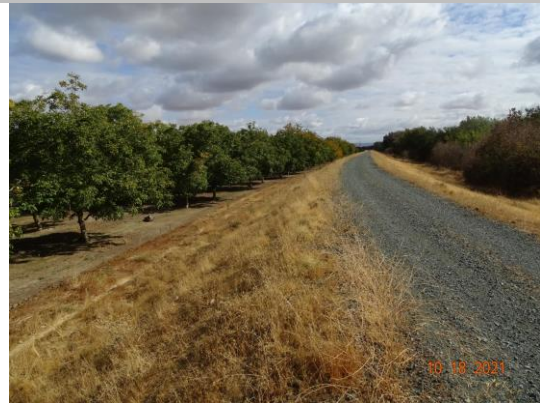
Photo 1 of 1 : FA_2021_RD2103_11_23_20211020_00042.jpg

LM Start	0.00	Rating **	M	Issue No.	23
LM End	2.47	Issue Type +	Ma	Location *	LS
Category	Earthen Levee			GPS Latitude/Longitude	
				Start	End
Item	Vegetation			38.993419 °	39.007619 °
				-121.437342 °	-121.397618 °
DWR ID	DWR_RD2103_02_f_2021_23				
Comment Code					
V1 : Control annual grass and weeds on the levee slopes and easements.					
Inspector Comment					
Annual vegetation on the landside slope needs to be maintained, Fall 2021.

View of annual vegetation on the landside slope, Fall 2021.

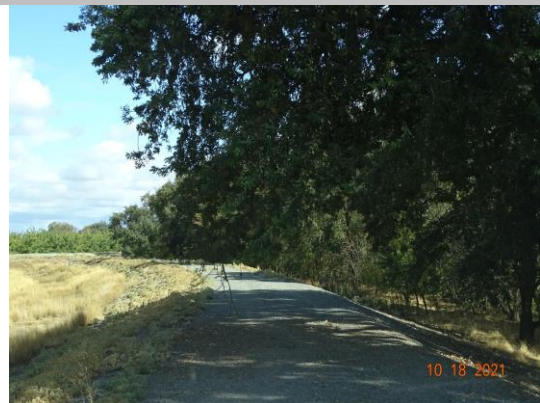
Photo 1 of 1 : FA_2021_RD2103_11_26_20211020_00046.jpg

LM Start	2.03	Rating **	M	Issue No.	26
LM End	2.03	Issue Type +	Ma	Location *	CR
Category	Earthen Levee			GPS Latitude/Longitude	
				Start	End
Item	Trim / Thin Trees			39.003171 °	39.003171 °
				-121.403029 °	-121.403029 °
DWR ID	DWR_RD2103_02_f_2021_26				
Comment Code					
T4 : Trim trees over roadway to at least 12 feet above ground level.					
Inspector Comment					
Low hanging tree branches need be be trimmed to 12 feet about the road surface to allow access, Fall 2021.

View of low hanging tree branches over the levee road, Fall 2021.

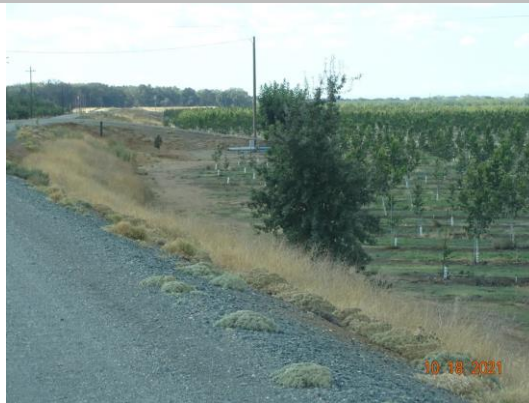
Photo 1 of 1 : FA_2021_RD2103_11_15_20211020_00047.jpg

LM Start	4.05	Rating **	M	Issue No.	15
LM End	4.05	Issue Type +	Ma	Location *	LS
Category	Earthen Levee			GPS Latitude/Longitude	
				Start	End
Item	Trim / Thin Trees			39.023654 °	39.023654 °
				-121.377906 °	-121.377906 °
DWR ID	DWR_RD2103_02_s_2020_15				
Comment Code					
T2 : Thin trees to allow visibility of the ground and room to flood fight.					
Inspector Comment					
Remove small tree from levee toe that is less than 4" in diameter, Fall 2021.

View looking downstream landside at a small tree at the levee toe less than 4" in diameter, Fall 2021.
