**Flood Control Project Maintenance  
Levee Inspections**

**Maintenance Issue Types Only, Levee Inspection Report By Mile - Fall 2022**

**Reclamation District No. 2103 Wheatland Vicinity**

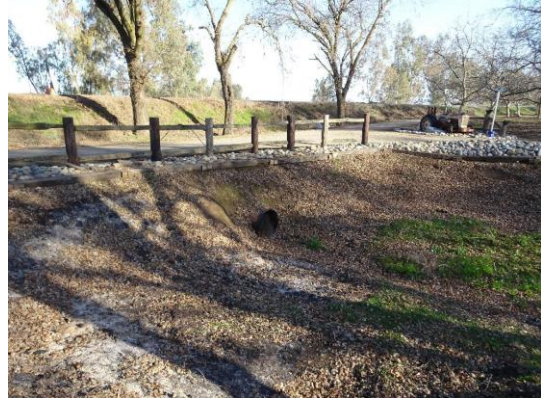
Photo 1 of 3 : UCIP\_FA\_2022\_70898\_98696.jpg

LM Start	0.82	Rating **	U	Issue No.	29
LM End	0.82	Issue Type +	Ma	Location *	
Category	Supplemental			GPS Latitude/Longitude	
				Start	End
Item	DWR UCIP LMA Responsibility			39.024811 °	39.024811 °
				-121.440750 °	-121.440750 °
DWR ID	19471

Comment Code					
Inspector Comment					
DS_ID:19471 FS_ID:70898 EP_NO: N/A Repair Type: Urgent EVAL Issue: 1, Pipe Integrity Crossing Status: Found UCIP Comments: 01/21/2021 Record has been updated from No Action Needed to Urgent. DWR DMP has found integrity issues, LOF between 5 and 6. Recommend monitoring crossing until funding becomes available to address. No permit was found authorizing this encroachment. CVFPB will need to review crossing to determine owner. (O. Magana - DWR UCIP) FIELD_STRUCT_DESC: 36-inch corrugated metal drainage pipe through the levee, 14.4 feet below the crown. Concrete headwall, flap gate, and 3-foot by 6-foot concrete splash apron on the waterside (WS) toe. Outfall drain from old Grasshopper Slough. [Additional Reference(s): DWR Levee Log, 2005, (HLM 0.83). USACE Sacramento O&M Manual, Unit No. 146, November 1962, Revised June 2017, (HLM 0.83). USACE As-Built Drawing No. 2-4-55-1, Sheet No. 55-1/4, 20 August 1937, (Station 251+50)]. FS Date: 1/21/2021

LS view: pipe inlet visible on the LS

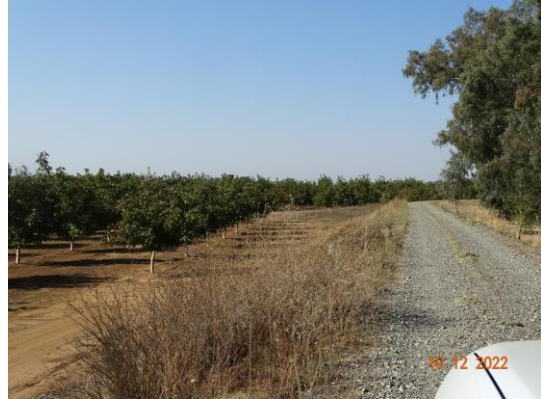
Photo 1 of 1 : FA\_2022\_RD2103\_10\_25\_20221028\_00053.jpg

LM Start	1.47	Rating **	M	Issue No.	25
LM End	1.68	Issue Type +	Ma	Location *	LS
Category	Earthen Levee			GPS Latitude/Longitude	
				Start	End
Item	Vegetation			39.028062 °	39.028432 °
				-121.430413 °	-121.426611 °
DWR ID	DWR_RD2103_01_f_2022_25				
Comment Code					
V1 : Control annual grass and weeds on the levee slopes and easements.					
Inspector Comment					
Annual vegetation on the landside slope needs to be maintained, Fall 2022.

Annual vegetation needs to be maintained, Fall 2022.

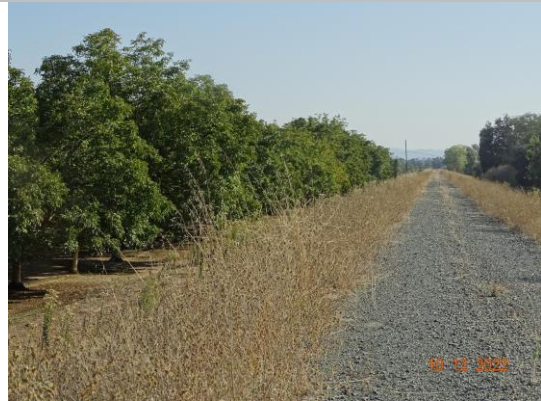
Photo 1 of 1 : FA\_2022\_RD2103\_11\_27\_20221028\_00046.jpg

LM Start	0.02	Rating **	M	Issue No.	27
LM End	3.71	Issue Type +	Ma	Location *	LS
Category	Earthen Levee			GPS Latitude/Longitude	
				Start	End
Item	Vegetation			38.993531 °	39.020143 °
				-121.436957 °	-121.382376 °
DWR ID	DWR_RD2103_02_f_2022_27				
Comment Code					
V1 : Control annual grass and weeds on the levee slopes and easements.					
Inspector Comment					
Vegetation on the landside slope needs to be maintained, Fall 2022.

Vegetation on the landside slope needs to be maintained, Fall 2022.

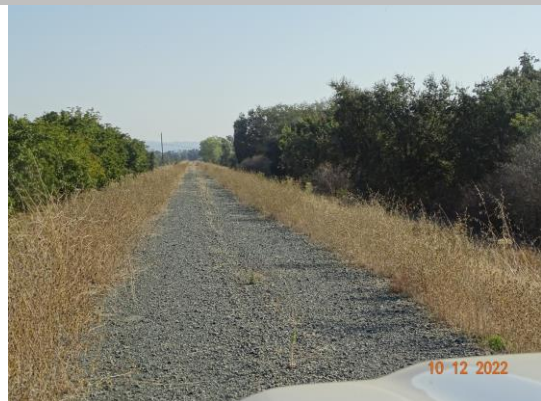
Photo 1 of 1 : FA\_2022\_RD2103\_11\_25\_20221028\_00047.jpg

LM Start	0.02	Rating **	M	Issue No.	25
LM End	2.35	Issue Type +	Ma	Location *	WS
Category	Earthen Levee			GPS Latitude/Longitude	
				Start	End
Item	Vegetation			38.993531 °	39.006491 °
				-121.436956 °	-121.399272 °
DWR ID	DWR_RD2103_02_f_2022_25				
Comment Code					
V1 : Control annual grass and weeds on the levee slopes and easements.					
Inspector Comment					
Vegetation on the waterside slope needs to be maintained, Fall 2022.

Vegetation on the waterside slope needs to be maintained, Fall 2022.

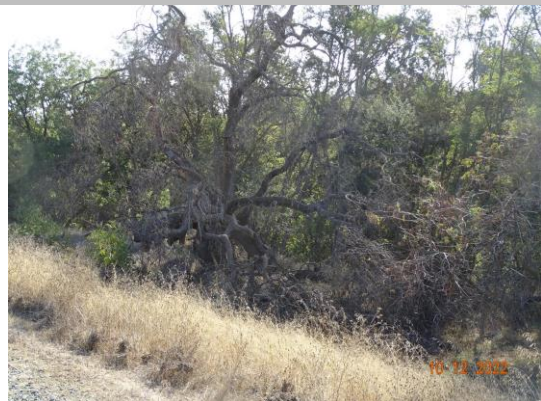
Photo 1 of 1 : FA\_2022\_RD2103\_11\_14\_20221028\_00048.jpg

LM Start	0.62	Rating **	M	Issue No.	14
LM End	0.62	Issue Type +	Ma	Location *	WS
Category	Earthen Levee			GPS Latitude/Longitude	
				Start	End
Item	Trim / Thin Trees			38.996033 °	38.996033 °
				-121.426284 °	-121.426284 °
DWR ID	DWR_RD2103_02_s_2021_14				
Comment Code					
T2 : Tree or limb.					
Inspector Comment					
The fallen tree on the waterside slope should be removed, Fall 2022.

View of a fallen tree on the waterside slope, Fall 2022.

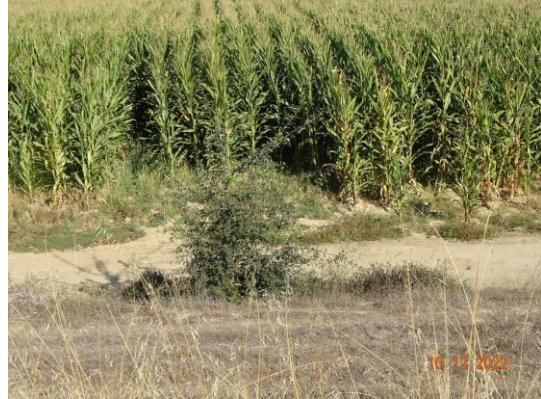
Photo 1 of 1 : FA\_2022\_RD2103\_11\_28\_20221028\_00049.jpg

LM Start	0.72	Rating **	M	Issue No.	28
LM End	0.72	Issue Type +	Ma	Location *	LS
Category	Earthen Levee			GPS Latitude/Longitude	
				Start	End
Item	Trim / Thin Trees			38.996510 °	38.996510 °
				-121.424539 °	-121.424539 °
DWR ID	DWR_RD2103_02_s_2022_28				
Comment Code					
T1 : Trim and thin trees to at least five feet above ground level to allow visibility of the ground and room to flood fight.					
Inspector Comment					
Starter tree near the landside toe needs to be removed, Fall 2022.

View of starter tree near the landside toe, Fall 2022.

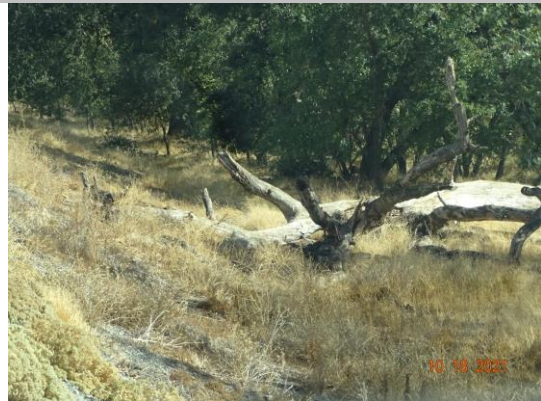
Photo 1 of 1 : FA\_2022\_RD2103\_11\_11\_20220927\_00001.jpg

LM Start	1.86	Rating **	M	Issue No.	11
LM End	1.86	Issue Type +	Ma	Location *	WS
Category	Earthen Levee			GPS Latitude/Longitude	
				Start	End
Item	Trim / Thin Trees			39.001644 °	39.001644 °
				-121.405450 °	-121.405450 °
DWR ID	DWR_RD2103_02_f_2020_11				
Comment Code					
T2 : Tree or limb.					
Inspector Comment					
Remove downed tree from levee slope, Fall 2022.

View of downed tree on the waterside slope, Fall 2021.

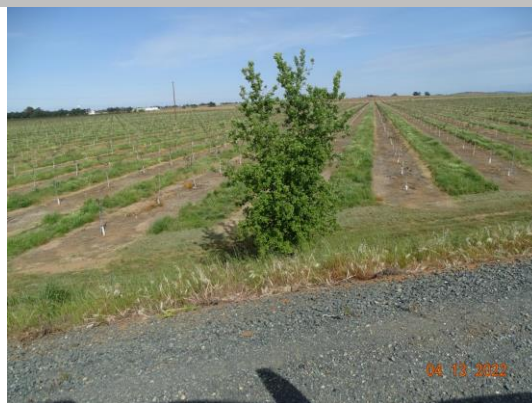
Photo 1 of 1 : FA\_2022\_RD2103\_11\_15\_20220927\_00003.jpg

LM Start	4.05	Rating **	M	Issue No.	15
LM End	4.05	Issue Type +	Ma	Location *	LS
Category	Earthen Levee			GPS Latitude/Longitude	
				Start	End
Item	Trim / Thin Trees			39.023654 °	39.023654 °
				-121.377906 °	-121.377906 °
DWR ID	DWR_RD2103_02_s _ 2020_15				
Comment Code					
T1 : Trim and thin trees to at least five feet above ground level to allow visibility of the ground and room to flood fight.					
Inspector Comment					
Remove small tree from levee toe that is less than 4" in diameter, Fall 2022.

View of a small tree at the levee toe less than 4" in diameter, Spring 2022.
