**Flood Control Project Maintenance
Levee Inspections**

Maintenance Issue Types Only, Levee Inspection Report By Mile - Fall 2023

Reclamation District No. 2103 Wheatland Vicinity

Waterway	Bank	Unit Miles	Inspection Start/End	Inspector
Unit No. 01 South Dry Creek	Left	4.64	10/04/2023 10/04/2023	Brooks Weisser

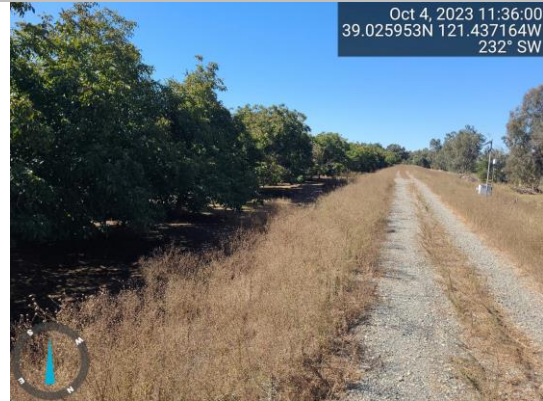
Photo 1 of 1 : FA_2023_RD2103_10_16_20231010_00022.jpg

LM Start	0.01	Rating **	U	Issue No.	16
LM End	1.03	Issue Type +	Ma	Location *	LS
Category	Earthen Levee			GPS Latitude/Longitude	
				Start	End
Item	Vegetation			39.019829°	39.025972°
				-121.453906°	-121.437157°
DWR ID	DWR_RD2103_01_f_2023_16				
Comment Code					
V1 : Control annual grass and weeds on the levee slopes and easements.					
Inspector Comment					
Vegetation on the landside slope needs to be maintained, Fall 2023.

View of vegetation on the landside slope, Fall 2023.

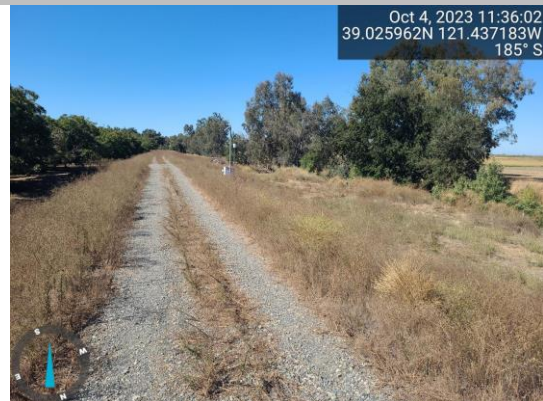
Photo 1 of 1 : FA_2023_RD2103_10_17_20231010_00023.jpg

LM Start	0.01	Rating **	U	Issue No.	17
LM End	1.03	Issue Type +	Ma	Location *	WS
Category	Earthen Levee			GPS Latitude/Longitude	
				Start	End
Item	Vegetation			39.019836°	39.025974°
				-121.453910°	-121.437160°
DWR ID	DWR_RD2103_01_f_2023_17				
Comment Code					
V1 : Control annual grass and weeds on the levee slopes and easements.					
Inspector Comment					
Annual vegetation on the waterside slope needs to be maintained, Fall 2023.

View of annual vegetation on the waterside slope, Fall 2023.

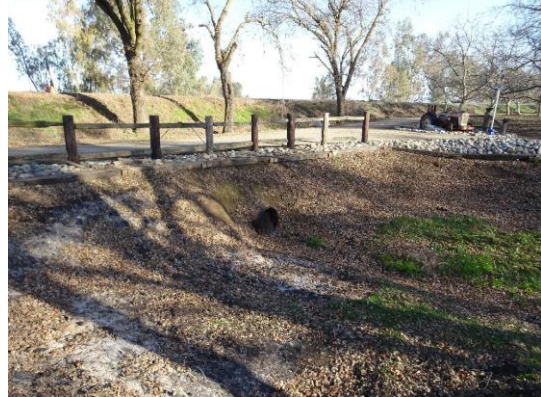
Photo 1 of 3 : UCIP_FA_2023_79236_98696.jpg

Comment Code					
Inspector Comment					
DS_ID:19471 FS_ID:79236 EP_NO: N/A Repair Type: No Action Needed EVAL Issue: Crossing Status: Found UCIP Comments: 03/01/2023 Record updated from Urgent to No Action Needed. MBK Engineers provided information that cast-in-place liner has been installed within the existing 36-inch CMP. (O.Yakimov - DWR UCIP) 01/21/2021 Record has been updated from No Action Needed to Urgent. DWR DMP has found integrity issues, LOF between 5 and 6. Recommend monitoring crossing until funding becomes available to address. No permit was found authorizing this encroachment. CVFPB will need to review crossing to determine owner. (O. Magana - DWR UCIP) FIELD_STRUCT_DESC: 36-inch CIPP-lined corrugated metal drainage pipe through the levee, 14.4 feet below the crown. Concrete headwall, flap gate, and 3-foot by 6-foot concrete splash apron on the waterside (WS) toe. Outfall drain from old Grasshopper Slough. [Additional Reference(s): DWR Levee Log, 2005, (HLM 0.83). USACE Sacramento O&M Manual, Unit No. 146, November 1962, Revised June 2017, (HLM 0.83). USACE As-Built Drawing No. 2-4-55-1, Sheet No. 55-1/4, 20 August 1937, (Station 251+50)]. FS Date: 1/21/2021 12:55:41 PM

LS view: pipe inlet visible on the LS

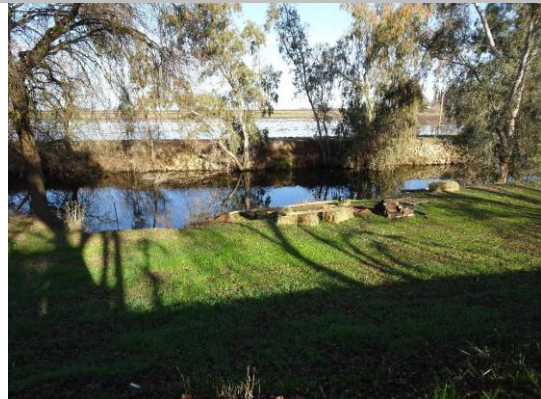
Photo 2 of 3 : UCIP_FA_2023_79236_98691.jpg

WS view: overview of WS

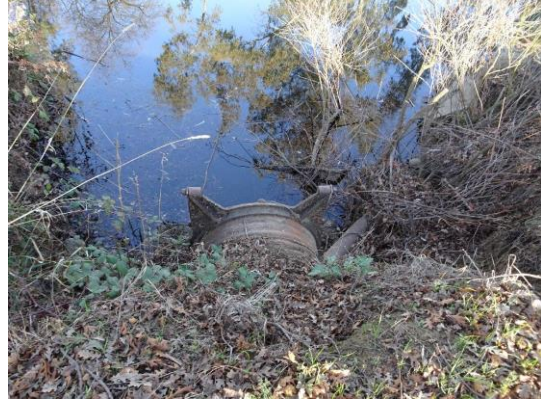
Photo 3 of 3 : UCIP_FA_2023_79236_98693.jpg

WS view: pipe with flap gate visible on the WS toe, photo 2 of 2.

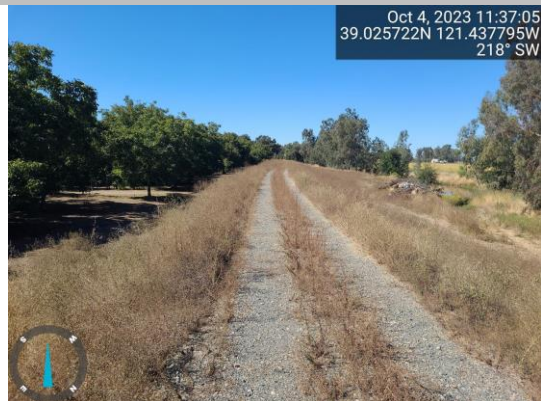
Photo 1 of 1 : FA_2023_RD2103_10_20_20231010_00024.jpg

LM Start	0.84	Rating **	U	Issue No.	20
LM End	1.00	Issue Type +	Ma	Location *	CR
Category	Earthen Levee			GPS Latitude/Longitude	
				Start	End
Item	Vegetation			39.024921°	39.025763°
				-121.440439°	-121.437775°
DWR ID	DWR_RD2103_01_f_2023_20				
Comment Code					
V1 : Control annual grass and weeds on the levee slopes and easements.					
Inspector Comment					
Annual vegetation on the levee crown needs to be maintained, Fall 2023.

View of vegetation on the levee crown, Fall 2023.

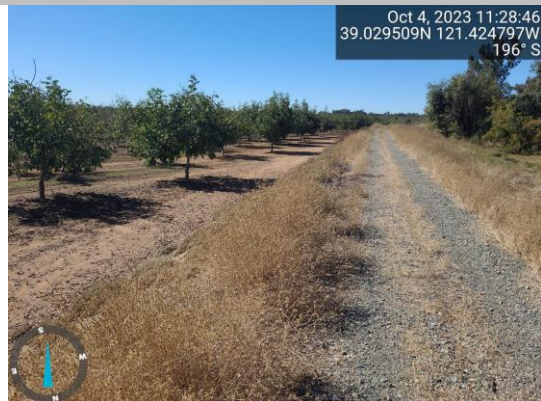
Photo 1 of 1 : FA_2023_RD2103_10_14_20231010_00020.jpg

LM Start	1.03	Rating **	M	Issue No.	14
LM End	1.81	Issue Type +	Ma	Location *	LS
Category	Earthen Levee			GPS Latitude/Longitude	
				Start	End
Item	Vegetation			39.025971°	39.029514°
				-121.437153°	-121.424757°
DWR ID	DWR_RD2103_01_f_2023_14				
Comment Code					
V1 : Control annual grass and weeds on the levee slopes and easements.					
Inspector Comment					
Vegetation on the landside slope needs to be maintained, Fall 2023.

View of vegetation on the landside slope, Fall 2023.

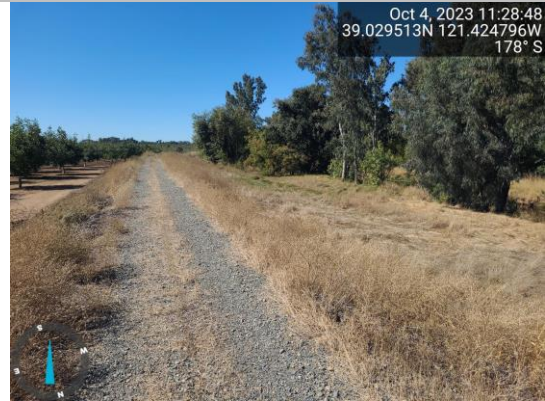
Photo 1 of 1 : FA_2023_RD2103_10_15_20231010_00019.jpg

LM Start	1.03	Rating **	M	Issue No.	15
LM End	1.81	Issue Type +	Ma	Location *	WS
Category	Earthen Levee			GPS Latitude/Longitude	
				Start	End
Item	Vegetation			39.025968°	39.029507°
				-121.437149°	-121.424756°
DWR ID	DWR_RD2103_01_f_2023_15				
Comment Code					
V1 : Control annual grass and weeds on the levee slopes and easements.					
Inspector Comment					
Vegetation on the waterside slope needs to be maintained, Fall 2023.

View of vegetation on the waterside slope, Fall 2023.

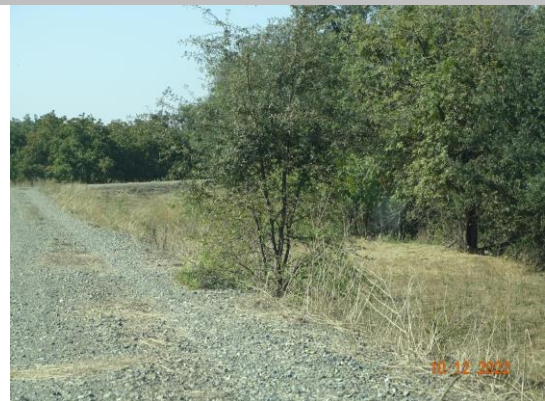
Photo 1 of 1 : FA_2023_RD2103_10_26_20230913_00006.jpg

LM Start	1.14	Rating **	M	Issue No.	26
LM End	1.14	Issue Type +	Ma	Location *	WS
Category	Earthen Levee			GPS Latitude/Longitude	
				Start	End
Item	Trim / Thin Trees			39.026820°	39.026820°
				-121.435614°	-121.435614°
DWR ID	DWR_RD2103_01_f_2021_26				
Comment Code					
T1 : Trim and thin trees to at least five feet above ground level to allow visibility of the ground and room to flood fight.					
Inspector Comment					
Remove small starter tree on the waterside hinge, Fall 2023.

View of starter tree on the waterside hinge, Fall 2022.

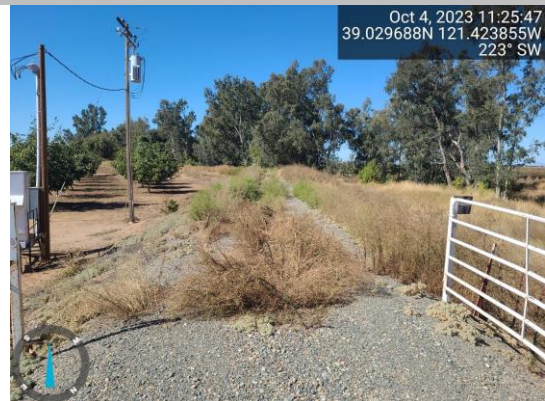
Photo 1 of 1 : FA_2023_RD2103_10_10_20231010_00018.jpg

LM Start	1.80	Rating **	U	Issue No.	10
LM End	1.87	Issue Type +	Ma	Location *	CR
Category	Earthen Levee			GPS Latitude/Longitude	
				Start	End
Item	Vegetation			39.029513°	39.029688°
				-121.424756°	-121.423789°
DWR ID	DWR_RD2103_01_f_2023_10				
Comment Code					
V3 : Keep the crown roadway free of vegetation.					
Inspector Comment					
Vegetation on the levee crown needs to be maintained, Fall 2023.

View of vegetation on the levee crown, Fall 2023.

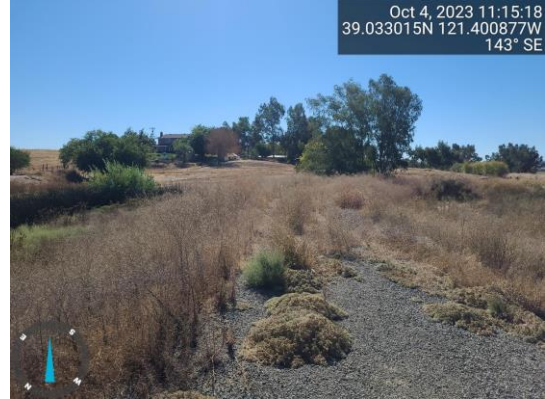
Photo 1 of 1 : FA_2023_RD2103_10_9_20231010_00017.jpg

LM Start	3.32	Rating **	U	Issue No.	9
LM End	3.55	Issue Type +	Ma	Location *	CR
Category	Earthen Levee			GPS Latitude/Longitude	
				Start	End
Item	Vegetation			39.033050°	39.030016°
				-121.400903°	-121.400804°
DWR ID	DWR_RD2103_01_f_2023_9				
Comment Code					
V3 : Keep the crown roadway free of vegetation.					
Inspector Comment					
Vegetation on the levee crown and slopes needs to be maintained, Fall 2023.

View of annual vegetation on the levee crown and slopes, Fall 2023.

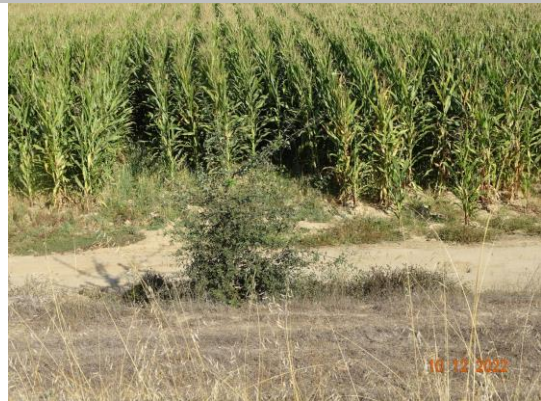
Photo 1 of 1 : FA_2023_RD2103_11_28_20230913_00004.jpg

LM Start	0.72	Rating **	M	Issue No.	28
LM End	0.72	Issue Type +	Ma	Location *	LS
Category	Earthen Levee			GPS Latitude/Longitude	
				Start	End
Item	Trim / Thin Trees			38.996510°	38.996510°
				-121.424539°	-121.424539°
DWR ID	DWR_RD2103_02_s_2022_28				
Comment Code					
T1 : Trim and thin trees to at least five feet above ground level to allow visibility of the ground and room to flood fight.					
Inspector Comment					
Starter tree near the landside toe needs to be removed, Fall 2023.

View of starter tree near the landside toe, Fall 2022.

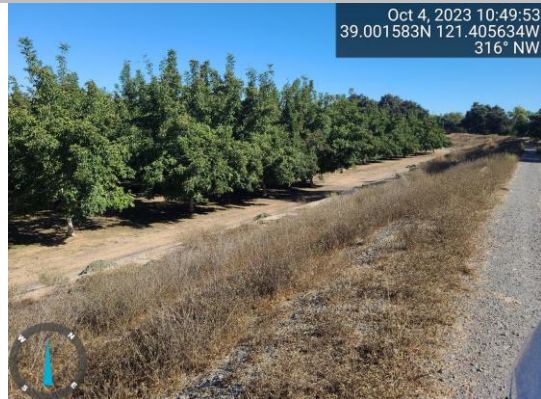
Photo 1 of 1 : FA_2023_RD2103_11_2_20231010_00008.jpg

LM Start	1.81	Rating **	M	Issue No.	2
LM End	4.80	Issue Type +	Ma	Location *	LS
Category	Earthen Levee			GPS Latitude/Longitude	
				Start	End
Item	Vegetation			39.001185°	39.030824°
				-121.406098°	-121.367649°
DWR ID	DWR_RD2103_02_f_2023_2				
Comment Code					
V1 : Control annual grass and weeds on the levee slopes and easements.					
Inspector Comment					
Annual vegetation on the landside slope needs to be maintained, Fall 2023.

View of annual vegetation on the landside slope, Fall 2023.

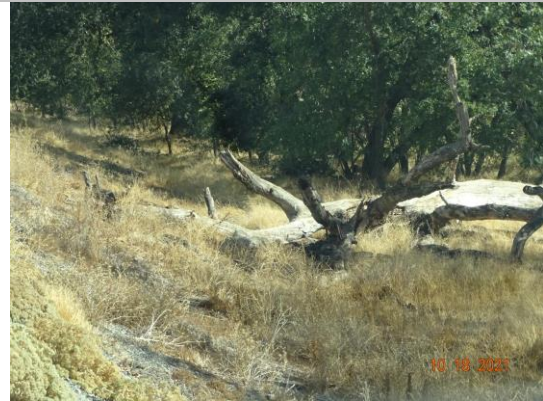
Photo 1 of 1 : FA_2023_RD2103_11_11_20230913_00001.jpg

LM Start	1.86	Rating **	M	Issue No.	11
LM End	1.86	Issue Type +	Ma	Location *	WS
Category	Earthen Levee			GPS Latitude/Longitude	
				Start	End
Item	Trim / Thin Trees			39.001644°	39.001644°
				-121.405450°	-121.405450°
DWR ID	DWR_RD2103_02_f_2020_11				
Comment Code					
T2 : Tree or limb.					
Inspector Comment					
Remove downed tree from levee slope, Fall 2023.

View of downed tree on the waterside slope, Fall 2021.

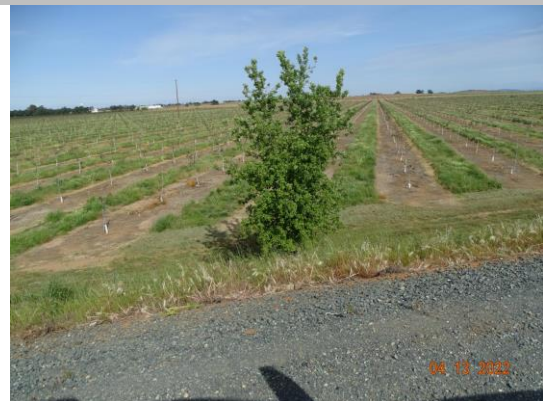
Photo 1 of 1 : FA_2023_RD2103_11_15_20230913_00003.jpg

LM Start	4.05	Rating **	M	Issue No.	15
LM End	4.05	Issue Type +	Ma	Location *	LS
Category	Earthen Levee			GPS Latitude/Longitude	
				Start	End
Item	Trim / Thin Trees			39.023654°	39.023654°
				-121.377906°	-121.377906°
DWR ID	DWR_RD2103_02_s_2020_15				
Comment Code					
T1 : Trim and thin trees to at least five feet above ground level to allow visibility of the ground and room to flood fight.					
Inspector Comment					
Remove small tree from levee toe that is less than 4" in diameter, Fall 2023.

View of a small tree at the levee toe less than 4" in diameter, Spring 2022.
