**Flood Control Project Maintenance  
Levee Inspections****Maintenance Issue Types Only, Levee Inspection Report By Mile - Fall 2024****Reclamation District No. 2103 Wheatland Vicinity**

Waterway	Bank	Unit Miles	Inspection Start/End	Inspector
Unit No. 01 South Dry Creek	Left	4.64	10/02/2024 10/02/2024	Brooks Weisser

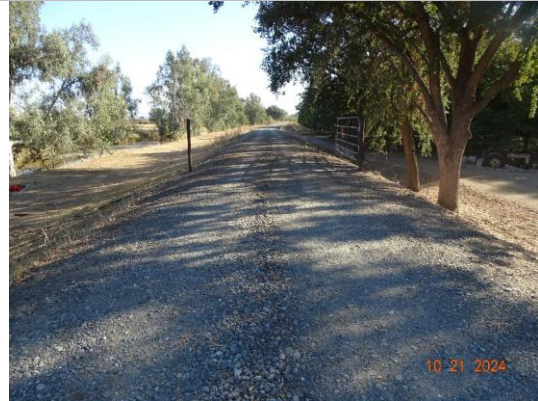
Photo 1 of 3 : UCIP\_FA\_2024\_85125\_125842.jpg

LM Start	0.82	Rating **	U	Issue No.	21
LM End	0.82	Issue Type +	Ma	Location *	
Category	Supplemental			GPS Latitude/Longitude	
				Start	End
Item	DWR UCIP LMA Responsibility			39.024811°	39.024811°
				-121.440750°	-121.440750°
DWR ID	19471

Comment Code					
Inspector Comment					
DS_ID:19471 FS_ID:85125 EP_NO: N/A Repair Type: Urgent EVAL Issue: 1, Pipe Integrity Crossing Status: Found UCIP Comments: 10/21/2024 Record remains Urgent. DMP internal video inspection has found severe pipe defects. Crossing will be monitored until funding becomes available to address the issues. CIPP lining appears to be separating from the 36-inch CMP at the inlet on LS. Twigs are blocking the inlet on LS; recommend clearing. (M. Thao - DWR UCIP) 09/25/2024 Record updated from No Action Needed to Urgent. DMP internal video inspection has found severe pipe defects. Crossing will be monitored until funding becomes available to address the issues. (M. Thao - DWR UCIP) 03/01/2023 Record updated from Urgent to No Action Needed. MBK Engineers provided information that cast-in-place liner has been installed within the existing 36-inch CMP. (O. Yakimov - DWR UCIP) 01/21/2021 Record has been updated from No Action Needed to Urgent. DWR DMP has found integrity issues, LOF between 5 and 6. Recommend monitoring crossing until funding becomes available to address. No permit was found authorizing this encroachment. CVFPB will need to review crossing to determine owner. (O. Magana - DWR UCIP) FIELD_STRUCT_DESC: 36-inch CIPP-lined corrugated metal drainage pipe through the levee, 14.4 feet below the crown. Concrete headwall, flap gate, and 3-foot by 6-foot concrete splash apron on the waterside (WS) toe. Outfall drain from old Grasshopper Slough. [Additional Reference(s): DWR Levee Log, 2005, (HLM 0.83). USACE Sacramento O&M Manual, Unit No. 146, November 1962, Revised June 2017, (HLM 0.83). USACE As-Built Drawing No. 2-4-55-1, Sheet No. 55-1/4, 20 August 1937, (Station 251+50)]. FS Date: 10/21/2024 1:09:04 PM

Levee crown looking upstream.

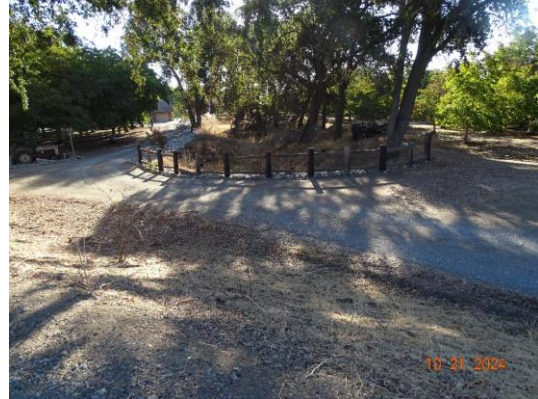
Photo 2 of 3 : UCIP\_FA\_2024\_85125\_125843.jpg

LS view: General overview looking from crown.

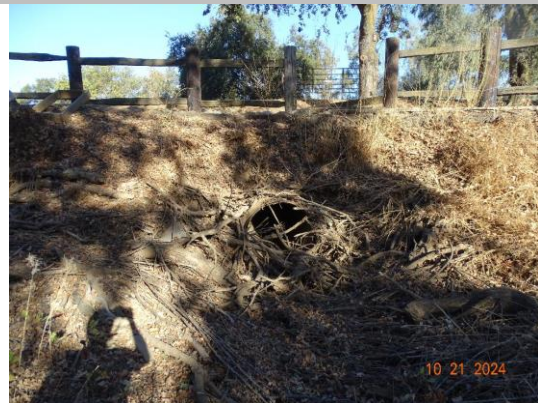
Photo 3 of 3 : UCIP\_FA\_2024\_85125\_125844.jpg

LS view: Pipe inlet within drainage canal; looking toward levee.

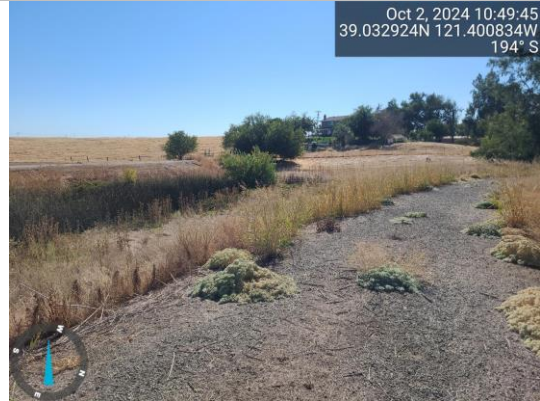
Photo 1 of 1 : FA\_2024\_RD2103\_10\_9\_20241004\_00017.jpg

LM Start	3.32	Rating **	M	Issue No.	9
LM End	4.64	Issue Type +	Ma	Location *	WS
Category	Earthen Levee			GPS Latitude/Longitude	
				Start	End
Item	Vegetation			39.032971°	39.041396°
				-121.400844°	-121.392002°
DWR ID	DWR_RD2103_01_f_2024_9				
Comment Code					
V1 : Control annual grass and weeds on the levee slopes and easements.					
Inspector Comment					
Annual vegetation on the waterside slope needs to be maintained, Fall 2024.

View of annual vegetation on the waterside slope, Fall 2024.

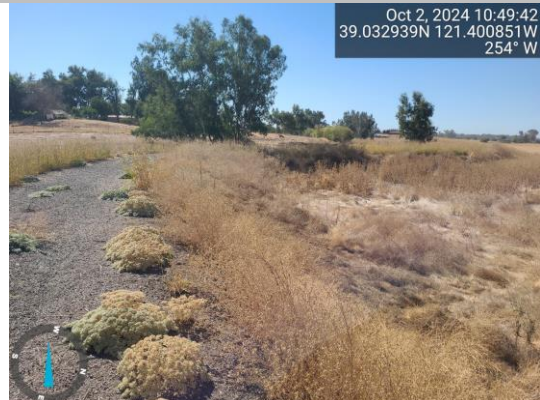
Photo 1 of 1 : FA\_2024\_RD2103\_10\_8\_20241004\_00016.jpg

LM Start	3.32	Rating **	M	Issue No.	8
LM End	4.64	Issue Type +	Ma	Location *	LS
Category	Earthen Levee			GPS Latitude/Longitude	
				Start	End
Item	Vegetation			39.032970°	39.041396°
				-121.400844°	-121.392002°
DWR ID	DWR_RD2103_01_f_2024_8				
Comment Code					
V1 : Control annual grass and weeds on the levee slopes and easements.					
Inspector Comment					
Annual vegetation on the landside slope needs to be maintained, Fall 2024.

View of annual vegetation on the landside slope, Fall 2024.

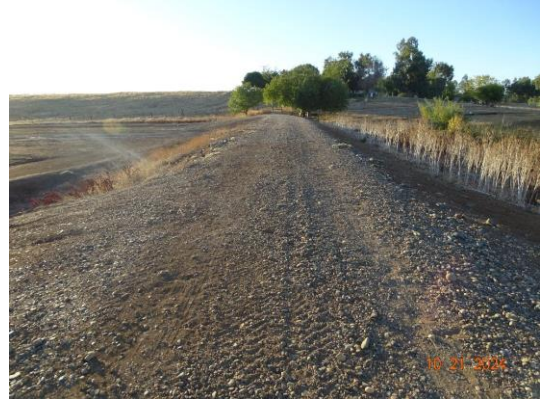
Photo 1 of 3 : UCIP\_FA\_2024\_85132\_125871.jpg

LM Start	3.59	Rating **	M	Issue No.	23	
LM End	3.59	Issue Type +	Ma	Location *		
Category	Supplemental			GPS Latitude/Longitude		
				Start	End	
Item	DWR UCIP LMA Responsibility			39.033052°	39.033052°	
				-121.400410°	-121.400410°	
DWR ID	19511

Comment Code						
Inspector Comment						
DS_ID:19511 FS_ID:85132 EP_NO: N/A Repair Type: Non-Urgent EVAL Issue: Crossing Status: Not Found UCIP Comments: 10/21/2024 Record remains Non-Urgent. Crossing not found. Geophysical results did not confirm presence of pipe through levee. Record will remain in UCIP's inspection records until future Levee Improvement Project can confirm no crossing was found through the levee. (M. Thao - DWR UCIP) 01/21/2021 Record has been updated from No Action Needed to Non-Urgent. DWR DMP geophysical study found no positive signal of pipe at latitude, longitude 38.033052, -121.400410. No evidence of pipe was found during field inspection. No permit was found authorizing this encroachment. CVFPB will need to review crossing to determine owner. Record will remain in UCIP's database and should be monitored until a levee improvement project can confirm that this crossing has been removed from the levee. (O. Magana - DWR UCIP) 03/26/2015 Possibly replaced by 24-inch at same location. (W. Wylie - DWR UCIP) FIELD_STRUCT_DESC: 18-inch steel drainage pipe through the levee, 12.0 feet below the crown. Flap gate on the waterside (WS). [Additional Reference(s): USACE Sacramento O&M Manual, Unit No. 146, November 1962, Revised June 2017, (HLM 3.70). USACE As-Built Drawing No. 2-4-55-1, Sheet Nos. 55-1/5 and 55-1/9, 20 August 1937, (Stations 380+80 "E" and 11+20 "E"), 36" corrugated metal pipe (CMP) and 24" CMP referenced]. FS Date: 10/21/2024 8:53:31 AM

Levee crown looking upstream.

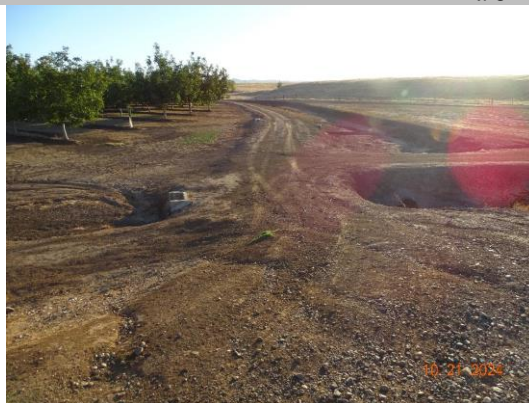
Photo 2 of 3 : UCIP\_FA\_2024\_85132\_125870.jpg

LS view: General overview looking from crown.

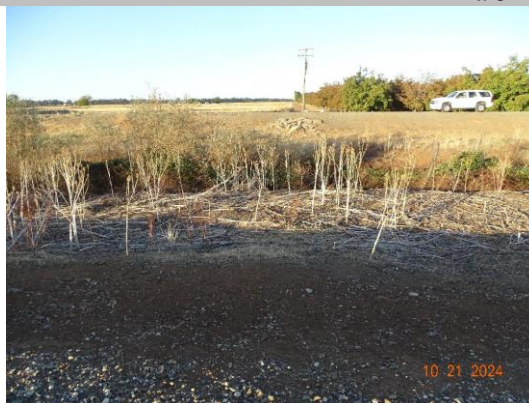
Photo 3 of 3 : UCIP\_FA\_2024\_85132\_125872.jpg

WS view: General overview looking from crown.

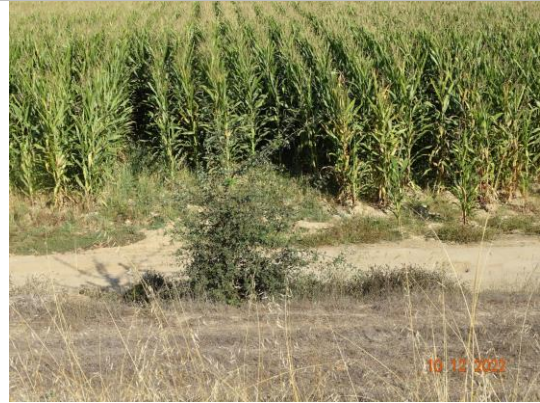
Photo 1 of 1 : FA\_2024\_RD2103\_11\_28\_20240829\_00003.jpg

LM Start	0.72	Rating **	M	Issue No.	28
LM End	0.72	Issue Type +	Ma	Location *	LS
Category	Earthen Levee			GPS Latitude/Longitude	
				Start	End
Item	Trim / Thin Trees			38.996510°	38.996510°
				-121.424539°	-121.424539°
DWR ID	DWR_RD2103_02_s_2022_28				
Comment Code					
T1 : Trim and thin trees to at least five feet above ground level to allow visibility of the ground and room to flood fight.					
Inspector Comment					
Starter tree near the landside toe needs to be removed, Fall 2024.

View of starter tree near the landside toe, Fall 2022.

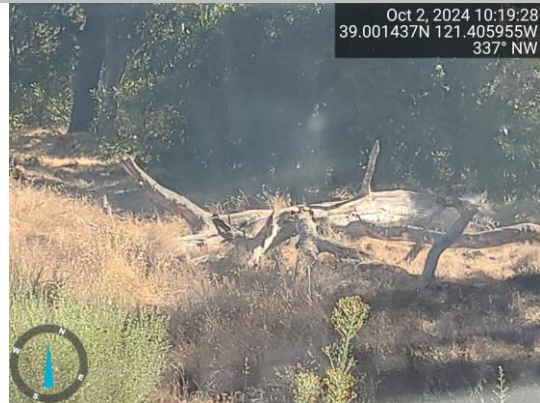
Photo 1 of 1 : FA\_2024\_RD2103\_11\_11\_20241004\_00007.jpg

LM Start	1.86	Rating **	M	Issue No.	11
LM End	1.86	Issue Type +	Ma	Location *	WS
Category	Earthen Levee			GPS Latitude/Longitude	
				Start	End
Item	Trim / Thin Trees			39.001644°	39.001644°
				-121.405450°	-121.405450°
DWR ID	DWR_RD2103_02_f_2020_11				
Comment Code					
T2 : Tree or limb.					
Inspector Comment					
Remove downed tree from levee slope, Fall 2024.

View of downed tree on the waterside slope, Fall 2024.

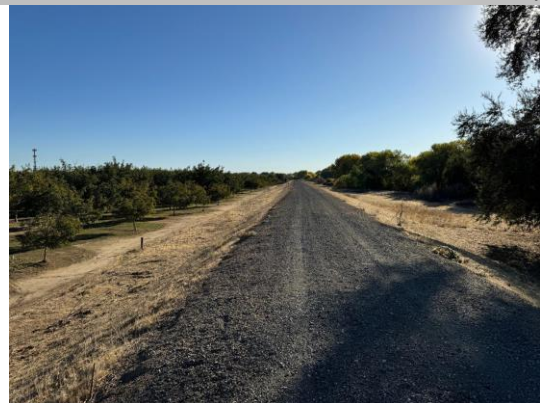
Photo 1 of 1 : FA\_2024\_RD2103\_11\_2\_20241108\_00011.jpg

LM Start	2.06	Rating **	A	Issue No.	2
LM End	2.42	Issue Type +	Ma	Location *	LS
Category	Earthen Levee			GPS Latitude/Longitude	
				Start	End
Item	Vegetation			39.003446°	39.007245°
				-121.402689°	-121.398484°
DWR ID	DWR_RD2103_02_f_2024_2				
Comment Code					
V1 : Control annual grass and weeds on the levee slopes and easements.					
Inspector Comment					
Annual vegetation on the landside slope needs to be maintained, Fall 2024.

View of annual vegetation on the landside slope, Fall 2024.

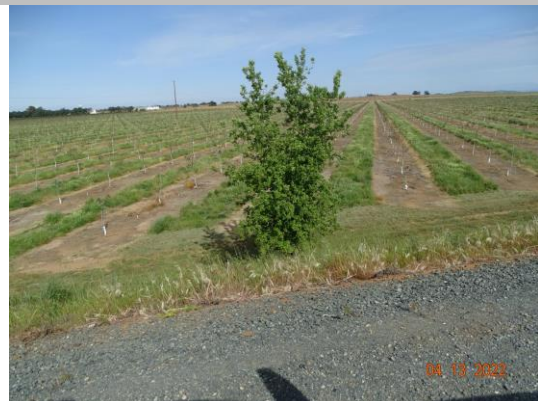
Photo 1 of 1 : FA\_2024\_RD2103\_11\_15\_20240829\_00002.jpg

LM Start	4.05	Rating **	M	Issue No.	15
LM End	4.05	Issue Type +	Ma	Location *	LS
Category	Earthen Levee			GPS Latitude/Longitude	
				Start	End
Item	Trim / Thin Trees			39.023654°	39.023654°
				-121.377906°	-121.377906°
DWR ID	DWR_RD2103_02_s_2020_15				
Comment Code					
T1 : Trim and thin trees to at least five feet above ground level to allow visibility of the ground and room to flood fight.					
Inspector Comment					
Remove small tree from levee toe that is less than 4" in diameter, Fall 2024.

View of a small tree at the levee toe less than 4" in diameter, Spring 2022.
