**Flood Control Project Maintenance
Levee Inspections**

Maintenance Issue Types Only, Levee Inspection Report By Mile - Spring 2015

Reclamation District No. 2103 Wheatland Vicinity

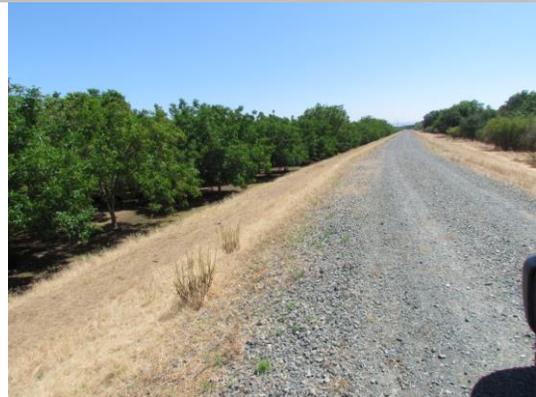
Photo 1 of 1 : SP_2015_RD2103_11_20_20150529_00004.jpg

LM Start	0.01	Rating **	A/W	Issue No.	20
LM End	2.95	Issue Type +	Ma	Location *	LS
Category	Earthen Levee		GPS Latitude/Longitude		
			Start	End	
Item	Vegetation		38.993442 °	39.012376 °	
			-121.437253 °	-121.392299 °	
DWR ID	DWR_RD2103_02_s_2015_20				
Action/Comments					
Control annual grass and weeds on the levee slopes and easements.

View of the vegetation on the landside of the levee facing upstream.

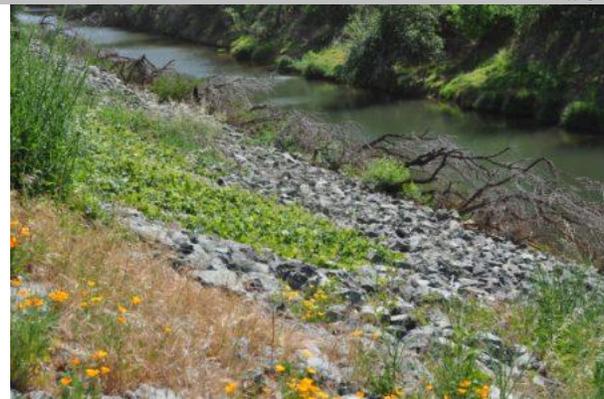
Photo 1 of 2 : SP_2015_RD2103_11_4_20150401_00001.jpg

LM Start	0.29	Rating **	A/W	Issue No.	4
LM End	0.50	Issue Type +	Ma	Location *	WS
Category	Earthen Levee		GPS Latitude/Longitude		
			Start	End	
Item	Riprap Revetments		38.994660 °	38.995537 °	
			-121.432170 °	-121.428535 °	
DWR ID	DWR_RD2103_02_s_2012_4				
Action/Comments					
Inspector Comments: The District has a concern with dead trees placed in the rip rap that may not stay in place during a high water event.

View of revetment with dead trees, Spring 2013.
