**Flood Control Project Maintenance
Levee Inspections**

Fall 2010 Levee Maintenance Deficiency Summary Report

Reclamation District No. 2104 Peters Pocket Tract

Waterway			Bank	Unit Miles
Unit No. 01 Cache Slough			Left	7.40
	Spring (March - May)	Summer (June - August)	(September - November) Fall	Winter (December - February)
Unit Maintenance Rating (Fall Only)			U	
Date of Inspection	3/16/2010		9/23/2010	
DWR Inspector	Herman Phillips		Herman Phillips	
Accompanied By			Mr. Richard Silva RD 2104

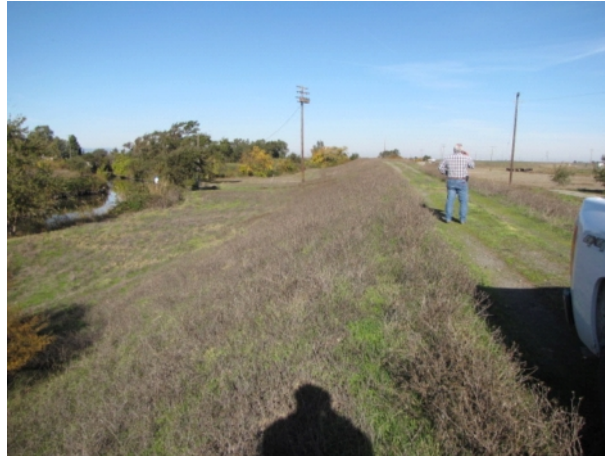
Levee Mile Report Line	1
Start Levee Mile	0.19
End Levee Mile	0.19
Location	Land Side
Category	Earthen Levee
Item	Vegetation
Levee mile 0.18 looking up stream water side levee slope. 11-17-2010	
phillips_f_20101118_311.jpg

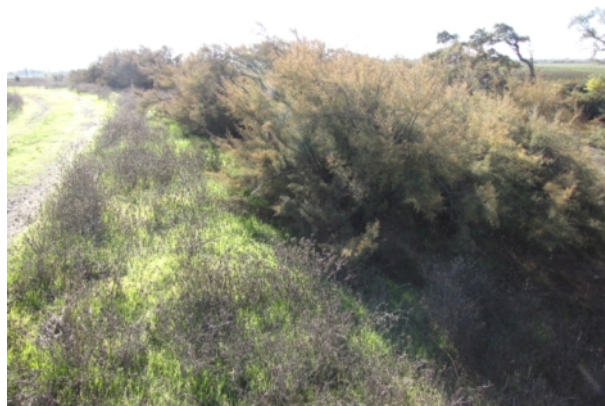
Levee Mile Report Line	2
Start Levee Mile	0.19
End Levee Mile	0.22
Location	Water Side
Category	Earthen Levee
Item	Vegetation
Looking downstream from Levee mile 0.19 Soft cedar need to be removed from levee slopes. 11-17-2010	
phillips_f_20101118_312.jpg

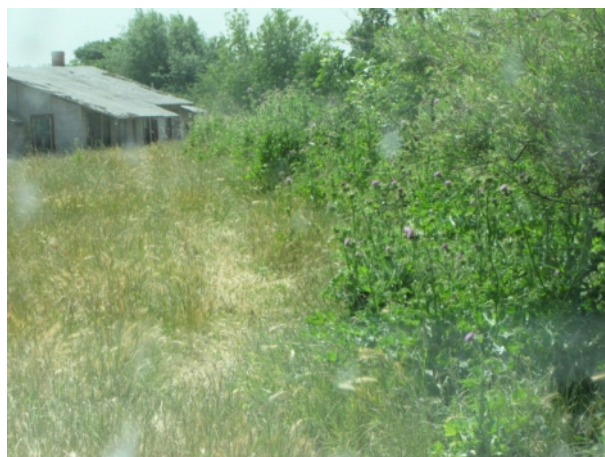
Levee Mile Report Line	13
Start Levee Mile	1.43
End Levee Mile	1.60
Location	Water Side
Category	Earthen Levee
Item	Vegetation
This photo shown here was listed with a U rating. The water side is completely over grown from shoulder to beyond waterside toe. The crown has weeds 2-feet tall.	
phillips_f_20100923_232.jpg

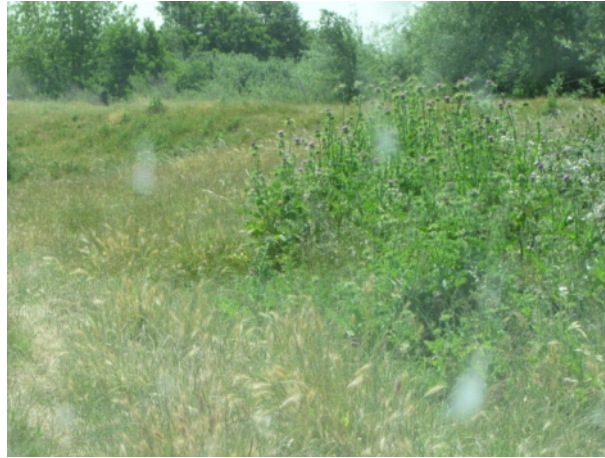
Levee Mile Report Line	13
Start Levee Mile	1.43
End Levee Mile	1.60
Location	Water Side
Category	Earthen Levee
Item	Vegetation

standing on L/M 1.60 Looking downstream to 1.98 land ward levee over grown. This levee has not had any maintenance since last inspection. Taken 11-17-2010

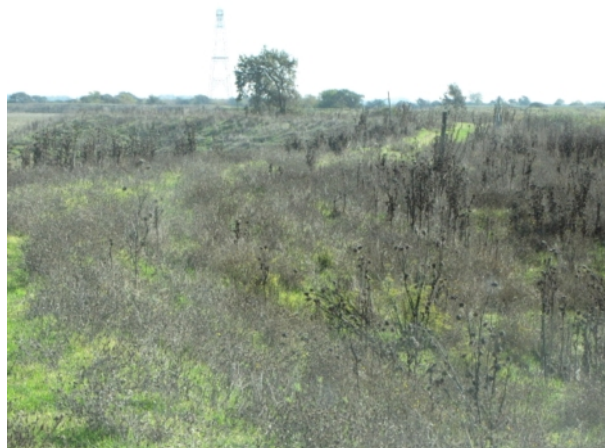
Levee Mile Report Line	13
Start Levee Mile	1.43
End Levee Mile	1.60
Location	Water Side
Category	Earthen Levee
Item	Vegetation

Standing at levee mile 1.60 looking downstream of landside wild growth remains on levee section. This section was rated unsatisfactory during the spring inspection, no change 11-17-2010.

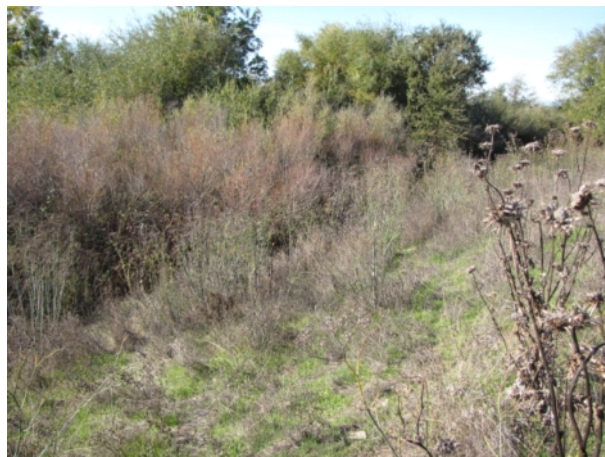
Levee Mile Report Line	14
Start Levee Mile	1.55
End Levee Mile	1.60
Location	Water Side
Category	Earthen Levee
Item	Trim / Thin Trees

Looking back downstream from levee mile 1.55 unsatisfactory wild growth remains on levee section. Photo taken 11-17-2010

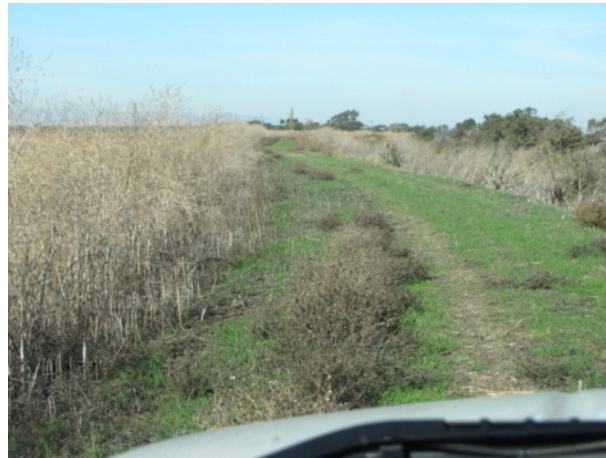
Levee Mile Report Line	16
Start Levee Mile	1.69
End Levee Mile	2.60
Location	Crown
Category	Earthen Levee
Item	Vegetation

Looking down stream from levee 1.69 to 2.60 crown has not been sterilized.

16	1.69	2.60	Earthen Levee	Vegetation	CR	U	Remove the wild growth other than native grasses from the levee slopes. Inspector Comments: This unit has not improved since the last inspection, nothing has been done.	38.294125 ° -121.740428 °	38.294290 ° -121.726933 °	15 Y

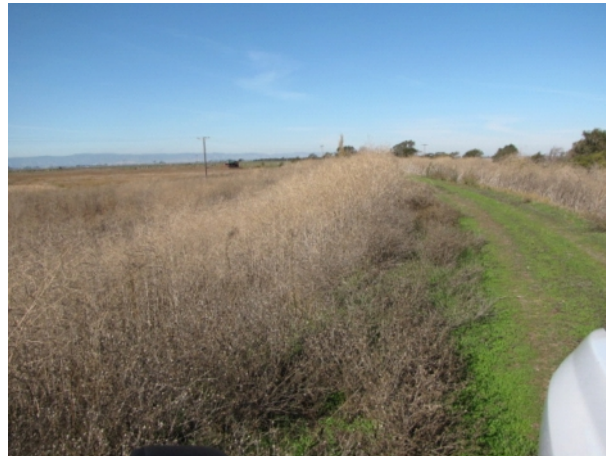
Levee Mile Report Line	20
Start Levee Mile	4.21
End Levee Mile	4.70
Location	Land Side
Category	Earthen Levee
Item	Vegetation

Standing at levee mile 4.21 looking downstream to 4.70 no maintenance since last inspection wild growth on landside and waterside levee slopes. Unsatisfactory. Photo taken 11-17-2010

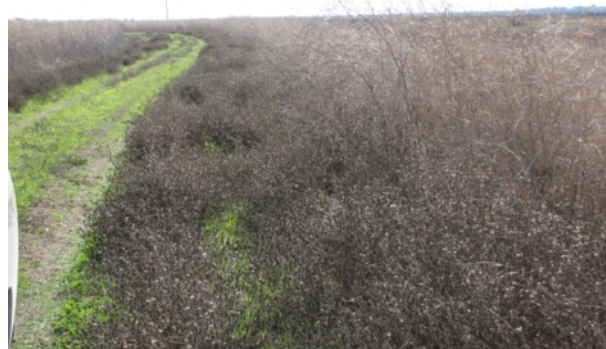
Levee Mile Report Line	20
Start Levee Mile	4.21
End Levee Mile	4.70
Location	Land Side
Category	Earthen Levee
Item	Vegetation

Standing at levee mile 4.21 looking downstream waterside to levee mile 4.70 unsatisfactory growth. Photo taken 11-17-2010

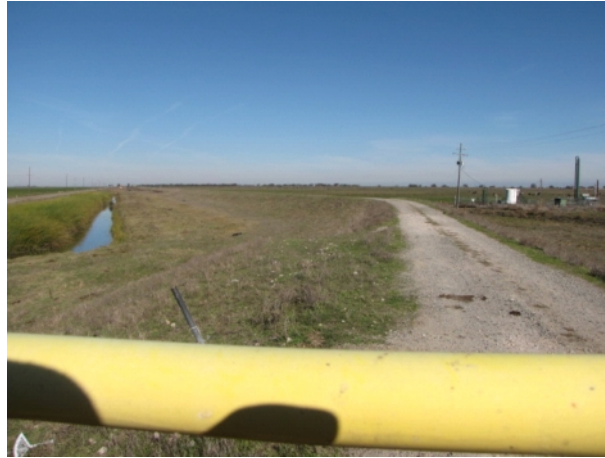
Levee Mile Report Line	23
Start Levee Mile	7.40
End Levee Mile	7.40
Location	Land Side
Category	Earthen Levee
Item	Vegetation

This photo taken at end of District levee mile 7.40 looking back up stream. Taken 11-17-2010
