**Flood Control Project Maintenance
Levee Inspections**

Fall 2011 Levee Maintenance Deficiency Summary Report

Reclamation District No. 2104 Peters Pocket Tract

Levee Inspection Report By Mile - Fall 2011

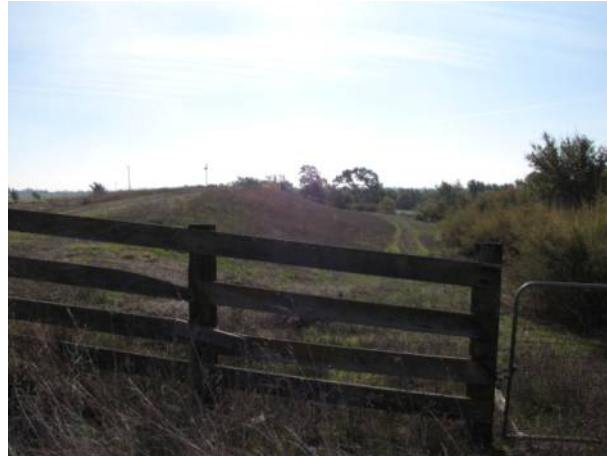
Levee Mile Report Line	1
Start Levee Mile	0.00
End Levee Mile	0.00
Location	Water Side
Category	Earthen Levee
Item	Vegetation
Levee mile 0.00 waterward slope RD 2104 looking downstream. Photo taken 11-15-2011.	
phillips_f_20111207_112.jpg

Waterway						Bank	Unit Miles	Inspection Start/End		Inspector
Unit No. 01 Cache Slough						Left	7.40	11/15/2011 11/15/2011		Herman Phillips
LMR No.	Levee Mile		Category	Item	Location	Rating	Action/Comment	GPS Latitude/Longitude		Issue No. Photo
	Start	End						Start	End	
1	0.00	0.00	Earthen Levee	Vegetation	WS	M	Remove the wild growth other than native grasses from the levee slopes.	38.308296 ° -121.758594 °	38.308296 ° -121.758594 °	40 Y
2	0.00	0.00	Earthen Levee	Vegetation	LS	M	Remove the wild growth other than native grasses from the levee slopes.	38.308296 ° -121.758594 °	38.308296 ° -121.758594 °	42 Y
3	0.02	0.96	Earthen Levee	Vegetation	CR	M	Remove the wild growth other than native grasses from the levee slopes.	38.308008 ° -121.758610 °	38.299242 ° -121.749754 °	2
4	0.19	0.22	Earthen Levee	Vegetation	WS	U	Remove the wild growth other than native grasses from the levee slopes.	38.305912 ° -121.757520 °	38.305583 ° -121.757220 °	8 Y

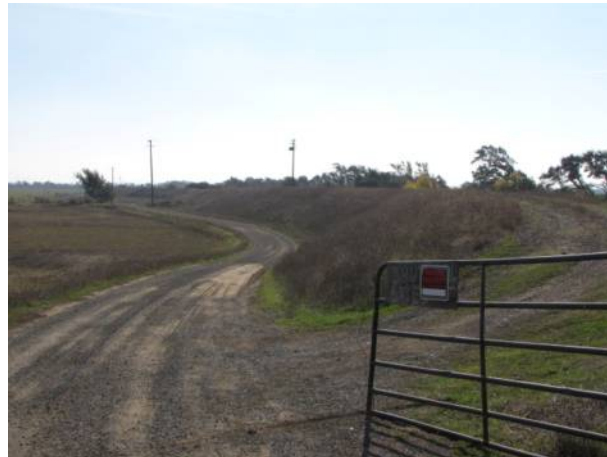
Levee Mile Report Line	2
Start Levee Mile	0.00
End Levee Mile	0.00
Location	Land Side
Category	Earthen Levee
Item	Vegetation
Levee mile 0.00 looking downstream landward slope. Photo taken 11-15-2011.	
phillips_f_20111207_116.jpg

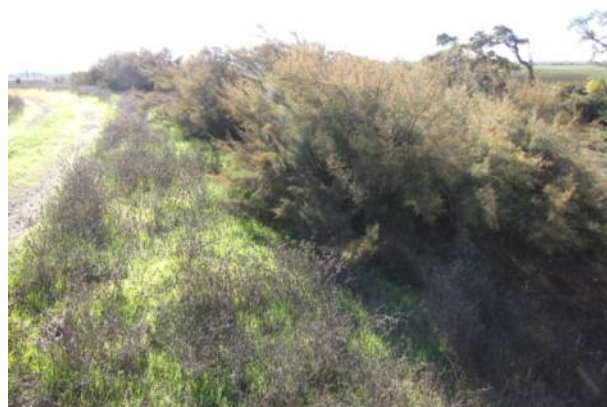
Levee Mile Report Line	4
Start Levee Mile	0.19
End Levee Mile	0.22
Location	Water Side
Category	Earthen Levee
Item	Vegetation
Looking downstream from levee mile 0.19. Soft cedar need to be removed from levee slopes. 11-17-2010	
phillips_f_20110929_203.jpg

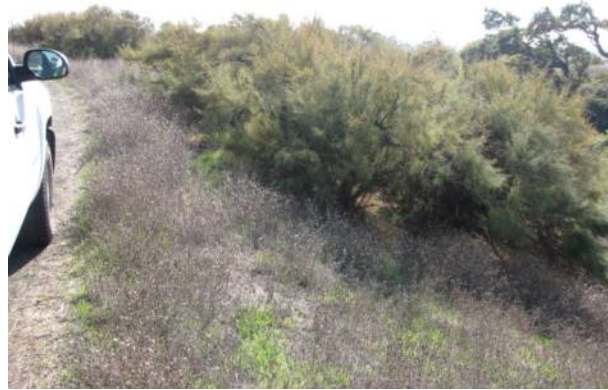
Levee Mile Report Line	4
Start Levee Mile	0.19
End Levee Mile	0.22
Location	Water Side
Category	Earthen Levee
Item	Vegetation

RD 2104 Unsatisfactory wild growth on water ward slope. Photo taken 11-15-2011.

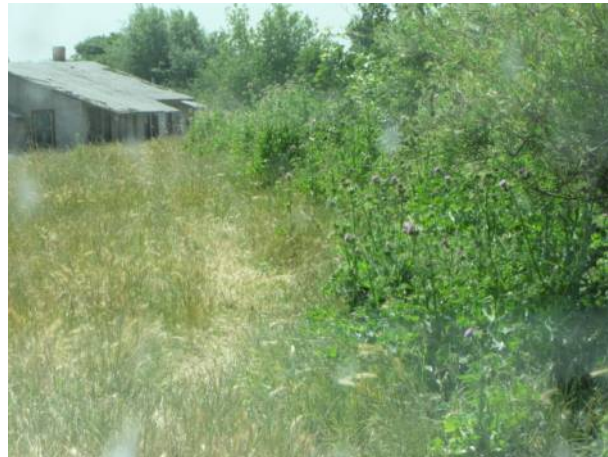
Levee Mile Report Line	20
Start Levee Mile	1.43
End Levee Mile	1.60
Location	Water Side
Category	Earthen Levee
Item	Vegetation

This photo shown here was listed with a U rating. The waterside is completely overgrown from shoulder to beyond waterside toe. The crown has weeds 2-feet tall.

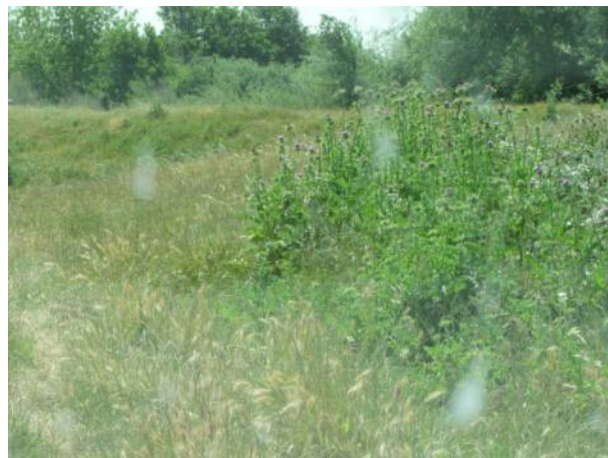
Levee Mile Report Line	20
Start Levee Mile	1.43
End Levee Mile	1.60
Location	Water Side
Category	Earthen Levee
Item	Vegetation

Standing on L/M 1.60 Looking downstream to 1.98 landward levee over grown. This levee has not had any maintenance since last inspection. Taken 11-17-2010

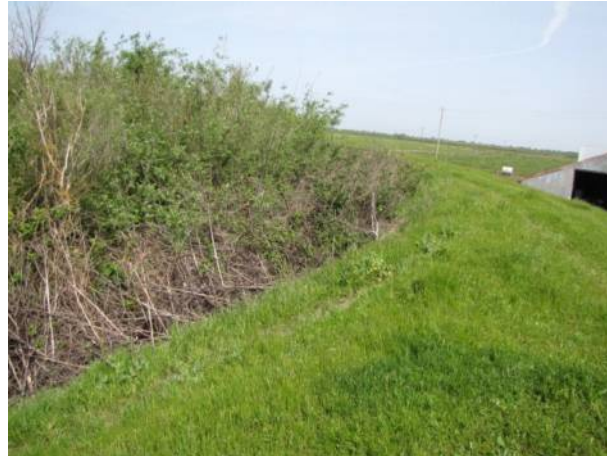
Levee Mile Report Line	20
Start Levee Mile	1.43
End Levee Mile	1.60
Location	Water Side
Category	Earthen Levee
Item	Vegetation
Looking back upstream from levee mile 1.60 waterside of RD 2104 Remain to be unsatisfactory. Photo taken 4-14-2011.	
phillips_f_20110929_207.jpg

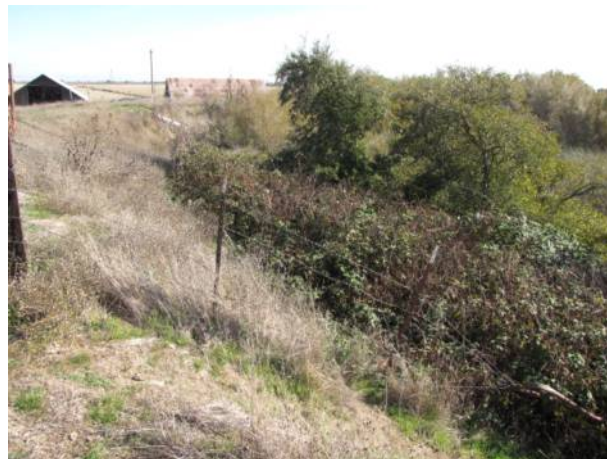
Levee Mile Report Line	20
Start Levee Mile	1.43
End Levee Mile	1.60
Location	Water Side
Category	Earthen Levee
Item	Vegetation
Issue 11 waterward looking downstream. Photo taken 11-15-2011.	
phillips_f_20111207_118.jpg

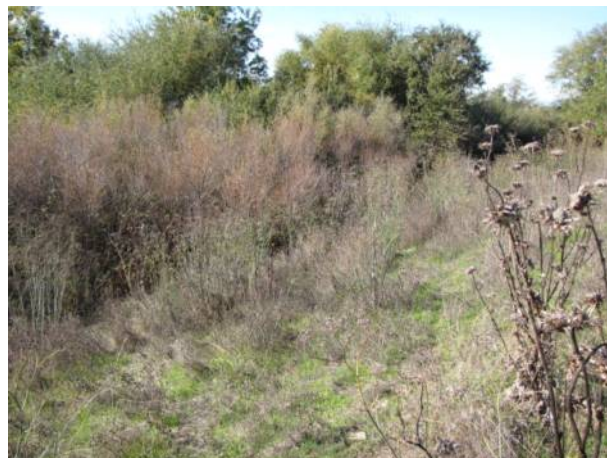
Levee Mile Report Line	22
Start Levee Mile	1.55
End Levee Mile	1.60
Location	Water Side
Category	Earthen Levee
Item	Trim / Thin Trees
Looking back downstream from levee mile 1.55 unsatisfactory wild growth remains on levee section. Photo taken 11-17-2010	
phillips_f_20110929_208.jpg

22	1.55	1.60	Earthen Levee	Trim / Thin Trees	WS	U	Trim trees to at least five feet above ground level. Inspector Comments: The District has done no maintenance here since last inspection.	38.295462 ° -121.741443 °	38.294912 ° -121.741178 °	12 Y
23	1.57	1.60	Earthen Levee	Vegetation	WS	M	Remove the wild growth other than native grasses from the levee slopes.	38.295263 ° -121.741415 °	38.294915 ° -121.741277 °	22
24	1.64	1.64	Earthen Levee	Encroachments	LS	M	Material	38.293747 ° -121.739126 °	38.293747 ° -121.739126 °	23 Y
25	1.66	1.70	Earthen Levee	Vegetation	CR	U	Remove the wild growth other than native grasses from the levee slopes.	38.294199 ° -121.740998 °	38.294099 ° -121.740453 °	34 Y
26	1.69	2.60	Earthen Levee	Vegetation	CR	U	Remove the wild growth other than native grasses from the levee slopes. Inspector Comments: This unit has not improved since the last inspection, nothing has been done.	38.294125 ° -121.740428 °	38.294290 ° -121.726933 °	15 Y

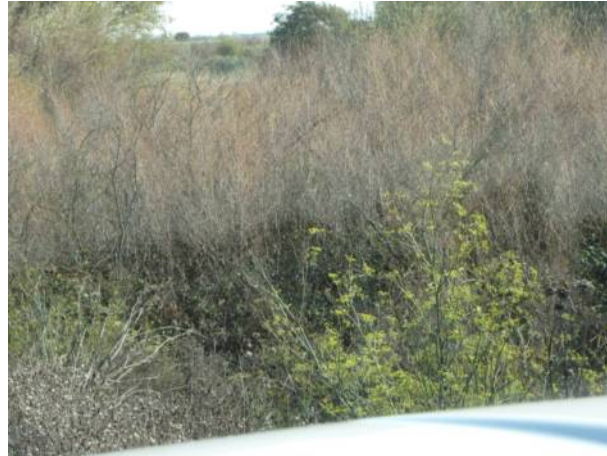
Levee Mile Report Line	22
Start Levee Mile	1.55
End Levee Mile	1.60
Location	Water Side
Category	Earthen Levee
Item	Trim / Thin Trees
Photo taken 11-15-2011. Unsatisfactory wild growth.	
phillips_f_20111207_113.jpg

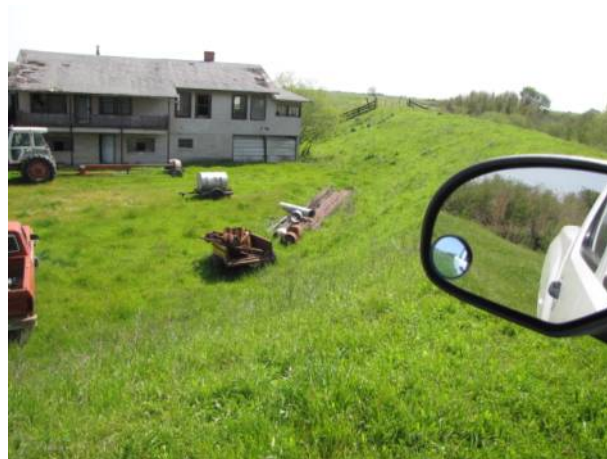
Levee Mile Report Line	24
Start Levee Mile	1.64
End Levee Mile	1.64
Location	Land Side
Category	Earthen Levee
Item	Encroachments
Looking at the material within 10-foot of landward toe levee mile 1.64 RD 2104. Photo taken 4-14-2011	
phillips_f_20110929_214.jpg

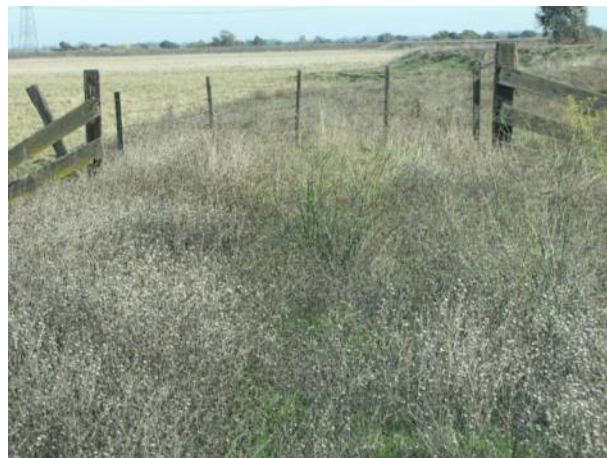
Levee Mile Report Line	25
Start Levee Mile	1.66
End Levee Mile	1.70
Location	Crown
Category	Earthen Levee
Item	Vegetation
Unsatisfactory wild growth on levee crown roadway. Photo taken 11-15-2011.	
phillips_f_20111207_117.jpg

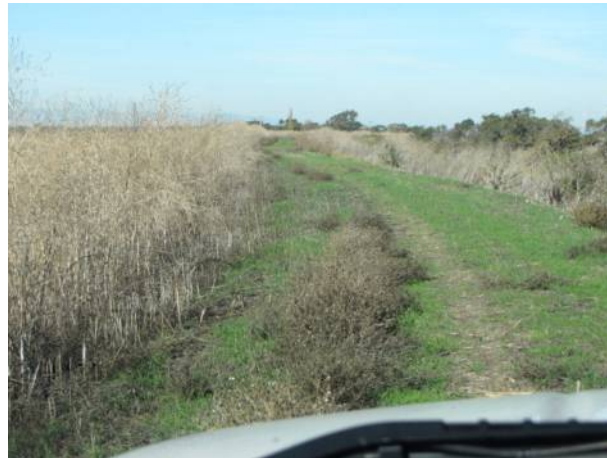
Levee Mile Report Line	26
Start Levee Mile	1.69
End Levee Mile	2.60
Location	Crown
Category	Earthen Levee
Item	Vegetation

Looking downstream from levee 1.69 to 2.60 crown has not been sterilized.

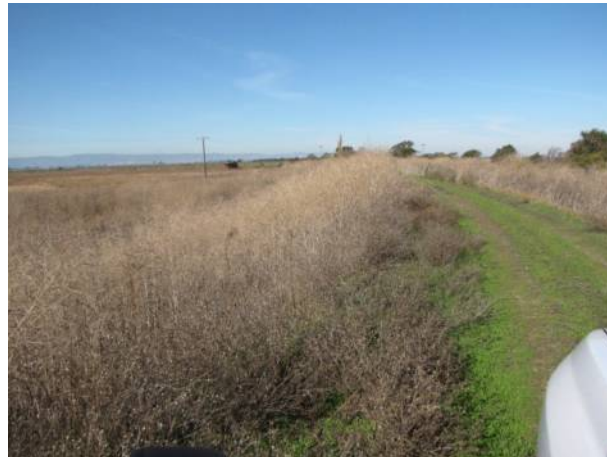
Levee Mile Report Line	32
Start Levee Mile	4.21
End Levee Mile	4.70
Location	Land Side
Category	Earthen Levee
Item	Vegetation

Standing at levee mile 4.21 looking downstream to 4.70. No maintenance since last inspection, wild growth on landside and waterside levee slopes. Unsatisfactory. Photo taken 11-17-2010

LMR No.	Levee Mile		Category	Item	Location *	Rating **	Action/Comment	GPS Latitude/Longitude		Issue No. Photo
	Start	End						Start	End	
32	4.21	4.70	Earthen Levee	Vegetation	LS	U	Remove the wild growth other than native grasses from the levee slopes. Inspector Comments: The District has not done any maintenance to the levee since last inspection, it remains unsatisfactory. Photos taken to show the land side, water side and the crown roadway overgrown.	38.297456 ° -121.738944 °	38.318412 ° -121.744876 °	19 Y
33	4.58	4.65	Earthen Levee	Vegetation	WS	M	Remove the wild growth other than native grasses from the levee slopes. Inspector Comments: This levee is overgrown and is in need of maintenance. There are weeds taller than 5-feet tall on the levee section.	38.313130 ° -121.739023 °	38.313872 ° -121.739830 °	25
34	4.88	4.88	Earthen Levee	Erosion / Bank Caving	LS	M	Note and monitor erosion site.	38.319559 ° -121.747085 °	38.319559 ° -121.747085 °	24 Y

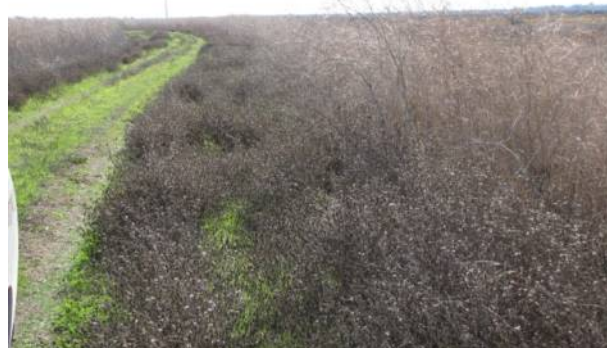
Levee Mile Report Line	32
Start Levee Mile	4.21
End Levee Mile	4.70
Location	Land Side
Category	Earthen Levee
Item	Vegetation

Standing at levee mile 4.21 looking downstream waterside to levee mile 4.70 unsatisfactory growth. Photo taken 11-17-2010

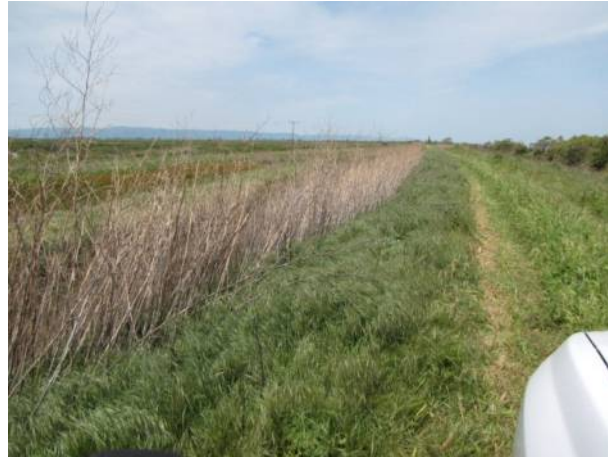
Levee Mile Report Line	32
Start Levee Mile	4.21
End Levee Mile	4.70
Location	Land Side
Category	Earthen Levee
Item	Vegetation

Looking downstream landside of RD 2104 Levee mile 4.21 unsatisfactory growth slopes and crown roadway. Photo taken 4-14-2011.

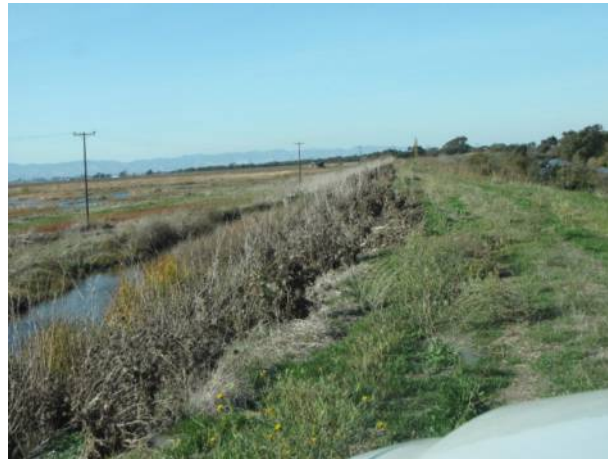
Levee Mile Report Line	32
Start Levee Mile	4.21
End Levee Mile	4.70
Location	Land Side
Category	Earthen Levee
Item	Vegetation

Levee mile 4.21-4.70. Photo taken 11-15-2011.

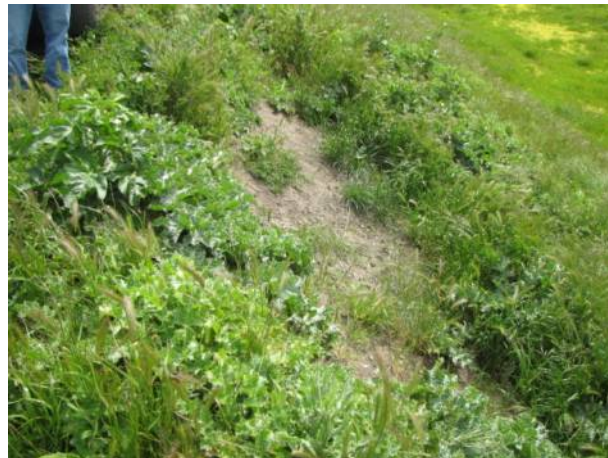
Levee Mile Report Line	34
Start Levee Mile	4.88
End Levee Mile	4.88
Location	Land Side
Category	Earthen Levee
Item	Erosion / Bank Caving

Erosion noted at levee mile 4.88 made by livestock along landside slope. Photo taken 4-14-2011.

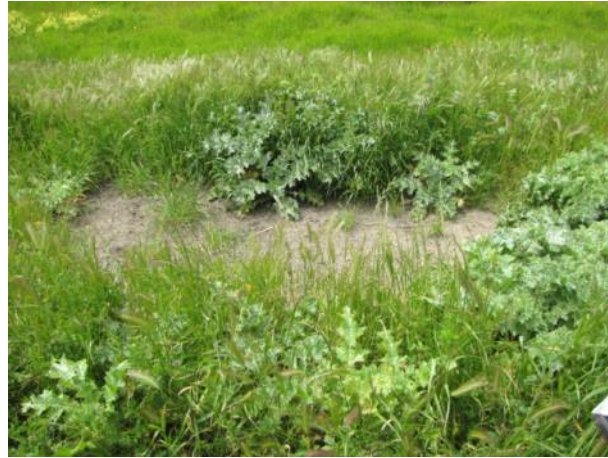
Levee Mile Report Line	35
Start Levee Mile	4.90
End Levee Mile	4.90
Location	Land Side
Category	Earthen Levee
Item	Erosion / Bank Caving

Erosion noted at levee mile 4.90 RD 2104 landside slope. Livestock caused this erosion. Photo taken 4-14-2011.

35	4.90	4.90	Earthen Levee	Erosion / Bank Caving	LS	M	Note and monitor erosion site.	38.319812 ° -121.747434 °	38.319812 ° -121.747434 °	29 Y
36	5.03	5.03	Earthen Levee	Erosion / Bank Caving	LS	M	Note and monitor erosion site.	38.321582 ° -121.748546 °	38.321582 ° -121.748546 °	41 Y
37	5.51	6.75	Earthen Levee	Crown Surface / Depressions / Rutting	CR	M	Regrade the crown roadway for proper drainage.	38.322340 ° -121.748377 °	38.316815 ° -121.758227 °	26
38	5.95	6.58	Earthen Levee	Vegetation	LS	M	Remove the wild growth other than native grasses from the levee slopes.	38.325074 ° -121.754512 °	38.319323 ° -121.758251 °	39
39	5.95	6.63	Earthen Levee	Vegetation	WS	M	Remove the wild growth other than native grasses from the levee slopes.	38.325074 ° -121.754511 °	38.318590 ° -121.758209 °	38

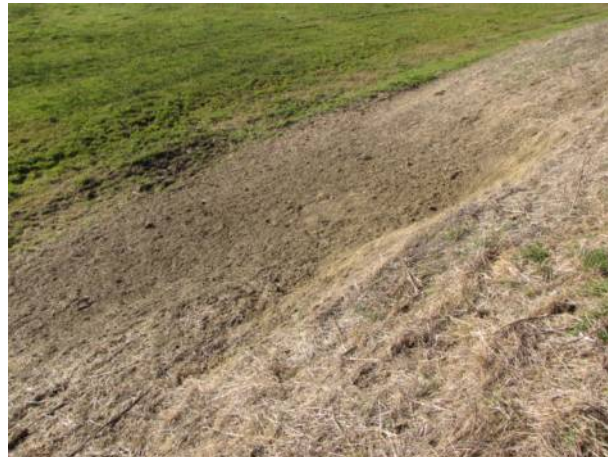
Levee Mile Report Line	36
Start Levee Mile	5.03
End Levee Mile	5.03
Location	Land Side
Category	Earthen Levee
Item	Erosion / Bank Caving

Erosion done by live stock (bulls) on levee section at this location. Photo taken 11-15-2011.
