**Flood Control Project Maintenance  
Levee Inspections**

**Fall 2012 Levee Maintenance Deficiency Summary Report**

**Reclamation District No. 2104 Peters Pocket Tract**

**Levee Inspection Report By Mile - Fall 2012**

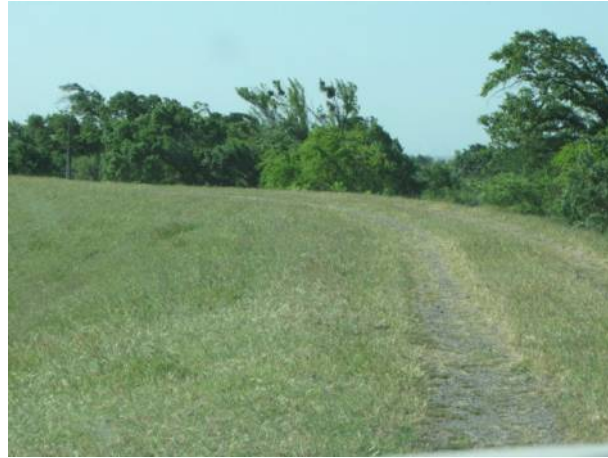
Levee Mile Report Line	4
Start Levee Mile	0.00
End Levee Mile	0.00
Location	Land Side
Category	Earthen Levee
Item	Vegetation

RD 2104 Looking downstream from gate. Photo taken 5-2-2012.

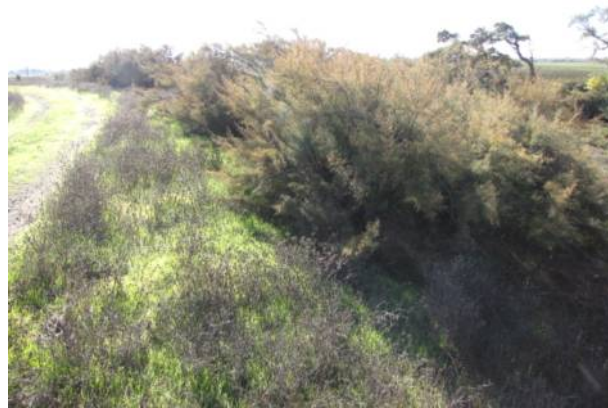
Levee Mile Report Line	7
Start Levee Mile	0.19
End Levee Mile	0.22
Location	Water Side
Category	Earthen Levee
Item	Vegetation

Looking downstream from levee mile 0.19. Soft cedar need to be removed from levee slopes. 11-17-2010

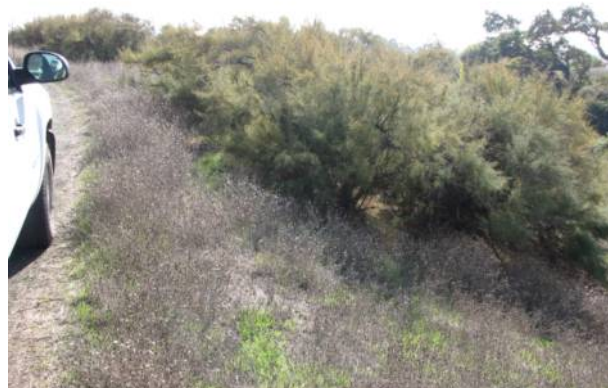
Levee Mile Report Line	7
Start Levee Mile	0.19
End Levee Mile	0.22
Location	Water Side
Category	Earthen Levee
Item	Vegetation

RD 2104 Unsatisfactory wild growth on waterward slope. Photo taken 11-15-2011.

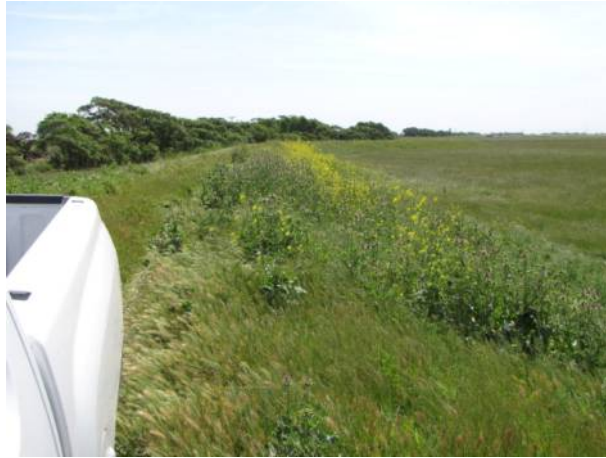
Levee Mile Report Line	23
Start Levee Mile	1.40
End Levee Mile	7.40
Location	Crown
Category	Earthen Levee
Item	Crown Surface / Depressions / Rutting

Overgrown crown roadway. Photo taken 5-2-2012.

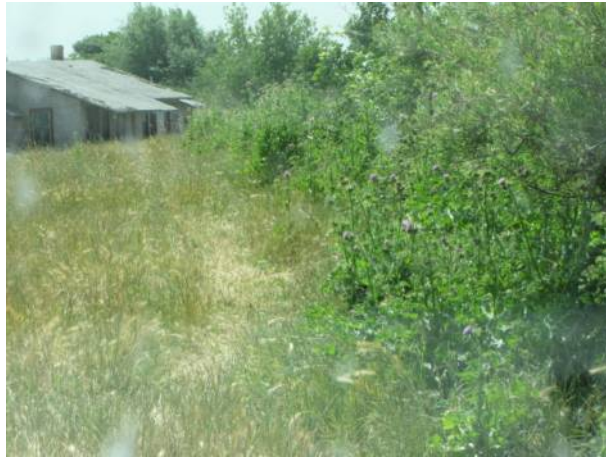
Levee Mile Report Line	25
Start Levee Mile	1.43
End Levee Mile	1.60
Location	Water Side
Category	Earthen Levee
Item	Vegetation

This photo shown here was listed with a U rating. The waterside is completely overgrown from shoulder to beyond waterside toe. The crown has weeds 2-feet tall.

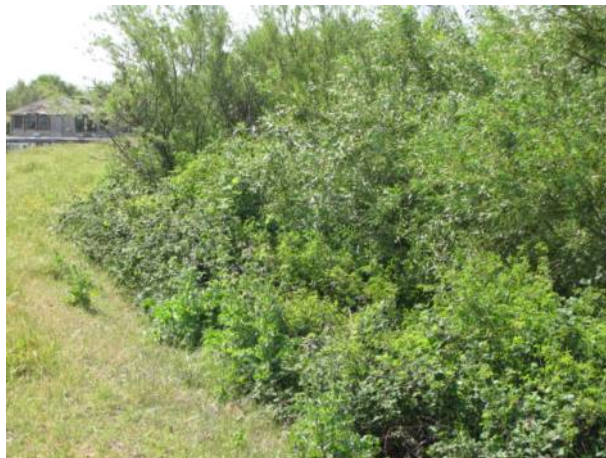
Levee Mile Report Line	25
Start Levee Mile	1.43
End Levee Mile	1.60
Location	Water Side
Category	Earthen Levee
Item	Vegetation

Overgrown shoulder and slope. Photo taken 5-2-2012.

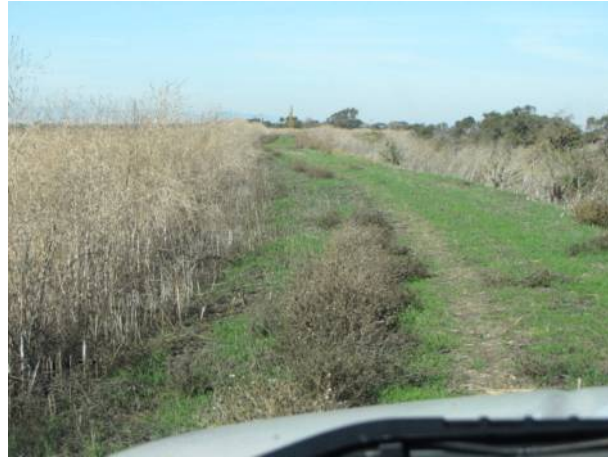
Levee Mile Report Line	29
Start Levee Mile	1.69
End Levee Mile	2.60
Location	Crown
Category	Earthen Levee
Item	Vegetation

Looking downstream from levee 1.69 to 2.60 crown has not been sterilized.

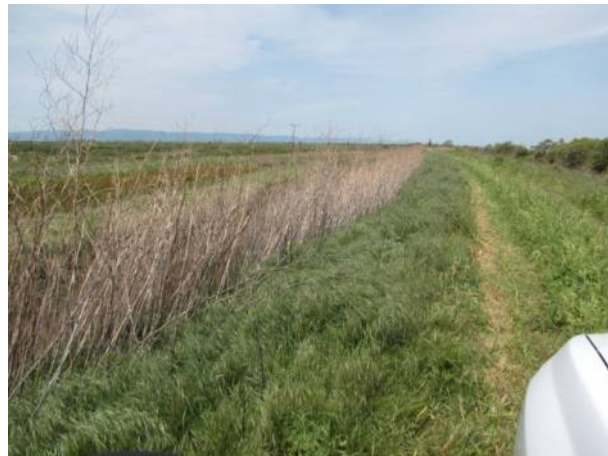
Levee Mile Report Line	36
Start Levee Mile	4.21
End Levee Mile	4.70
Location	Land Side
Category	Earthen Levee
Item	Vegetation

Looking downstream landside of RD 2104 from levee mile 4.21 at unsatisfactory growth slopes and crown roadway. Photo taken 4-14-2011.

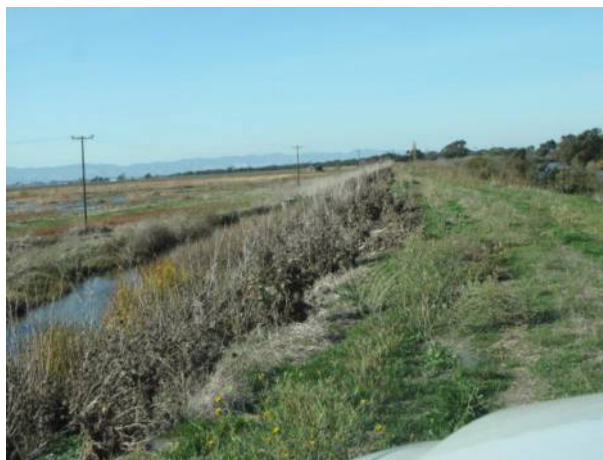
Levee Mile Report Line	36
Start Levee Mile	4.21
End Levee Mile	4.70
Location	Land Side
Category	Earthen Levee
Item	Vegetation

Levee mile 4.21-4.70. Photo taken 11-15-2011.

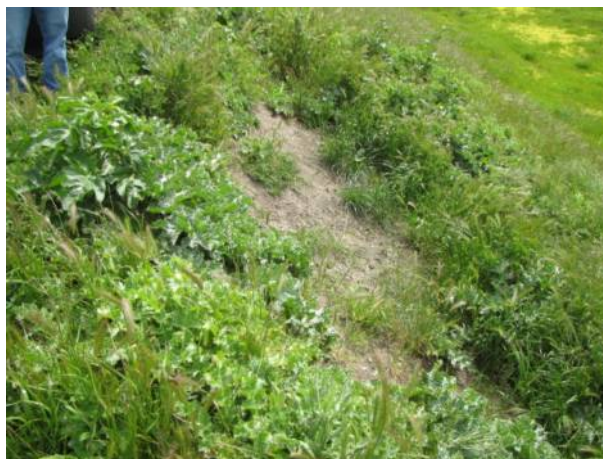
Levee Mile Report Line	38
Start Levee Mile	4.88
End Levee Mile	4.88
Location	Land Side
Category	Earthen Levee
Item	Erosion / Bank Caving

Erosion noted at levee mile 4.88 made by livestock along landside slope. Photo taken 4-14-2011.

DWR ID: DWR_RD2104_01_s_2012_25		
38	4.88	4.88	Earthen Levee	Erosion / Bank Caving	LS	M Ma	E1 : Note and monitor erosion site.	38.319559 ° -121.747085 °	38.319559 ° -121.747085 °	24 Y
								DWR ID: DWR_RD2104_01_s_2012_24
