**Flood Control Project Maintenance
Levee Inspections**

Fall 2013 Levee Maintenance Deficiency Summary Report

Reclamation District No. 2104 Peters Pocket Tract

Levee Inspection Report By Mile - Fall 2013

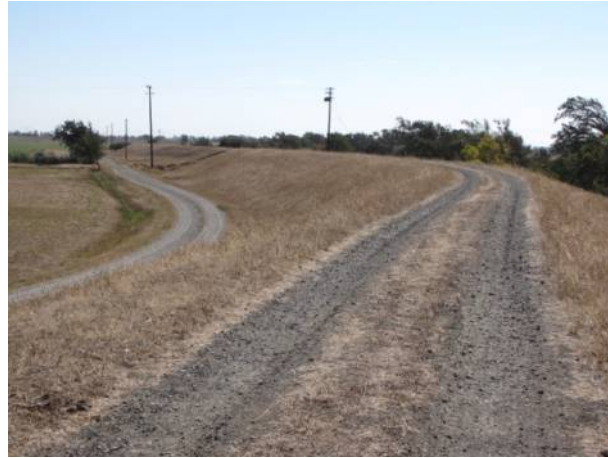
Levee Mile Report Line	5
Start Levee Mile	0.01
End Levee Mile	0.01
Location	Land Side
Category	Earthen Levee
Item	Vegetation

RD 2104 Looking downstream from levee mile 0.01. Photo taken 10-22-2013.

DWR ID: DWR_RD2104_01_f_2012_34		
5	0.01	0.01	Earthen Levee	Vegetation	LS	M Ma	V2 : Remove the wild growth other than native grasses from the levee slopes.	38.308296 ° -121.758594 °	38.308296 ° -121.758594 °	42 Y
								DWR ID: DWR_RD2104_01_s_2012_42		
6	0.07	5.10	Earthen Levee	Vegetation	WS	M Ma	V1 : Control annual grass and weeds on the levee slopes and easements.	38.307417 ° -121.758430 °	38.318426 ° -121.744512 °	11
								DWR ID: DWR_RD2104_01_f_2013_11		
7	0.07	5.10	Earthen Levee	Vegetation	LS	M Ma	V1 : Control annual grass and weeds on the levee slopes and easements.	38.307417 ° -121.758430 °	38.318426 ° -121.744513 °	4
								DWR ID: DWR_RD2104_01_f_2013_4		
8	0.19	0.22	Earthen Levee	Vegetation	WS	U Ma	V2 : Remove the wild growth other than native grasses from the levee slopes. Inspector Comments: Remove unsatisfactory wild growth from waterside levee slope.	38.305912 ° -121.757520 °	38.305583 ° -121.757220 °	8 Y

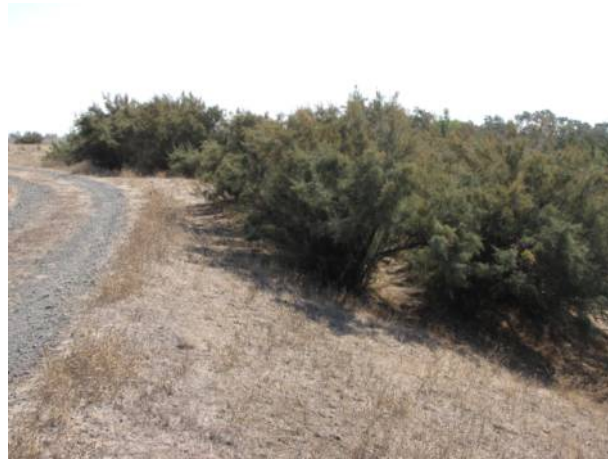
Levee Mile Report Line	8
Start Levee Mile	0.19
End Levee Mile	0.22
Location	Water Side
Category	Earthen Levee
Item	Vegetation

Wild growth waterward shoulder and slope. Photo taken 10-22-2013.

DWR ID: DWR_RD2104_01_s_2012_8		
9	0.20	0.22	Earthen Levee	Vegetation	WS	M Ma	V2 : Remove the wild growth other than native grasses from the levee slopes.	38.305837 ° -121.757463 °	38.305547 ° -121.757178 °	17
								DWR ID: DWR_RD2104_01_s_2012_17		
10	0.27	0.27	Earthen Levee	Crown Surface / Depressions / Rutting	CR	M Ma	C2 : Repair depressions or ruts in the crown or slope.	38.305022 ° -121.756692 °	38.305022 ° -121.756692 °	1
								DWR ID: DWR_RD2104_01_s_2012_1		
11	0.30	0.30	Earthen Levee	Trim / Thin Trees	LS	M Ma	T4 : Trim trees over roadway to at least 12 feet above ground level.	38.304657 ° -121.756570 °	38.304657 ° -121.756570 °	18
								DWR ID: DWR_RD2104_01_s_2012_18		
12	0.31	0.31	Earthen Levee	Vegetation	LS	M Ma	V2 : Remove the wild growth other than native grasses from the levee slopes.	38.304662 ° -121.756520 °	38.304662 ° -121.756520 °	3
								DWR ID: DWR_RD2104_01_s_2012_3

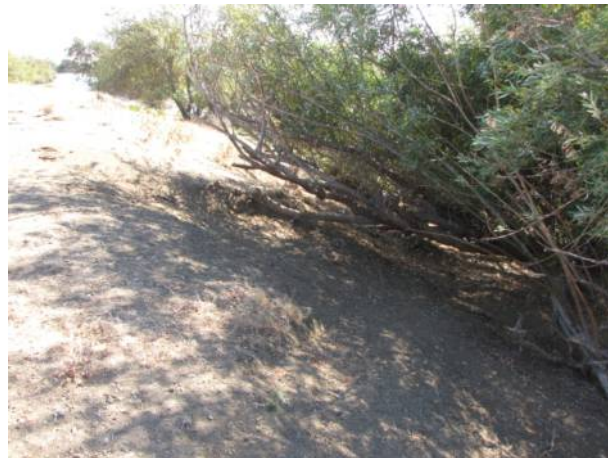
Levee Mile Report Line	22
Start Levee Mile	1.36
End Levee Mile	1.37
Location	Water Side
Category	Earthen Levee
Item	Animal Control

Levee mile 1.27 water side erosion on slope caused by cattle. Photo taken 10-22-2013.

DWR ID: DWR_RD2104_01_s_2012_30		
21	1.11	1.11	Earthen Levee	Trim / Thin Trees	LS	M Ma	T2 : Thin trees to allow visibility of the ground and room to flood fight.	38.297886 ° -121.748133 °	38.297886 ° -121.748133 °	31
								DWR ID: DWR_RD2104_01_s_2012_31		
22	1.36	1.37	Earthen Levee	Animal Control	WS	U Ma	A2 : Repair the levee slope damaged by livestock and prevent large animal access. Inspector Comments: Damage to levee slope caused by cattle.	38.296280 ° -121.744399 °	38.296209 ° -121.744330 °	60 Y
								DWR ID: DWR_RD2104_01_f_2013_60		
23	1.36	1.37	Earthen Levee	Trim / Thin Trees	WS	M Ma	T1 : Trim trees to at least five feet above ground level. Inspector Comments: Remove tree branches off levee slope waterside.	38.296237 ° -121.744327 °	38.296158 ° -121.744262 °	9
								DWR ID: DWR_RD2104_01_s_2012_9		
24	1.37	1.38	Earthen Levee	Trim / Thin Trees	WS	M Ma	T1 : Trim trees to at least five feet above ground level.	38.296168 ° -121.744355 °	38.296110 ° -121.744300 °	13

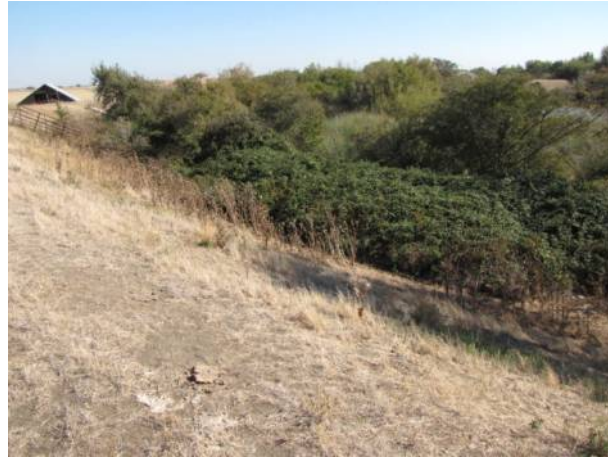
Levee Mile Report Line	25
Start Levee Mile	1.40
End Levee Mile	5.63
Location	Water Side
Category	Earthen Levee
Item	Vegetation

DWR ID: DWR_RD2104_01_s_2012_13		
25	1.40	5.63	Earthen Levee	Vegetation	WS	U Ma	V2 : Remove the wild growth other than native grasses from the levee slopes. Inspector Comments: The slope here is overgrown with unwanted vegetation from levee mile 1.40-5.63. This District has not done any maintenance on this levee in several years, livestock has taken over this levee. Fall 2013.	38.295721 ° -121.742440 °	38.323299 ° -121.749736 °	27 Y
								DWR ID: DWR_RD2104_01_s_2012_27

RD 2104 Looking downstream from levee mile 1.40 water side at the wild growth on slope. Photo taken 10-22-2013.

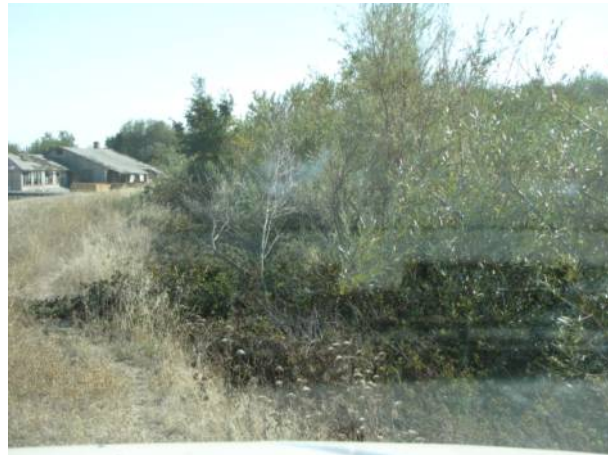
Levee Mile Report Line	25
Start Levee Mile	1.40
End Levee Mile	5.63
Location	Water Side
Category	Earthen Levee
Item	Vegetation

Another view of the wild growth taking over the slope and shoulder. Photo taken 10-22-2013.

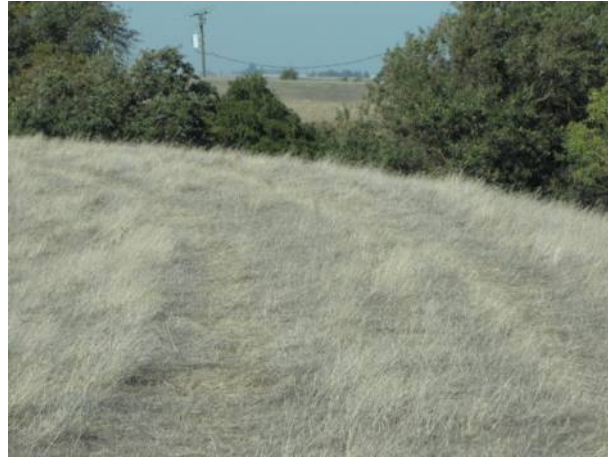
Levee Mile Report Line	37
Start Levee Mile	3.54
End Levee Mile	5.10
Location	Crown
Category	Earthen Levee
Item	Vegetation

RD2104 Looking downstream from levee mile 3.54 towards levee 5.10 this photo shows the overgrown crown. Photo taken 10-22-2013.

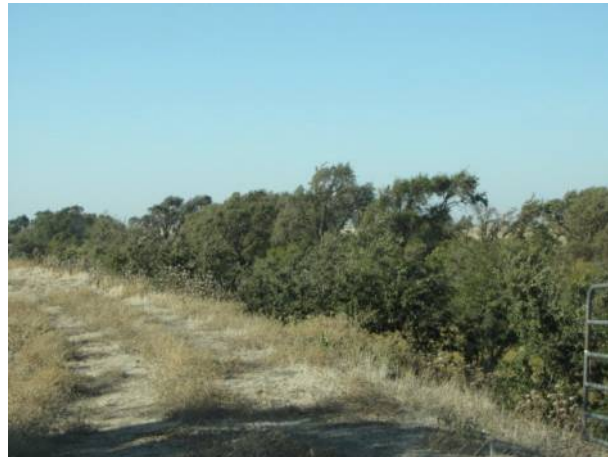
Levee Mile Report Line	39
Start Levee Mile	4.58
End Levee Mile	4.65
Location	Water Side
Category	Earthen Levee
Item	Vegetation

DWR ID: DWR_RD2104_01_f_2013_22									
39	4.58	4.65	Earthen Levee	Vegetation	WS U Ma	V7 : Trees / Woody Vegetation	38.313139 ° -121.739046 °	38.313905 ° -121.739877 °	61 Y
DWR ID: DWR_RD2104_01_f_2013_61

This woody growth on the waterside slope is unacceptable. Photo taken 10-22-2013.

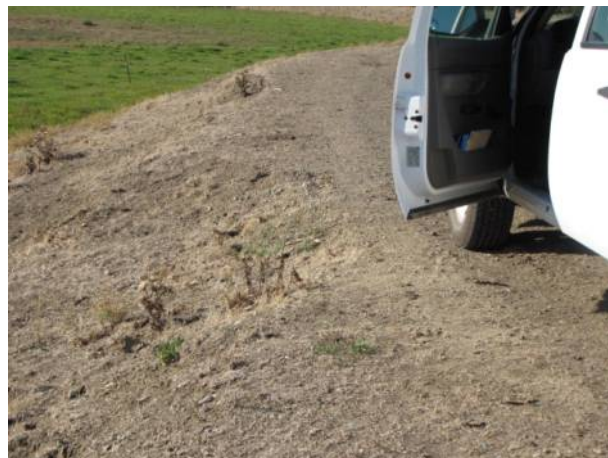
Levee Mile Report Line	52
Start Levee Mile	5.79
End Levee Mile	5.80
Location	Land Side
Category	Earthen Levee
Item	Slope Stability

This erosion along the slope cuts into the crown and sholder of the landside, there are livestock on levee section. Photo taken 10-22-2013.

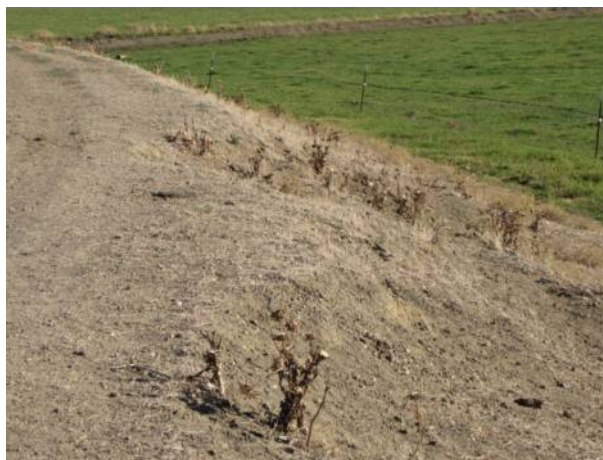
Levee Mile Report Line	52
Start Levee Mile	5.79
End Levee Mile	5.80
Location	Land Side
Category	Earthen Levee
Item	Slope Stability

Looking from upstream side of erosion site. Photo taken 10-22-2013.
