**Flood Control Project Maintenance
Levee Inspections**

Fall 2014 Levee Maintenance Deficiency Summary Report

Reclamation District No. 2104 Peters Pocket Tract

Levee Inspection Report By Mile - Fall 2014

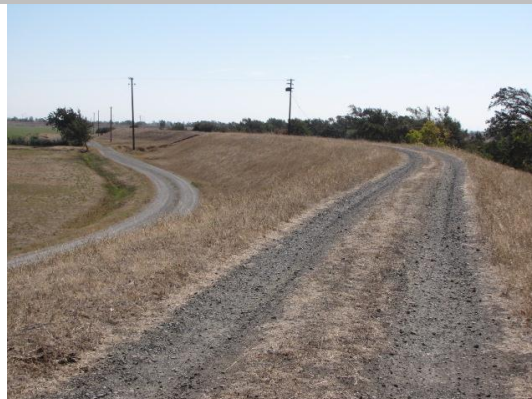
Photo 1 of 1 : FA_2014_RD2104_249_42_20141110_00084.jpg

LM Start	0.00	Rating **	M	Issue No.	42
LM End	0.00	Issue Type +	Ma	Location *	LS
Category	Earthen Levee			GPS Latitude/Longitude	
				Start	End
Item	Vegetation			38.308296 °	38.308296 °
				-121.758594 °	-121.758594 °
DWR ID	DWR_RD2104_01_s_2012_42				
Action/Comments					
Remove the wild growth other than native grasses from the levee slopes.

Looking downstream from levee mile 0.00 landside slope. RD 2104.

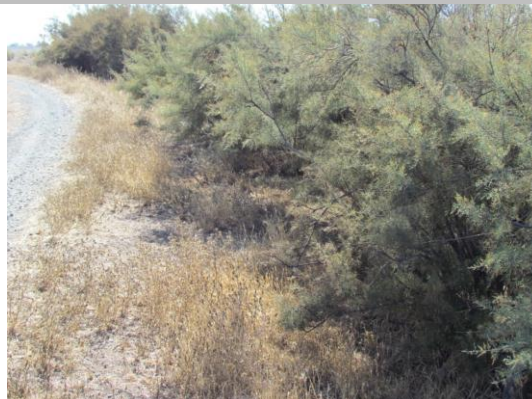
Photo 1 of 1 : FA_2014_RD2104_249_8_20141110_00085.jpg

LM Start	0.19	Rating **	U	Issue No.	8
LM End	0.22	Issue Type +	Ma	Location *	WS
Category	Earthen Levee			GPS Latitude/Longitude	
				Start	End
Item	Vegetation			38.305912 °	38.305583 °
				-121.757520 °	-121.757220 °
DWR ID	DWR_RD2104_01_s_2012_8				
Action/Comments					
Remove the wild growth other than native grasses from the levee slopes.					
Inspector Comments: Remove the wild growth of soft cedar trees waterward slope and shoulder.

Unsatisfactory woody growth on waterward shoulder and slope.

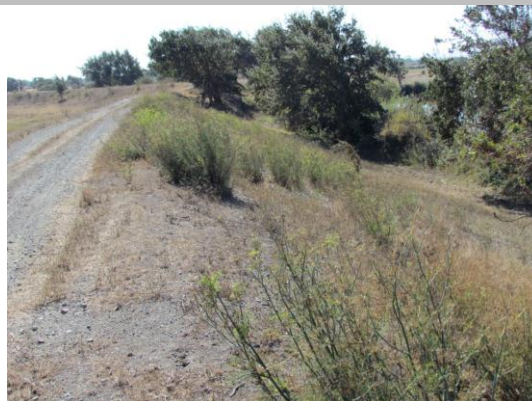
Photo 1 of 1 : FA_2014_RD2104_249_20_20141110_00086.jpg

LM Start	0.23	Rating **	U	Issue No.	20
LM End	5.08	Issue Type +	Ma	Location *	WS
Category	Earthen Levee			GPS Latitude/Longitude	
				Start	End
Item	Vegetation			38.305498 °	38.318437 °
				-121.757151 °	-121.744451 °
DWR ID	DWR_RD2104_01_s_2012_20				
Action/Comments					
Remove the wild growth other than native grasses from the levee slopes.

Wild weeds and brush growth on waterward slope.

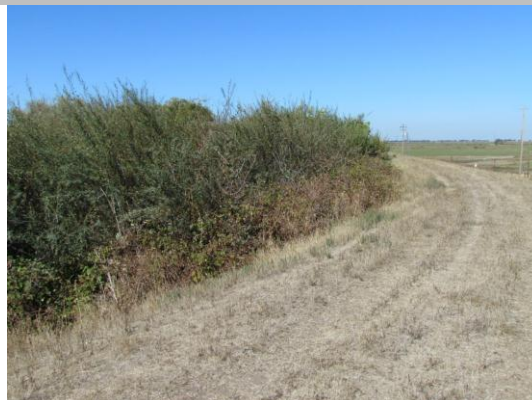
Photo 1 of 1 : FA_2014_RD2104_249_66_20141110_00089.jpg

LM Start	1.38	Rating **	U	Issue No.	66
LM End	4.59	Issue Type +	Ma	Location *	CR
Category	Earthen Levee			GPS Latitude/Longitude	
				Start	End
Item	Vegetation			38.296153 °	38.313187 °
				-121.744238 °	-121.739071 °
DWR ID	DWR_RD2104_01_s_2014_66				
Action/Comments					
Keep the crown roadway free of vegetation.					
Inspector Comments: Crown road should be free of vegetation.

Unwanted vegetation present on crown roadway.

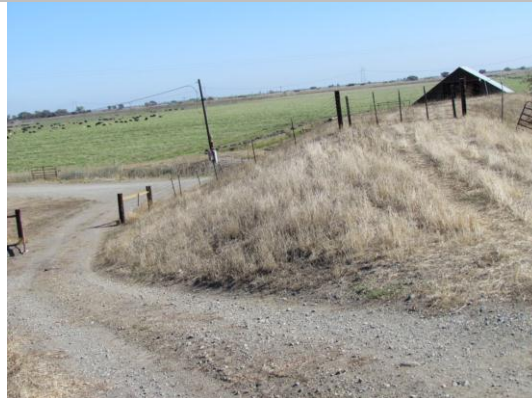
Photo 1 of 1 : FA_2014_RD2104_249_43_20141110_00087.jpg

LM Start	1.49	Rating **	U	Issue No.	43
LM End	3.23	Issue Type +	Ma	Location *	LS
Category	Earthen Levee			GPS Latitude/Longitude	
				Start	End
Item	Vegetation			38.295688 °	38.298662 °
				-121.742488 °	-121.730313 °
DWR ID	DWR_RD2104_01_f_2014_43				
Action/Comments					
Control annual grass and weeds on the levee slopes and easements. Inspector Comments: Overgrown weeds taken over the slope and crown roadway. No maintenance has been done on levee section.

Unsatisfactory growth of wild weeds on landward levee slope and crown roadway.

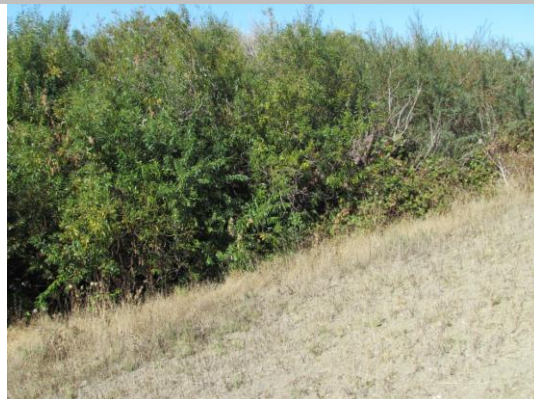
Photo 1 of 2 : FA_2014_RD2104_249_49_20141110_00088.jpg

LM Start	1.50	Rating **	U	Issue No.	49
LM End	1.56	Issue Type +	Ma	Location *	WS
Category	Earthen Levee			GPS Latitude/Longitude	
				Start	End
Item	Vegetation			38.295706 °	38.295454 °
				-121.742451 °	-121.741529 °
DWR ID	DWR_RD2104_01_s_2013_49				
Action/Comments					
Remove the wild growth other than native grasses from the levee slopes.					
Inspector Comments: No maintenance since last inspection.

Looking back upstream from levee mile 1.56 to levee mile 1.50 waterward, woody tree growth blocking view of levee slopes and shoulder.

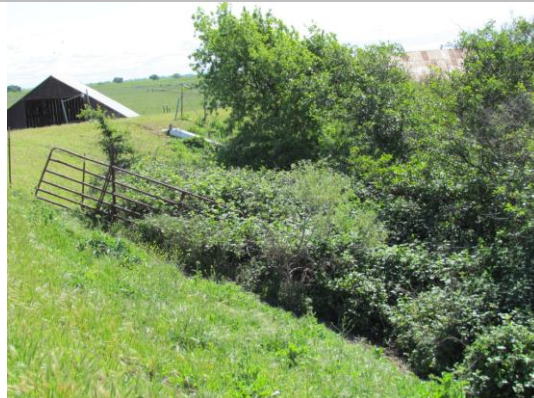
Photo 2 of 2 : FA_2014_RD2104_249_49_20141008_00003.jpg

RD 2104 Levee mile 1.50 looking downstream at wild growth on water sideslope and toe.

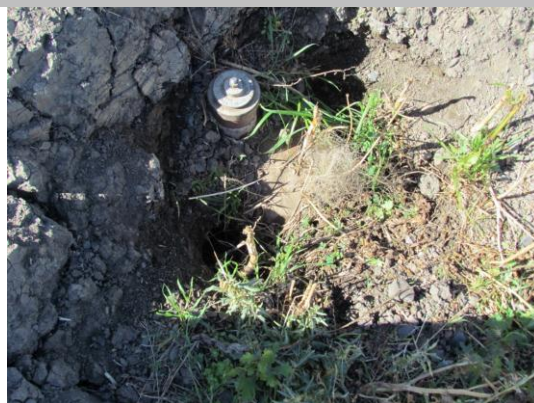
Photo 1 of 2 : FA_2014_RD2104_249_120_20141110_00093.jpg

LM Start	4.33	Rating **	U	Issue No.	120
LM End	4.33	Issue Type +	En	Location *	LS
Category	Earthen Levee			GPS Latitude/Longitude	
				Start	End
Item	Encroachments			38.310912 °	38.310912 °
				-121.736172 °	-121.736172 °
DWR ID	DWR_RD2104_01_f_2014_120				
Action/Comments					
Pipe Inspector Comments: Unauthorized repair of pipe through levee, Pipe is leaking through levee repair. Work was not done properly, levee slope landward damaged, spoils piled on the slope. Need repair done before flood season. Photo taken.10-24-2014.

View of aunaunauthorized pipe work. The siphon breaker on the waterward side has water running under pipe back through levee.

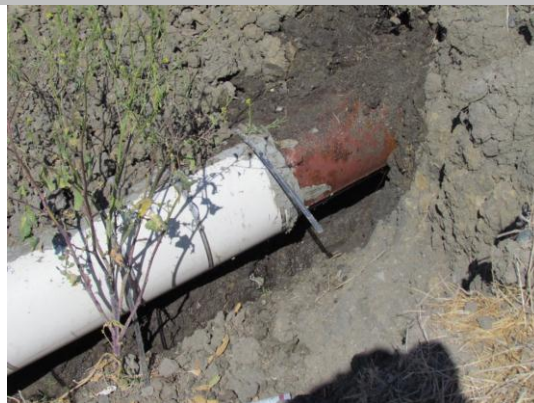
Photo 2 of 2 : FA_2014_RD2104_249_120_20141110_00094.jpg

View of pipe landward. Water is shown coming through levee around pipe.

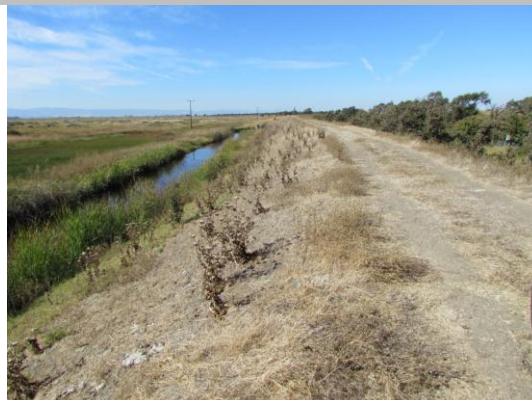
Photo 1 of 1 : FA_2014_RD2104_249_122_20141110_00091.jpg

LM Start	4.58	Rating **	U	Issue No.	122
LM End	5.09	Issue Type +	Ma	Location *	LS
Category	Earthen Levee			GPS Latitude/Longitude	
				Start	End
Item	Vegetation			38.313130 °	38.318388 °
				-121.739050 °	-121.744370 °
DWR ID	DWR_RD2104_01_f_2014_122				
Action/Comments					
Remove the wild growth other than native grasses from the levee slopes.

Unsatisfactory wild growth on landward levee shoulder and slope.

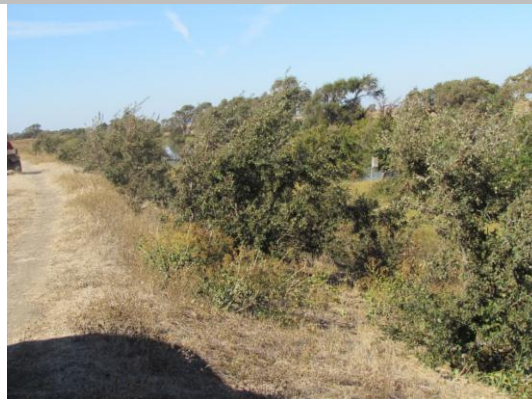
Photo 1 of 1 : FA_2014_RD2104_249_123_20141110_00092.jpg

LM Start	4.58	Rating **	U	Issue No.	123
LM End	5.09	Issue Type +	Ma	Location *	WS
Category	Earthen Levee			GPS Latitude/Longitude	
				Start	End
Item	Vegetation			38.313135 °	38.318388 °
				-121.739073 °	-121.744370 °
DWR ID	DWR_RD2104_01_f_2014_123				
Action/Comments					
Remove the wild growth other than native grasses from the levee slopes.

Wild woody tree growth on waterside slope and shoulder.

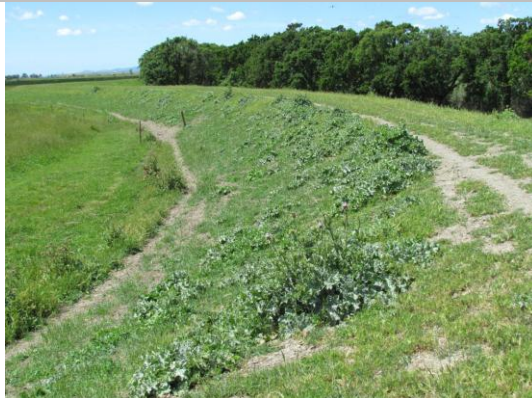
Photo 1 of 1 : FA_2014_RD2104_249_78_20141008_00006.jpg

LM Start	6.01	Rating **	U	Issue No.	78
LM End	6.04	Issue Type +	Ma	Location *	LS
Category	Earthen Levee			GPS Latitude/Longitude	
				Start	End
Item	Vegetation			38.324905 °	38.324722 °
				-121.755241 °	-121.755701 °
DWR ID	DWR_RD2104_01_s_2014_78				
Action/Comments					
Keep the crown roadway free of vegetation.

Unwanted broadleaf growth on the landside slope and toe.
