**Flood Control Project Maintenance  
Levee Inspections**

**Fall 2015 Levee Maintenance Deficiency Summary Report**

**Reclamation District No. 2104 Peters Pocket Tract**

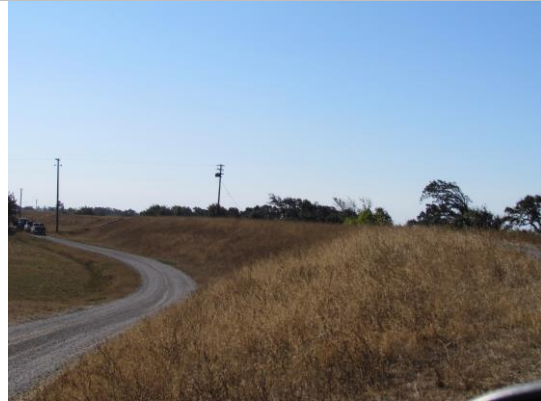
Photo 1 of 1 : FA\_2015\_RD2104\_249\_47\_20151013\_00022.jpg

RD 2104 Looking downstream at landside slope levee mile 0.06-0.28,

| Control annual grass and weeds on the levee slopes and easements. | | | | | |

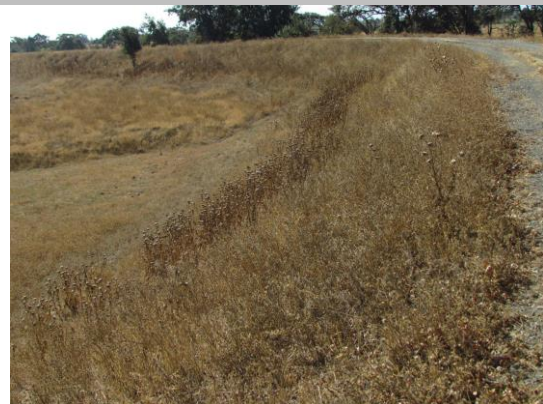
Photo 1 of 1 : FA\_2015\_RD2104\_249\_48\_20151013\_00023.jpg

Looking downstream from 0.39 -0.76 tall milkweeds on the slope.

| Control annual grass and weeds on the levee slopes and easements.<br>Inspector Comments: Remove the star thistle from the landward levee slope. | | | | | |

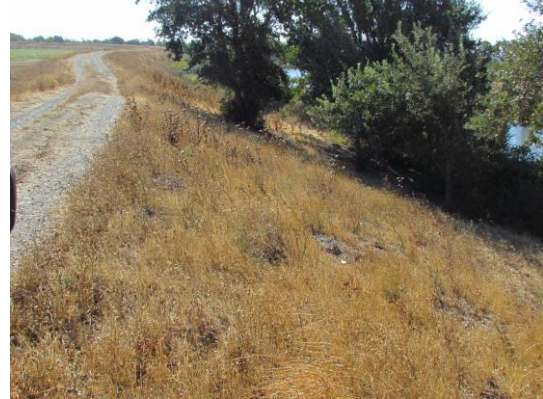
Photo 1 of 1 : FA\_2015\_RD2104\_249\_51\_20151013\_00024.jpg

Looking downstream waterside 0.42-0.68 unsatisfactory tall weeds covering the slope.

| Inspector Comments: Remove the dead weeds from the levee slope. | | | | | |

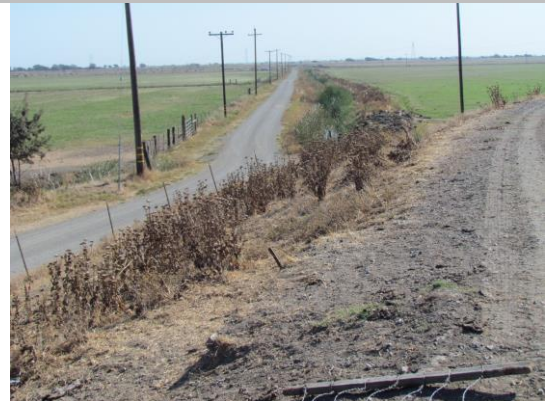
Photo 1 of 1 : FA\_2015\_RD2104\_249\_61\_20151013\_00025.jpg

Looking downstream from the landside shoulder dead tall star thistle covering the slope and toe.

| Control annual grass and weeds on the levee slopes and easements. | | | | | |

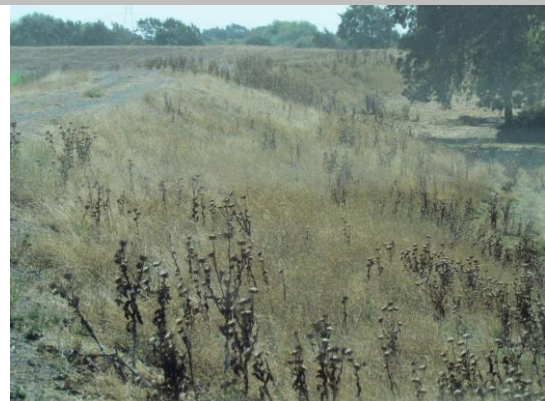
Photo 1 of 1 : FA\_2015\_RD2104\_249\_62\_20151027\_00032.jpg

Looking downstream from levee mile 0.89- 1.48 waterside slope tall weeds taken over the slope.

| Control annual grass and weeds on the levee slopes and easements.<br>Inspector Comments: Remove the tall weeds from the levee section. | | | | | |

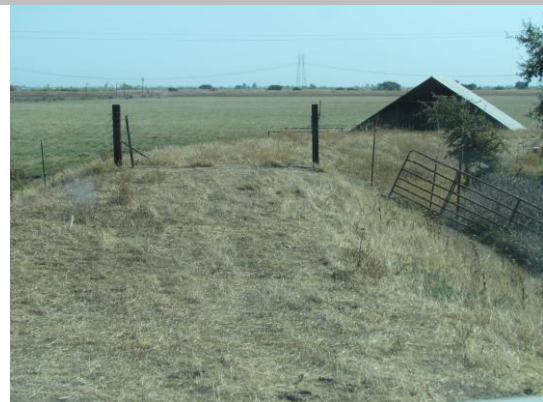
Photo 1 of 1 : FA\_2015\_RD2104\_249\_66\_20151027\_00033.jpg

Levee mile 1.27- 4.24 crown roadway covered in vegetation.

| Keep the crown roadway free of vegetation.<br>Inspector Comments: Crown road should be free of vegetation. | | | | | |

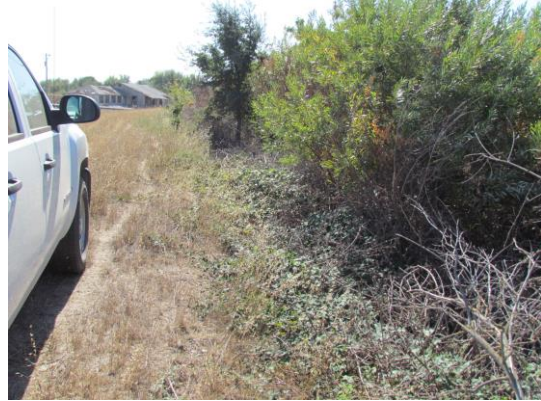
Photo 1 of 1 : FA\_2015\_RD2104\_249\_49\_20151027\_00034.jpg

From levee mile 1.38 -1.44 woody vegetation on the waterside levee slope.

| Remove the wild growth other than native grasses from the levee slopes.<br>Inspector Comments: The landowner has applied some spray to the woody tree growth and wild vegetation, more spray is needed here. | | | | | |

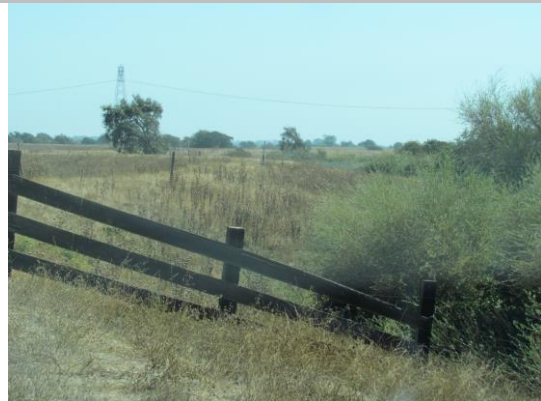
Photo 1 of 1 : FA\_2015\_RD2104\_249\_63\_20151027\_00035.jpg

Waterside slope downstream of 1.55- 3.18 wild tall weeds on the slope.

| Control annual grass and weeds on the levee slopes and easements.<br>Inspector Comments: Remove the tall weeds from the slope. | | | | | |

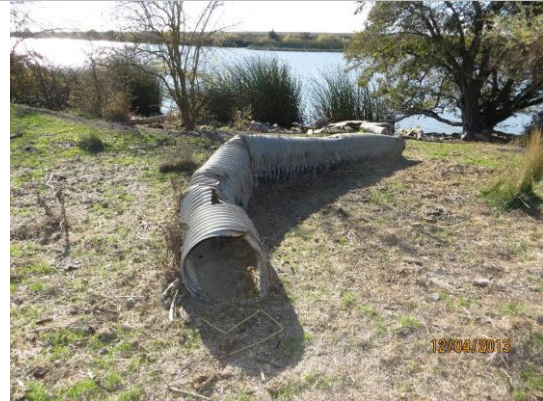
Photo 1 of 1 : UCIP\_FA\_2015\_2738.jpg

Pipe debris on WS berm.

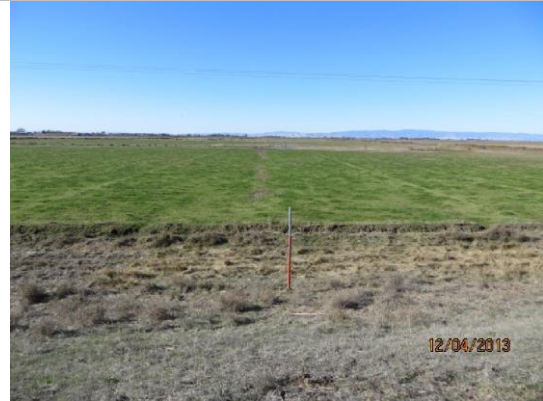
Photo 1 of 2 : UCIP\_FA\_2015\_2748.jpg

| Inspector Comments: FS_ID:41834<br>DS_ID:24720<br>EP_NO: 14184<br>FS_HLM: 3.292<br>Repair Type: Non-Urgent<br>Crossing Status: Found<br>UCIP Comments: Signs in disrepair and need proper markings.<br>FIELD_STRUCT_DESC: 6-inch steel gasoline through the levee 3-feet below the crown. Signs on LS and WS toe.<br>FS Date: 12/04/2013 | | | | | |

Sign post on LS toe.

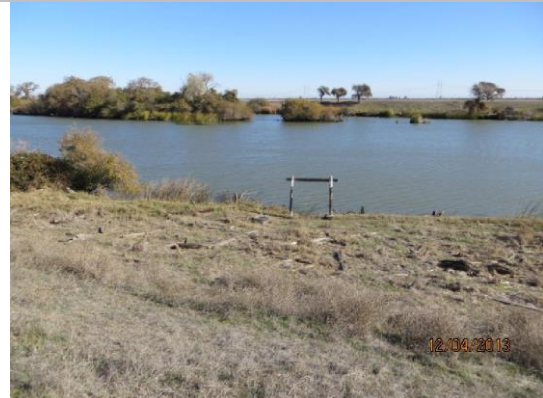
Photo 2 of 2 : UCIP\_FA\_2015\_2749.jpg

Sign on WS berm.

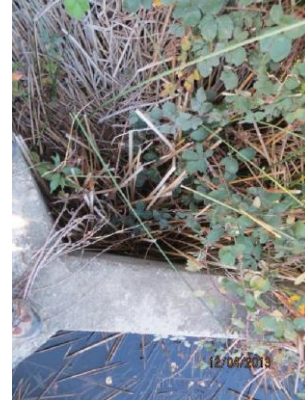
Photo 1 of 3 : UCIP\_FA\_2015\_2739.jpg

| Inspector Comments: FS_ID:24992<br>DS_ID:24707<br>EP_NO: 4412<br>FS_HLM: 3.377<br>Repair Type: Non-Urgent<br>Crossing Status: Indicator Found<br>UCIP Comments: Heavy vegetation at concrete headwall on LS toe and at possible outlet area on WS toe. If possible, vegetation should be cleared to check if this is an accurate location. Erosion around backside of headwall at LS toe.<br>FIELD_STRUCT_DESC: 4 x 4 concrete culvert through the levee 17.0-feet below the crown. Originally included in O+M manual, 1964.<br>Concrete headwall on LS toe.<br>FS Date: 12/04/2013 | | | | | |

Some erosion on levee side of headwall at LS toe.

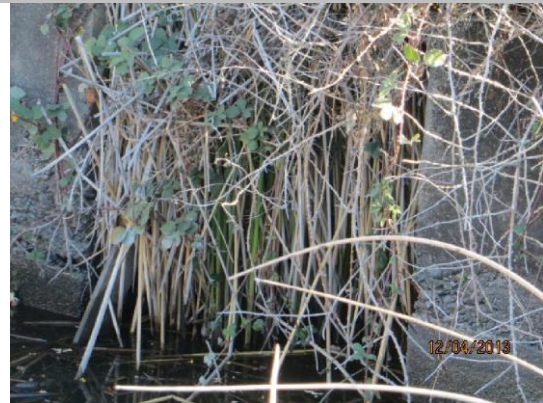
Photo 2 of 3 : UCIP\_FA\_2015\_2740.jpg

Vegetation covering possible location for 4X4 concrete culvert at LS toe.

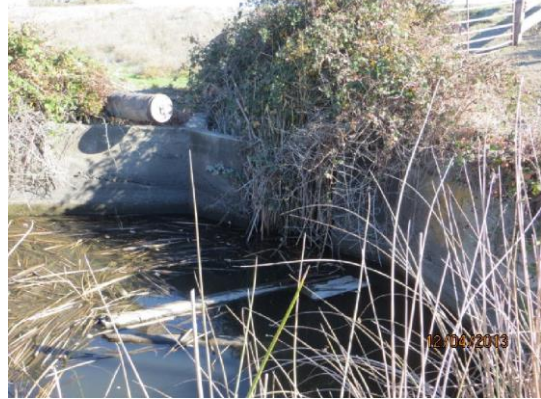
Photo 3 of 3 : UCIP\_FA\_2015\_2741.jpg

Vegetation covering possible location for 4X4 concrete culvert at LS toe.

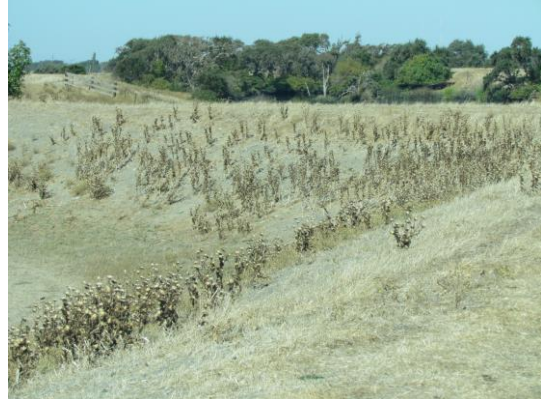
Photo 1 of 1 : FA\_2015\_RD2104\_249\_67\_20151027\_00029.jpg

Looking downstream from the landside slope tall thistle is present on the levee section.

| Inspector Comments: Remove the thistle from the levee slope. | | | | | |

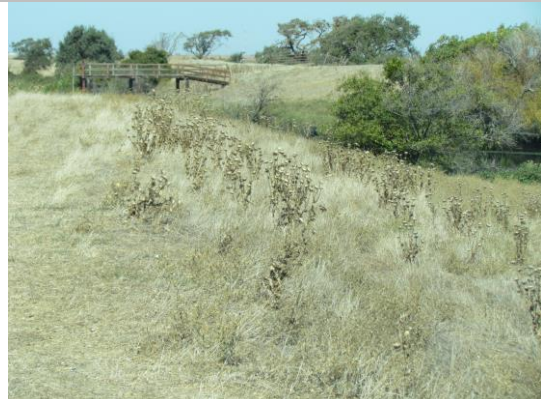
Photo 1 of 1 : FA\_2015\_RD2104\_249\_70\_20151027\_00030.jpg

Looking downstream from the waterside slope thistle and other tall weeds present on the levee.

| Control annual grass and weeds on the levee slopes and easements.<br>Inspector Comments: Remove the weeds from the waterside levee slope. | | | | | |

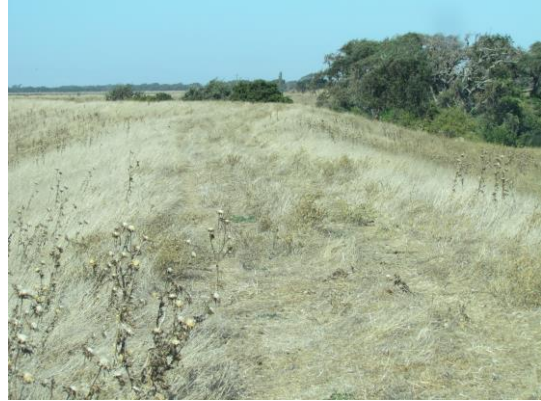
Photo 1 of 1 : FA\_2015\_RD2104\_249\_74\_20151027\_00026.jpg

Looking downstream from levee mile 3.65 - 4.01 the weeds has taken over the crown roadway.

| Keep the crown roadway free of vegetation.<br>Inspector Comments: The crown roadway should be free of vegetation. | | | | | |

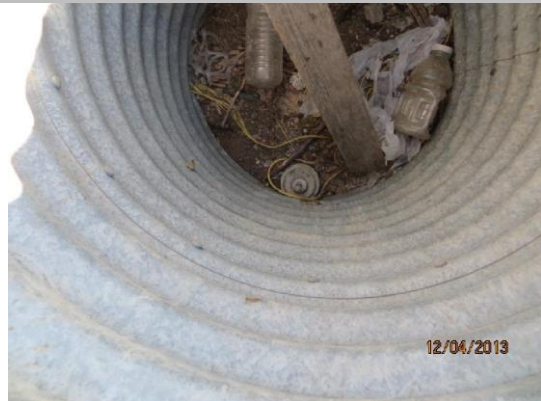
Photo 1 of 3 : UCIP\_FA\_2015\_2742.jpg

| Inspector Comments: FS_ID:24995<br>DS_ID:24706<br>EP_NO: 10183<br>FS_HLM: 4.337<br>Repair Type: Urgent<br>Crossing Status: Found<br>UCIP Comments: Pipe rusted through on WS berm. Siphon breaker in CMP riser blocked by riser misalignment.<br>FIELD_STRUCT_DESC: 12-inch steel drainpipe through the levee 4.0-feet below the crown. Pump on pile structure in drainage ditch on landward side. One C.M. cutoff wall and a Siphon breaker in a 24-inch CMP riser on the waterward shoulder. Flap gate on waterward end. (ABO No. 10183 - Miller) Originally included in O+M manual, 1964.<br>Asbuilt Dwg. 50-04-3379.<br>FS Date: 12/04/2013 | | | | | |

Siphon breaker in CMP riser blocked by the risers misalignment.

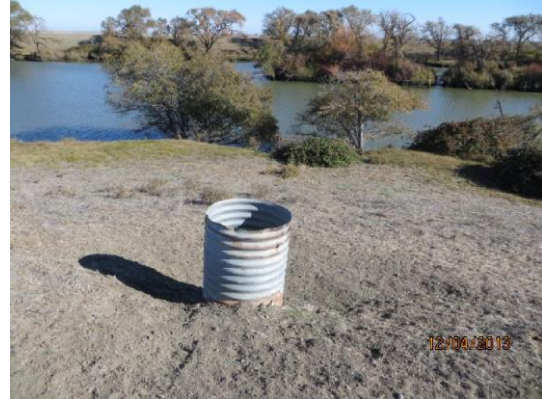
Photo 2 of 3 : UCIP\_FA\_2015\_2743.jpg

Inspector Comments: FS\_ID:24995  
 DS\_ID:24706  
 EP\_NO: 10183  
 FS\_HLM: 4.337  
 Repair Type: Urgent  
 Crossing Status: Found  
 UCIP Comments: Pipe rusted through on WS berm. Siphon breaker in CMP riser blocked by riser misalignment.  
 FIELD\_STRUCT\_DESC: 12-inch steel drainpipe through the levee 4.0-feet below the crown. Pump on pile structure in drainage ditch on landward side. One C.M. cutoff wall and a Siphon breaker in a 24-inch CMP riser on the waterward shoulder. Flap gate on waterward end. (ABO No. 10183 - Miller) Originally included in O+M manual, 1964. Asbuilt Dwg. 50-04-3379.  
 FS Date: 12/04/2013

Siphon breaker in CMP riser on WS slope.

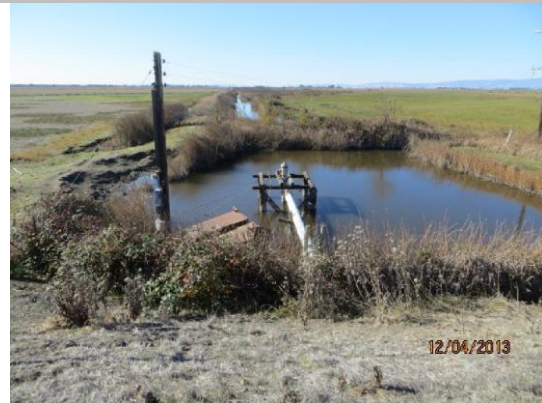
Photo 3 of 3 : UCIP\_FA\_2015\_2744.jpg

Pump on pier off LS toe at ponding area. power pole and meter on LS toe.

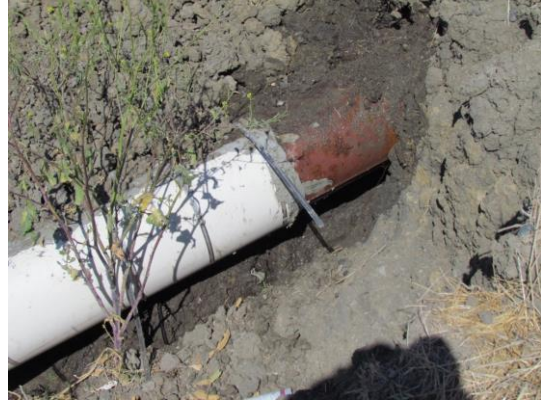
Photo 1 of 2 : FA\_2015\_RD2104\_249\_120\_20150915\_00009.jpg

Inspector Comments: Unauthorized repair of pipe through levee, Pipe is leaking through levee repair. Work was not done properly, levee slope landward damaged, spoils piled on the slope. Need repair done before flood season. Photo taken.10-24-2014 to date the pipe hasn't been properly repaired. The land owner has applied for a permit.

View of pipe landward. Water is shown coming through levee around pipe.

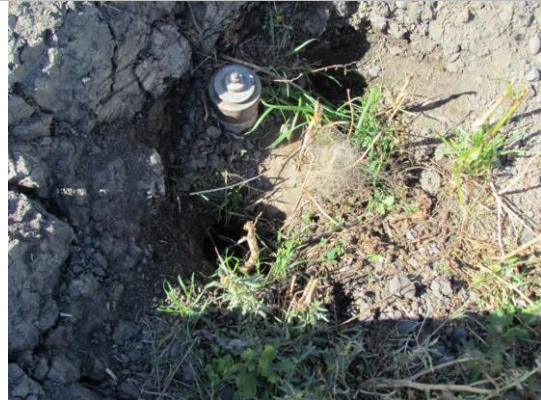
Photo 2 of 2 : FA\_2015\_RD2104\_249\_120\_20150915\_00010.jpg

View of unauthorized pipe work. The siphon breaker on the waterward side has water running under pipe back through levee.

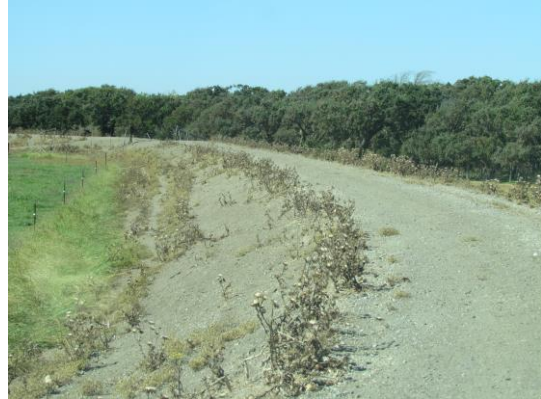
Photo 1 of 1 : FA\_2015\_RD2104\_249\_122\_20151027\_00027.jpg

Unsatisfactory wild growth on the landside levee shoulder and slope.

| Inspector Comments: Remove the wild growth from the levee slope. | | | | | |

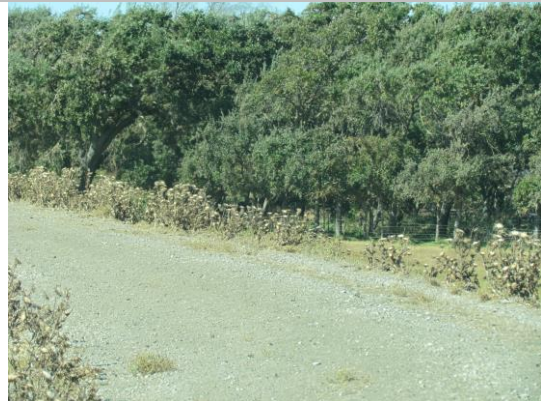
Photo 1 of 1 : FA\_2015\_RD2104\_249\_123\_20151027\_00028.jpg

Wild woody tree growth on the waterside slope and shoulder.

| Inspector Comments: Remove the wild woody tree growth from the water side slope. | | | | | |

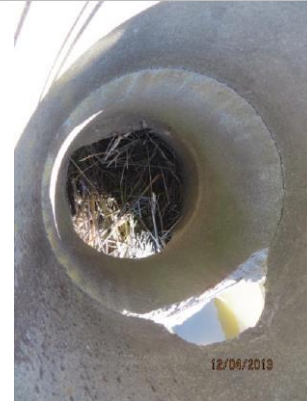
Photo 1 of 3 : UCIP\_FA\_2015\_2745.jpg

Inspector Comments: FS\_ID:24996  
 DS\_ID:24705  
 EP\_NO: 10182  
 FS\_HLM: 4.661  
 Repair Type: Urgent  
 Crossing Status: Found  
 UCIP Comments: Vegetation and soil buildup throughout pipe preventing flapgate from closing. Remove vegetation to allow gate to close properly.  
 FIELD\_STRUCT\_DESC: 24-inch CMP drainpipe through the levee 15.0-feet below the crown. 36-inch concrete standpipe on LS toe. Flapgate on WS toe. Two C.M. cut of walls. (ABO No. 10182 - Machado)  
 Originally included in O+M manual, 1964. Asbuilt Dwg. 50-04-3379.  
 FS Date: 12/04/2013

36-inch concrete riser with vegetation buildup inside.

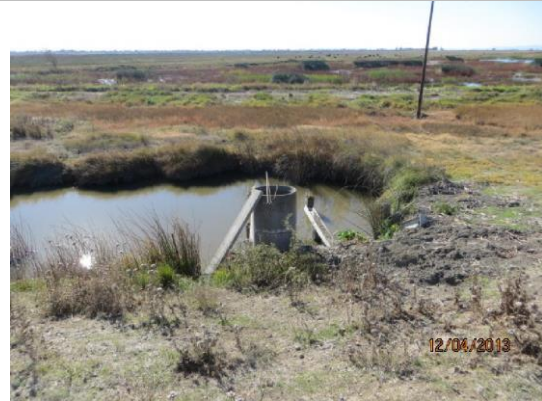
Photo 2 of 3 : UCIP\_FA\_2015\_2746.jpg

36-inch concrete riser on LS toe at channel.

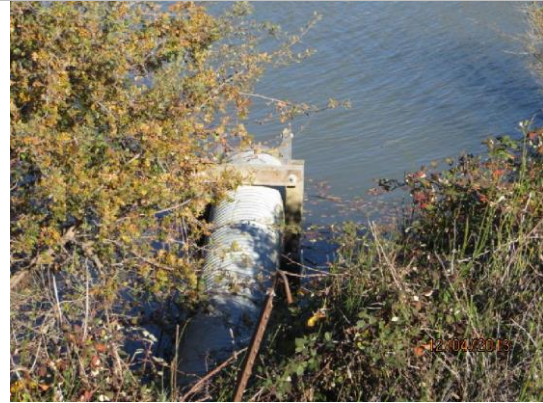
Photo 3 of 3 : UCIP\_FA\_2015\_2747.jpg

CMP pipe and flapgate off WS toe.

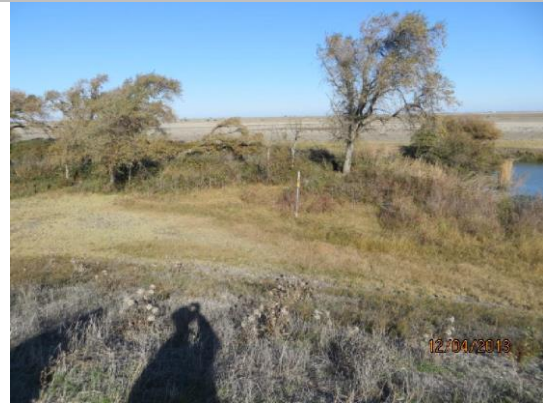
Photo 1 of 2 : UCIP\_FA\_2015\_2750.jpg

| Inspector Comments: FS_ID:25003<br>DS_ID:24704<br>EP_NO: 10182<br>FS_HLM: 5.03<br>Repair Type: Non-Urgent<br>Crossing Status: Found<br>UCIP Comments: Sign on WS toe needs repair.<br>FIELD_STRUCT_DESC: 8-inch gas line through levee at high elevation. Sign on WS and LS toe. (ABO No. 10182 - Machado) Asbuilt<br>Dwg. 50-04-3379.<br>FS Date: 12/04/2013 | | | | | |

Sign pole on WS toe missing sign.

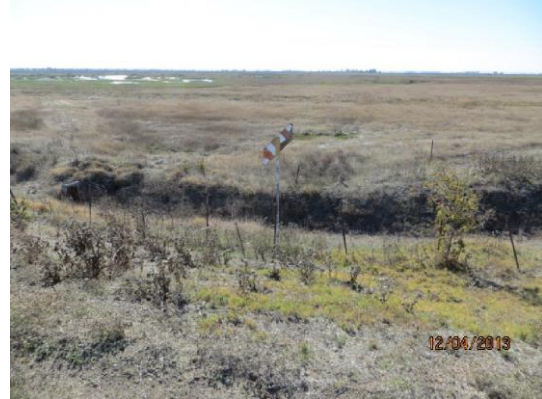
Photo 2 of 2 : UCIP\_FA\_2015\_2751.jpg

Gasline marker on LS toe.

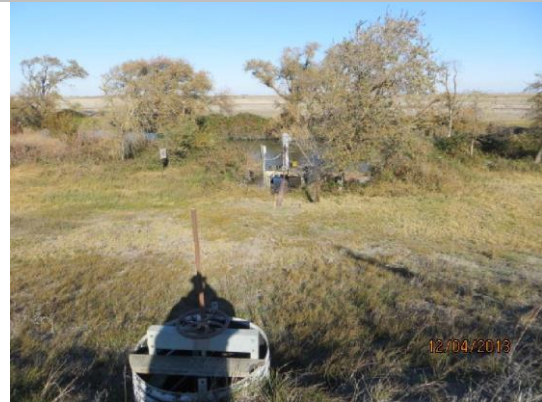
Photo 1 of 2 : UCIP\_FA\_2015\_2776.jpg

| Inspector Comments: FS_ID:25005<br>DS_ID:24703<br>EP_NO: N/A<br>FS_HLM: 5.05<br>Repair Type: Non-Urgent<br>Crossing Status: Found<br>UCIP Comments: Good candidate for video inspection.<br>FIELD_STRUCT_DESC: 18-inch steel irrigation pipe through the levee 13.5-feet below the crown. Pump on pile structure in stream. Slide gate in 36-inch CMP riser on waterward slope. Two cutoff walls. Concrete "U" headwall and air vent at toe of landward slope. Asbuilt Dwg. 50-04-3379. Electrical conduit through levee at same location.<br>FS Date: 12/04/2013 | | | | | |

Slide gate in CMP riser on WS slope with pump on pier in background.

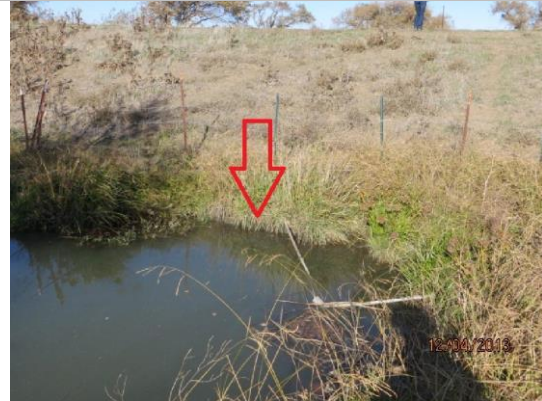
Photo 2 of 2 : UCIP\_FA\_2015\_2777.jpg

Concrete headwall on LS toe at irrigation ditch.

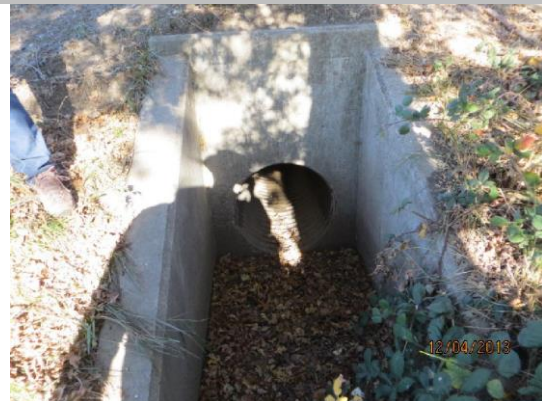
Photo 1 of 3 : UCIP\_FA\_2015\_2588.jpg

Inspector Comments: FS\_ID:25006  
DS\_ID:24702  
EP\_NO: 10182  
FS\_HLM: 5.102  
Repair Type: Non-Urgent  
Crossing Status: Found  
UCIP Comments: Minor erosion of base under headwall on WS toe. Heavy corrosion of pipe at WS toe. Further evaluation of pipe integrity needed.  
FIELD\_STRUCT\_DESC: 24-inch CMP drain pipe through the levee 13.5-feet below the crown. Concrete "U" headwalls on both ends. Two C.M. cutoff walls. Flap gate on waterward end. (ABO No. 10182 - Machado)  
FS Date: 12/04/2013

Concrete U shaped headwall on LS toe.

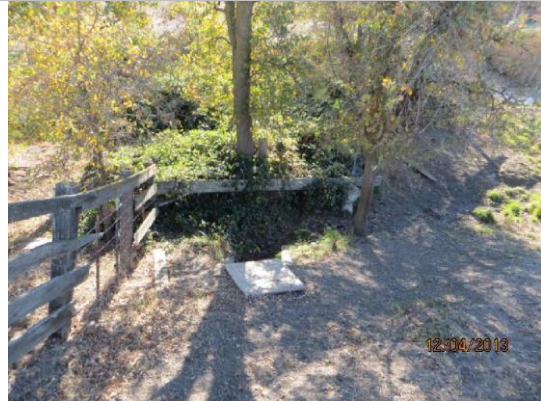
Photo 2 of 3 : UCIP\_FA\_2015\_2589.jpg

Concrete U shaped headwall on LS toe.

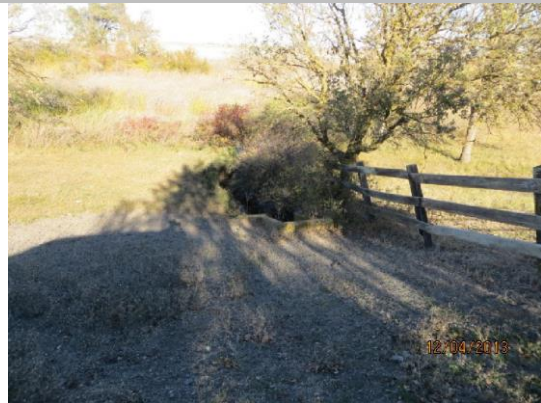
Photo 3 of 3 : UCIP\_FA\_2015\_2590.jpg

Concrete U shaped headwall on WS toe.

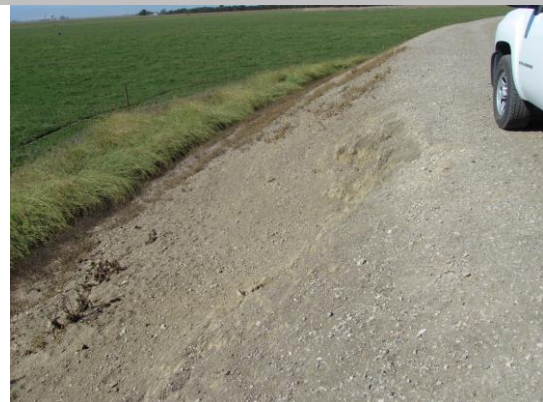
Photo 1 of 1 : FA\_2015\_RD2104\_249\_75\_20151027\_00036.jpg

Erosion site on the landside slope into the shoulder.

| Schedule repair of erosion site prior to the next inspection.<br>Inspector Comments: Repair the erosion on the landside slope caused by livestock. | | | | | |

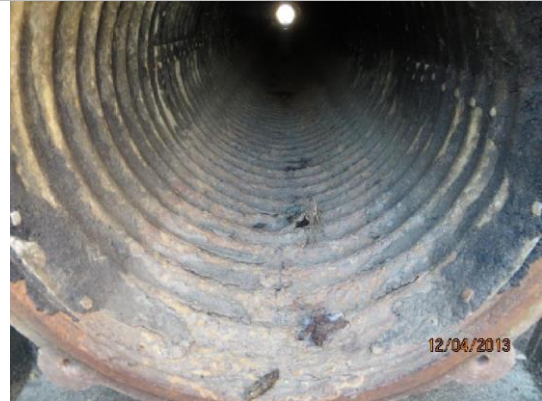
Photo 1 of 3 : UCIP\_FA\_2015\_2591.jpg

Inspector Comments: FS\_ID:25007  
 DS\_ID:24701  
 EP\_NO: 10182  
 FS\_HLM: 5.505  
 Repair Type: Urgent  
 Crossing Status: Found  
 UCIP Comments: Footing under headwall on WS toe severely undermined. Pipe rusted heavily with holes at WS and may need replacement.  
 FIELD\_STRUCT\_DESC: 24-inch CMP drain pipe through levee 13.0 feet below crown. Two cutoff walls. Concrete "U" headwalls on both ends. Flap gate on water end. (ABO No. 10182 - Machado). Asbuilt Dwg. 50-04-3379.  
 FS Date: 12/04/2013

Corrosion through pipe with holes on WS toe.

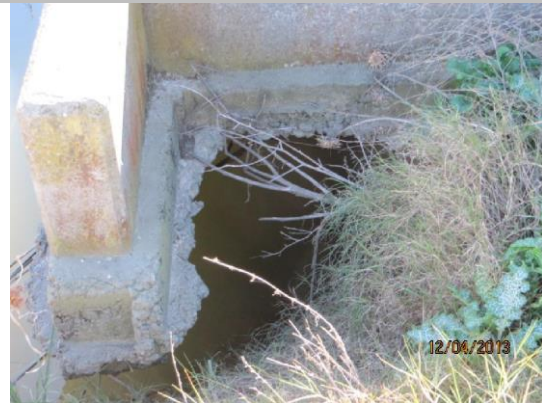
Photo 2 of 3 : UCIP\_FA\_2015\_2592.jpg

Headwall undermined on WS toe.

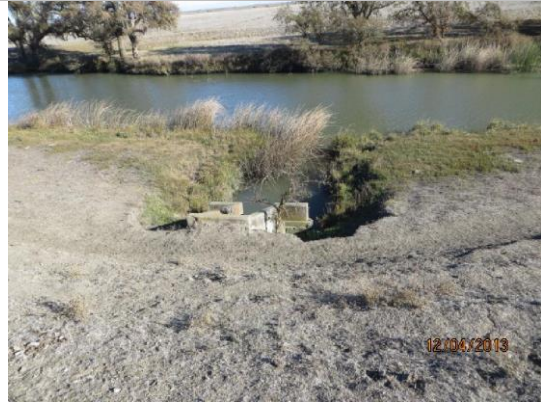
Photo 3 of 3 : UCIP\_FA\_2015\_2593.jpg

Concrete U-shaped headwall on WS toe. Note erosion scarp around headwall.
