**Flood Control Project Maintenance  
Levee Inspections**

**Fall 2016 Levee Maintenance Deficiency Summary Report**

**Reclamation District No. 2104 Peters Pocket Tract**

**Levee Inspection Report By Mile - Fall 2016**

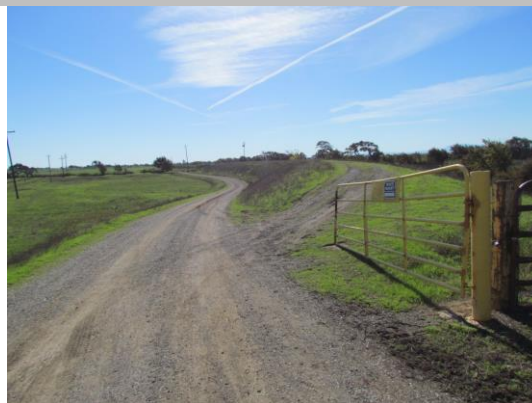
Photo 1 of 1 : FA\_2016\_RD2104\_249\_15\_20161107\_00038.jpg

LM Start	0.01	Rating **	M	Issue No.	15
LM End	4.24	Issue Type +	Ma	Location *	LS
Category	Earthen Levee			GPS Latitude/Longitude	
				Start	End
Item	Vegetation			38.308090 °	38.313175 °
				-121.758615 °	-121.739101 °
DWR ID	DWR_RD2104_01_f_2016_15				
Comment Code					
V1 : Control annual grass and weeds on the levee slopes and easements.					
Inspector Comment					
Control the annual grasses on the landside slope and toe.

RD 2104 Fall inspection levee mile 0.01-3.47.

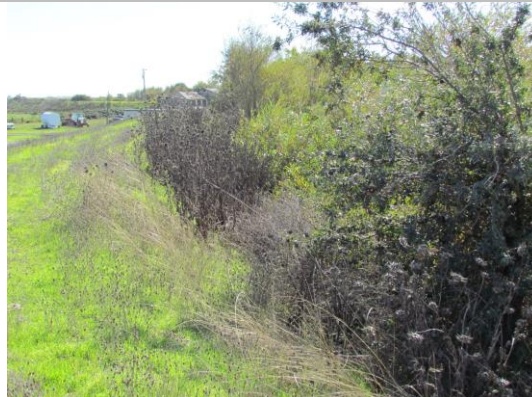
Photo 1 of 1 : FA\_2016\_RD2104\_249\_27\_20161107\_00042.jpg

LM Start	1.43	Rating **	U	Issue No.	27
LM End	1.49	Issue Type +	Ma	Location *	WS
Category	Earthen Levee			GPS Latitude/Longitude	
				Start	End
Item	Vegetation			38.295622 °	38.294853 °
				-121.741655 °	-121.741213 °
DWR ID	DWR_RD2104_01_f_2016_27				
Comment Code					
V2 : Remove the wild growth other than native grasses from the levee slopes.					
Inspector Comment					
Remove the woody vegetation from the waterside levee slope and shoulder.

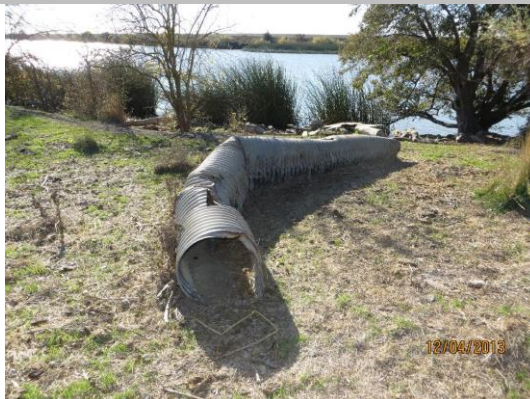
Photo 1 of 1 : UCIP\_FA\_2016\_41347\_45043.jpg

LM Start	2.40	Rating **	M	Issue No.	132
LM End	2.40	Issue Type +	En	Location *	WS
Category	Supplemental			GPS Latitude/Longitude	
				Start	End
Item	DWR UCIP Field Study			38.291579 °	38.291579 °
				-121.726159 °	-121.726159 °
DWR ID					
Comment Code					
Inspector Comment					
FS_ID:41347 DS_ID:24726 EP_NO: N/A Repair Type: Non-Urgent Crossing Status: Indicator Found UCIP Comments: 24-inch CMP debris on WS berm may indicate pipe was abandoned. FIELD_STRUCT_DESC: *ABANDONED* 24-inch CMP drain pipe through the levee 18-feet below the crown. Flapgate on the WS toe. Originally included in O+M manual, 1964. FS Date: 12/4/2013

Pipe debris on WS berm.

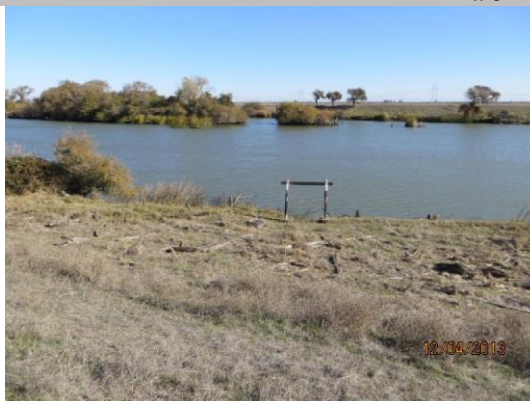
Photo 1 of 2 : UCIP\_FA\_2016\_41834\_45069.jpg

LM Start	3.04	Rating **	M	Issue No.	133
LM End	3.04	Issue Type +	En	Location *	WS
Category	Supplemental			GPS Latitude/Longitude	
				Start	End
Item	DWR UCIP Field Study			38.299447 °	38.299447 °
				-121.730444 °	-121.730444 °
DWR ID					
Comment Code					
Inspector Comment					
FS_ID:41834					
DS_ID:24720					
EP_NO: 14184					
Repair Type: Non-Urgent					
Crossing Status: Found					
UCIP Comments: Signs in disrepair and need proper markings.					
FIELD_STRUCT_DESC: 6-inch steel gasoline through the levee 3-feet below the crown. Signs on LS and WS toe.					
FS Date: 12/4/2013

Sign on WS berm.

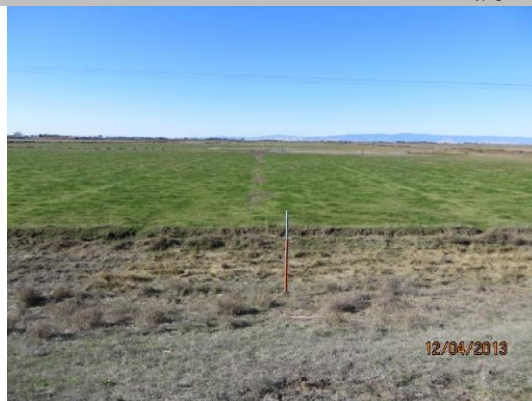
Photo 2 of 2 : UCIP\_FA\_2016\_41834\_45068.jpg

LM Start	3.04	Rating **	M	Issue No.	133 (cont)	
LM End	3.04	Issue Type +	En	Location *	WS	
Category	Supplemental			GPS Latitude/Longitude		
				Start		End
Item	DWR UCIP Field Study			38.299447 °		38.299447 °
				-121.730444 °		-121.730444 °
DWR ID						
Comment Code						
Inspector Comment						
FS_ID:41834						
DS_ID:24720						
EP_NO: 14184						
Repair Type: Non-Urgent						
Crossing Status: Found						
UCIP Comments: Signs in disrepair and need proper markings.						
FIELD_STRUCT_DESC: 6-inch steel gasoline through the levee 3-feet below the crown. Signs on LS and WS toe.						
FS Date: 12/4/2013

Sign post on LS toe.

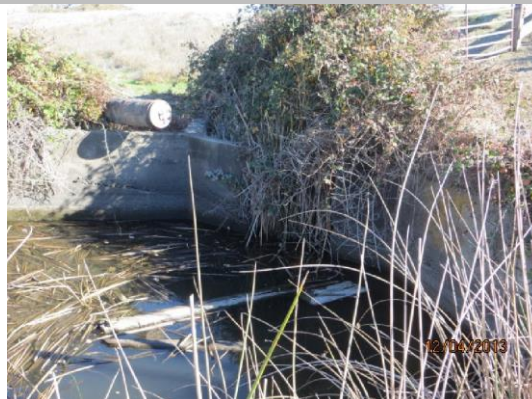
Photo 1 of 2 : UCIP\_FA\_2016\_24992\_45051.jpg

LM Start	3.12	Rating **	M	Issue No.	131
LM End	3.12	Issue Type +	En	Location *	CR
Category	Supplemental			GPS Latitude/Longitude	
				Start	End
Item	DWR UCIP Field Study			38.300605 °	38.300605 °
				-121.730440 °	-121.730440 °
DWR ID					
Comment Code					
Inspector Comment					
FS_ID:24992 DS_ID:24707 EP_NO: 4412 Repair Type: Non-Urgent Crossing Status: Indicator Found UCIP Comments: Heavy vegetation at concrete headwall on LS toe and at possible outlet area on WS toe. If possible, vegetation should be cleared to check if this is an accurate location. Erosion around backside of headwall at LS toe. FIELD_STRUCT_DESC: 4 x 4 concrete culvert through the levee 17.0-feet below the crown. Originally included in O+M manual, 1964. Concrete headwall on LS toe. FS Date: 12/4/2013

Vegetation covering possible location for 4X4 concrete culvert at LS toe.

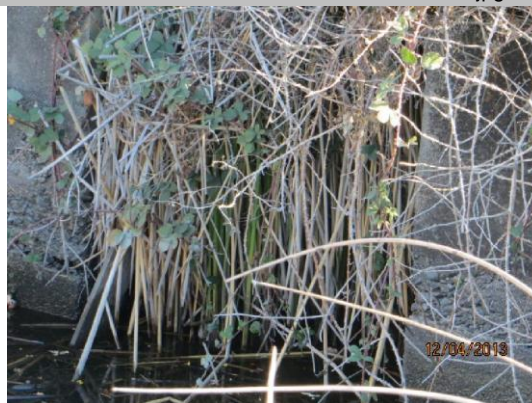
Photo 2 of 2 : UCIP\_FA\_2016\_24992\_45050.jpg

Vegetation covering possible location for 4X4 concrete culvert at LS toe.

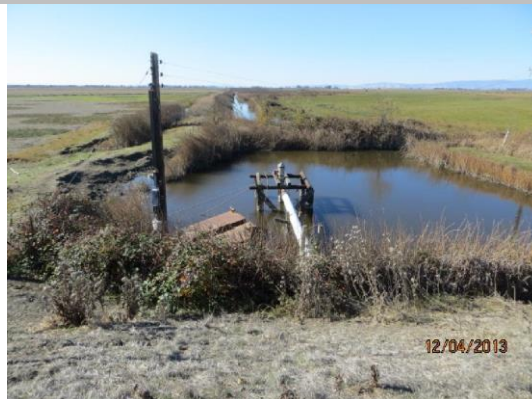
Photo 1 of 2 : UCIP\_FA\_2016\_24995\_45056.jpg

LM Start	4.01	Rating **	U	Issue No.	124
LM End	4.01	Issue Type +	En	Location *	CR
Category	Supplemental			GPS Latitude/Longitude	
				Start	End
Item	DWR UCIP Field Study			38.310873 °	38.310873 °
				-121.736189 °	-121.736189 °
DWR ID					
Comment Code					
Inspector Comment					
FS_ID:24995 DS_ID:24706 EP_NO: 10183 Repair Type: Urgent Crossing Status: Found UCIP Comments: Pipe rusted through on WS berm. Siphon breaker in CMP riser blocked by riser misalignment. FIELD_STRUCT_DESC: 12-inch steel drainpipe through the levee 4.0-feet below the crown. Pump on pile structure in drainage ditch on landward side. One C.M. cutoff wall and a Siphon breaker in a 24-inch CMP riser on the waterward shoulder. Flap gate on waterward end. (ABO No. 10183 - Miller) Originally included in O+M manual, 1964. Asbuilt Dwg. 50-04-3379. FS Date: 12/4/2013

Pump on pier off LS toe at ponding area. power pole and meter on LS toe.

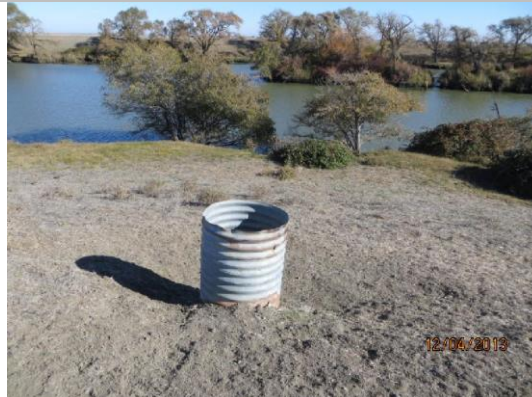
Photo 2 of 2 : UCIP\_FA\_2016\_24995\_45055.jpg

Siphon breaker in CMP riser on WS slope.

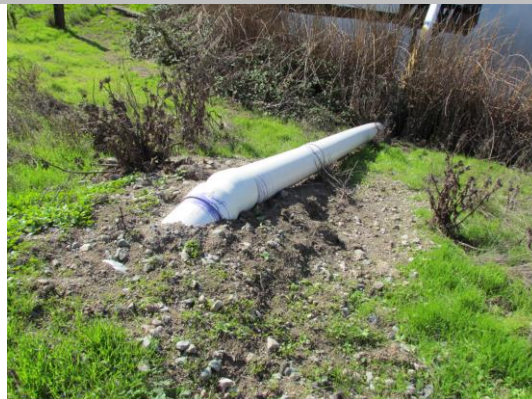
Photo 1 of 2 : FA\_2016\_RD2104\_249\_120\_20161107\_00041.jpg

LM Start	4.01	Rating **	U	Issue No.	120
LM End	4.01	Issue Type +	En	Location *	LS
Category	Earthen Levee			GPS Latitude/Longitude	
				Start	End
Item	Encroachments			38.310912 °	38.310912 °
				-121.736172 °	-121.736172 °
DWR ID	DWR_RD2104_01_f_2014_120				
Comment Code					
PI : Pipe					
Inspector Comment					
This pipe was written up during the inspection 2014. Unauthorized repairs, unacceptable plastic pipe and repairs done without CVFPB Permit.

View of unauthorized pipe through levee crown roadway leading to the pump in raised wooden structure in irrigation ditch landward.

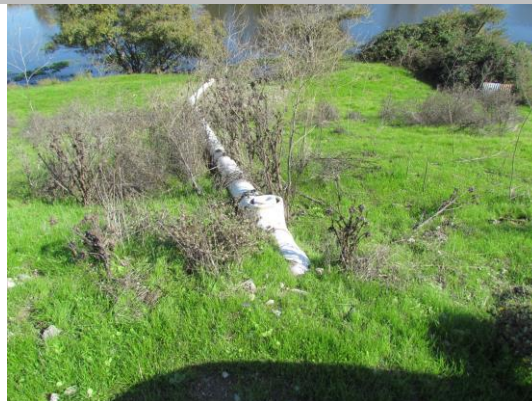
Photo 2 of 2 : FA\_2016\_RD2104\_249\_120\_20161107\_00039.jpg

View of unauthorized pipe work, waterside slope. The siphon breaker broken off coupling.

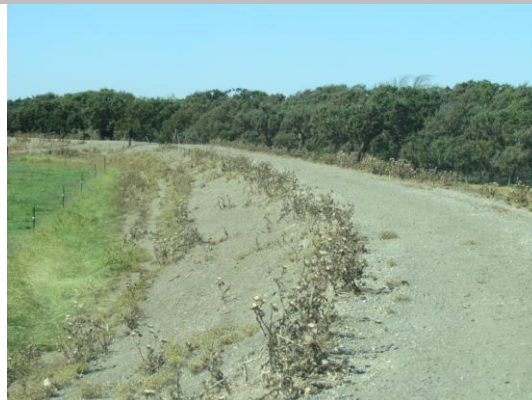
Photo 1 of 2 : FA\_2016\_RD2104\_249\_122\_20160919\_00010.jpg

LM Start	4.24	Rating **	U	Issue No.	122
LM End	5.57	Issue Type +	Ma	Location *	LS
Category	Earthen Levee			GPS Latitude/Longitude	
				Start	End
Item	Vegetation			38.313130 °	38.324828 °
				-121.739050 °	-121.755401 °
DWR ID	DWR_RD2104_01_f_2014_122				
Comment Code					
V2 : Remove the wild growth other than native grasses from the levee slopes.					
Inspector Comment					
Remove the wild growth from the levee slope.

Unsatisfactory wild growth on the landside levee shoulder and slope.

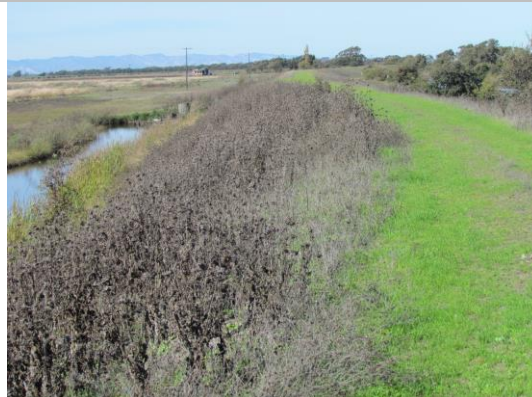
Photo 2 of 2 : FA\_2016\_RD2104\_249\_122\_20161107\_00043.jpg

LM Start	4.24	Rating **	U	Issue No.	122 (cont)	
LM End	5.57	Issue Type +	Ma	Location *	LS	
Category	Earthen Levee			GPS Latitude/Longitude		
				Start		End
Item	Vegetation			38.313130 °		38.324828 °
				-121.739050 °		-121.755401 °
DWR ID	DWR_RD2104_01_f_2014_122					
Comment Code						
V2 : Remove the wild growth other than native grasses from the levee slopes.						
Inspector Comment						
Remove the wild growth from the levee slope.

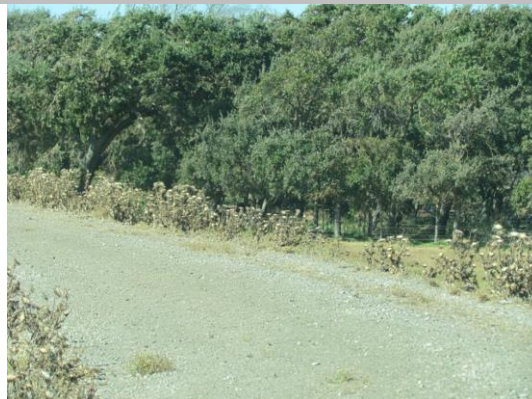
Photo 1 of 1 : FA\_2016\_RD2104\_249\_123\_20160919\_00011.jpg

LM Start	4.24	Rating **	U	Issue No.	123
LM End	4.71	Issue Type +	Ma	Location *	WS
Category	Earthen Levee			GPS Latitude/Longitude	
				Start	End
Item	Vegetation			38.313135 °	38.318388 °
				-121.739073 °	-121.744370 °
DWR ID	DWR_RD2104_01_f_2014_123				
Comment Code					
V2 : Remove the wild growth other than native grasses from the levee slopes.					
Inspector Comment					
Remove the wild woody tree growth and wild vegetation.

Wild woody tree growth on the waterside slope and shoulder.

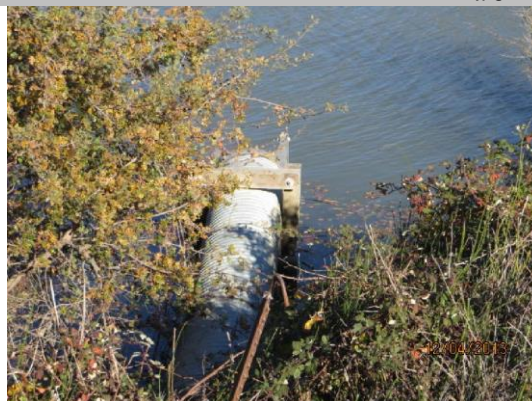
Photo 1 of 2 : UCIP\_FA\_2016\_24996\_45062.jpg

LM Start	4.31	Rating **	U	Issue No.	125
LM End	4.31	Issue Type +	En	Location *	WS
Category	Supplemental			GPS Latitude/Longitude	
				Start	End
Item	DWR UCIP Field Study			38.313955 °	38.313955 °
				-121.739930 °	-121.739930 °
DWR ID					
Comment Code					
Inspector Comment					
FS_ID:24996 DS_ID:24705 EP_NO: 10182 Repair Type: Urgent Crossing Status: Found UCIP Comments: Vegetation and soil buildup throughout pipe preventing flapgate from closing. Remove vegetation to allow gate to close properly. FIELD_STRUCT_DESC: 24-inch CMP drainpipe through the levee 15.0-feet below the crown. 36-inch concrete standpipe on LS toe. Flapgate on WS toe. Two C.M. cut of walls. (ABO No. 10182 - Machado) Originally included in O+M manual, 1964. Asbuilt Dwg. 50-04-3379. FS Date: 12/4/2013

CMP pipe and flapgate off WS toe.

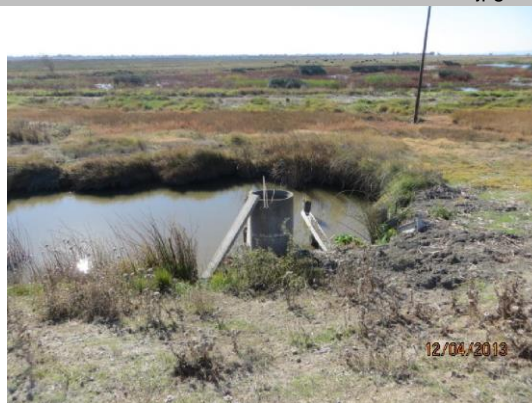
Photo 2 of 2 : UCIP\_FA\_2016\_24996\_45061.jpg

36-inch concrete riser on LS toe at channel.

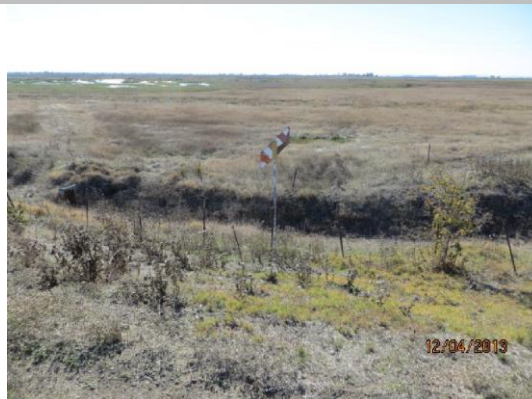
Photo 1 of 2 : UCIP\_FA\_2016\_25003\_45081.jpg

LM Start	4.65	Rating **	M	Issue No.	126
LM End	4.65	Issue Type +	En	Location *	WS
Category	Supplemental			GPS Latitude/Longitude	
				Start	End
Item	DWR UCIP Field Study			38.317941 °	38.317941 °
				-121.743503 °	-121.743503 °
DWR ID					
Comment Code					
Inspector Comment					
FS_ID:25003 DS_ID:24704 EP_NO: 10182 Repair Type: Non-Urgent Crossing Status: Found UCIP Comments: Sign on WS toe needs repair. FIELD_STRUCT_DESC: 8-inch gas line through levee at high elevation. Sign on WS and LS toe. (ABO No. 10182 - Machado) Asbuilt Dwg. 50-04-3379. FS Date: 12/4/2013

Gasline marker on LS toe.

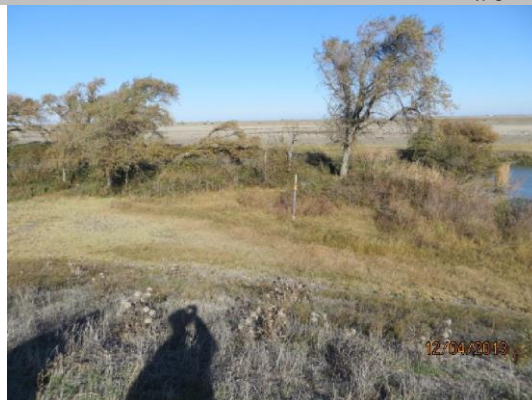
Photo 2 of 2 : UCIP\_FA\_2016\_25003\_45080.jpg

Sign pole on WS toe missing sign.

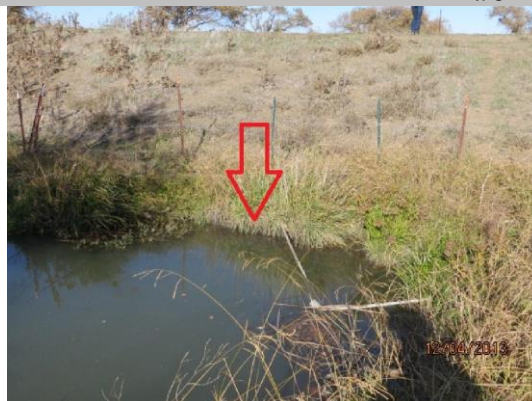
Photo 1 of 2 : UCIP\_FA\_2016\_25005\_45083.jpg

LM Start	4.67	Rating **	M	Issue No.	127
LM End	4.67	Issue Type +	En	Location *	WS
Category	Supplemental			GPS Latitude/Longitude	
				Start	End
Item	DWR UCIP Field Study			38.318119 °	38.318119 °
				-121.743730 °	-121.743730 °
DWR ID					
Comment Code					
Inspector Comment					
FS_ID:25005					
DS_ID:24703					
EP_NO: N/A					
Repair Type: Non-Urgent					
Crossing Status: Found					
UCIP Comments: Good candidate for video inspection.					
FIELD_STRUCT_DESC: 18-inch steel irrigation pipe through the levee					
13.5-feet below the crown. Pump on pile structure in stream. Slide gate					
in 36-inch CMP riser on waterward slope. Two cutoff walls. Concrete					
"U" headwall and air vent at toe of landward slope. Asbuilt Dwg. 50-04-					
3379. Electrical conduit through levee at same location.					
FS Date: 12/4/2013

Concrete headwall on LS toe at irrigation ditch.

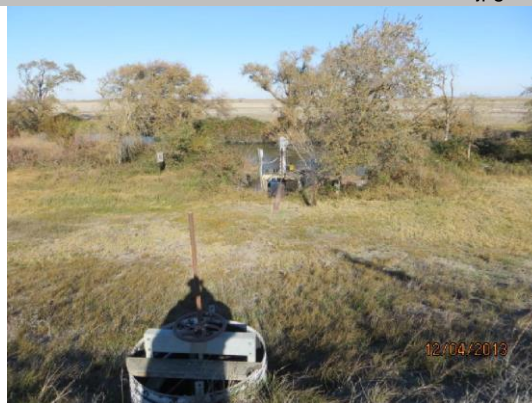
Photo 2 of 2 : UCIP\_FA\_2016\_25005\_45082.jpg

Slide gate in CMP riser on WS slope with pump on pier in background.

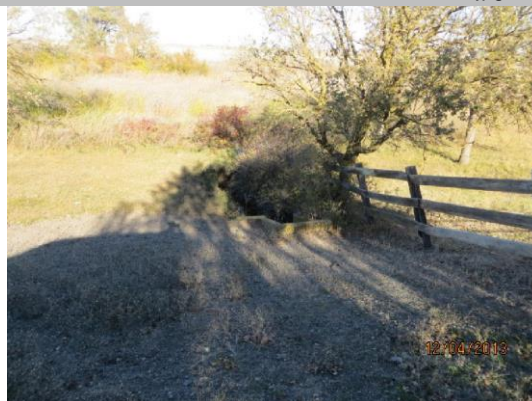
Photo 1 of 2 : UCIP\_FA\_2016\_25006\_45086.jpg

LM Start	4.72	Rating **	M	Issue No.	128
LM End	4.72	Issue Type +	En	Location *	WS
Category	Supplemental			GPS Latitude/Longitude	
				Start	End
Item	DWR UCIP Field Study			38.318432 °	38.318432 °
				-121.744540 °	-121.744540 °
DWR ID					
Comment Code					
Inspector Comment					
FS_ID:25006 DS_ID:24702 EP_NO: 10182 Repair Type: Non-Urgent Crossing Status: Found UCIP Comments: Minor erosion of base under headwall on WS toe. Heavy corrosion of pipe at WS toe. Further evaluation of pipe integrity needed. FIELD_STRUCT_DESC: 24-inch CMP drain pipe through the levee 13.5-feet below the crown. Concrete "U" headwalls on both ends. Two C.M. cutoff walls. Flap gate on waterward end. (ABO No. 10182 - Machado) FS Date: 12/4/2013

Concrete U shaped headwall on WS toe.

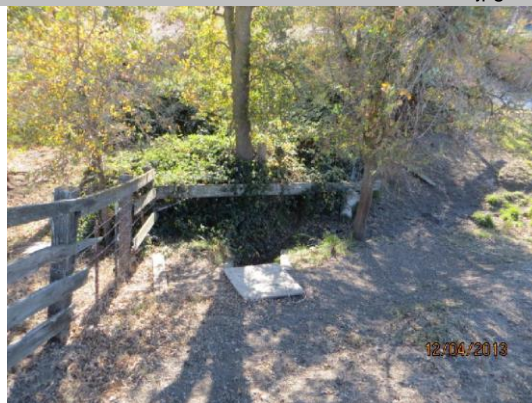
Photo 2 of 2 : UCIP\_FA\_2016\_25006\_45085.jpg

Concrete U shaped headwall on LS toe.

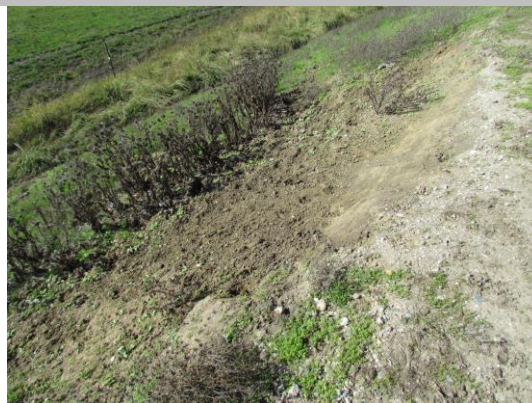
Photo 1 of 1 : FA\_2016\_RD2104\_249\_75\_20161107\_00044.jpg

LM Start	4.96	Rating **	U	Issue No.	75
LM End	4.96	Issue Type +	Ma	Location *	LS
Category	Earthen Levee			GPS Latitude/Longitude	
				Start	End
Item	Erosion / Bank Caving			38.320408 °	38.320408 °
				-121.748173 °	-121.748173 °
DWR ID	DWR_RD2104_01_f_2015_75				
Comment Code					
E2 : Schedule repair of erosion site prior to the next inspection.					
Inspector Comment					
Repair the erosion on the landside slope caused by livestock.

RD 2104 site on the landside slope into the shoulder.

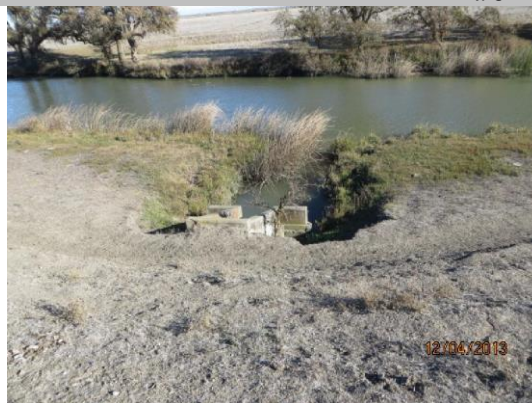
Photo 1 of 2 : UCIP\_FA\_2016\_25007\_45090.jpg

LM Start	5.09	Rating **	U	Issue No.	129
LM End	5.09	Issue Type +	En	Location *	LS
Category	Supplemental			GPS Latitude/Longitude	
				Start	End
Item	DWR UCIP Field Study			38.322215 °	38.322215 °
				-121.748418 °	-121.748418 °
DWR ID					
Comment Code					
Inspector Comment					
FS_ID:25007 DS_ID:24701 EP_NO: 10182 Repair Type: Urgent Crossing Status: Found UCIP Comments: Footing under headwall on WS toe severely undermined. Pipe rusted heavily with holes at WS and may need replacement. FIELD_STRUCT_DESC: 24-inch CMP drain pipe through levee 13.0 feet below crown. Two cutoff walls. Concrete "U" headwalls on both ends. Flap gate on water end. (ABO No. 10182 - Machado). Asbuilt Dwg. 50-04-3379. FS Date: 12/4/2013

Concrete U-shaped headwall on WS toe. Note erosion scarp around headwall.
