**Flood Control Project Maintenance
Levee Inspections**

Fall 2017 Levee Maintenance Deficiency Summary Report

Levee Inspection Report By Mile - Fall 2017

Reclamation District No. 2104 Peters Pocket Tract

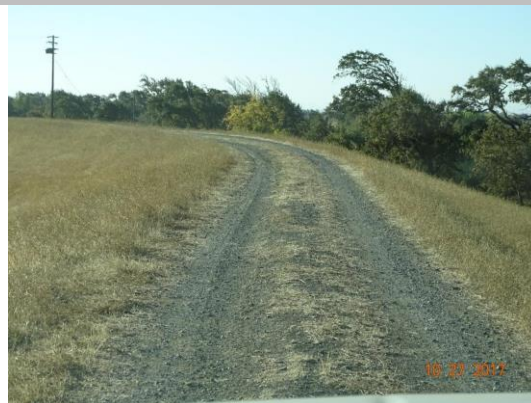
Photo 1 of 1 : FA_2017_RD2104_249_18_20171117_00038.jpg

LM Start	0.02	Rating **	A/W	Issue No.	18
LM End	1.45	Issue Type +	Ma	Location *	CR
Category	Earthen Levee			GPS Latitude/Longitude	
				Start	End
Item	Vegetation			38.308053 °	38.295298 °
				-121.758557 °	-121.741413 °
DWR ID	DWR_RD2104_01_f_2016_18				
Comment Code					
V9 : Keep the crown roadway free of vegetation.					
Inspector Comment

Crown currently has minimal vegetation.

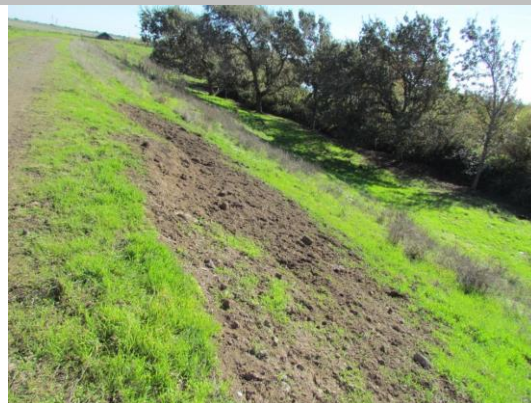
Photo 1 of 1 : FA_2017_RD2104_249_22_20171002_00001.jpg

LM Start	1.20	Rating **	U	Issue No.	22
LM End	1.20	Issue Type +	Ma	Location *	WS
Category	Earthen Levee			GPS Latitude/Longitude	
				Start	End
Item	Erosion / Bank Caving			38.296615 °	38.296615 °
				-121.745372 °	-121.745372 °
DWR ID	DWR_RD2104_01_f_2016_22				
Comment Code					
E2 : Schedule repair of erosion site prior to the next inspection.					
Inspector Comment					
Make the repairs to the erosion site listed on the waterside slope.

RD 2104 Levee mile 1.20 waterside slope.

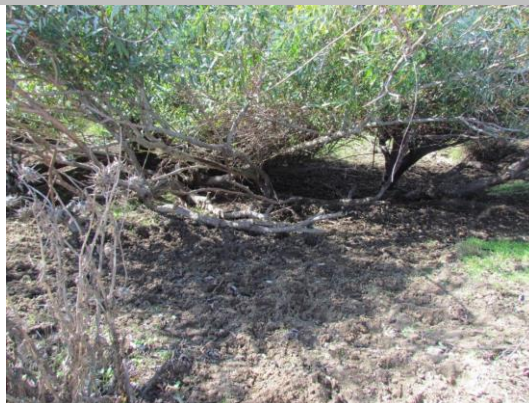
Photo 1 of 1 : FA_2017_RD2104_249_23_20171002_00002.jpg

LM Start	1.27	Rating **	M	Issue No.	23
LM End	1.27	Issue Type +	Ma	Location *	WS
Category	Earthen Levee			GPS Latitude/Longitude	
				Start	End
Item	Slope Stability			38.296182 °	38.296182 °
				-121.744318 °	-121.744318 °
DWR ID	DWR_RD2104_01_f_2016_23				
Comment Code					
S1 : Repair slope instability.					
Inspector Comment					
Repair the slope damaged by cows and trim up the tree limbs partially blocking the erosion site.

RD 2104 Levee mile 1.27 wateside.

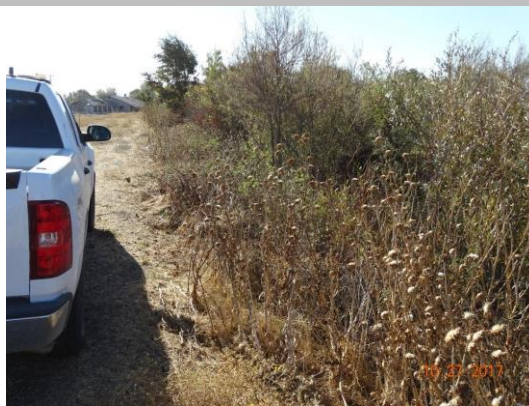
Photo 1 of 1 : FA_2017_RD2104_249_11_20171117_00039.jpg

LM Start	1.44	Rating **	M	Issue No.	11
LM End	1.48	Issue Type +	Ma	Location *	WS
Category	Earthen Levee			GPS Latitude/Longitude	
				Start	End
Item	Vegetation			38.295487 °	38.294947 °
				-121.741530 °	-121.741215 °
DWR ID	DWR_RD2104_01_f_2017_11				
Comment Code					
V2 : Remove the wild growth other than native grasses from the levee slopes.					
Inspector Comment

Remove wild growth to 20 feet from crown.

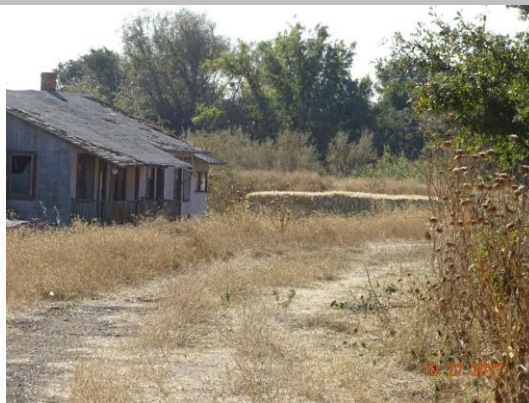
Photo 1 of 1 : FA_2017_RD2104_249_13_20171117_00040.jpg

LM Start	1.45	Rating **	M	Issue No.	13
LM End	1.57	Issue Type +	Ma	Location *	CR
Category	Earthen Levee			GPS Latitude/Longitude	
				Start	End
Item	Vegetation			38.295298 °	38.294108 °
				-121.741413 °	-121.740393 °
DWR ID	DWR_RD2104_01_f_2017_13				
Comment Code					
V9 : Keep the crown roadway free of vegetation.					
Inspector Comment

Crown vegetation should be reduced to facilitate inspection and access.

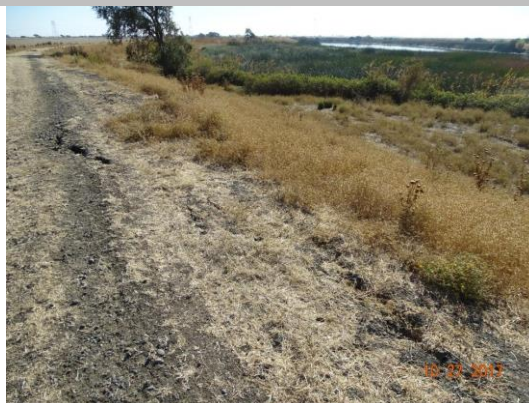
Photo 1 of 1 : FA_2017_RD2104_249_15_20171117_00041.jpg

LM Start	1.72	Rating **	M	Issue No.	15
LM End	1.72	Issue Type +	Ma	Location *	WS
Category	Earthen Levee			GPS Latitude/Longitude	
				Start	End
Item	Cracking			38.293465 °	38.293465 °
				-121.737778 °	-121.737778 °
DWR ID	DWR_RD2104_01_f_2017_15				
Comment Code					
CR1 : Monitor and have inspected by geotechnical engineer.					
Inspector Comment

Curved cracks in crown indicate possible slope instability on waterside slope. Cracks are 8 feet long x up to 6 inches wide x 3 feet deep. No other indications of slope instability observed. Levee toe is approx 40 feet from channel/slough edge.

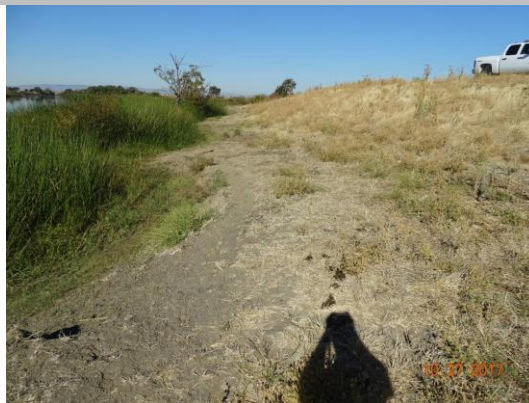
Photo 1 of 1 : FA_2017_RD2104_249_16_20171117_00042.jpg

LM Start	1.93	Rating **	M	Issue No.	16
LM End	1.94	Issue Type +	Ma	Location *	WS
Category	Earthen Levee			GPS Latitude/Longitude	
				Start	End
Item	Erosion / Bank Caving			38.292027 °	38.291947 °
				-121.734575 °	-121.734453 °
DWR ID	DWR_RD2104_01_s_2012_16				
Comment Code					
E1 : Note and monitor erosion site.					
Inspector Comment

Scalloped bank erosion along slough is approaching levee toe.

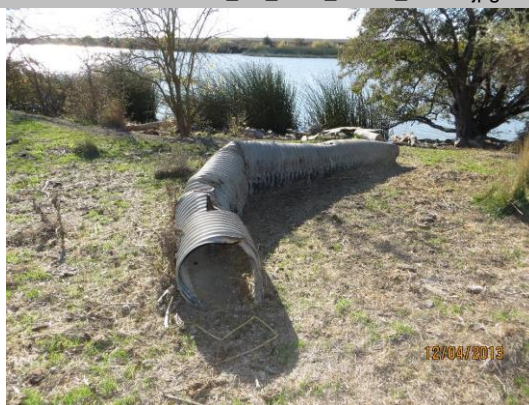
Photo 1 of 1 : UCIP_FA_2017_41347_45043.jpg

LM Start	2.40	Rating **	M	Issue No.	120
LM End	2.40	Issue Type +	En	Location *	
Category	Supplemental			GPS Latitude/Longitude	
				Start	End
Item	DWR UCIP Field Study			38.291579 °	38.291579 °
				-121.726159 °	-121.726159 °
DWR ID					
Comment Code					
Inspector Comment					
FS_ID:41347					
DS_ID:24726					
EP_NO: N/A					
Repair Type: Non-Urgent					
Crossing Status: Indicator Found					
UCIP Comments: 24-inch CMP debris on WS berm may indicate pipe was abandoned.					
FIELD_STRUCT_DESC: *ABANDONED* 24-inch corrugated metal drainage pipe through the levee, 18 feet below the crown. Flap gate on the waterside (WS) toe. [Additional Reference(s): USACE Sacramento O&M Manual 108, April 1964, (HLM 2.60)].					
FS Date: 12/4/2013

Pipe debris on WS berm.

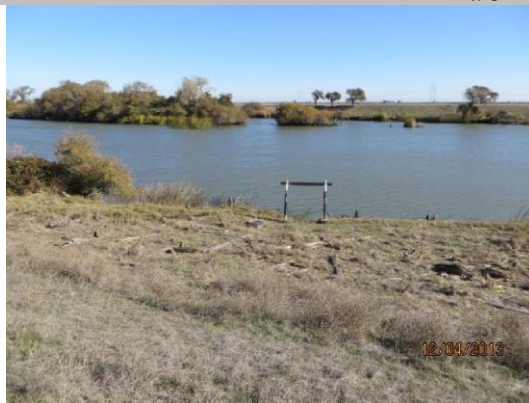
Photo 1 of 3 : UCIP_FA_2017_41834_45069.jpg

LM Start	3.04	Rating **	M	Issue No.	121
LM End	3.04	Issue Type +	En	Location *	
Category	Supplemental			GPS Latitude/Longitude	
				Start	End
Item	DWR UCIP Field Study			38.299447 °	38.299447 °
				-121.730444 °	-121.730444 °
DWR ID					
Comment Code					
Inspector Comment					
FS_ID:41834 DS_ID:24720 EP_NO: 14184 Repair Type: Non-Urgent Crossing Status: Found UCIP Comments: Signs in disrepair and need proper markings. FIELD_STRUCT_DESC: 6-inch steel gas line through the levee, 3 feet below the crown. Signs on both toes of the levee. FS Date: 12/4/2013

Sign on WS berm.

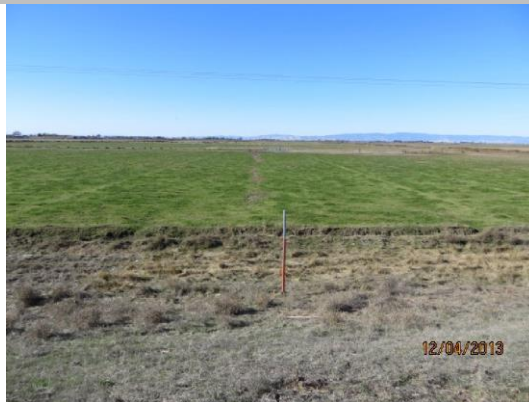
Photo 2 of 3 : UCIP_FA_2017_41834_45068.jpg

Sign post on LS toe.

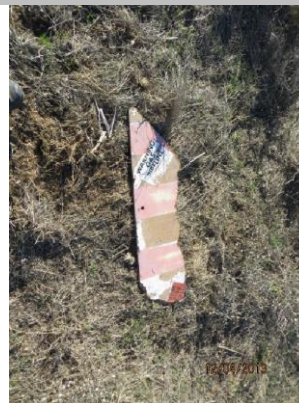
Photo 3 of 3 : UCIP_FA_2017_41834_45070.jpg

LM Start	3.04	Rating **	M	Issue No.	121 (cont)	
LM End	3.04	Issue Type +	En	Location *		
Category	Supplemental			GPS Latitude/Longitude		
				Start	End	
Item	DWR UCIP Field Study			38.299447 °	38.299447 °	
				-121.730444 °	-121.730444 °	
DWR ID						
Comment Code						
Inspector Comment						
FS_ID:41834 DS_ID:24720 EP_NO: 14184 Repair Type: Non-Urgent Crossing Status: Found UCIP Comments: Signs in disrepair and need proper markings. FIELD_STRUCT_DESC: 6-inch steel gas line through the levee, 3 feet below the crown. Signs on both toes of the levee. FS Date: 12/4/2013

Broken sign marker on LS toe.

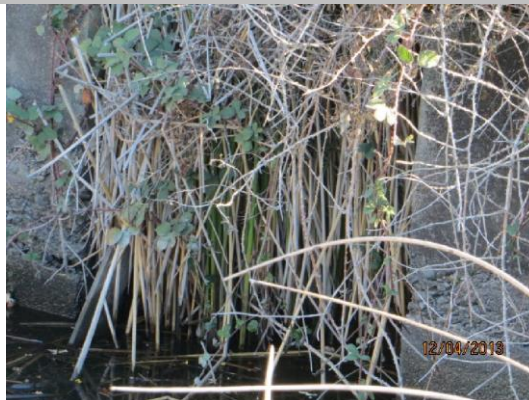
LM Start	3.12	Rating **	M	Issue No.	122
LM End	3.12	Issue Type +	En	Location *	
Category	Supplemental			GPS Latitude/Longitude	
				Start	End
Item	DWR UCIP Field Study			38.300605 °	38.300605 °
				-121.730440 °	-121.730440 °
DWR ID					
Comment Code					
Inspector Comment					
FS_ID:24992 DS_ID:24707 EP_NO: 4412 Repair Type: Non-Urgent Crossing Status: Indicator Found UCIP Comments: Heavy vegetation at concrete headwall on LS toe and at possible outlet area on WS toe. If possible, vegetation should be cleared to check if this is an accurate location. Erosion around backside of headwall at LS toe. FIELD_STRUCT_DESC: 48-inch by 48-inch reinforced concrete box drainage culvert through the levee, 17 feet below the crown. Concrete headwall on the landside (LS) toe. [Additional Reference(s): DWR Levee Log, 2006. USACE Sacramento O&M Manual 108, April 1964, (HLM 3.37)]. FS Date: 12/4/2013

Vegetation covering possible location for 4X4 concrete culvert at LS toe.

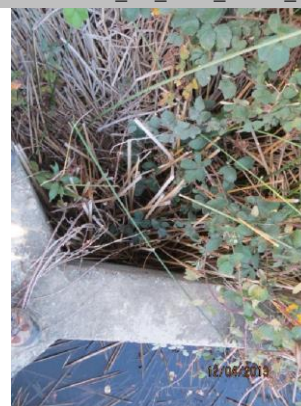
Photo 3 of 3 : UCIP_FA_2017_24992_45049.jpg

Comment Code						
Inspector Comment						
FS_ID:24992						
DS_ID:24707						
EP_NO: 4412						
Repair Type: Non-Urgent						
Crossing Status: Indicator Found						
UCIP Comments: Heavy vegetation at concrete headwall on LS toe and at possible outlet area on WS toe. If possible, vegetation should be cleared to check if this is an accurate location. Erosion around backside of headwall at LS toe.						
FIELD_STRUCT_DESC: 48-inch by 48-inch reinforced concrete box drainage culvert through the levee, 17 feet below the crown. Concrete headwall on the landside (LS) toe. [Additional Reference(s): DWR Levee Log, 2006. USACE Sacramento O&M Manual 108, April 1964, (HLM 3.37)].						
FS Date: 12/4/2013

Some erosion on levee side of headwall at LS toe.

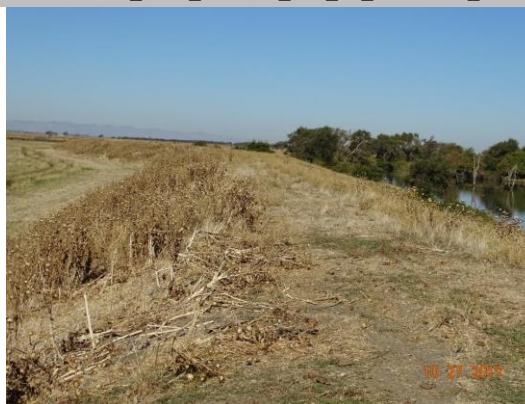
Photo 1 of 1 : FA_2017_RD2104_249_17_20171117_00043.jpg

LM Start	3.64	Rating **	M	Issue No.	17
LM End	4.00	Issue Type +	Ma	Location *	CR
Category	Earthen Levee			GPS Latitude/Longitude	
				Start	End
Item	Vegetation			38.306633 °	38.310697 °
				-121.732975 °	-121.736157 °
DWR ID	DWR_RD2104_01_f_2017_17				
Comment Code					
V9 : Keep the crown roadway free of vegetation.					
Inspector Comment

Crown vegetation should be reduced to facilitate inspection and access.

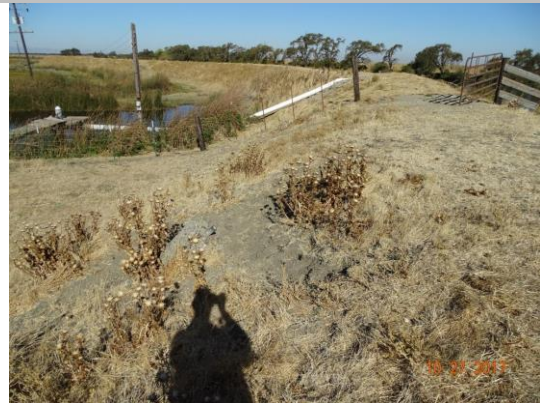
Photo 1 of 1 : FA_2017_RD2104_249_21_20171117_00044.jpg

LM Start	4.00	Rating **	M	Issue No.	21
LM End	4.00	Issue Type +	Ma	Location *	LS
Category	Earthen Levee			GPS Latitude/Longitude	
				Start	End
Item	Slope Stability			38.310672 °	38.310672 °
				-121.736155 °	-121.736155 °
DWR ID	DWR_RD2104_01_f_2017_21				
Comment Code					
S2 : Repair the levee slope damaged by foot traffic and prevent access where possible.					
Inspector Comment

Repair landside slope eroded by livestock, and prevent future erosion.

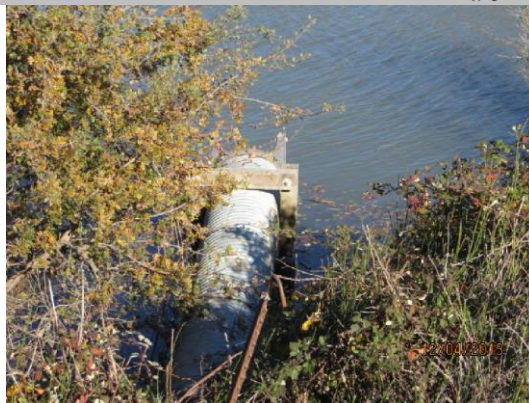
Photo 1 of 3 : UCIP_FA_2017_51459_45062.jpg

Comment Code					
Inspector Comment					
FS_ID:51459 DS_ID:24705 EP_NO: 10182 Repair Type: Non-Urgent Crossing Status: Found UCIP Comments: 12/06/2016 Crossing has been downgraded from "Urgent" to "Non-Urgent" no signs of leaks observed along pipe alignment (limited inspection on WS toe). According to LMA representative, this crossing was replaced 6 years ago (2010) at WS concrete apron. Recommend conducting internal inspection of pipe through the levee and LS to determine pipe integrity. (O. Magana - DWR UCIP)12/04/2013 Vegetation and soil buildup throughout pipe preventing flapgate from closing. Remove vegetation to allow gate to close properly. (W. Wylie - DWR UCIP) FIELD_STRUCT_DESC: 24-inch corrugated metal drainage pipe through the levee, 15 feet below the crown. 36-inch concrete standpipe on the landside (LS) toe. Flap gate on the waterside (WS) toe. Two corrugated metal cutoff walls installed. (24-inch pipe [HLM 4.65] authorized under Automatic Board Order (ABO) issued as Permit No. 10182, 1974 - Julia Trust Machado). [Additional Reference(s): DWR Levee Log, 2006. USACE Sacramento O&M Manual 108, April 1964, (HLM 4.65), Drawing No. 50-04-3379]. FS Date: 12/6/2016

CMP pipe and flapgate off WS toe.

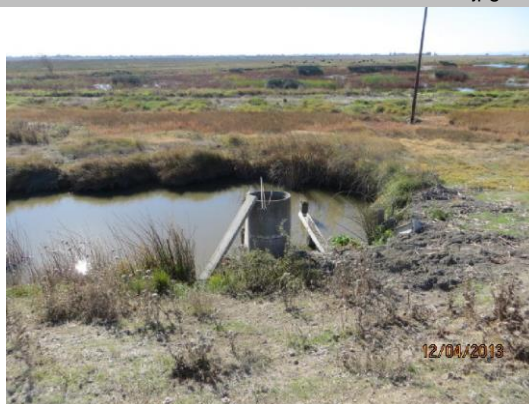
Photo 2 of 3 : UCIP_FA_2017_51459_45061.jpg

36-inch concrete riser on LS toe at channel.

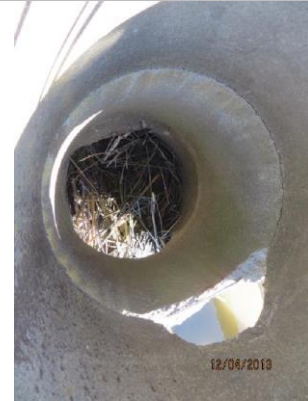
Photo 3 of 3 : UCIP_FA_2017_51459_45060.jpg

36-inch concrete riser with vegetation buildup inside.

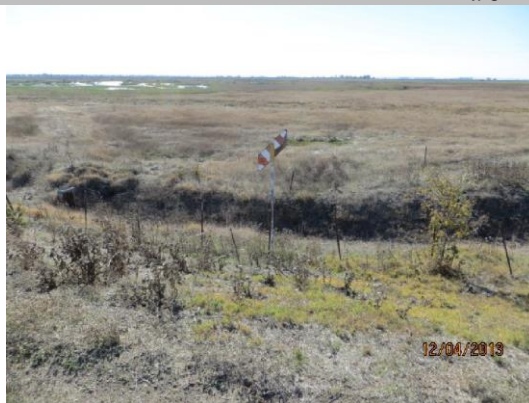
Photo 1 of 2 : UCIP_FA_2017_25003_45081.jpg

LM Start	4.65	Rating **	M	Issue No.	124
LM End	4.65	Issue Type +	En	Location *	
Category	Supplemental			GPS Latitude/Longitude	
				Start	End
Item	DWR UCIP Field Study			38.317941 °	38.317941 °
				-121.743503 °	-121.743503 °
DWR ID					
Comment Code					
Inspector Comment					
FS_ID:25003					
DS_ID:24704					
EP_NO: 10182					
Repair Type: Non-Urgent					
Crossing Status: Found					
UCIP Comments: Sign on WS toe needs repara.					
FIELD_STRUCT_DESC: 8-inch steel gas line through the levee, at the high elevation. Signs on both toes of the levee. (Automatic Board Order (ABO) issued as Permit No. 10182, 1974 - Julia Trust Machado).					
[Additional Reference(s): DWR Levee Log, 2006. USACE Sacramento O&M Manual 108, April 1964, Drawing No. 50-04-3379].					
FS Date: 12/4/2013

Gasline marker on LS toe.

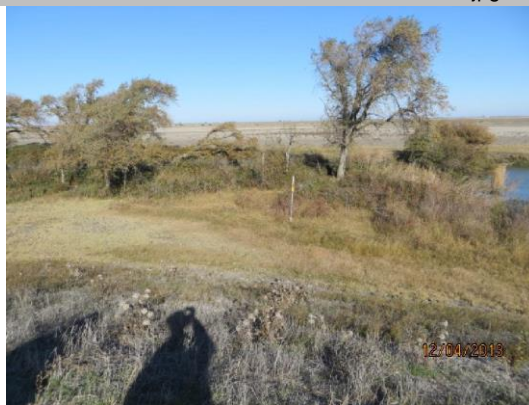
Photo 2 of 2 : UCIP_FA_2017_25003_45080.jpg

Sign pole on WS toe missing sign.

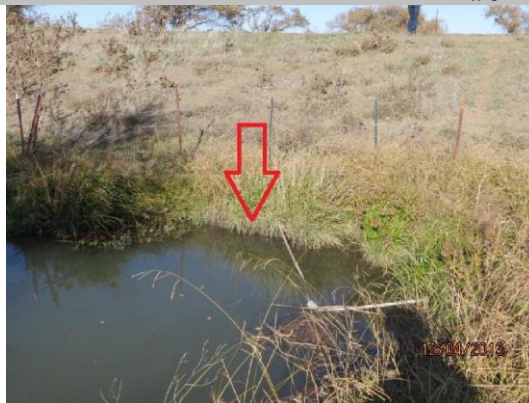
Photo 1 of 2 : UCIP_FA_2017_25005_45083.jpg

Comment Code						
Inspector Comment						
FS_ID:25005 DS_ID:24703 EP_NO: N/A Repair Type: Non-Urgent Crossing Status: Found UCIP Comments: Good candidate for video inspection. FIELD_STRUCT_DESC: 18-inch steel irrigation pipe through the levee, 13.5 feet below the crown. Pump on pile structure in the stream. Slide gate in a 36-inch corrugated metal pipe (CMP) riser on the waterside (WS) slope. Two cutoff walls. Concrete U-shaped headwall and air vent at the landside (LS) toe. Electrical conduit through the levee at the same location. [Additional Reference(s): DWR Levee Log, 2006. USACE Sacramento O&M Manual 108, April 1964, (HLM 5.06), Drawing No. 50-04-3379]. FS Date: 12/4/2013

Concrete headwall on LS toe at irrigation ditch.

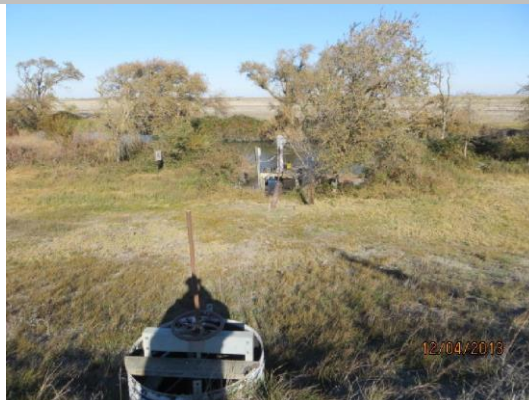
Photo 2 of 2 : UCIP_FA_2017_25005_45082.jpg

Slide gate in CMP riser on WS slope with pump on pier in background.

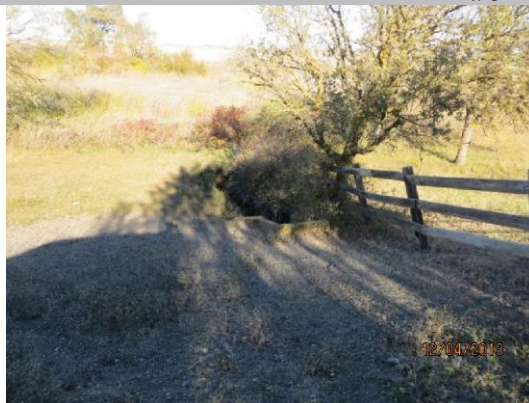
Photo 1 of 3 : UCIP_FA_2017_25006_45086.jpg

LM Start	4.72	Rating **	M	Issue No.	126	
LM End	4.72	Issue Type +	En	Location *		
Category	Supplemental			GPS Latitude/Longitude		
				Start		End
Item	DWR UCIP Field Study			38.318432 °	38.318432 °	
				-121.744540 °	-121.744540 °	
DWR ID						
Comment Code						
Inspector Comment						
FS_ID:25006 DS_ID:24702 EP_NO: 10182 Repair Type: Non-Urgent Crossing Status: Found UCIP Comments: Minor erosion of base under headwall on WS toe. Heavy corrosion of pipe at WS toe. Further evaluation of pipe integrity needed. FIELD_STRUCT_DESC: 24-inch corrugated metal drainage pipe through the levee, 13.5 feet below the crown. Concrete U-shaped headwalls on both ends. Two corrugated metal cutoff walls. Flap gate on the waterside (WS) end. (Automatic Board Order (ABO) issued as Permit No. 10182, 1974 - Julia Trust Machado). [Additional Reference(s): DWR Levee Log, 2006]. FS Date: 12/4/2013

Concrete U shaped headwall on WS toe.

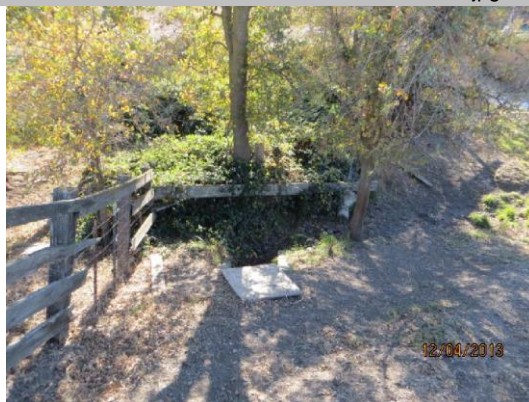
Photo 2 of 3 : UCIP_FA_2017_25006_45085.jpg

Concrete U shaped headwall on LS toe.

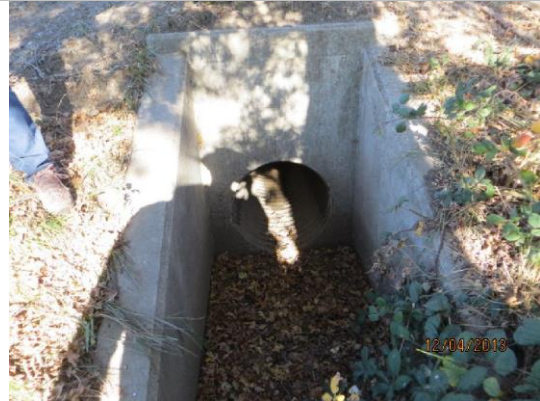
Photo 3 of 3 : UCIP_FA_2017_25006_45084.jpg

Comment Code						
Inspector Comment						
FS_ID:25006						
DS_ID:24702						
EP_NO: 10182						
Repair Type: Non-Urgent						
Crossing Status: Found						
UCIP Comments: Minor erosion of base under headwall on WS toe.						
Heavy corrosion of pipe at WS toe. Further evaluation of pipe integrity needed.						
FIELD_STRUCT_DESC: 24-inch corrugated metal drainage pipe through the levee, 13.5 feet below the crown. Concrete U-shaped headwalls on both ends. Two corrugated metal cutoff walls. Flap gate on the waterside (WS) end. (Automatic Board Order (ABO) issued as Permit No. 10182, 1974 - Julia Trust Machado). [Additional						
Reference(s): DWR Levee Log, 2006].						
FS Date: 12/4/2013

Concrete U shaped headwall on LS toe.

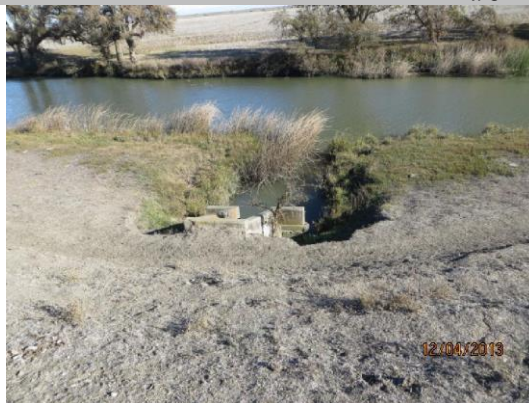
Photo 1 of 3 : UCIP_FA_2017_51460_45090.jpg

Comment Code					
Inspector Comment					
FS_ID:51460 DS_ID:24701 EP_NO: 10182 Repair Type: Urgent Crossing Status: Found UCIP Comments: 12/06/2016 same as last inspection--pipe remains "Urgent" CMP shows holes through wall and concrete headwall is undermined. Need to contact owner. Owner will need to work with the CVFPB to comply with Title 23. (O. Magana - DWR UCIP)12/04/2013 Footing under headwall on WS toe severely undermined. Pipe rusted heavily with holes at WS and may need replacement. (W. Wylie - DWR UCIP) FIELD_STRUCT_DESC: 24-inch corrugated metal drainage pipe through the levee, 13 feet below the crown. Two cutoff walls. Concrete U-shaped headwalls on both ends. Flap gate on the waterside (WS). (24-inch pipe [HLM 5.50] authorized under Automatic Board Order (ABO) issued as Permit No. 10182, 1974 - Julia Trust Machado). [Additional Reference(s): DWR Levee Log, 2006. USACE Sacramento O&M Manual 108, April 1964, (HLM 5.5), listed as a 12-inch pipe, Drawing No. 50-04-3379, listed as an 18-inch pipe]. FS Date: 12/6/2016

Concrete U-shaped headwall on WS toe. Note erosion scarp around headwall.

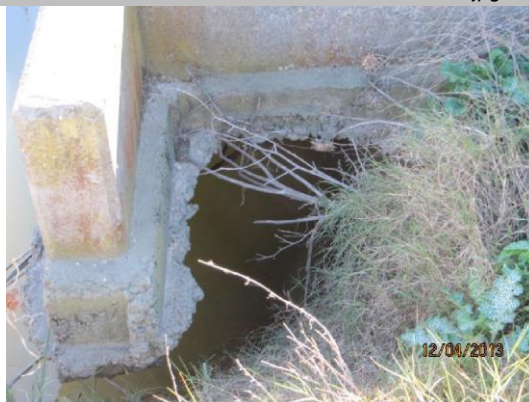
Photo 2 of 3 : UCIP_FA_2017_51460_45089.jpg

Headwall undermined on WS toe.

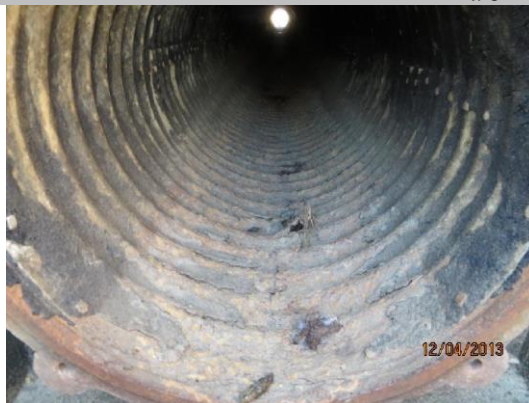
Photo 3 of 3 : UCIP_FA_2017_51460_45088.jpg

Comment Code						
Inspector Comment						
FS_ID:51460 DS_ID:24701 EP_NO: 10182 Repair Type: Urgent Crossing Status: Found UCIP Comments: 12/06/2016 same as last inspection--pipe remains "Urgent" CMP shows holes through wall and concrete headwall is undermined. Need to contact owner. Owner will need to work with the CVFPB to comply with Title 23. (O. Magana - DWR UCIP)12/04/2013 Footing under headwall on WS toe severely undermined. Pipe rusted heavily with holes at WS and may need replacement. (W. Wylie - DWR UCIP) FIELD_STRUCT_DESC: 24-inch corrugated metal drainage pipe through the levee, 13 feet below the crown. Two cutoff walls. Concrete U-shaped headwalls on both ends. Flap gate on the waterside (WS). (24-inch pipe [HLM 5.50] authorized under Automatic Board Order (ABO) issued as Permit No. 10182, 1974 - Julia Trust Machado). [Additional Reference(s): DWR Levee Log, 2006. USACE Sacramento O&M Manual 108, April 1964, (HLM 5.5), listed as a 12-inch pipe, Drawing No. 50-04-3379, listed as an 18-inch pipe]. FS Date: 12/6/2016

Corosion through pipe with holes on WS toe.

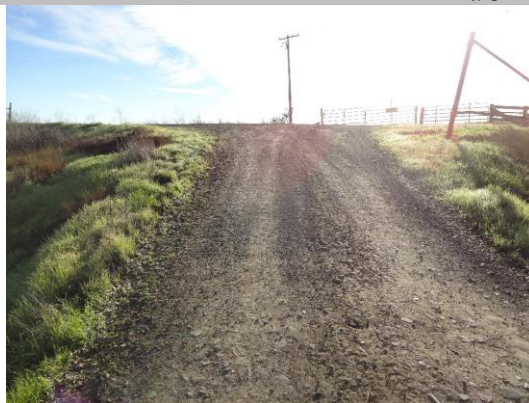
Photo 1 of 3 : UCIP_FA_2017_51461_76913.jpg

FS_ID:51461
DS_ID:24699
EP_NO: 10184
Repair Type: Urgent
Crossing Status: Indicator Found
UCIP Comments: 12/06/2016 No indicators were found. According to LMA representative, the gas line has been abandoned and markers have been removed about 10-15 years ago. Solano County was performing work on the LS toe approximately 700 feet from LS toe and according to their underground service alert (USA) survey completed for their construction site no PGE line was identified. Need to contact owner to determine abandoned as-builts for 8-inch line. (O. Magana - DWR UCIP)12/04/2013 Pump station visible to north on LS toe. Good indicator of location. Need PG+E to mark pipe location. (W. Wylie - DWR UCIP)
FIELD_STRUCT_DESC: 8-inch iron gas line through the levee, 2 feet below the crown. (8-inch gas line authorized under Automatic Board Order (ABO) issued as Permit No. 10184, 1974 - Pacific Gas and Electric Company [PG&E]. 8-inch gas line first referenced in the USACE O&M as-built drawings from 1956). [Additional Reference(s): DWR Levee Log, 2006. USACE Sacramento O&M Manual 108, April 1964, Drawing No. 50-04-3379A, Sheet 3379/2, Page 2 of 7, (Station 82+30)].

No signs present at ramp to enter RD2104.

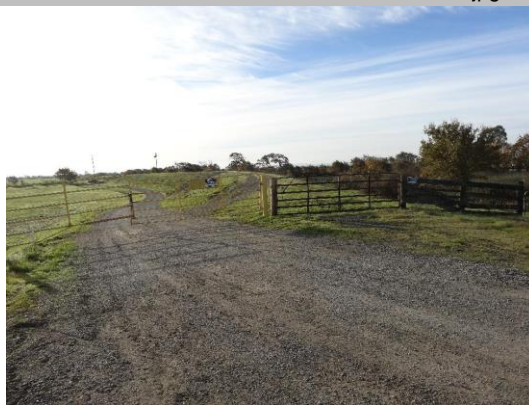
Photo 2 of 3 : UCIP_FA_2017_51461_76914.jpg

No signs present of gas line.

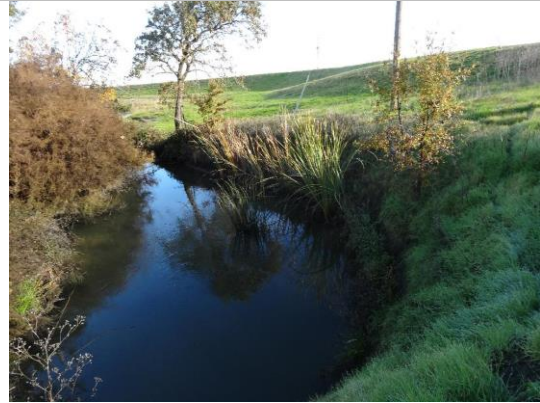
Photo 3 of 3 : UCIP_FA_2017_51461_76915.jpg

Comment Code						
Inspector Comment						
FS_ID:51461 DS_ID:24699 EP_NO: 10184 Repair Type: Urgent Crossing Status: Indicator Found UCIP Comments: 12/06/2016 No indicators were found. According to LMA representative, the gas line has been abandoned and markers have been removed about 10-15 years ago. Solano County was performing work on the LS toe approximately 700 feet from LS toe and according to their underground service alert (USA) survey completed for their construction site no PGE line was identified. Need to contact owner to determine abandoned as-builts for 8-inch line. (O. Magana - DWR UCIP)12/04/2013 Pump station visible to north on LS toe. Good indicator of location. Need PG+E to mark pipe location. (W. Wylie - DWR UCIP) FIELD_STRUCT_DESC: 8-inch iron gas line through the levee, 2 feet below the crown. (8-inch gas line authorized under Automatic Board Order (ABO) issued as Permit No. 10184, 1974 - Pacific Gas and Electric Company [PG&E]. 8-inch gas line first referenced in the USACE O&M as-built drawings from 1956). [Additional Reference(s): DWR Levee Log, 2006. USACE Sacramento O&M Manual 108, April 1964, Drawing No. 50-04-3379A, Sheet 3379/2, Page 2 of 7, (Station 82+30)]. FS Date: 12/6/2016

Photo of where the line is estimated to cross on LS.
