**Flood Control Project Maintenance
Levee Inspections**

Fall 2018 Levee Maintenance Deficiency Summary Report

Reclamation District No. 2104 Peters Pocket Tract

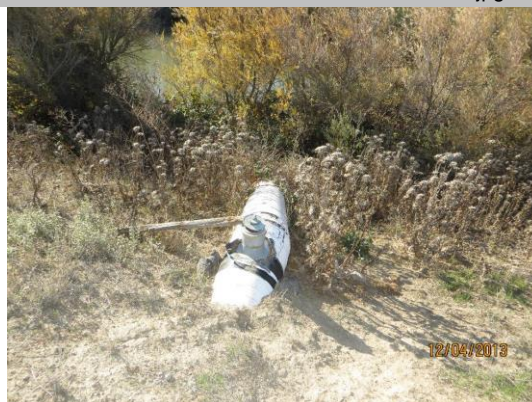
Photo 2 of 3 : UCIP_FA_2018_24984_45041.jpg

Siphon breaker on pipe at WS slope.

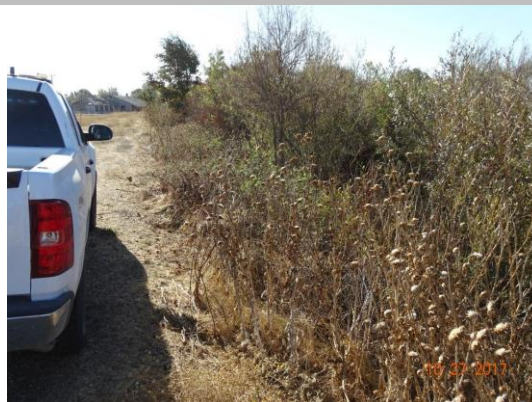
Photo 1 of 1 : FA_2018_RD2104_249_11_20180925_00002.jpg

LM Start	1.44	Rating **	U	Issue No.	11
LM End	1.48	Issue Type +	Ma	Location *	WS
Category	Earthen Levee			GPS Latitude/Longitude	
				Start	End
Item	Vegetation			38.295487°	38.294947°
				-121.741530°	-121.741215°
DWR ID	DWR_RD2104_01_f_2017_11				
Comment Code					
V2 : Remove the wild growth other than native grasses from the levee slopes.					
Inspector Comment

Remove wild growth to 20 feet from crown.

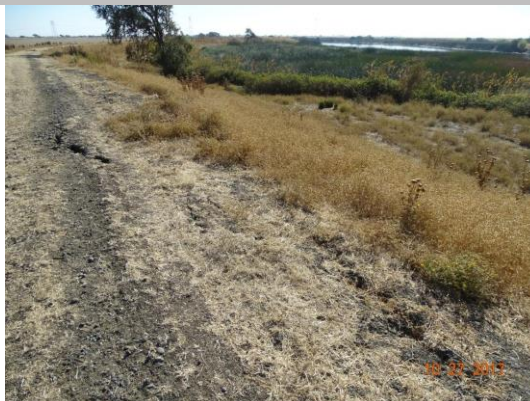
Photo 1 of 1 : FA_2018_RD2104_249_15_20180925_00004.jpg

LM Start	1.72	Rating **	A/W	Issue No.	15
LM End	1.72	Issue Type +	Ma	Location *	WS
Category	Earthen Levee			GPS Latitude/Longitude	
				Start	End
Item	Cracking			38.293465°	38.293465°
				-121.737778°	-121.737778°
DWR ID	DWR_RD2104_01_f_2017_15				
Comment Code					
CR1 : Monitor and have inspected by geotechnical engineer.					
Inspector Comment

Curved cracks in crown indicate possible slope instability on waterside slope. Cracks are 8 feet long x up to 6 inches wide x 3 feet deep. No other indications of slope instability observed. Levee toe is approx 40 feet from channel/slough edge.

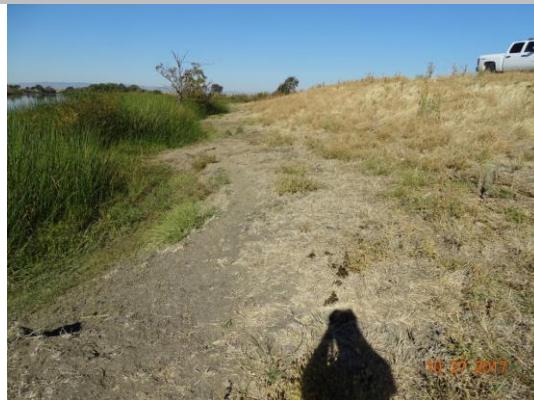
Photo 1 of 1 : FA_2018_RD2104_249_16_20180925_00005.jpg

Scalloped bank erosion along slough is approaching levee toe.

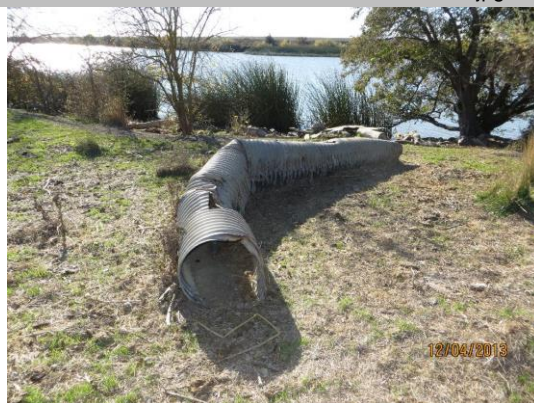
Photo 1 of 1 : UCIP_FA_2018_41347_45043.jpg

LM Start	2.40	Rating **	M	Issue No.	57	
LM End	2.40	Issue Type +	En	Location *		
Category	Supplemental			GPS Latitude/Longitude		
				Start	End	
Item	DWR UCIP Field Study			38.291579 °	38.291579 °	
				-121.726159 °	-121.726159 °	
DWR ID	24726					
Comment Code						
Inspector Comment						
FS_ID:41347						
DS_ID:24726						
EP_NO: N/A						
Repair Type: Non-Urgent						
Crossing Status: Indicator Found						
UCIP Comments: 24-inch CMP debris on WS berm may indicate pipe was abandoned.						
FIELD_STRUCT_DESC: *ABANDONED* 24-inch corrugated metal drainage pipe through the levee, 18 feet below the crown. Flap gate on the waterside (WS) toe. [Additional Reference(s): USACE Sacramento O&M Manual 108, April 1964, (HLM 2.60)].						
FS Date: 12/4/2013

Pipe debris on WS berm.

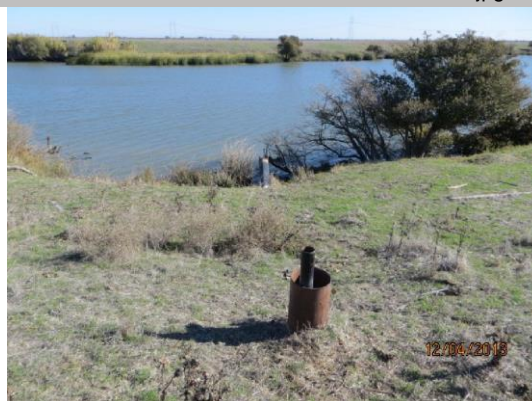
Photo 1 of 2 : UCIP_FA_2018_24990_45047.jpg

Comment Code					
Inspector Comment					
FS_ID:24990 DS_ID:24708 EP_NO: 10185 Repair Type: No Action Needed Crossing Status: Found UCIP Comments: 09/14/2017 Permit is unavailable, missing page 3 official permit documentation. (DWR UCIP - O. Magana) FIELD_STRUCT_DESC: 12-inch steel drainage pipe through the levee, 4 feet below the crown. Pump on pile structure in drainage canal on the landside (LS). Siphon breaker in a 12-inch steel riser on the waterside (WS) slope. (Automatic Board Order (ABO) issued as Permit No. 10185, 1964 - Erwin E. and Lucy G. Vasser, limited information available electronic version of permit missing. Replaced under Permit No. 4412, 1963 - Ervin E. and Lucy G. Vassar, limited details available electronic permit copy unavailable). [Additional Reference(s): DWR Levee Log, 2006. USACE Sacramento O&M Manual 108, April 1964, (HLM 3.12), Drawing No. 50-04-3379]. FS Date: 12/4/2013

Siphon breaker in steel riser on WS slope with pipe and flap gate visible in background at WS berm.

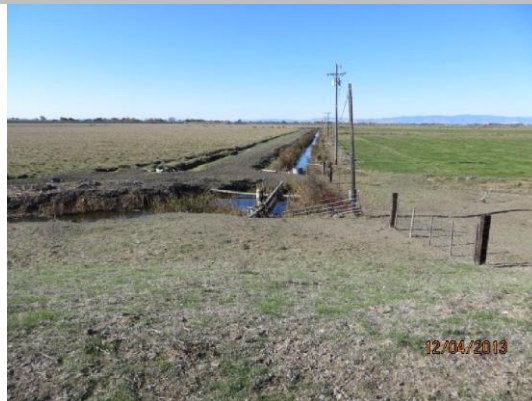
Photo 2 of 2 : UCIP_FA_2018_24990_45046.jpg

Pump on pier in ditch off LS toe.

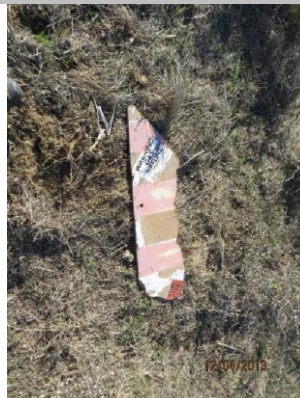
Photo 3 of 3 : UCIP_FA_2018_41834_45070.jpg

Broken sign marker on LS toe.

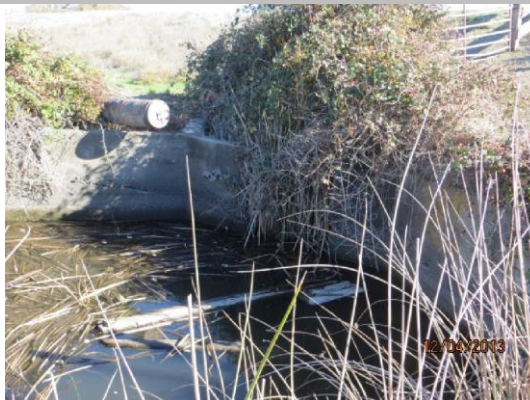
Photo 1 of 3 : UCIP_FA_2018_24992_45051.jpg

Comment Code						
Inspector Comment						
FS_ID:24992 DS_ID:24707 EP_NO: 4412 Repair Type: Non-Urgent Crossing Status: Indicator Found UCIP Comments: Heavy vegetation at concrete headwall on LS toe and at possible outlet area on WS toe. If possible, vegetation should be cleared to check if this is an accurate location. Erosion around backside of headwall at LS toe. FIELD_STRUCT_DESC: 48-inch by 48-inch reinforced concrete box drainage culvert through the levee, 17 feet below the crown. Concrete headwall on the landside (LS) toe. [Additional Reference(s): DWR Levee Log, 2006. USACE Sacramento O&M Manual 108, April 1964, (HLM 3.37)]. FS Date: 12/4/2013

Vegetation covering possible location for 4X4 concrete culvert at LS toe.

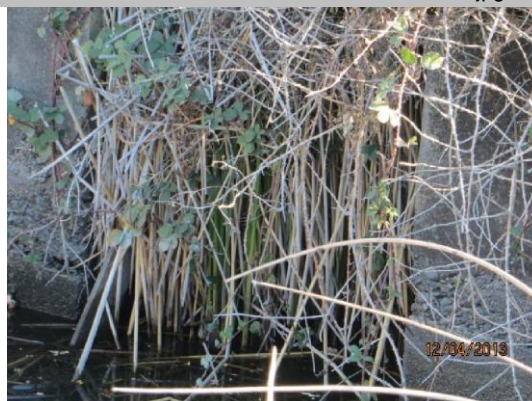
Photo 2 of 3 : UCIP_FA_2018_24992_45050.jpg

Vegetation covering possible location for 4X4 concrete culvert at LS toe.

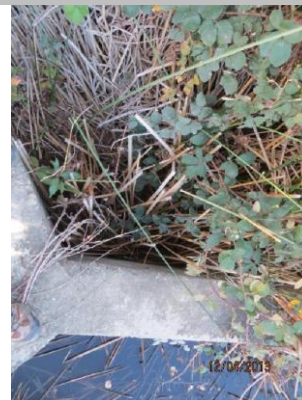
Photo 3 of 3 : UCIP_FA_2018_24992_45049.jpg

Some erosion on levee side of headwall at LS toe.

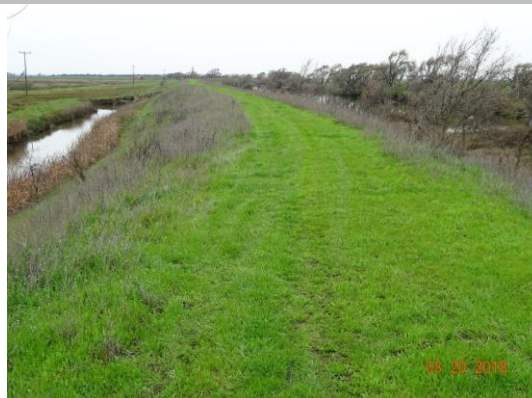
Photo 2 of 2 : FA_2018_RD2104_249_17_20180925_00006.jpg

Waterside (right) vegetation should be managed to 20 feet from crown to allow inspection and access.

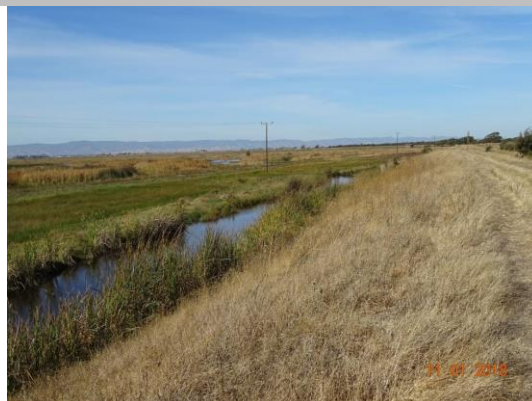
Photo 1 of 2 : FA_2018_RD2104_249_10_20181102_00038.jpg

LM Start	4.25	Rating **	M	Issue No.	10
LM End	4.30	Issue Type +	Ma	Location *	LS
Category	Earthen Levee			GPS Latitude/Longitude	
				Start	End
Item	Vegetation			38.313253 °	38.313822 °
				-121.739152 °	-121.739757 °
DWR ID	DWR_RD2104_01_s_2018_10				
Comment Code					
V2 : Remove the wild growth other than native grasses from the levee slopes.					
Inspector Comment					
Maintain vegetation on the land side slope

View looking upstream at vegetation on the land side slope (November 2018).

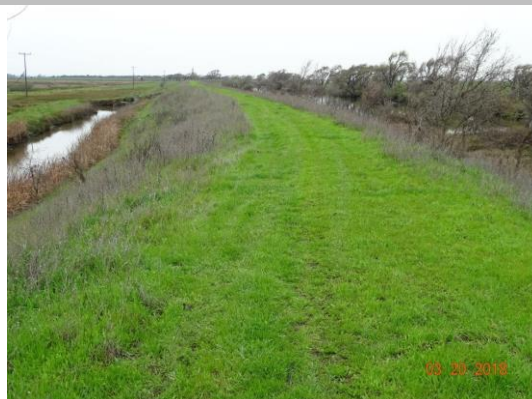
Photo 2 of 2 : FA_2018_RD2104_249_10_20180925_00001.jpg

Landside (left) vegetation should be managed to allow inspection and access to slope and toe.

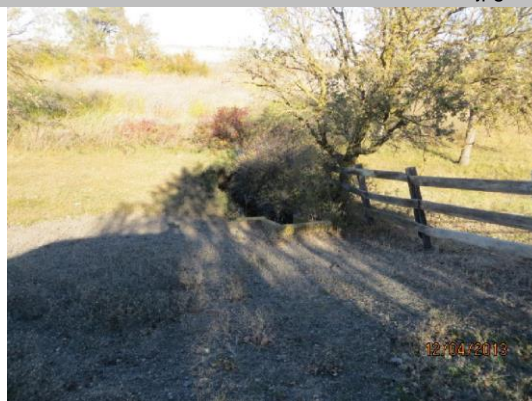
Photo 1 of 3 : UCIP_FA_2018_25006_45086.jpg

Comment Code						
Inspector Comment						
FS_ID:25006						
DS_ID:24702						
EP_NO: 10182						
Repair Type: Non-Urgent						
Crossing Status: Found						
UCIP Comments: Minor erosion of base under headwall on WS toe.						
Heavy corrosion of pipe at WS toe. Further evaluation of pipe integrity needed.						
FIELD_STRUCT_DESC: 24-inch corrugated metal drainage pipe through the levee, 13.5 feet below the crown. Concrete U-shaped headwalls on both ends. Two corrugated metal cutoff walls. Flap gate on the waterside (WS) end. (Automatic Board Order (ABO) issued as Permit No. 10182, 1974 - Julia Trust Machado). [Additional Reference(s): DWR Levee Log, 2006].						
FS Date: 12/4/2013

Concrete U shaped headwall on WS toe.

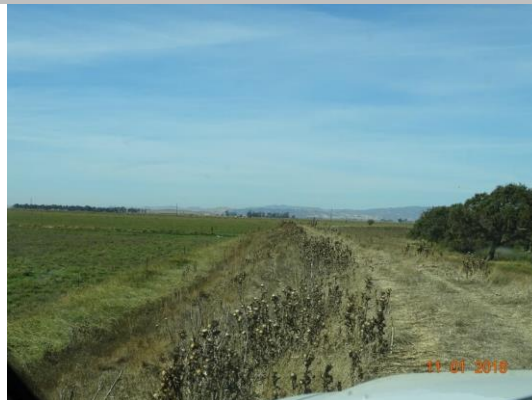
Photo 1 of 1 : FA_2018_RD2104_249_32_20181102_00040.jpg

View looking upstream at vegetation on the land side slope (November 2018).

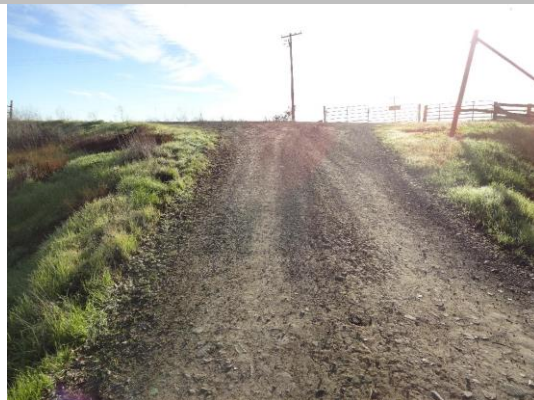
Photo 1 of 3 : UCIP_FA_2018_53385_76913.jpg

FS_ID:53385
DS_ID:24699
EP_NO: 10184
Repair Type: Non-Urgent
Crossing Status: Indicator Found
UCIP Comments: 10/12/2018 Crossing downgraded to Non-Urgent due to reclassification of gas lines. Need to contact owner to determine current status of crossing (D. Sanoski - DWR UCIP).12/06/2016 No indicators were found. According to LMA representative, the gas line has been abandoned and markers have been removed about 10-15 years ago. Solano County was performing work on the LS toe approximately 700 feet from LS toe and according to their underground service alert (USA) survey completed for their construction site no PGE line was identified. Need to contact owner to determine abandoned as-builts for 8-inch line. (O. Magana - DWR UCIP)12/04/2013 Pump station visible to north on LS toe. Good indicator of location. Need PG+E to mark pipe location. (W. Wylie - DWR UCIP)
FIELD_STRUCT_DESC: 8-inch iron gas line through the levee, 2 feet below the crown. (8-inch gas line authorized under Automatic Board Order (ABO) issued as Permit No. 10184, 1974 - Pacific Gas and Electric Company [PG&E]. 8-inch gas line first referenced in the USACE O&M as-built drawings from 1956). [Additional Reference(s): DWR Levee Log, 2006. USACE Sacramento O&M Manual 108, April 1964, Drawing No. 50-04-3379A, Sheet 3379/2, Page 2 of 7, (Station 82+30)].

No signs present at ramp to enter RD2104.
