**Flood Control Project Maintenance  
Levee Inspections**

**Fall 2019 Levee Maintenance Deficiency Summary Report**

**Flood Control Project Maintenance  
Levee Inspections****LMA District Cover Sheet****Fall 2019 Levee Inspection Results****Reclamation District No. 2104 Peters Pocket Tract**

**Reclamation District No. 2104 Peters Pocket Tract**

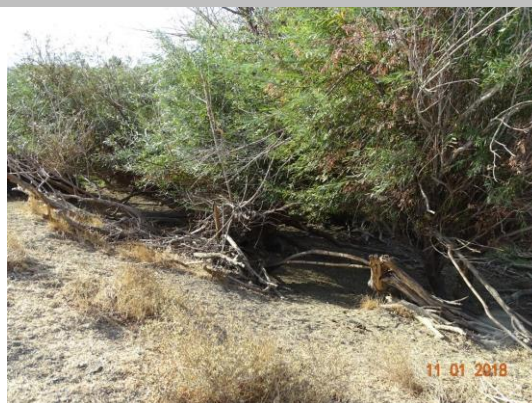
Photo 1 of 1 : FA\_2019\_RD2104\_249\_29\_20190826\_00010.jpg

View of tree branches on the waterside slope (November 2018).

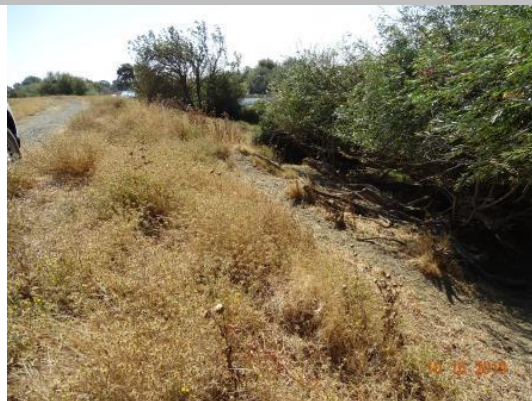
Photo 1 of 1 : FA\_2019\_RD2104\_249\_23\_20191015\_00041.jpg

View looking downstream at trail caused by cows on the waterside slope (Fall 2019).

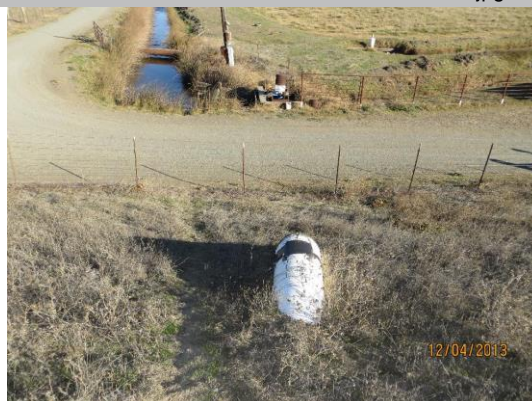
Photo 1 of 3 : UCIP\_FA\_2019\_24984\_45042.jpg

Comment Code						
Inspector Comment						
DS_ID:24711						
FS_ID:24984						
EP_NO: 10185						
Repair Type: No Action Needed						
Crossing Status: Found						
UCIP Comments: 09/14/2017 Permit is unavailable, missing page 3 official permit documentation. (DWR UCIP - O. Magana)						
FIELD_STRUCT_DESC: 16-inch steel drainage pipe through the levee, 5.7 feet below the crown. Pump in an irrigation ditch on the landside (LS). Siphon breaker on the waterside (WS) slope. (Automatic Board Order (ABO) issued as Permit No. 10185, 1964 - Erwin E. and Lucy G. Vasser, limited details available electronic permit unavailable).						
[Additional Reference(s): DWR Levee Log, 2006. USACE Sacramento O&M Manual 108, April 1964, (HLM 1.52), Drawing Nos. 50-04-1977 and 50-04-3379].						
FS Date: 12/4/2013

Pipe on LS slope with pump in irrigation ditch off LS toe visible in background.

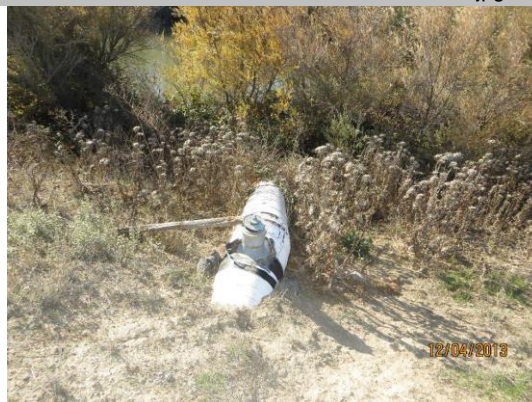
Photo 2 of 3 : UCIP\_FA\_2019\_24984\_45041.jpg

Siphon breaker on pipe at WS slope.

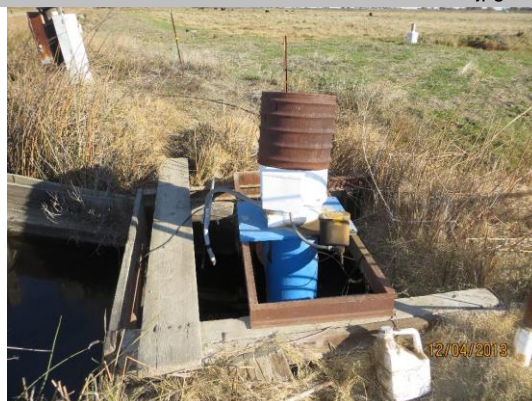
Photo 3 of 3 : UCIP\_FA\_2019\_24984\_45040.jpg

Pump in wooden distribution box off LS toe.

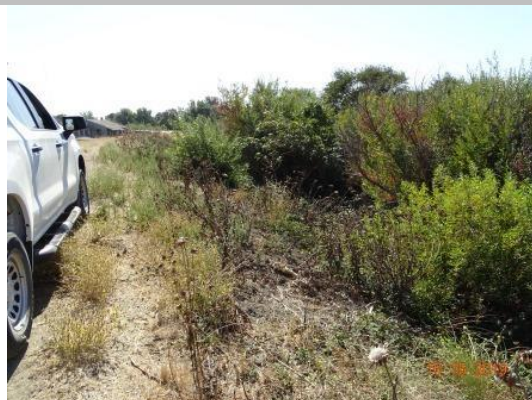
Photo 1 of 1 : FA\_2019\_RD2104\_249\_11\_20191015\_00042.jpg

LM Start	1.44	Rating **	U	Issue No.	11
LM End	1.48	Issue Type +	Ma	Location *	WS
Category	Earthen Levee			GPS Latitude/Longitude	
				Start	End
Item	Vegetation			38.295487 °	38.294947 °
				-121.741530 °	-121.741215 °
DWR ID	DWR_RD2104_01_f_2017_11				
Comment Code					
V2 : Remove the wild growth other than native grasses from the levee slopes.					
Inspector Comment

View looking downstream at thick vegetation on the waterside slope (Fall 2019).

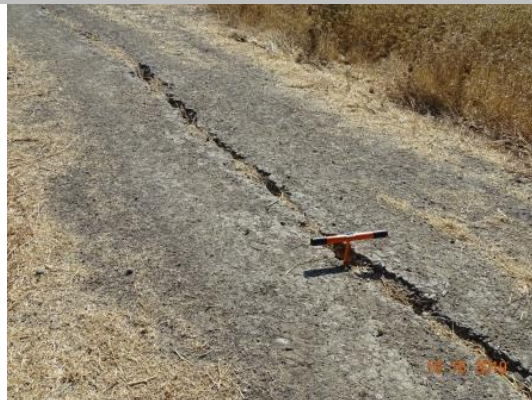
Photo 1 of 1 : FA\_2019\_RD2104\_249\_35\_20191015\_00045.jpg

LM Start	1.60	Rating **	U	Issue No.	35
LM End	1.60	Issue Type +	Ma	Location *	CR
Category	Earthen Levee			GPS Latitude/Longitude	
				Start	End
Item	Cracking			38.294005 °	38.294005 °
				-121.739810 °	-121.739810 °
DWR ID	DWR_RD2104_01_f_2019_35				
Comment Code					
CR1 : Monitor and have inspected by geotechnical engineer.					
Inspector Comment					
There is at least a 48" crack through the center of the crown.

View of deep crack with 48" pole stuck all the way into it on the crown (Fall 2019).

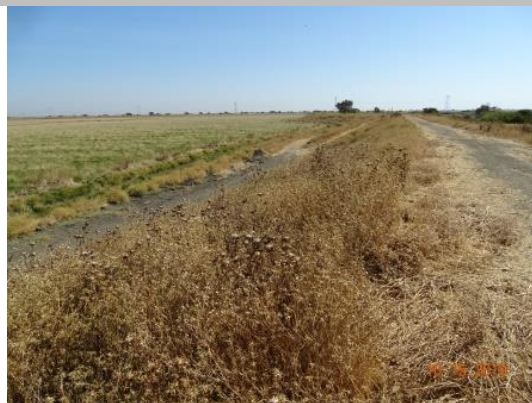
Photo 1 of 1 : FA\_2019\_RD2104\_249\_34\_20191015\_00043.jpg

LM Start	1.60	Rating **	U	Issue No.	34
LM End	2.40	Issue Type +	Ma	Location *	LS
Category	Earthen Levee			GPS Latitude/Longitude	
				Start	End
Item	Vegetation			38.293989 °	38.291552 °
				-121.739818 °	-121.726162 °
DWR ID	DWR_RD2104_01_f_2019_34				
Comment Code					
V1 : Control annual grass and weeds on the levee slopes and easements.					
Inspector Comment

View looking downstream at thick annual vegetation on the landside slope (Fall 2019).

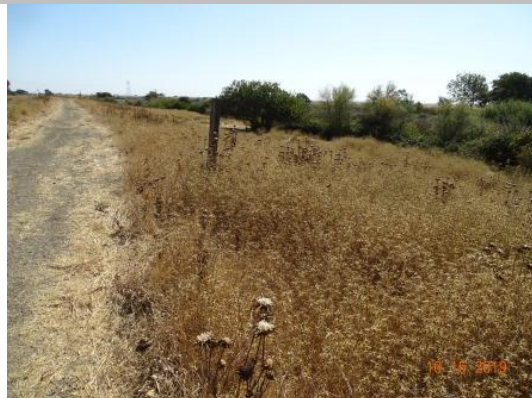
Photo 1 of 1 : FA\_2019\_RD2104\_249\_32\_20191015\_00044.jpg

View looking downstream at thick annual vegetation on the waterside slope (Fall 2019).

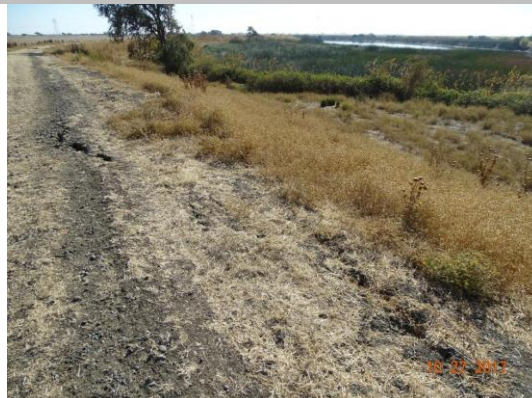
Photo 1 of 1 : FA\_2019\_RD2104\_249\_15\_20190826\_00003.jpg

LM Start	1.72	Rating **	A/W	Issue No.	15
LM End	1.72	Issue Type +	Ma	Location *	WS
Category	Earthen Levee			GPS Latitude/Longitude	
				Start	End
Item	Cracking			38.293465°	38.293465°
				-121.737778°	-121.737778°
DWR ID	DWR_RD2104_01_f_2017_15				
Comment Code					
CR1 : Monitor and have inspected by geotechnical engineer.					
Inspector Comment

Curved cracks in crown indicate possible slope instability on waterside slope. Cracks are 8 feet long x up to 6 inches wide x 3 feet deep. No other indications of slope instability observed. Levee toe is approx 40 feet from channel/slough edge.

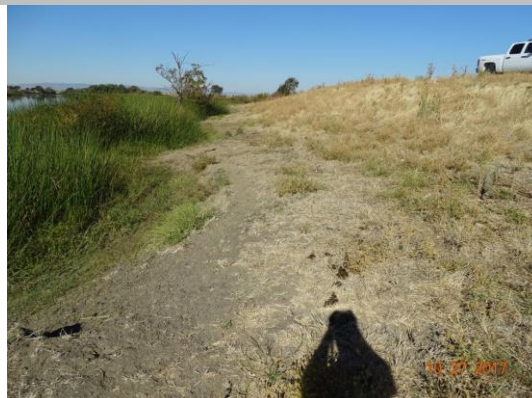
Photo 1 of 1 : FA\_2019\_RD2104\_249\_16\_20190826\_00004.jpg

LM Start	1.93	Rating **	A/W	Issue No.	16
LM End	1.94	Issue Type +	Ma	Location *	WS
Category	Earthen Levee			GPS Latitude/Longitude	
				Start	End
Item	Erosion / Bank Caving			38.292027°	38.291947°
				-121.734575°	-121.734453°
DWR ID	DWR_RD2104_01_s_2012_16				
Comment Code					
E1 : Note and monitor erosion site.					
Inspector Comment					
Erosion is not in levee prism but monitor to see if it moves into prism.

Scalloped bank erosion along slough is approaching levee toe.

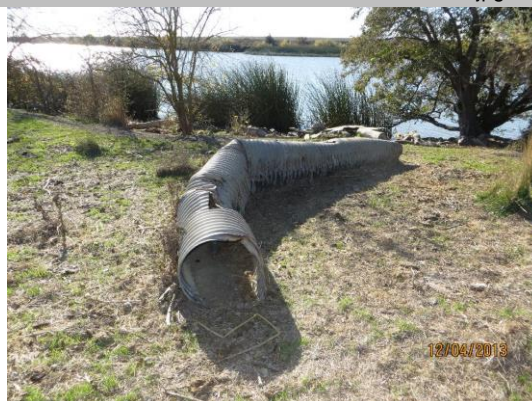
Photo 1 of 1 : UCIP\_FA\_2019\_41347\_45043.jpg

LM Start	2.40	Rating **	M	Issue No.	57	
LM End	2.40	Issue Type +	En	Location *		
Category	Supplemental			GPS Latitude/Longitude		
				Start	End	
Item	DRAFT DWR UCIP Field Study			38.291579 °	38.291579 °	
				-121.726159 °	-121.726159 °	
DWR ID	24726					
Comment Code						
Inspector Comment						
DS_ID:24726						
FS_ID:41347						
EP_NO: N/A						
Repair Type: Non-Urgent						
Crossing Status: Indicator Found						
UCIP Comments: 24-inch CMP debris on WS berm may indicate pipe was abandoned.						
FIELD_STRUCT_DESC: *ABANDONED* 24-inch corrugated metal drainage pipe through the levee, 18 feet below the crown. Flap gate on the waterside (WS) toe. [Additional Reference(s): USACE Sacramento O&M Manual 108, April 1964, (HLM 2.60)].						
FS Date: 12/4/2013

Pipe debris on WS berm.

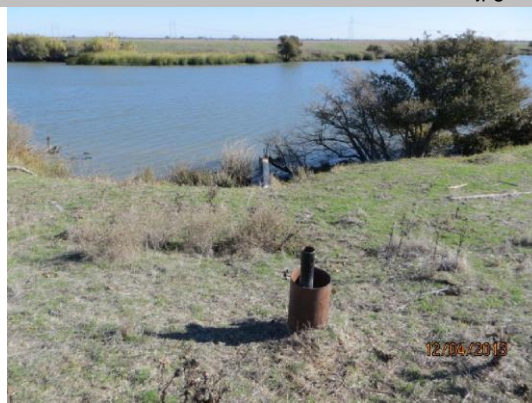
Photo 1 of 2 : UCIP\_FA\_2019\_24990\_45047.jpg

Comment Code						
Inspector Comment						
DS_ID:24708 FS_ID:24990 EP_NO: 10185 Repair Type: No Action Needed Crossing Status: Found UCIP Comments: 09/14/2017 Permit is unavailable, missing page 3 official permit documentation. (DWR UCIP - O. Magana) FIELD_STRUCT_DESC: 12-inch steel drainage pipe through the levee, 4 feet below the crown. Pump on pile structure in drainage canal on the landside (LS). Siphon breaker in a 12-inch steel riser on the waterside (WS) slope. (Automatic Board Order (ABO) issued as Permit No. 10185, 1964 - Erwin E. and Lucy G. Vasser, limited information available electronic version of permit missing. Replaced under Permit No. 4412, 1963 - Ervin E. and Lucy G. Vassar, limited details available electronic permit copy unavailable). [Additional Reference(s): DWR Levee Log, 2006. USACE Sacramento O&M Manual 108, April 1964, (HLM 3.12), Drawing No. 50-04-3379]. FS Date: 12/4/2013

Siphon breaker in steel riser on WS slope with pipe and flap gate visible in background at WS berm.

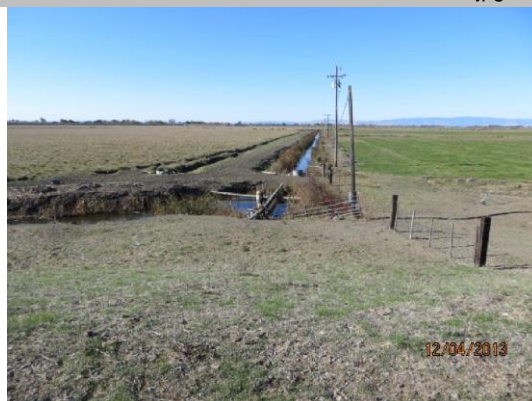
Photo 2 of 2 : UCIP\_FA\_2019\_24990\_45046.jpg

Pump on pier in ditch off LS toe.

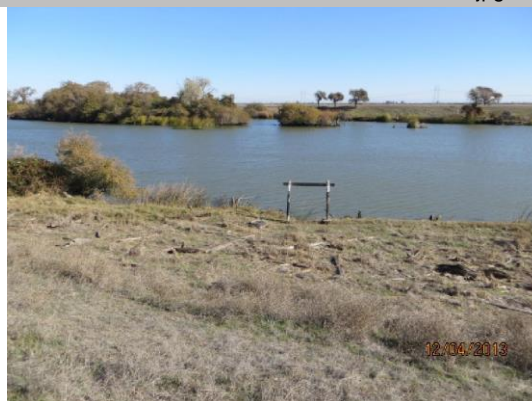
Photo 1 of 3 : UCIP\_FA\_2019\_41834\_45069.jpg

LM Start	3.04	Rating **	M	Issue No.	59	
LM End	3.04	Issue Type +	En	Location *		
Category	Supplemental			GPS Latitude/Longitude		
				Start	End	
Item	DRAFT DWR UCIP Field Study			38.299447 °	38.299447 °	
				-121.730444 °	-121.730444 °	
DWR ID	24720					
Comment Code						
Inspector Comment						
DS_ID:24720						
FS_ID:41834						
EP_NO: 14184						
Repair Type: Non-Urgent						
Crossing Status: Found						
UCIP Comments: Signs in disrepair and need proper markings.						
FIELD_STRUCT_DESC: 6-inch steel gas line through the levee, 3 feet below the crown. Signs on both toes of the levee.						
FS Date: 12/4/2013

Sign on WS berm.

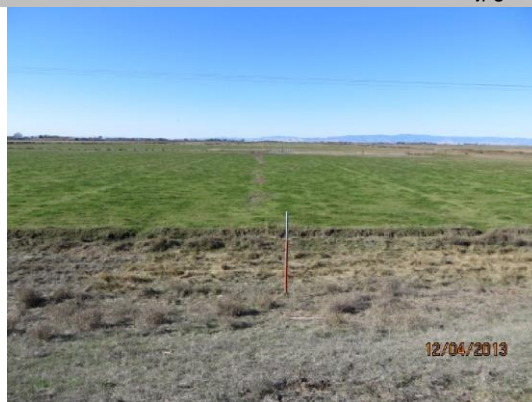
Photo 2 of 3 : UCIP\_FA\_2019\_41834\_45068.jpg

Sign post on LS toe.

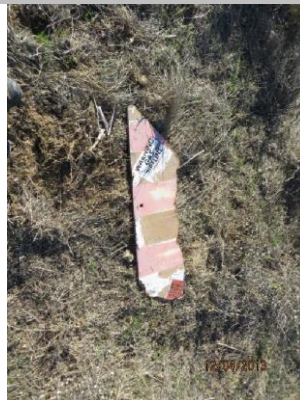
Photo 3 of 3 : UCIP\_FA\_2019\_41834\_45070.jpg

Broken sign marker on LS toe.

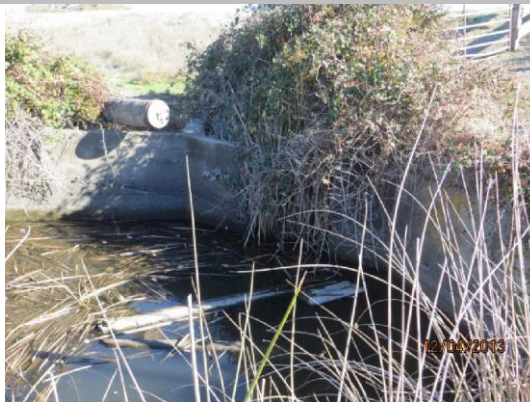
Photo 1 of 3 : UCIP\_FA\_2019\_24992\_45051.jpg

Comment Code					
Inspector Comment					
DS_ID:24707 FS_ID:24992 EP_NO: 4412 Repair Type: Non-Urgent Crossing Status: Indicator Found UCIP Comments: Heavy vegetation at concrete headwall on LS toe and at possible outlet area on WS toe. If possible, vegetation should be cleared to check if this is an accurate location. Erosion around backside of headwall at LS toe. FIELD_STRUCT_DESC: 48-inch by 48-inch reinforced concrete box drainage culvert through the levee, 17 feet below the crown. Concrete headwall on the landside (LS) toe. [Additional Reference(s): DWR Levee Log, 2006. USACE Sacramento O&M Manual 108, April 1964, (HLM 3.37)]. FS Date: 12/4/2013

Vegetation covering possible location for 4X4 concrete culvert at LS toe.

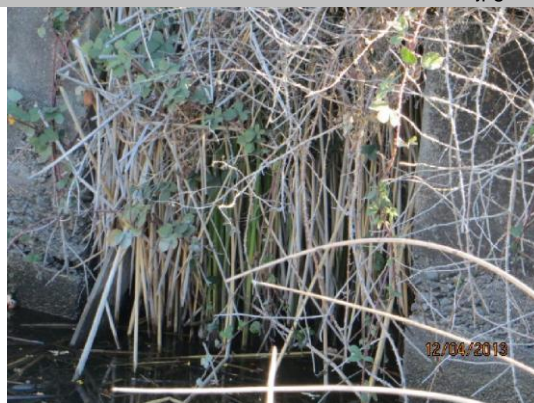
Photo 2 of 3 : UCIP\_FA\_2019\_24992\_45050.jpg

Vegetation covering possible location for 4X4 concrete culvert at LS toe.

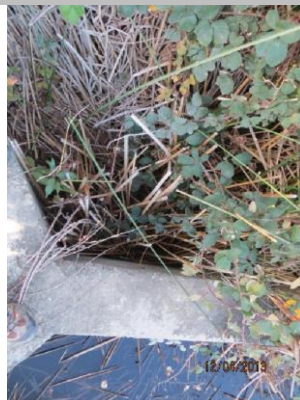
Photo 3 of 3 : UCIP\_FA\_2019\_24992\_45049.jpg

Some erosion on levee side of headwall at LS toe.

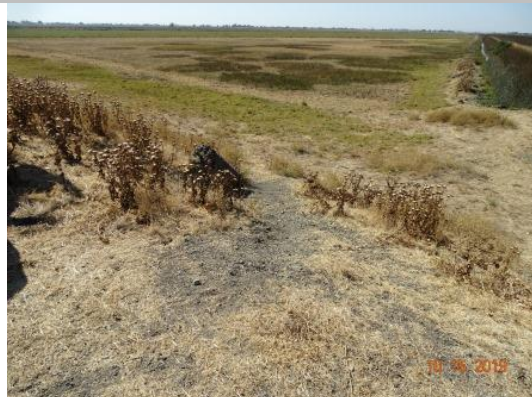
Photo 1 of 1 : FA\_2019\_RD2104\_249\_21\_20191015\_00046.jpg

LM Start	4.00	Rating **	M	Issue No.	21
LM End	4.00	Issue Type +	Ma	Location *	LS
Category	Earthen Levee			GPS Latitude/Longitude	
				Start	End
Item	Slope Stability			38.310672 °	38.310672 °
				-121.736155 °	-121.736155 °
DWR ID	DWR_RD2104_01_f_2018_21				
Comment Code					
S2 : Repair the levee slope damaged by foot traffic and prevent access where possible.					
Inspector Comment					
There is a cow path on the landside slope.

View looking downslope at cow path on the landside slope (Fall 2019).

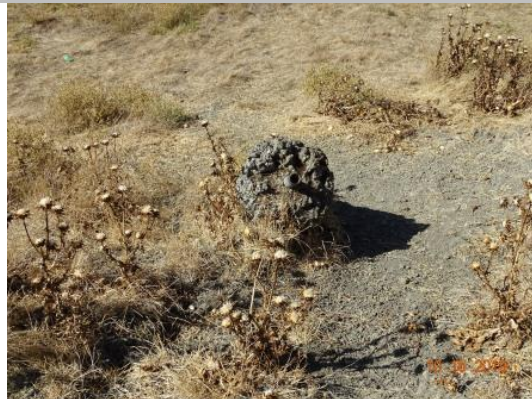
Photo 1 of 1 : FA\_2019\_RD2104\_249\_42\_20191015\_00047.jpg

View of large concrete block on the landside slope (Fall 2019).

LM Start	4.00	Rating **	M	Issue No.	42
LM End	4.00	Issue Type +	Ma	Location *	LS
Category	Earthen Levee			GPS Latitude/Longitude	
				Start	End
Item	Encroachments			38.310682 °	38.310682 °
				-121.736152 °	-121.736152 °
DWR ID	DWR_RD2104_01_f_2019_42				
Comment Code					
DE : Debris					
Inspector Comment					
Remove concrete block.

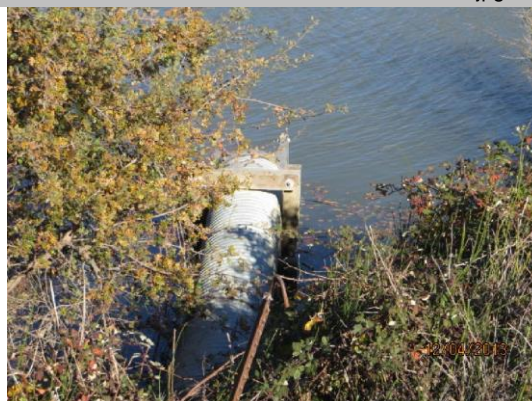
Photo 1 of 3 : UCIP\_FA\_2019\_51459\_45062.jpg

Comment Code						
Inspector Comment						
DS_ID:24705 FS_ID:51459 EP_NO: 10182 Repair Type: Non-Urgent Crossing Status: Found UCIP Comments: 12/06/2016 Crossing has been downgraded from "Urgent" to "Non-Urgent" no signs of leaks observed along pipe alignment (limited inspection on WS toe). According to LMA representative, this crossing was replaced 6 years ago (2010) at WS concrete apron. Recommend conducting internal inspection of pipe through the levee and LS to determine pipe integrity. (O. Magana - DWR UCIP)12/04/2013 Vegetation and soil buildup throughout pipe preventing flapgate from closing. Remove vegetation to allow gate to close properly. (W. Wylie - DWR UCIP) FIELD_STRUCT_DESC: 24-inch corrugated metal drainage pipe through the levee, 15 feet below the crown. 36-inch concrete standpipe on the landside (LS) toe. Flap gate on the waterside (WS) toe. Two corrugated metal cutoff walls installed. (24-inch pipe [HLM 4.65] authorized under Automatic Board Order (ABO) issued as Permit No. 10182, 1974 - Julia Trust Machado). [Additional Reference(s): DWR Levee Log, 2006. USACE Sacramento O&M Manual 108, April 1964, (HLM 4.65), Drawing No. 50-04-3379]. FS Date: 12/6/2016

CMP pipe and flapgate off WS toe.

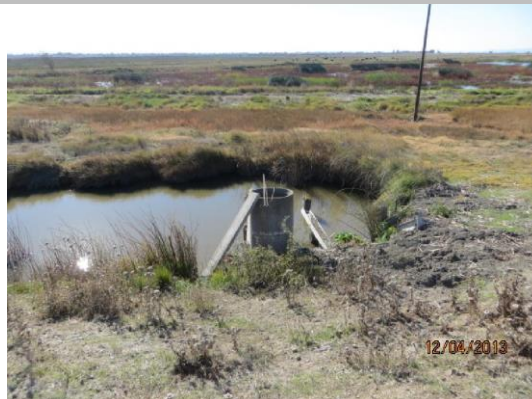
Photo 2 of 3 : UCIP\_FA\_2019\_51459\_45061.jpg

36-inch concrete riser on LS toe at channel.

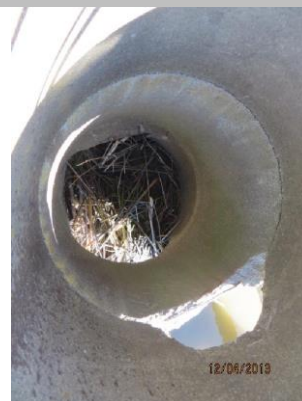
Photo 3 of 3 : UCIP\_FA\_2019\_51459\_45060.jpg

36-inch concrete riser with vegetation buildup inside.

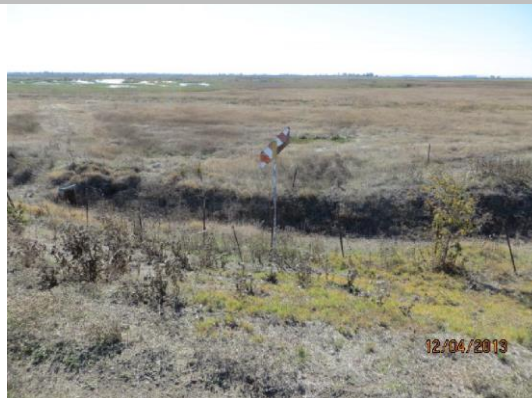
Photo 1 of 2 : UCIP\_FA\_2019\_25003\_45081.jpg

LM Start	4.65	Rating **	M	Issue No.	62
LM End	4.65	Issue Type +	En	Location *	
Category	Supplemental			GPS Latitude/Longitude	
				Start	End
Item	DRAFT DWR UCIP Field Study			38.317941 °	38.317941 °
				-121.743503 °	-121.743503 °
DWR ID	24704				
Comment Code					
Inspector Comment					
DS_ID:24704					
FS_ID:25003					
EP_NO: 10182					
Repair Type: Non-Urgent					
Crossing Status: Found					
UCIP Comments: Sign on WS toe needs repair.					
FIELD_STRUCT_DESC: 8-inch steel gas line through the levee, at the high elevation. Signs on both toes of the levee. (Automatic Board Order (ABO) issued as Permit No. 10182, 1974 - Julia Trust Machado).					
[Additional Reference(s): DWR Levee Log, 2006. USACE Sacramento O&M Manual 108, April 1964, Drawing No. 50-04-3379].					
FS Date: 12/4/2013

Gasline marker on LS toe.

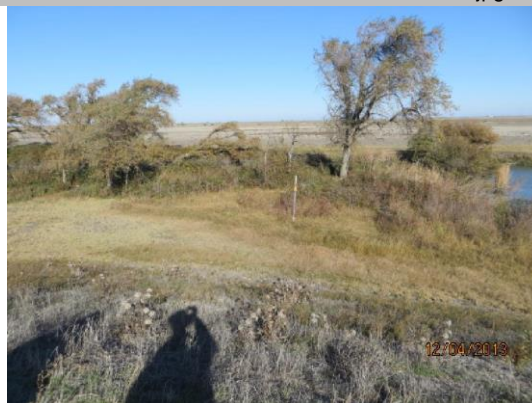
Photo 2 of 2 : UCIP\_FA\_2019\_25003\_45080.jpg

Sign pole on WS toe missing sign.

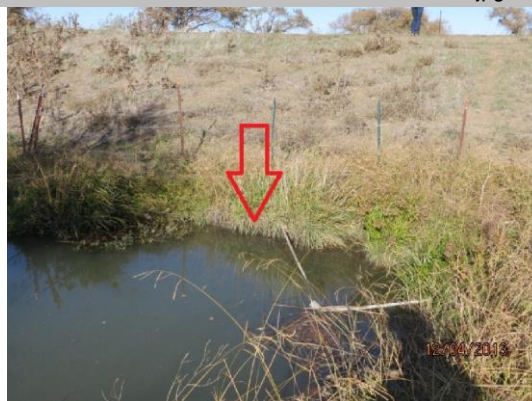
Photo 1 of 2 : UCIP\_FA\_2019\_25005\_45083.jpg

Comment Code						
Inspector Comment						
DS_ID:24703						
FS_ID:25005						
EP_NO: N/A						
Repair Type: Non-Urgent						
Crossing Status: Found						
UCIP Comments: Good candidate for video inspection.						
FIELD_STRUCT_DESC: 18-inch steel irrigation pipe through the levee, 13.5 feet below the crown. Pump on pile structure in the stream. Slide gate in a 36-inch corrugated metal pipe (CMP) riser on the waterside (WS) slope. Two cutoff walls. Concrete U-shaped headwall and air vent at the landside (LS) toe. Electrical conduit through the levee at the same location. [Additional Reference(s): DWR Levee Log, 2006. USACE Sacramento O&M Manual 108, April 1964, (HLM 5.06), Drawing No. 50-04-3379].						
FS Date: 12/4/2013

Concrete headwall on LS toe at irrigation ditch.

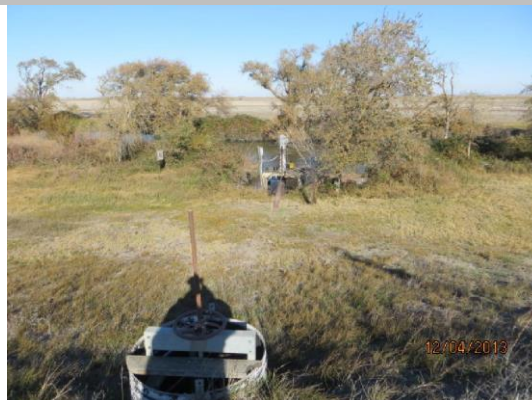
Photo 2 of 2 : UCIP\_FA\_2019\_25005\_45082.jpg

Slide gate in CMP riser on WS slope with pump on pier in background.

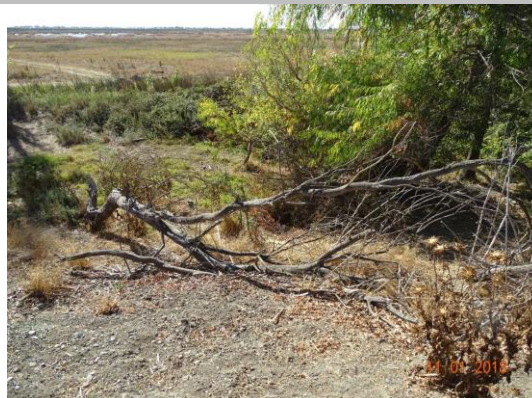
Photo 1 of 1 : FA\_2019\_RD2104\_249\_31\_20190826\_00011.jpg

View of down tree limb on the landside slope (November 2018).

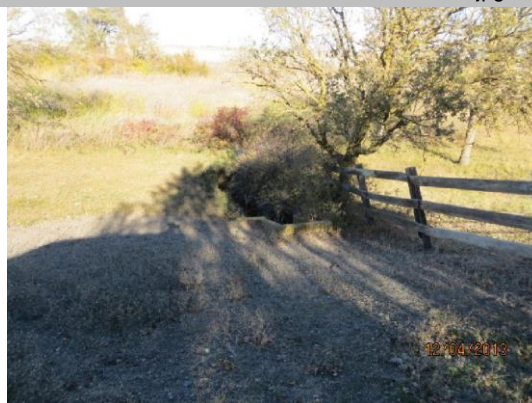
Photo 1 of 3 : UCIP\_FA\_2019\_25006\_45086.jpg

Comment Code						
Inspector Comment						
DS_ID:24702 FS_ID:25006 EP_NO: 10182 Repair Type: Non-Urgent Crossing Status: Found UCIP Comments: Minor erosion of base under headwall on WS toe. Heavy corrosion of pipe at WS toe. Further evaluation of pipe integrity needed. FIELD_STRUCT_DESC: 24-inch corrugated metal drainage pipe through the levee, 13.5 feet below the crown. Concrete U-shaped headwalls on both ends. Two corrugated metal cutoff walls. Flap gate on the waterside (WS) end. (Automatic Board Order (ABO) issued as Permit No. 10182, 1974 - Julia Trust Machado). [Additional Reference(s): DWR Levee Log, 2006]. FS Date: 12/4/2013

Concrete U shaped headwall on WS toe.

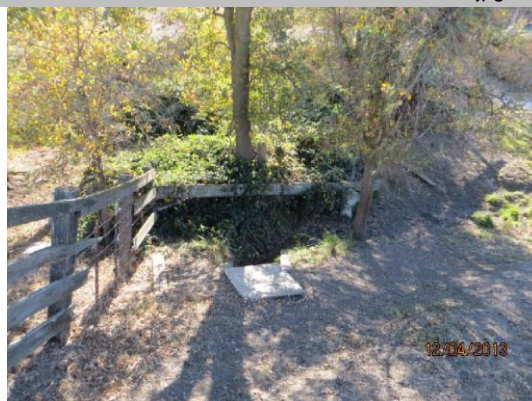
Photo 2 of 3 : UCIP\_FA\_2019\_25006\_45085.jpg

Concrete U shaped headwall on LS toe.

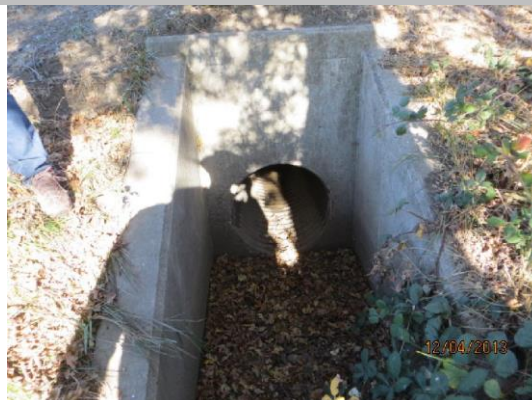
Photo 3 of 3 : UCIP\_FA\_2019\_25006\_45084.jpg

Concrete U shaped headwall on LS toe.

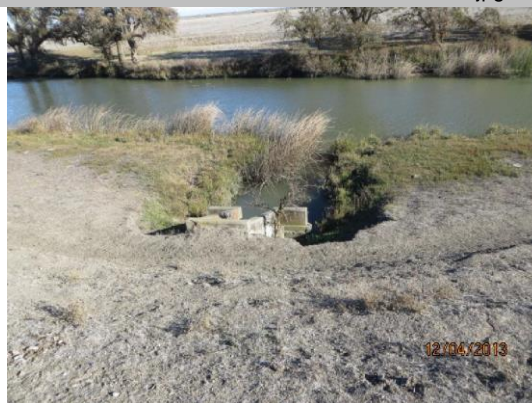
Photo 1 of 3 : UCIP\_FA\_2019\_53387\_45090.jpg

Concrete U-shaped headwall on WS toe. Note erosion scarp around headwall.

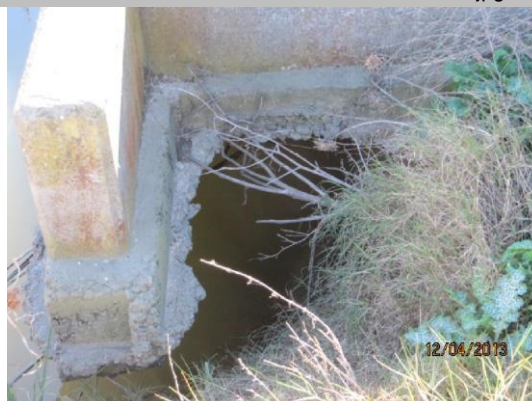
Photo 2 of 3 : UCIP\_FA\_2019\_53387\_45089.jpg

Headwall undermined on WS toe.

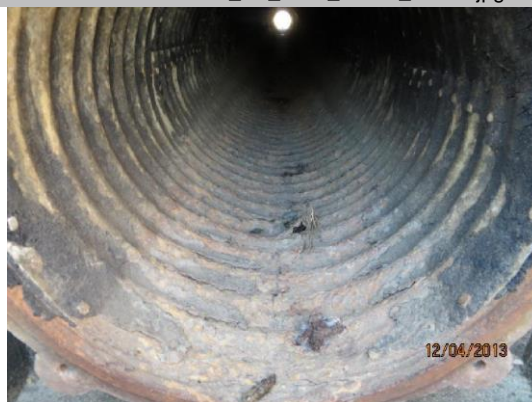
Photo 3 of 3 : UCIP\_FA\_2019\_53387\_45088.jpg

Corrosion through pipe with holes on WS toe.

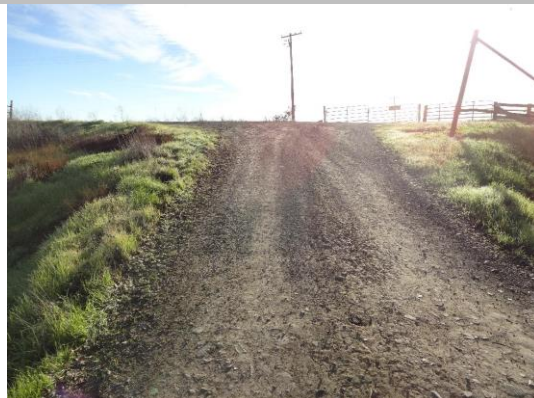
Photo 1 of 3 : UCIP\_FA\_2019\_53385\_76913.jpg

No signs present at ramp to enter RD2104.

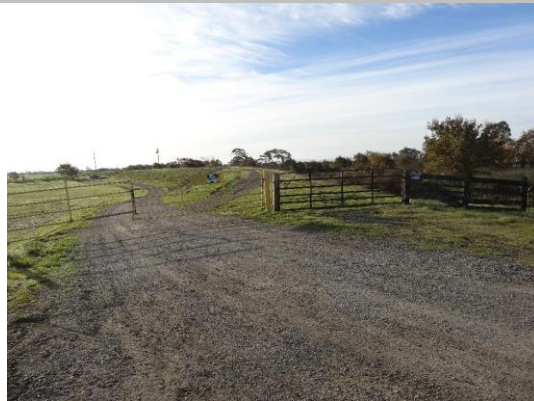
Photo 2 of 3 : UCIP\_FA\_2019\_53385\_76914.jpg

No signs present of gas line.

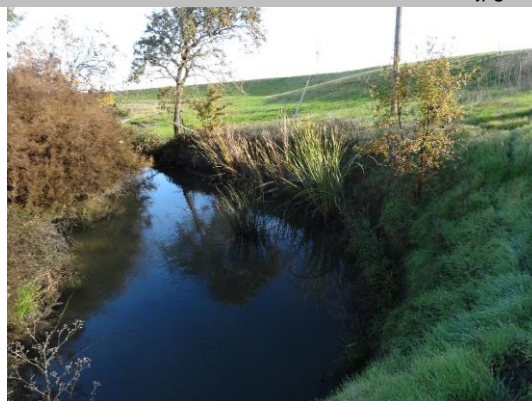
Photo 3 of 3 : UCIP\_FA\_2019\_53385\_76915.jpg

Photo of where the line is estimated to cross on LS.
