## Flood Control Project Maintenance Levee Inspections

### Fall 2020 Levee Maintenance Deficiency Summary Report

**Reclamation District No. 2104 Peters Pocket Tract**

Waterway	Bank	Unit Miles	Inspection Start/End	Inspector
Unit No. 01 Cache Slough/Unit No. 02 Haas Slough	Left	6.85	11/03/2020 11/03/2020	David Julian

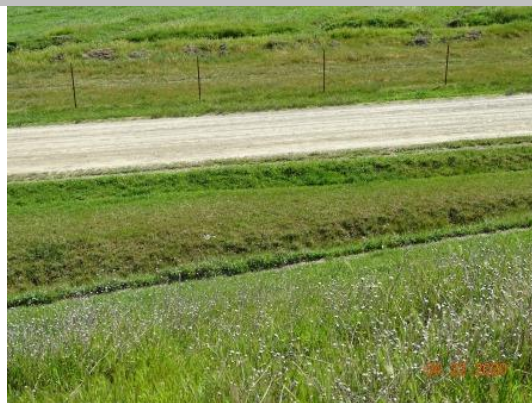
Photo 1 of 1 : FA\_2020\_RD2104\_249\_18\_20201009\_00003.jpg

LM Start	0.22	Rating **	M	Issue No.	18
LM End	0.30	Issue Type +	En	Location *	LS
Category	Earthen Levee			GPS Latitude/Longitude	
				Start	End
Item	Encroachments			38.305409 °	38.304384 °
				-121.756931 °	-121.756483 °
DWR ID	DWR_RD2104_01_s_2020_18				
Comment Code					
DT : Ditch					
Inspector Comment					
Ditch at the landside toe.

View of ditch at the landside toe (Spring 2020).

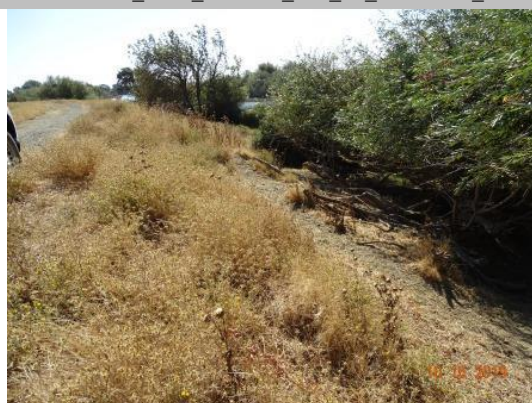
Photo 1 of 1 : FA\_2020\_RD2104\_249\_23\_20201009\_00006.jpg

LM Start	1.27	Rating **	M	Issue No.	23
LM End	1.27	Issue Type +	Ma	Location *	WS
Category	Earthen Levee			GPS Latitude/Longitude	
				Start	End
Item	Animal Control			38.296182 °	38.296182 °
				-121.744318 °	-121.744318 °
DWR ID	DWR_RD2104_01_f_2016_23				
Comment Code					
A2 : Repair the levee slope damaged by livestock and prevent large animal access.					
Inspector Comment					
Repair the slope damaged by cows.

View looking downstream at trail caused by cows on the waterside slope (Fall 2019).

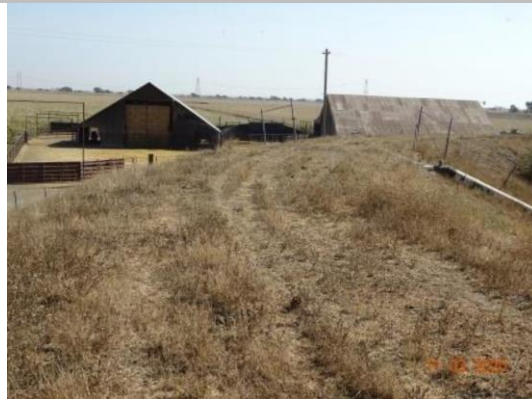
Photo 1 of 1 : FA\_2020\_RD2104\_249\_25\_20201103\_00039.jpg

View looking downstream at vegetation on the crown (Fall 2020).

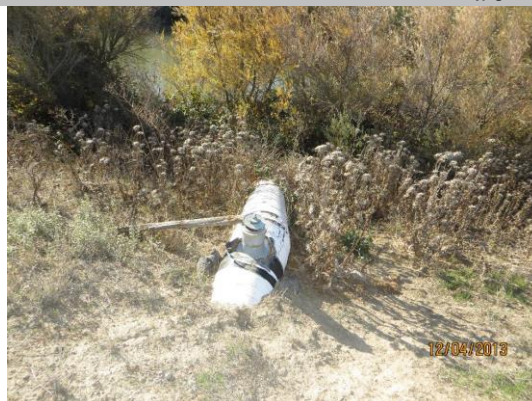
Photo 2 of 3 : UCIP\_FA\_2020\_24984\_45041.jpg

Siphon breaker on pipe at WS slope.

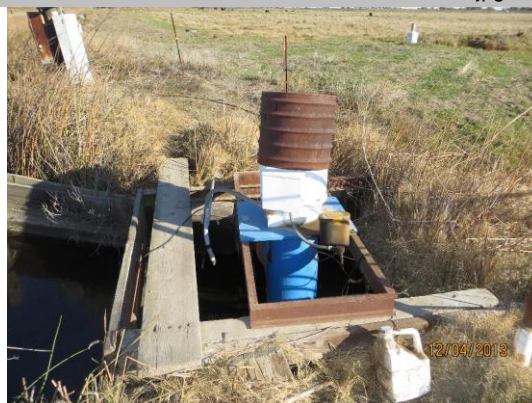
Photo 3 of 3 : UCIP\_FA\_2020\_24984\_45040.jpg

Pump in wooden distribution box off LS toe.

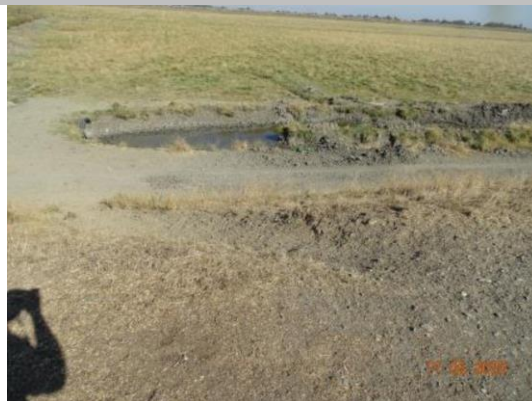
Photo 1 of 1 : FA\_2020\_RD2104\_249\_13\_20201103\_00040.jpg

LM Start	1.58	Rating **	M	Issue No.	13
LM End	1.58	Issue Type +	Ma	Location *	LS
Category	Earthen Levee			GPS Latitude/Longitude	
				Start	End
Item	Animal Control			38.294097 °	38.294097 °
				-121.740133 °	-121.740133 °
DWR ID	DWR_RD2104_01_f_2020_13				
Comment Code					
A2 : Repair the levee slope damaged by livestock and prevent large animal access.					
Inspector Comment					
Cow path digging into levee.

View of cow path down the landside slope (Fall 2020).

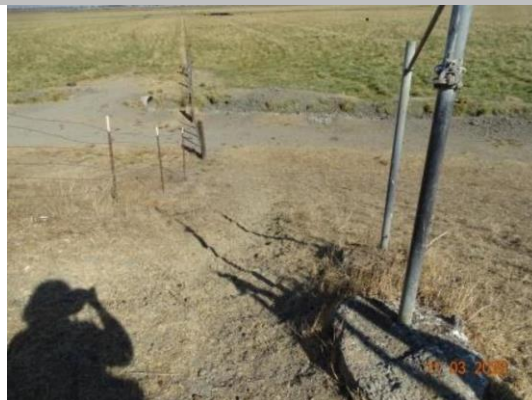
Photo 1 of 1 : FA\_2020\_RD2104\_249\_19\_20201103\_00041.jpg

LM Start	1.85	Rating **	M	Issue No.	19
LM End	1.85	Issue Type +	Ma	Location *	LS
Category	Earthen Levee			GPS Latitude/Longitude	
				Start	End
Item	Animal Control			38.292880 °	38.292880 °
				-121.735552 °	-121.735552 °
DWR ID	DWR_RD2104_01_f_2020_19				
Comment Code					
A2 : Repair the levee slope damaged by livestock and prevent large animal access.					
Inspector Comment					
Cow path on the landside slope

View of cow path down the landside slope (Fall 2020).

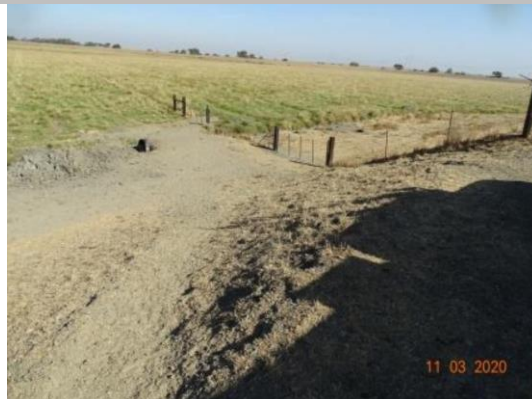
Photo 1 of 1 : FA\_2020\_RD2104\_249\_22\_20201103\_00042.jpg

LM Start	2.10	Rating **	M	Issue No.	22
LM End	2.10	Issue Type +	Ma	Location *	LS
Category	Earthen Levee			GPS Latitude/Longitude	
				Start	End
Item	Animal Control			38.292058 °	38.292058 °
				-121.731555 °	-121.731555 °
DWR ID	DWR_RD2104_01_f_2020_22				
Comment Code					
A2 : Repair the levee slope damaged by livestock and prevent large animal access.					
Inspector Comment					
Cow path

View of cow path down the landside slope (Fall 2020).

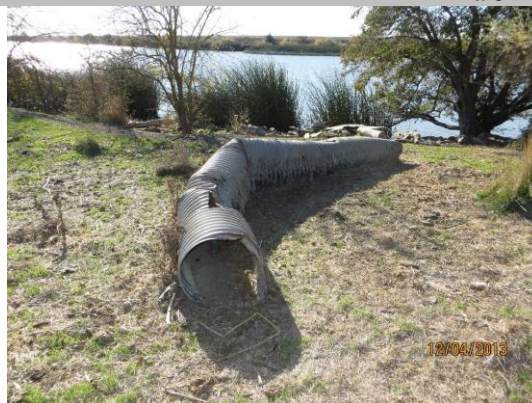
Photo 1 of 1 : UCIP\_FA\_2020\_41347\_45043.jpg

LM Start	2.40	Rating **	M	Issue No.	57
LM End	2.40	Issue Type +	En	Location *	
Category	Supplemental			GPS Latitude/Longitude	
				Start	End
Item	DWR UCIP Field Study			38.291579 °	38.291579 °
				-121.726159 °	-121.726159 °
DWR ID	24726				
Comment Code					
Inspector Comment					
DS_ID:24726 FS_ID:41347 EP_NO: N/A Repair Type: Non-Urgent EVAL Issue: Crossing Status: Indicator Found UCIP Comments: 24-inch CMP debris on WS berm may indicate pipe was abandoned. FIELD_STRUCT_DESC: *ABANDONED* 24-inch corrugated metal drainage pipe through the levee, 18 feet below the crown. Flap gate on the waterside (WS) toe. [Additional Reference(s): USACE Sacramento O&M Manual 108, April 1964, (HLM 2.60)]. FS Date: 12/4/2013

Pipe debris on WS berm.

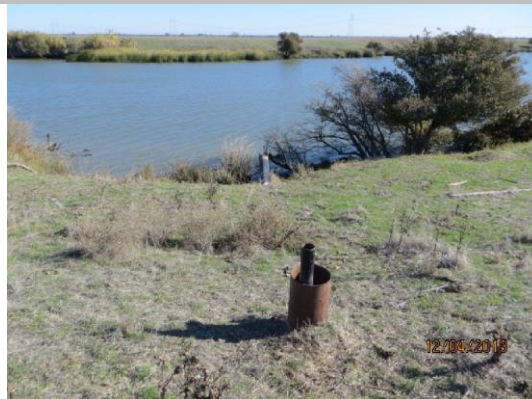
Photo 1 of 2 : UCIP\_FA\_2020\_24990\_45047.jpg

DS\_ID:24708  
FS\_ID:24990  
EP\_NO: 10185  
Repair Type: No Action Needed  
EVAL Issue:  
Crossing Status: Found  
UCIP Comments: 09/14/2017 Permit is unavailable, missing page 3 official permit documentation. (DWR UCIP - O. Magana)  
FIELD\_STRUCT\_DESC: 12-inch steel drainage pipe through the levee, 4 feet below the crown. Pump on pile structure in drainage canal on the landside (LS). Siphon breaker in a 12-inch steel riser on the waterside (WS) slope. (Automatic Board Order (ABO) issued as Permit No. 10185, 1964 - Erwin E. and Lucy G. Vasser, limited information available electronic version of permit missing. Replaced under Permit No. 4412, 1963 - Erwin E. and Lucy G. Vassar, limited details available electronic permit copy unavailable). [Additional Reference(s): DWR Levee Log, 2006. USACE Sacramento O&M Manual 108, April 1964, (HLM 3.12), Drawing No. 50-04-3379].  
FS Date: 12/4/2013

Siphon breaker in steel riser on WS slope with pipe and flap gate visible in background at WS berm.

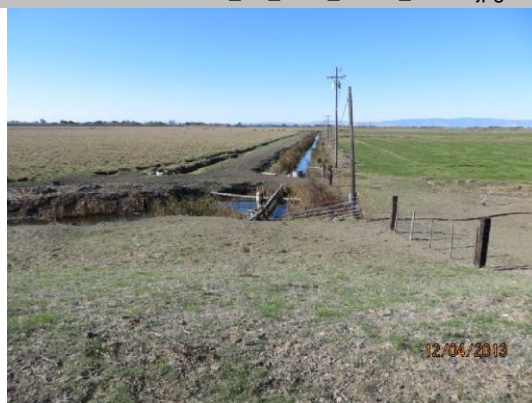
Photo 2 of 2 : UCIP\_FA\_2020\_24990\_45046.jpg

Pump on pier in ditch off LS toe.

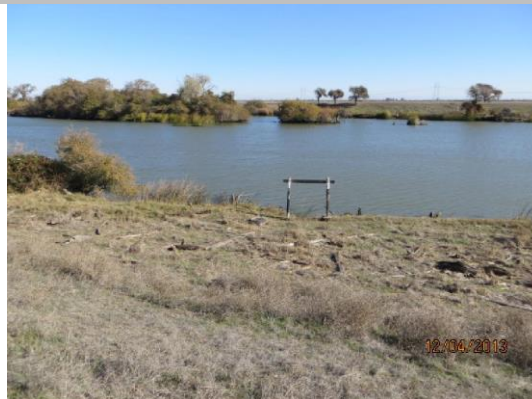
Photo 1 of 3 : UCIP\_FA\_2020\_41834\_45069.jpg

LM Start	3.04	Rating **	M	Issue No.	59
LM End	3.04	Issue Type +	En	Location *	
Category	Supplemental			GPS Latitude/Longitude	
				Start	End
Item	DWR UCIP Field Study			38.299447 °	38.299447 °
				-121.730444 °	-121.730444 °
DWR ID	24720				
Comment Code					
Inspector Comment					
DS_ID:24720 FS_ID:41834 EP_NO: 14184 Repair Type: Non-Urgent EVAL Issue: Crossing Status: Found UCIP Comments: Signs in disrepair and need proper markings. FIELD_STRUCT_DESC: 6-inch steel gas line through the levee, 3 feet below the crown. Signs on both toes of the levee. FS Date: 12/4/2013

Sign on WS berm.

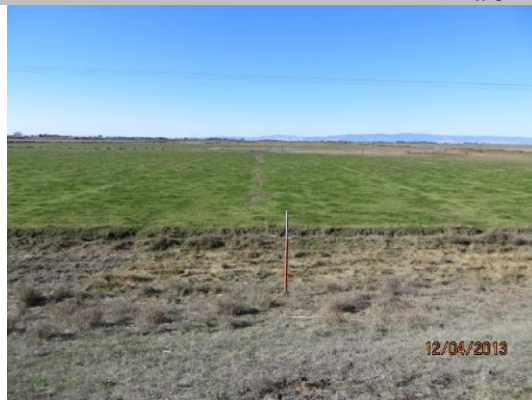
Photo 2 of 3 : UCIP\_FA\_2020\_41834\_45068.jpg

Sign post on LS toe.

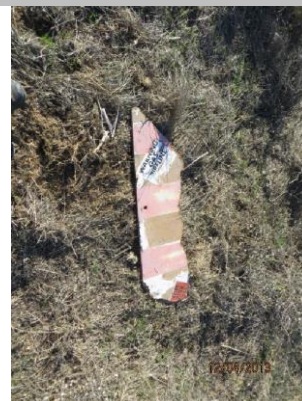
Photo 3 of 3 : UCIP\_FA\_2020\_41834\_45070.jpg

Broken sign marker on LS toe.

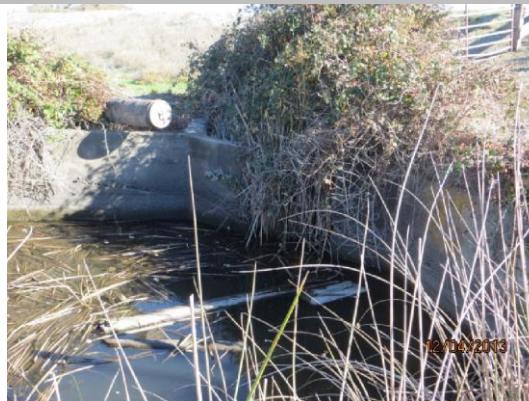
Photo 1 of 3 : UCIP\_FA\_2020\_24992\_45051.jpg

DS\_ID:24707  
 FS\_ID:24992  
 EP\_NO: 4412  
 Repair Type: Non-Urgent  
 EVAL Issue:  
 Crossing Status: Indicator Found  
 UCIP Comments: Heavy vegetation at concrete headwall on LS toe and at possible outlet area on WS toe. If possible, vegetation should be cleared to check if this is an accurate location. Erosion around backside of headwall at LS toe.  
 FIELD\_STRUCT\_DESC: 48-inch by 48-inch reinforced concrete box drainage culvert through the levee, 17 feet below the crown. Concrete headwall on the landside (LS) toe. [Additional Reference(s): DWR Levee Log, 2006. USACE Sacramento O&M Manual 108, April 1964, (HLM 3.37)].  
 FS Date: 12/4/2013

Vegetation covering possible location for 4X4 concrete culvert at LS toe.

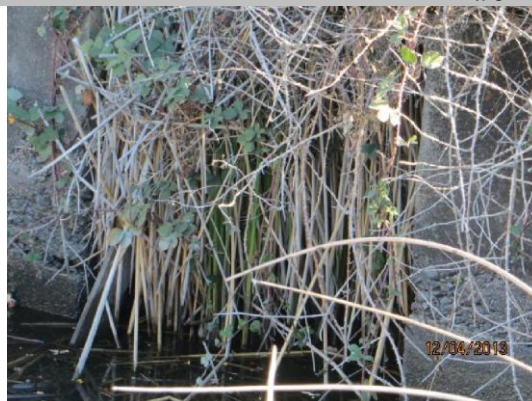
Photo 2 of 3 : UCIP\_FA\_2020\_24992\_45050.jpg

Vegetation covering possible location for 4X4 concrete culvert at LS toe.

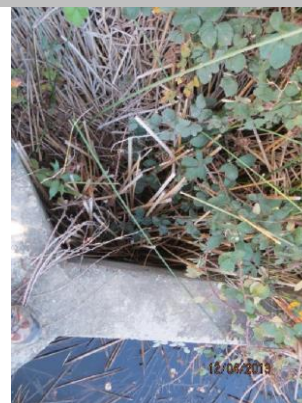
Photo 3 of 3 : UCIP\_FA\_2020\_24992\_45049.jpg

Some erosion on levee side of headwall at LS toe.

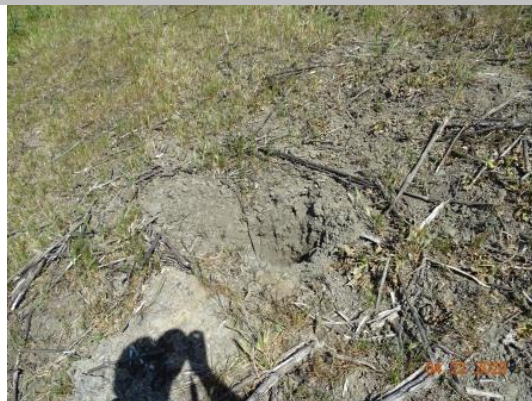
Photo 1 of 1 : FA\_2020\_RD2104\_249\_16\_20201009\_00002.jpg

LM Start	3.77	Rating **	M	Issue No.	16
LM End	3.77	Issue Type +	Ma	Location *	LS
Category	Earthen Levee			GPS Latitude/Longitude	
				Start	End
Item	Animal Control			38.307885 °	38.307885 °
				-121.734590 °	-121.734590 °
DWR ID	DWR_RD2104_01_s_2020_16				
Comment Code					
A3 : No rodents visible, but rodent burrows visible; need to backfill and compact or grout burrows.					
Inspector Comment					
One large hole in the landside slope.

View of large hole in the landside slope (Spring 2020).

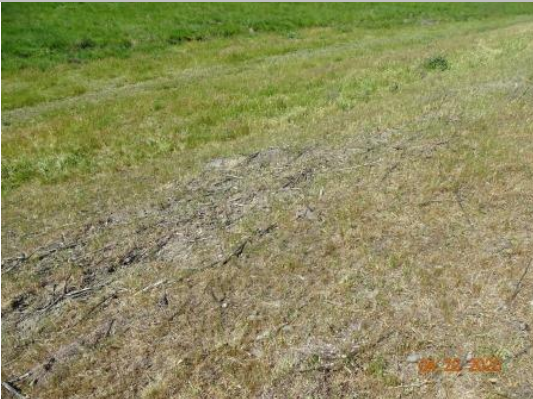
Photo 1 of 1 : FA\_2020\_RD2104\_249\_15\_20201009\_00001.jpg

View looking upstream at terracing due to cows in the landside slope (Spring 2020).

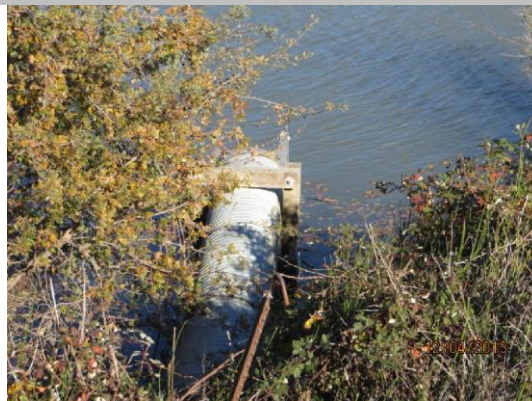
Photo 1 of 3 : UCIP\_FA\_2020\_51459\_45062.jpg

DS\_ID:24705  
FS\_ID:51459  
EP\_NO: 10182  
Repair Type: Non-Urgent  
EVAL Issue:  
Crossing Status: Found  
UCIP Comments: 12/06/2016 Crossing has been downgraded from "Urgent" to "Non-Urgent" no signs of leaks observed along pipe alignment (limited inspection on WS toe). According to LMA representative, this crossing was replaced 6 years ago (2010) at WS concrete apron. Recommend conducting internal inspection of pipe through the levee and LS to determine pipe integrity. (O. Magana - DWR UCIP)12/04/2013 Vegetation and soil buildup throughout pipe preventing flapgate from closing. Remove vegetation to allow gate to close properly. (W. Wylie - DWR UCIP)  
FIELD\_STRUCT\_DESC: 24-inch corrugated metal drainage pipe through the levee, 15 feet below the crown. 36-inch concrete standpipe on the landside (LS) toe. Flap gate on the waterside (WS) toe. Two corrugated metal cutoff walls installed. (24-inch pipe [HLM 4.65] authorized under Automatic Board Order (ABO) issued as Permit No. 10182, 1974 - Julia Trust Machado). [Additional Reference(s): DWR Levee Log, 2006. USACE Sacramento O&M Manual 108, April 1964, (HLM 4.65), Drawing No. 50-04-3379].

CMP pipe and flapgate off WS toe.

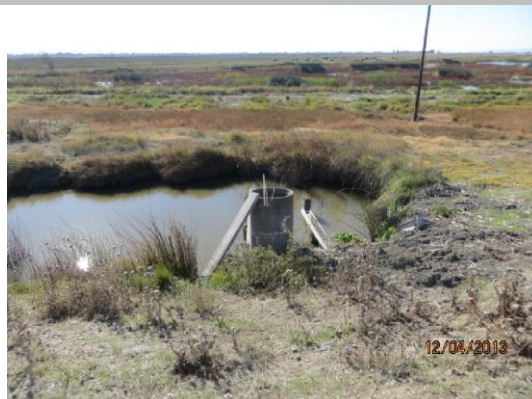
Photo 2 of 3 : UCIP\_FA\_2020\_51459\_45061.jpg

36-inch concrete riser on LS toe at channel.

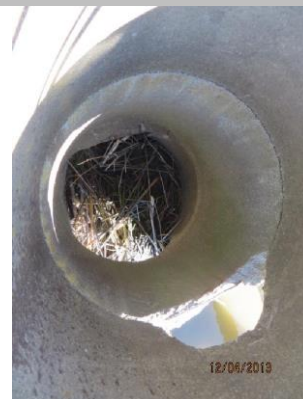
Photo 3 of 3 : UCIP\_FA\_2020\_51459\_45060.jpg

36-inch concrete riser with vegetation buildup inside.

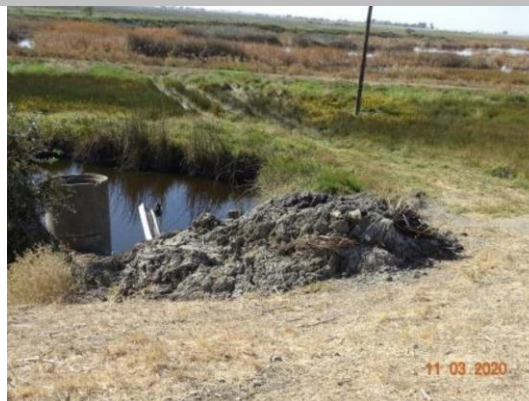
Photo 1 of 1 : FA\_2020\_RD2104\_249\_28\_20201103\_00044.jpg

LM Start	4.31	Rating **	M	Issue No.	28
LM End	4.31	Issue Type +	Ma	Location *	LS
Category	Earthen Levee			GPS Latitude/Longitude	
				Start	End
Item	Encroachments			38.313998 °	38.313998 °
				-121.739940 °	-121.739940 °
DWR ID	DWR_RD2104_01_f_2020_28				
Comment Code					
MA : Material					
Inspector Comment					
Dredged material on the landside slope.

View of dredged material on the landside slope (Fall 2020).

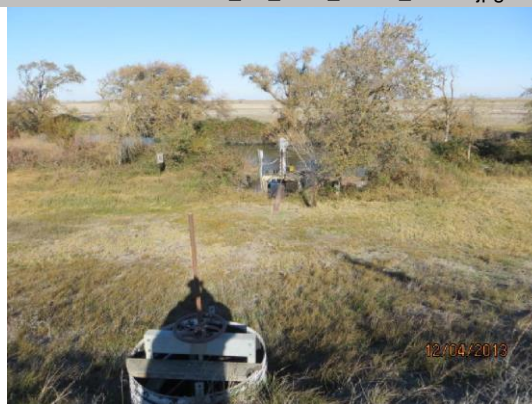
Photo 2 of 2 : UCIP\_FA\_2020\_25005\_45082.jpg

Slide gate in CMP riser on WS slope with pump on pier in background.

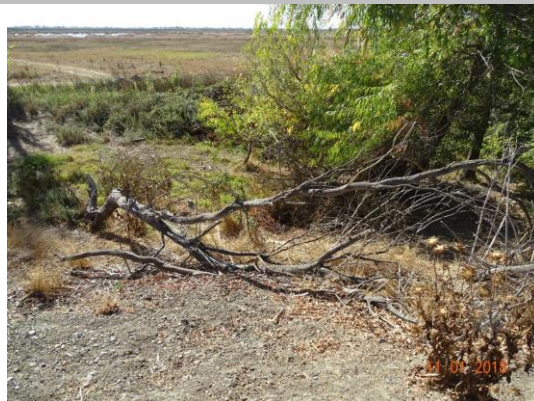
Photo 1 of 1 : FA\_2020\_RD2104\_249\_31\_20201009\_00009.jpg

View of down tree limb on the landside slope (November 2018).

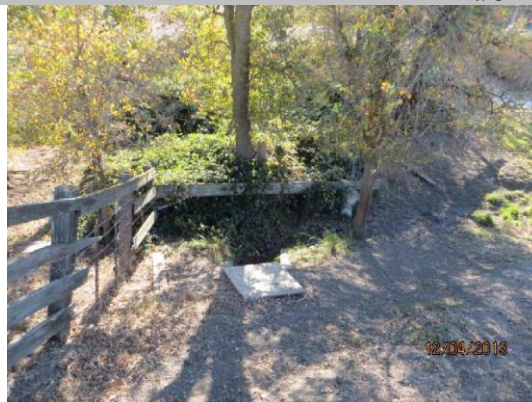
Photo 2 of 3 : UCIP\_FA\_2020\_25006\_45085.jpg

Concrete U shaped headwall on LS toe.

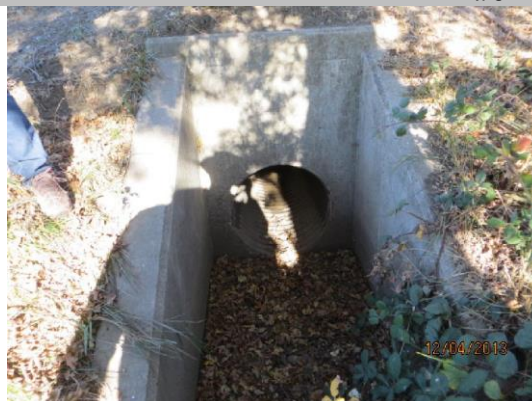
Photo 3 of 3 : UCIP\_FA\_2020\_25006\_45084.jpg

Concrete U shaped headwall on LS toe.

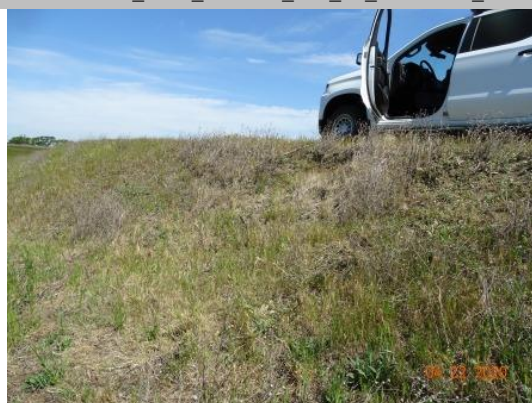
Photo 1 of 1 : FA\_2020\_RD2104\_249\_24\_20201009\_00007.jpg

LM Start	4.96	Rating **	M	Issue No.	24
LM End	4.96	Issue Type +	Ma	Location *	LS
Category	Earthen Levee			GPS Latitude/Longitude	
				Start	End
Item	Slope Stability			38.320382 °	38.320382 °
				-121.748155 °	-121.748155 °
DWR ID	DWR_RD2104_01_f_2017_24				
Comment Code					
S1 : Repair slope instability.					
Inspector Comment

View looking upstream slope instability at the landside hinge (Spring 2020).

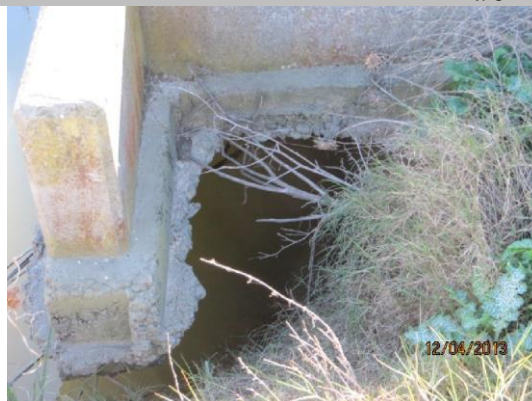
Photo 2 of 3 : UCIP\_FA\_2020\_53387\_45089.jpg

Headwall undermined on WS toe.

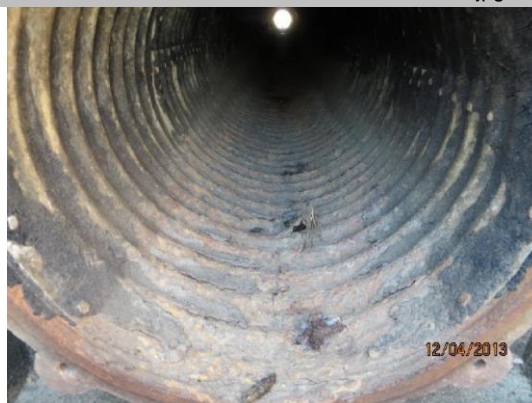
Photo 3 of 3 : UCIP\_FA\_2020\_53387\_45088.jpg

Corrosion through pipe with holes on WS toe.

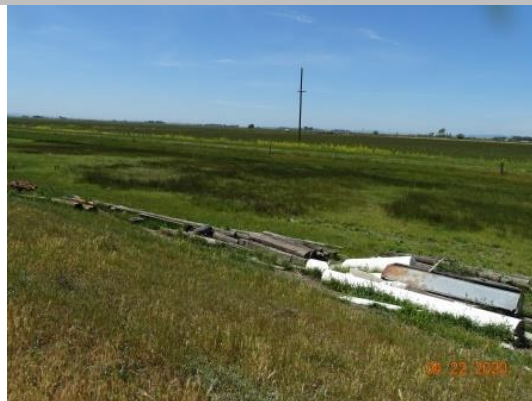
Photo 1 of 1 : FA\_2020\_RD2104\_249\_39\_20201009\_00010.jpg

LM Start	6.25	Rating **	U	Issue No.	39
LM End	6.25	Issue Type +	En	Location *	WS
Category	Earthen Levee			GPS Latitude/Longitude	
				Start	End
Item	Encroachments			38.316909 °	38.316909 °
				-121.758194 °	-121.758194 °
DWR ID	DWR_RD2104_01_s_2020_39				
Comment Code					
DE : Debris					
Inspector Comment					
Remove debris at waterside toe.

View looking upstream at debris on the waterside toe (Spring 2020).

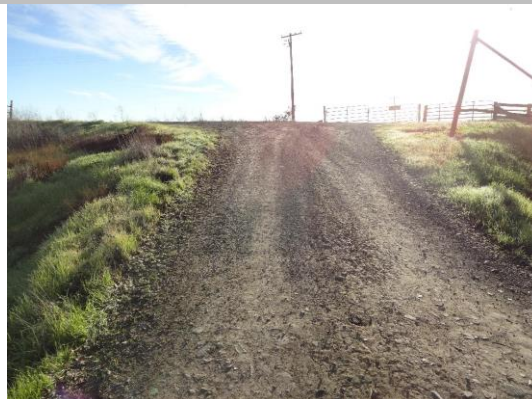
Photo 1 of 3 : UCIP\_FA\_2020\_53385\_76913.jpg

Comment Code						
Inspector Comment						
DS_ID:24699 FS_ID:53385 EP_NO: 10184 Repair Type: Non-Urgent EVAL Issue: Crossing Status: Indicator Found UCIP Comments: 10/12/2018 Crossing downgraded to Non-Urgent due to reclassification of gas lines. Need to contact owner to determine current status of crossing (D. Sanoski - DWR UCIP).12/06/2016 No indicators were found. According to LMA representative, the gas line has been abandoned and markers have been removed about 10-15 years ago. Solano County was performing work on the LS toe approximately 700 feet from LS toe and according to their underground service alert (USA) survey completed for their construction site no PGE line was identified. Need to contact owner to determine abandoned as-builts for 8-inch line. (O. Magana - DWR UCIP)12/04/2013 Pump station visible to north on LS toe. Good indicator of location. Need PG+E to mark pipe location. (W. Wylie - DWR UCIP) FIELD_STRUCT_DESC: 8-inch iron gas line through the levee, 2 feet below the crown. (8-inch gas line authorized under Automatic Board Order (ABO) issued as Permit No. 10184, 1974 - Pacific Gas and Electric Company [PG&E]. 8-inch gas line first referenced in the USACE O&M as-built drawings from 1956). [Additional Reference(s): DWR Levee Log, 2006. USACE Sacramento O&M Manual 108, April 1964, Drawing No. 50-04-3379A, Sheet 3379/2, Page 2 of 7, (Station 82+30)]. FS Date: 10/12/2018 5:13:00 PM

No signs present at ramp to enter RD2104.

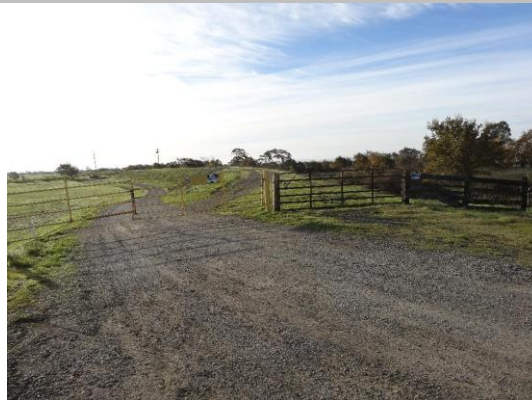
Photo 2 of 3 : UCIP\_FA\_2020\_53385\_76914.jpg

No signs present of gas line.

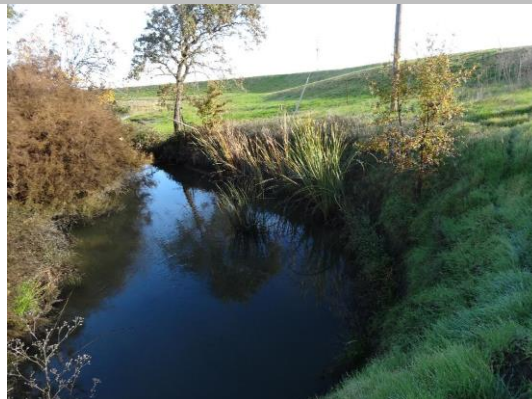
Photo 3 of 3 : UCIP\_FA\_2020\_53385\_76915.jpg

Photo of where the line is estimated to cross on LS.
