Flood Control Project Maintenance Levee Inspections

Fall 2021 Levee Maintenance Deficiency Summary Report

Reclamation District No. 2104 Peters Pocket Tract

Levee Inspection Report By Mile - Fall 2021

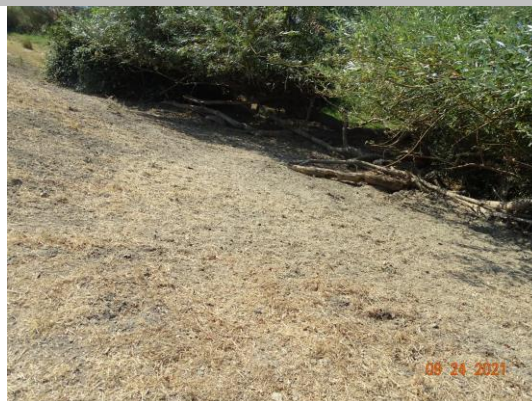
Photo 1 of 1 : FA_2021_RD2104_249_23_20210928_00043.jpg

LM Start	1.27	Rating **	M	Issue No.	23
LM End	1.27	Issue Type +	Ma	Location *	WS
Category	Earthen Levee			GPS Latitude/Longitude	
				Start	End
Item	Animal Control			38.296182 °	38.296182 °
				-121.744318 °	-121.744318 °
DWR ID	DWR_RD2104_01_f_2016_23				
Comment Code					
A2 : Repair the levee slope damaged by livestock and prevent large animal access.					
Inspector Comment					
Repair the slope damaged by cows.

View looking downstream at trail caused by cows on the waterside slope (Fall 2021).

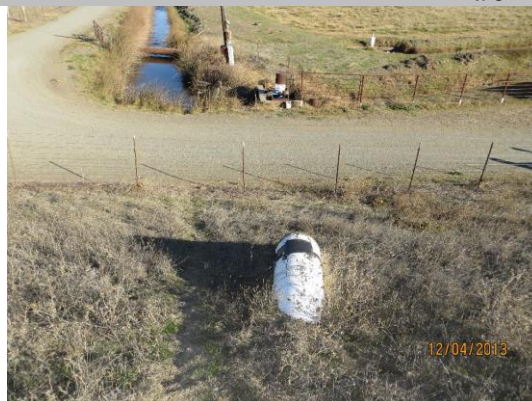
Photo 1 of 3 : UCIP_FA_2021_24984_45042.jpg

Comment Code						
Inspector Comment						
DS_ID:24711						
FS_ID:24984						
EP_NO: 10185						
Repair Type: No Action Needed						
EVAL Issue:						
Crossing Status: Found						
UCIP Comments: 09/14/2017 Permit is unavailable, missing page 3 official permit documentation. (DWR UCIP - O. Magana)						
FIELD_STRUCT_DESC: 16-inch steel drainage pipe through the levee, 5.7 feet below the crown. Pump in an irrigation ditch on the landside (LS). Siphon breaker on the waterside (WS) slope. (Automatic Board Order (ABO) issued as Permit No. 10185, 1964 - Erwin E. and Lucy G. Vasser, limited details available electronic permit unavailable).						
[Additional Reference(s): DWR Levee Log, 2006. USACE Sacramento O&M Manual 108, April 1964, (HLM 1.52), Drawing Nos. 50-04-1977 and 50-04-3379].						
FS Date: 12/4/2013

Pipe on LS slope with pump in irrigation ditch off LS toe visible in background.

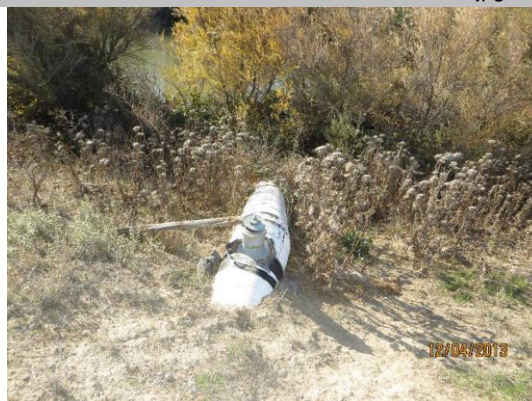
Photo 2 of 3 : UCIP_FA_2021_24984_45041.jpg

Siphon breaker on pipe at WS slope.

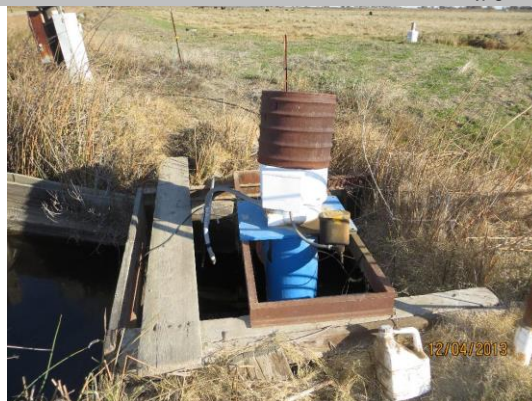
Photo 3 of 3 : UCIP_FA_2021_24984_45040.jpg

Pump in wooden distribution box off LS toe.

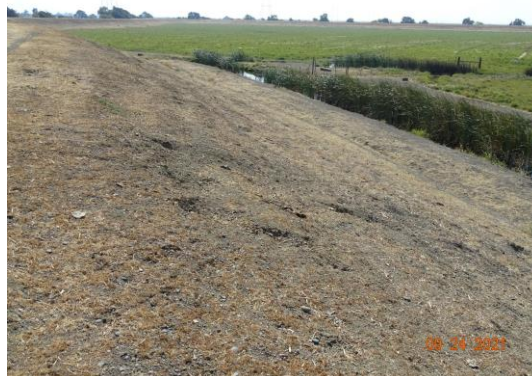
Photo 1 of 1 : FA_2021_RD2104_249_25_20210928_00044.jpg

LM Start	2.76	Rating **	M	Issue No.	25
LM End	2.76	Issue Type +	Ma	Location *	LS
Category	Earthen Levee			GPS Latitude/Longitude	
				Start	End
Item	Animal Control			38.295661 °	38.295661 °
				-121.728765 °	-121.728765 °
DWR ID	DWR_RD2104_01_f_2021_25				
Comment Code					
A2 : Repair the levee slope damaged by livestock and prevent large animal access.					
Inspector Comment

View looking downstream at depressions due to cows on the landside slope (Fall 2021).

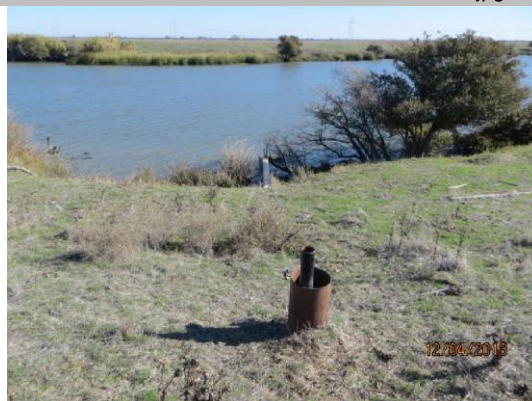
Photo 1 of 2 : UCIP_FA_2021_24990_45047.jpg

Comment Code					
Inspector Comment					
DS_ID:24708					
FS_ID:24990					
EP_NO: 10185					
Repair Type: No Action Needed					
EVAL Issue:					
Crossing Status: Found					
UCIP Comments: 09/14/2017 Permit is unavailable, missing page 3 official permit documentation. (DWR UCIP - O. Magana)					
FIELD_STRUCT_DESC: 12-inch steel drainage pipe through the levee, 4 feet below the crown. Pump on pile structure in drainage canal on the landside (LS). Siphon breaker in a 12-inch steel riser on the waterside (WS) slope. (Automatic Board Order (ABO) issued as Permit No. 10185, 1964 - Erwin E. and Lucy G. Vasser, limited information available electronic version of permit missing. Replaced under Permit No. 4412, 1963 - Ervin E. and Lucy G. Vassar, limited details available electronic permit copy unavailable). [Additional Reference(s): DWR Levee Log, 2006. USACE Sacramento O&M Manual 108, April 1964, (HLM 3.12), Drawing No. 50-04-3379].

Siphon breaker in steel riser on WS slope with pipe and flap gate visible in background at WS berm.

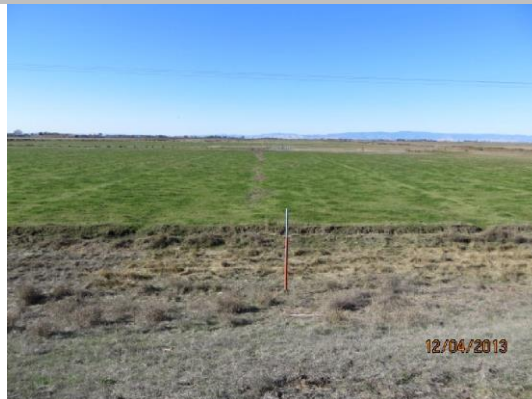
Photo 2 of 3 : UCIP_FA_2021_41834_45068.jpg

Sign post on LS toe.

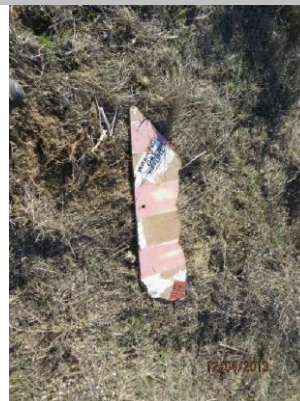
Photo 3 of 3 : UCIP_FA_2021_41834_45070.jpg

Broken sign marker on LS toe.

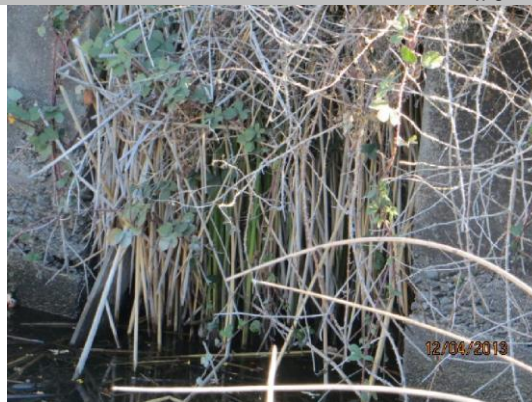
Photo 2 of 3 : UCIP_FA_2021_24992_45050.jpg

Vegetation covering possible location for 4X4 concrete culvert at LS toe.

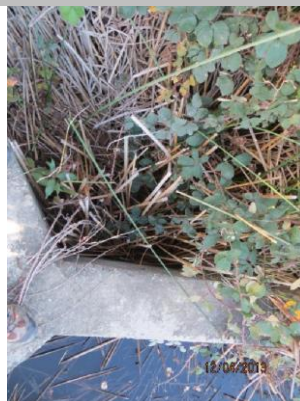
Photo 3 of 3 : UCIP_FA_2021_24992_45049.jpg

Some erosion on levee side of headwall at LS toe.

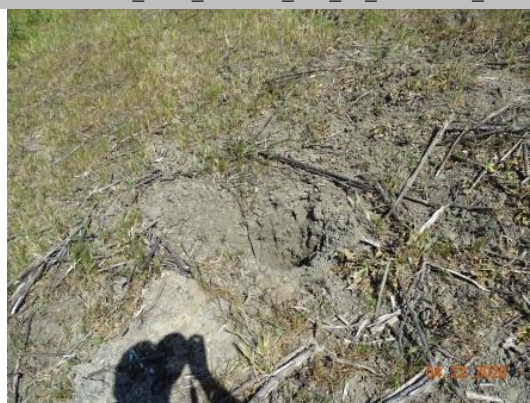
Photo 1 of 1 : FA_2021_RD2104_249_16_20210830_00003.jpg

View of large hole in the landside slope (Spring 2020).

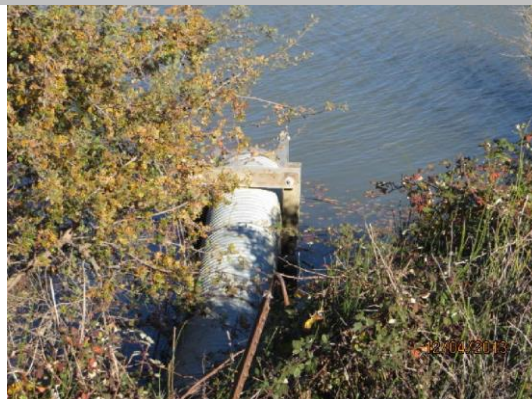
Photo 1 of 3 : UCIP_FA_2021_51459_45062.jpg

Comment Code						
Inspector Comment						
DS_ID:24705 FS_ID:51459 EP_NO: 10182 Repair Type: Non-Urgent EVAL Issue: Crossing Status: Found UCIP Comments: 12/06/2016 Crossing has been downgraded from "Urgent" to "Non-Urgent" no signs of leaks observed along pipe alignment (limited inspection on WS toe). According to LMA representative, this crossing was replaced 6 years ago (2010) at WS concrete apron. Recommend conducting internal inspection of pipe through the levee and LS to determine pipe integrity. (O. Magana - DWR UCIP)12/04/2013 Vegetation and soil buildup throughout pipe preventing flapgate from closing. Remove vegetation to allow gate to close properly. (W. Wylie - DWR UCIP) FIELD_STRUCT_DESC: 24-inch corrugated metal drainage pipe through the levee, 15 feet below the crown. 36-inch concrete standpipe on the landside (LS) toe. Flap gate on the waterside (WS) toe. Two corrugated metal cutoff walls installed. (24-inch pipe [HLM 4.65] authorized under Automatic Board Order (ABO) issued as Permit No. 10182, 1974 - Julia Trust Machado). [Additional Reference(s): DWR Levee Log, 2006. USACE Sacramento O&M Manual 108, April 1964, (HLM 4.65), Drawing No. 50-04-3379]. FS Date: 12/6/2016

CMP pipe and flapgate off WS toe.

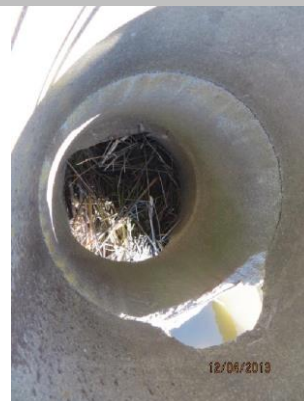
Photo 3 of 3 : UCIP_FA_2021_51459_45060.jpg

36-inch concrete riser with vegetation buildup inside.

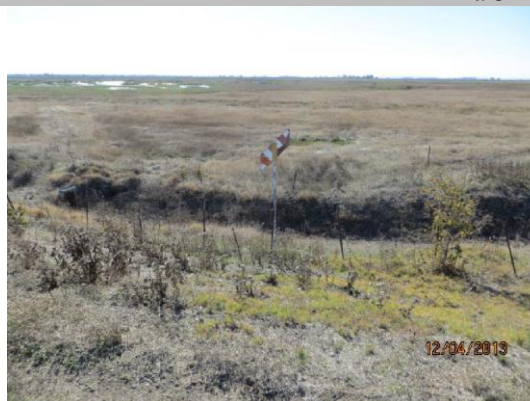
Photo 1 of 2 : UCIP_FA_2021_25003_45081.jpg

DS_ID:24704
 FS_ID:25003
 EP_NO: 10182
 Repair Type: Non-Urgent
 EVAL Issue:
 Crossing Status: Found
 UCIP Comments: Sign on WS toe needs repair.
 FIELD_STRUCT_DESC: 8-inch steel gas line through the levee, at the high elevation. Signs on both toes of the levee. (Automatic Board Order (ABO) issued as Permit No. 10182, 1974 - Julia Trust Machado).
 [Additional Reference(s): DWR Levee Log, 2006. USACE Sacramento O&M Manual 108, April 1964, Drawing No. 50-04-3379].
 FS Date: 12/4/2013

Gasline marker on LS toe.

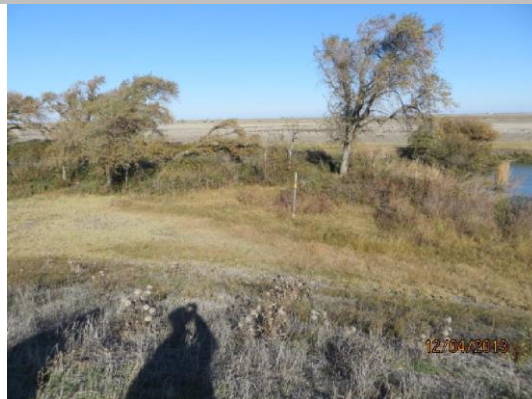
Photo 2 of 2 : UCIP_FA_2021_25003_45080.jpg

Sign pole on WS toe missing sign.

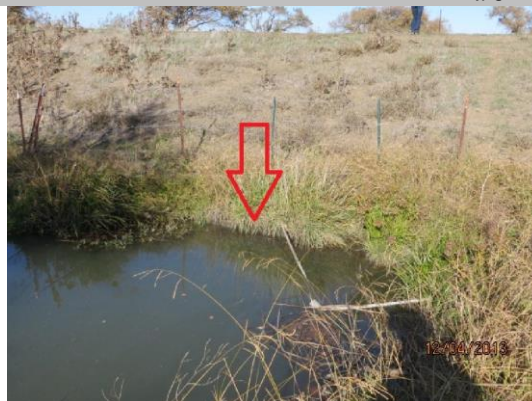
Photo 1 of 2 : UCIP_FA_2021_25005_45083.jpg

DS_ID:24703
 FS_ID:25005
 EP_NO: N/A
 Repair Type: Non-Urgent
 EVAL Issue:
 Crossing Status: Found
 UCIP Comments: Good candidate for video inspection.
 FIELD_STRUCT_DESC: 18-inch steel irrigation pipe through the levee, 13.5 feet below the crown. Pump on pile structure in the stream. Slide gate in a 36-inch corrugated metal pipe (CMP) riser on the waterside (WS) slope. Two cutoff walls. Concrete U-shaped headwall and air vent at the landside (LS) toe. Electrical conduit through the levee at the same location. [Additional Reference(s): DWR Levee Log, 2006. USACE Sacramento O&M Manual 108, April 1964, (HLM 5.06), Drawing No. 50-04-3379].
 FS Date: 12/4/2013

Concrete headwall on LS toe at irrigation ditch.

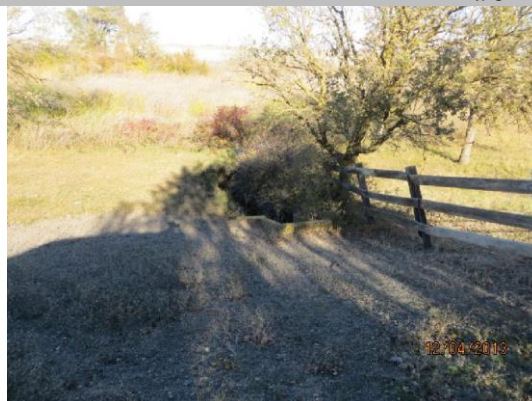
Photo 1 of 3 : UCIP_FA_2021_25006_45086.jpg

Concrete U shaped headwall on WS toe.

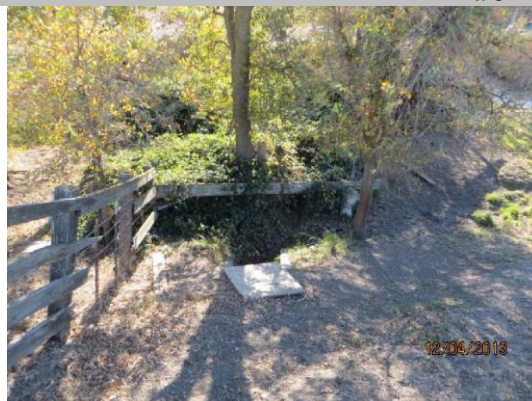
Photo 2 of 3 : UCIP_FA_2021_25006_45085.jpg

Concrete U shaped headwall on LS toe.

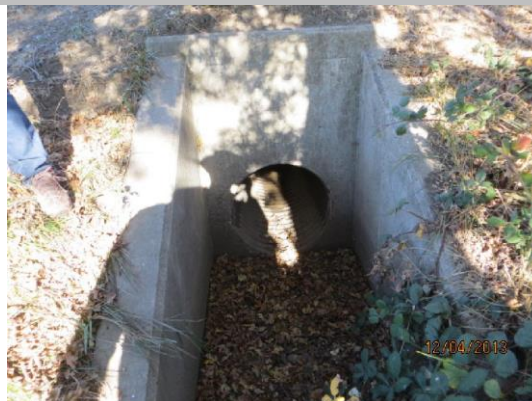
Photo 3 of 3 : UCIP_FA_2021_25006_45084.jpg

Concrete U shaped headwall on LS toe.

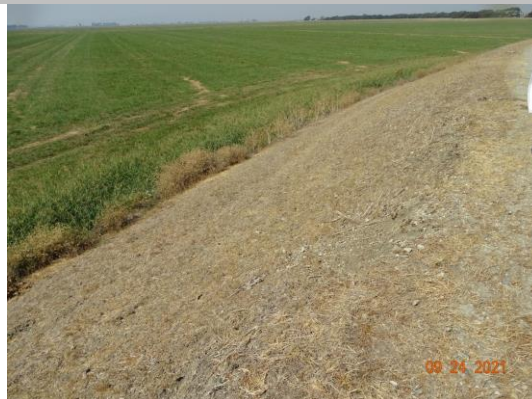
Photo 1 of 1 : FA_2021_RD2104_249_24_20210928_00045.jpg

LM Start	4.96	Rating **	M	Issue No.	24
LM End	4.96	Issue Type +	Ma	Location *	LS
Category	Earthen Levee			GPS Latitude/Longitude	
				Start	End
Item	Slope Stability			38.320382 °	38.320382 °
				-121.748155 °	-121.748155 °
DWR ID	DWR_RD2104_01_f_2017_24				
Comment Code					
S1 : Repair slope instability.					
Inspector Comment

View looking upstream at slope instability at the landside hinge (Fall 2021).

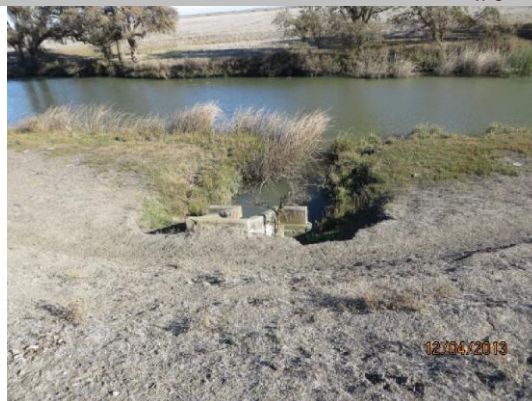
Photo 1 of 3 : UCIP_FA_2021_53387_45090.jpg

DS_ID:24701
FS_ID:53387
EP_NO: 10182
Repair Type: Urgent
EVAL Issue:
Crossing Status: Found
UCIP Comments: 10/12/2018 Same as last inspection; concrete headwall on WS still being undermined so crossing remains Urgent (D. Sanoski - DWR UCIP). 12/06/2016 same as last inspection--pipe remains "Urgent" CMP shows holes through wall and concrete headwall is undermined. Need to contact owner. Owner will need to work with the CVFPB to comply with Title 23. (O. Magana - DWR UCIP) 12/04/2013 Footing under headwall on WS toe severely undermined. Pipe rusted heavily with holes at WS and may need replacement. (W. Wylie - DWR UCIP)
FIELD_STRUCT_DESC: 24-inch corrugated metal drainage pipe through the levee, 13 feet below the crown. Two cutoff walls. Concrete U-shaped headwalls on both ends. Flap gate on the waterside (WS). (24-inch pipe [HLM 5.50] authorized under Automatic Board Order (ABO) issued as Permit No. 10182, 1974 - Julia Trust Machado). [Additional Reference(s): DWR Levee Log, 2006. USACE Sacramento O&M Manual 108, April 1964, (HLM 5.5), listed as a 12-inch pipe, Drawing No. 50-04-3379, listed as an 18-inch pipe].

Concrete U-shaped headwall on WS toe. Note erosion scarp around headwall.

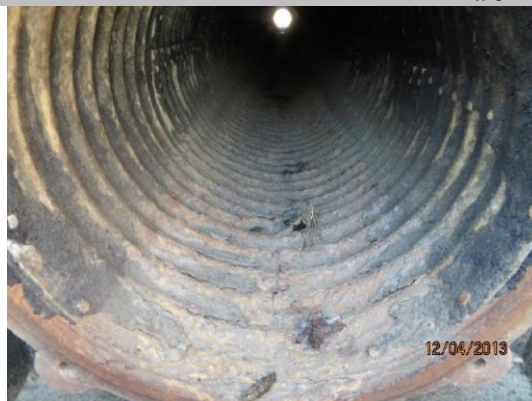
Photo 3 of 3 : UCIP_FA_2021_53387_45088.jpg

Corrosion through pipe with holes on WS toe.

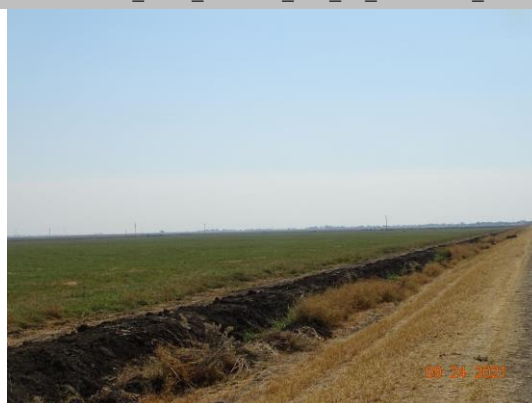
Photo 1 of 1 : FA_2021_RD2104_249_33_20210928_00046.jpg

View looking upstream at ditch within 15 feet of landside toe (Fall 2021).

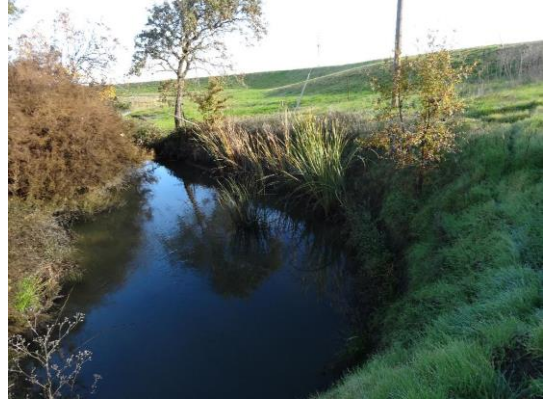
Photo 3 of 3 : UCIP_FA_2021_53385_76915.jpg

Photo of where the line is estimated to cross on LS.
