## Flood Control Project Maintenance Levee Inspections

### Fall 2022 Levee Maintenance Deficiency Summary Report

**Reclamation District No. 2104 Peters Pocket Tract**

**Levee Inspection Report By Mile - Fall 2022**

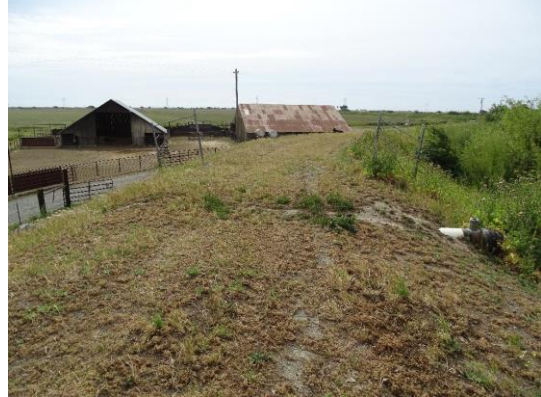
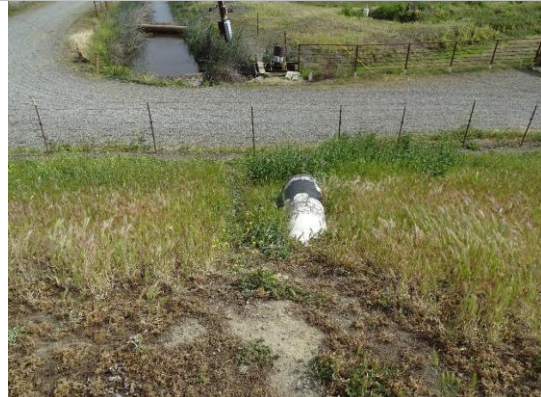
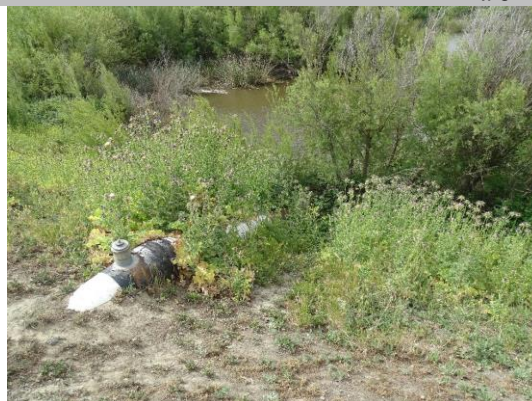
Comment Code						
Inspector Comment						
DS_ID:24711						
FS_ID:75136						
EP_NO: 10185						
Repair Type: No Action Needed						
EVAL Issue:						
Crossing Status: Found						
UCIP Comments: 05/05/2022 Record remains No Action Needed. No						
issues observed during inspection. Running while there. System						
Feature. (D.Sanoski - DWR UCIP)						
09/14/2017 Permit is unavailable, missing page 3 official permit						
documentation. (DWR UCIP - O. Magana)						
FIELD_STRUCT_DESC: 16-inch steel drainage pipe through the levee,

View of levee crown and pipe crossing.

View of pipe out of LS slope.

View of pipe out of WS slope.

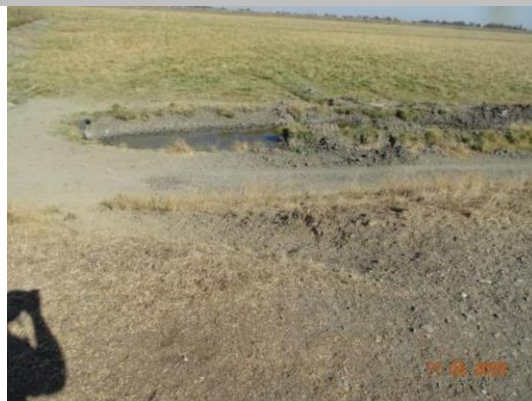
Photo 1 of 1 : FA\_2022\_RD2104\_249\_13\_20220831\_00001.jpg

LM Start	1.58	Rating **	M	Issue No.	13
LM End	1.58	Issue Type +	Ma	Location *	LS
Category	Earthen Levee			GPS Latitude/Longitude	
				Start	End
Item	Erosion / Livestock			38.294097 °	38.294097 °
				-121.740133 °	-121.740133 °
DWR ID	DWR_RD2104_01_f_2020_13				
Comment Code					
E4 : Repair the levee slope damaged by livestock and prevent large animal access.					
Inspector Comment					
There is a cow path that is digging into levee.

View of cow path down the landside slope (Fall 2020).

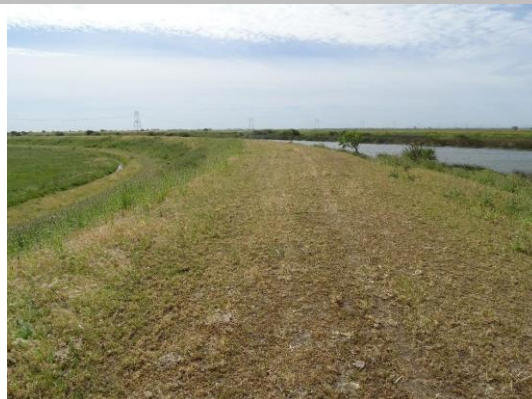
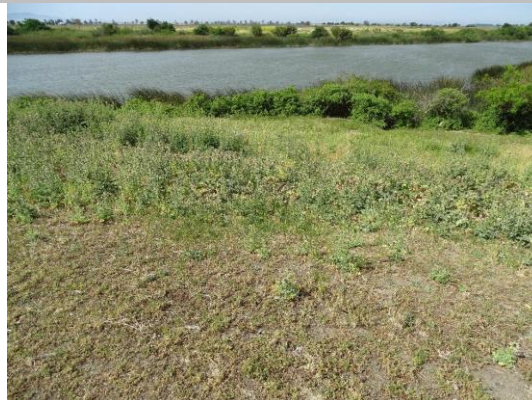
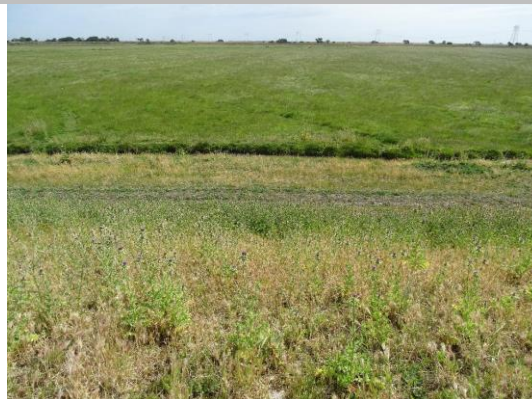
Comment Code						
Inspector Comment						
DS_ID:24721 FS_ID:75140 EP_NO: N/A Repair Type: Non-Urgent EVAL Issue: Crossing Status: Not Found UCIP Comments: 05/05/2022 Record remains Non-Urgent. Geophysical results did not confirm presence of pipe through levee. Record will remain in UCIP's inspection records until future Levee Improvement Project can confirm no crossing was found through the levee. System Feature. (D.Sanoski - DWR UCIP) FIELD_STRUCT_DESC: 16-inch drainage pipe of an unknown material through the levee, at an unknown depth. Flap gate on the waterside (WS) toe. [Additional Reference(s): USACE Sacramento O&M Manual 108, April 1964, (HLM 2.04)]. FS Date: 5/5/2022 12:06:18 PM

View of levee crown.

View of WS slope.

View of LS slope.

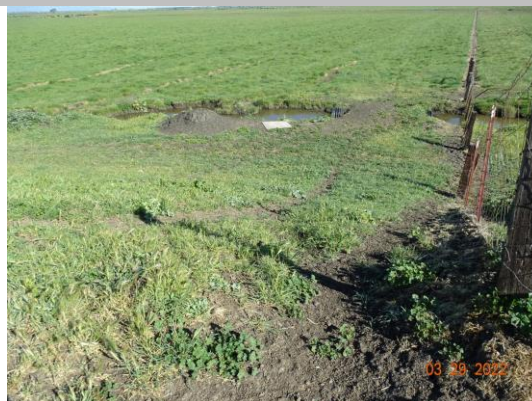
Photo 1 of 1 : FA\_2022\_RD2104\_249\_22\_20220831\_00007.jpg

LM Start	2.10	Rating **	M	Issue No.	22
LM End	2.10	Issue Type +	Ma	Location *	LS
Category	Earthen Levee			GPS Latitude/Longitude	
				Start	End
Item	Erosion / Livestock			38.292058 °	38.292058 °
				-121.731555 °	-121.731555 °
DWR ID	DWR_RD2104_01_f_2020_22				
Comment Code					
E4 : Repair the levee slope damaged by livestock and prevent large animal access.					
Inspector Comment					
There is a cow path on the landside slope.

View of cow path down the landside slope (Spring 2022).

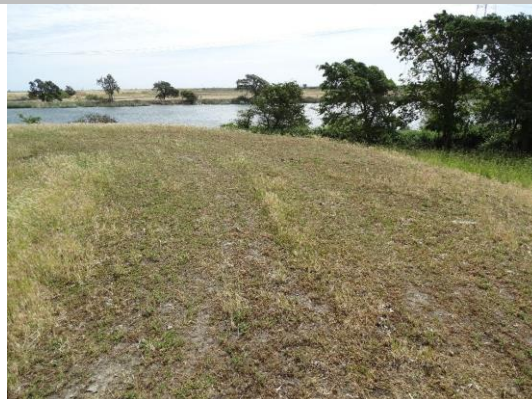
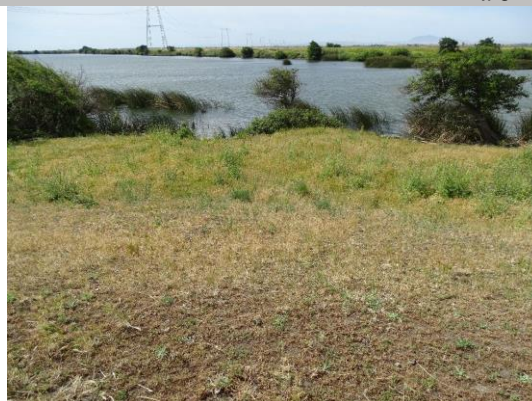
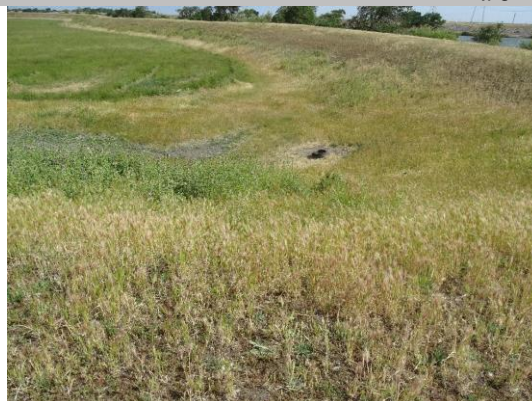
Comment Code					
Inspector Comment					
DS_ID:24726 FS_ID:75141 EP_NO: N/A Repair Type: Non-Urgent EVAL Issue: Crossing Status: Not Found UCIP Comments: 05/05/2022 Record remains Non-Urgent. Geophysical results did not confirm presence of pipe through levee. Record will remain in UCIP's inspection records until future Levee Improvement Project can confirm no crossing was found through the levee. No physical sign of abandoned pipe stated in last comment. System Feature. (D.Sanoski - DWR UCIP) 12/04/2013 24-inch CMP debris on WS berm may indicate pipe was abandoned. (W.Wylie - DWR UCIP) FIELD_STRUCT_DESC: 24-inch corrugated metal drainage pipe through the levee, 18 feet below the crown. Flap gate on the waterside (WS) toe. [Additional Reference(s): USACE Sacramento O&M Manual 108, April 1964, (HLM 2.60)]. FS Date: 5/5/2022 12:58:09 PM

View of levee crown.

View of WS slope.

View of LS slope.

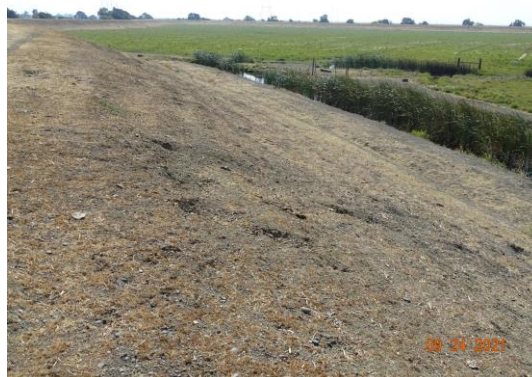
Photo 1 of 1 : FA\_2022\_RD2104\_249\_25\_20220831\_00010.jpg

LM Start	2.76	Rating **	M	Issue No.	25
LM End	2.76	Issue Type +	Ma	Location *	LS
Category	Earthen Levee			GPS Latitude/Longitude	
				Start	End
Item	Erosion / Livestock			38.295661 °	38.295661 °
				-121.728765 °	-121.728765 °
DWR ID	DWR_RD2104_01_f_2021_25				
Comment Code					
E4 : Repair the levee slope damaged by livestock and prevent large animal access.					
Inspector Comment

View looking downstream at depressions due to cows on the landside slope (Fall 2021).

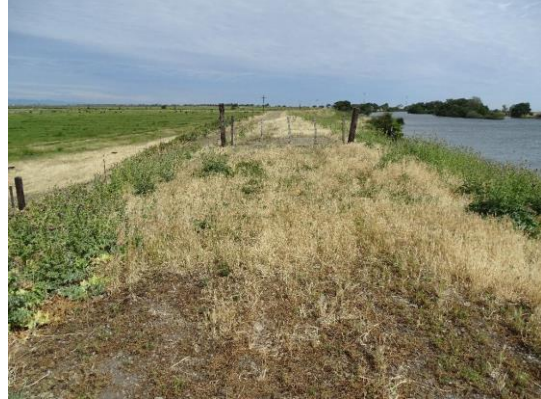
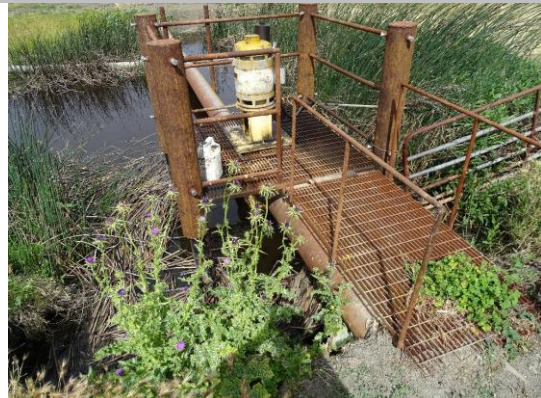
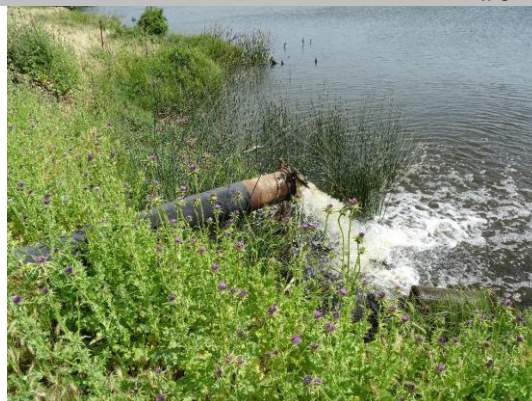
Comment Code					
Inspector Comment					
DS_ID:24708 FS_ID:75142 EP_NO: 10185 Repair Type: No Action Needed EVAL Issue: Crossing Status: Found UCIP Comments: 05/05/2022 Record remains No Action Needed. No issues observed during inspection. System Feature. (D.Sanoski - DWR UCIP) 09/14/2017 Permit is unavailable, missing page 3 official permit documentation. (DWR UCIP - O. Magana) FIELD_STRUCT_DESC: 12-inch steel drainage pipe through the levee, 4 feet below the crown. Pump on pile structure in drainage canal on the landside (LS). Siphon breaker in a 12-inch steel riser on the waterside (WS) slope. (Automatic Board Order (ABO) issued as Permit No. 10185, 1964 - Erwin E. and Lucy G. Vasser, limited information available electronic version of permit missing. Replaced under Permit No. 4412, 1963 - Ervin E. and Lucy G. Vassar, limited details available electronic permit copy unavailable). [Additional Reference(s): DWR Levee Log, 2006. USACE Sacramento O&M Manual 108, April 1964, (HLM 3.12), Drawing No. 50-04-3379]. FS Date: 5/5/2022 12:58:29 PM

View of levee crown.

View of pump on structure off LS toe.

View of pipe with flap gate out of WS berm.

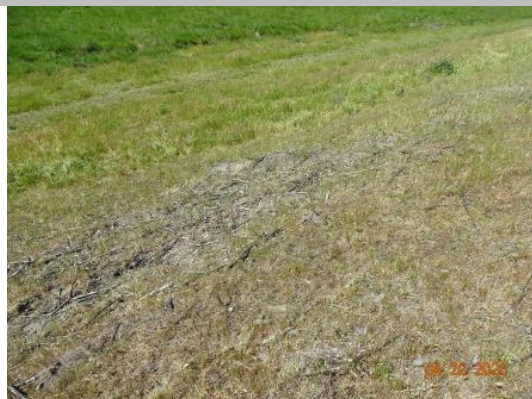
Photo 1 of 1 : FA\_2022\_RD2104\_249\_15\_20220831\_00002.jpg

LM Start	3.77	Rating **	M	Issue No.	15
LM End	3.84	Issue Type +	Ma	Location *	LS
Category	Earthen Levee			GPS Latitude/Longitude	
				Start	End
Item	Erosion / Livestock			38.307888 °	38.308483 °
				-121.734589 °	-121.735712 °
DWR ID	DWR_RD2104_01_s _ 2020_15				
Comment Code					
E4 : Repair the levee slope damaged by livestock and prevent large animal access.					
Inspector Comment					
Cows are digging into levee.

View looking upstream at terracing due to cows on the landside slope (Spring 2020).

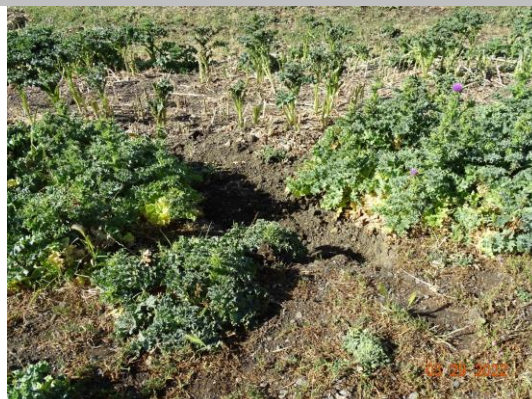
Photo 1 of 1 : FA\_2022\_RD2104\_249\_37\_20220831\_00013.jpg

LM Start	3.77	Rating **	M	Issue No.	37
LM End	3.77	Issue Type +	Ma	Location *	LS
Category	Earthen Levee			GPS Latitude/Longitude	
				Start	End
Item	Slope Stability			38.307897 °	38.307897 °
				-121.734669 °	-121.734669 °
DWR ID	DWR_RD2104_01_s _ 2022_37				
Comment Code					
S1 : Repair slope instability.					
Inspector Comment					
There is a small soil separation at top of landside slope.

View of small amount of soil separation in the landside shoulder (Spring 2022).

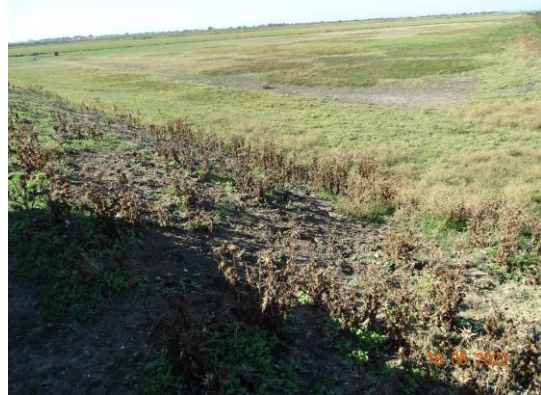
Photo 1 of 1 : FA\_2022\_RD2104\_249\_21\_20221017\_00021.jpg

LM Start	4.00	Rating **	M	Issue No.	21
LM End	4.00	Issue Type +	Ma	Location *	LS
Category	Earthen Levee			GPS Latitude/Longitude	
				Start	End
Item	Erosion / Livestock			38.310672 °	38.310672 °
				-121.736155 °	-121.736155 °
DWR ID	DWR_RD2104_01_f _ 2018_21				
Comment Code					
E4 : Repair the levee slope damaged by livestock and prevent large animal access.					
Inspector Comment					
There is a cow path on the landside slope.

View of the cow path on the LS slope (Fall 2022).

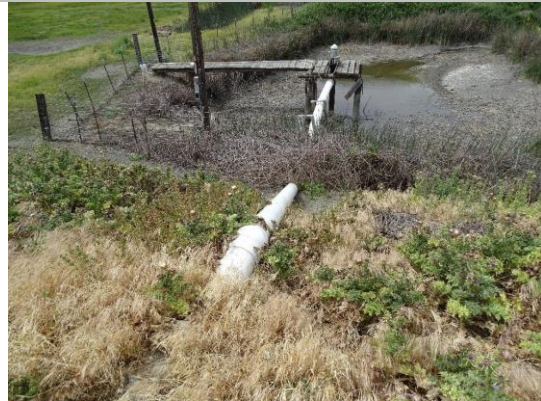
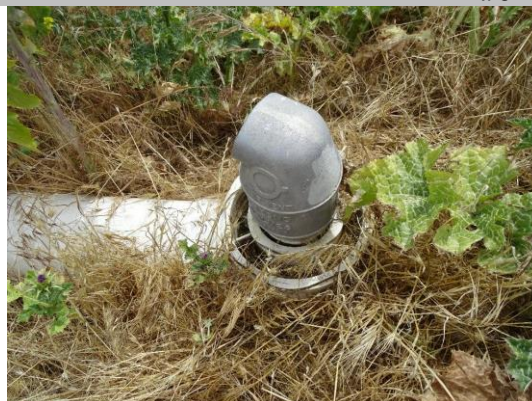
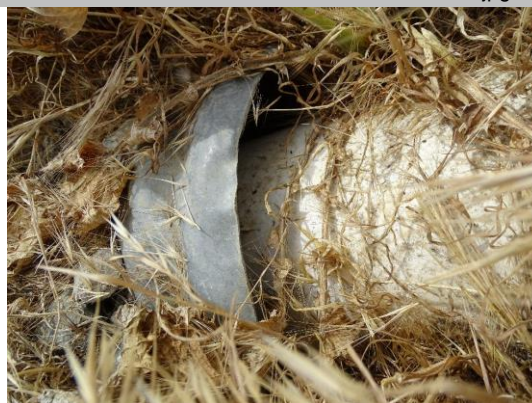
LM Start	4.01	Rating **	U	Issue No.	60	
LM End	4.01	Issue Type +	En	Location *		
Category	Supplemental			GPS Latitude/Longitude		
				Start		End
Item	DWR UCIP Field Study			38.310861 °		38.310861 °
				-121.736185 °		-121.736185 °
DWR ID	25763

Comment Code						
Inspector Comment						
DS_ID:25763 FS_ID:77169 EP_NO: N/A Repair Type: Urgent EVAL Issue: 3b, Flood Risk Crossing Status: Found UCIP Comments: 05/05/2022 Record is Urgent. Annular space between pipes under levee crown was not grouted. No permit has been found authorizing this pipe through the levee. (D.Sanoski - DWR UCIP)  FIELD_STRUCT_DESC: 10-inch PVC pipe sleeved through 12-inch CMP pipe through the levee just beneath the levee crown. Annular space not grouted. Pipe runs on the top of both levee slopes. Vertical pump on wooden pile structure in the drainage pit on landside (LS) with wooden walkway to it. Air release valve on waterside (WS) slope. FS Date: 5/5/2022

View of PVC pipe out of LS slope to pump.

View of air release valve on WS slope.

View of 10-inch PVC pipe sleeved through 12-inch CMP pipe just beneath the levee crown.

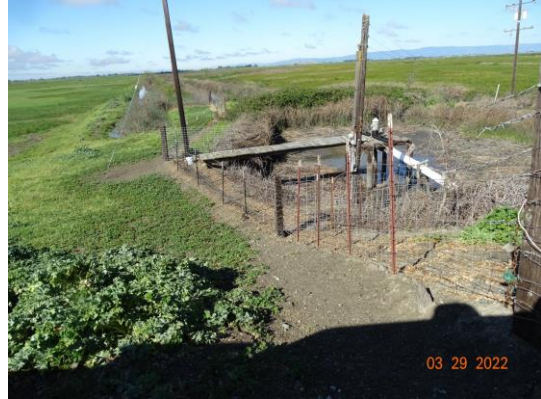
Photo 1 of 1 : FA\_2022\_RD2104\_249\_38\_20220831\_00014.jpg

LM Start	4.30	Rating **	M	Issue No.	38
LM End	4.30	Issue Type +	Ma	Location *	LS
Category	Earthen Levee			GPS Latitude/Longitude	
				Start	End
Item	Erosion / Livestock			38.313833 °	38.313833 °
				-121.739827 °	-121.739827 °
DWR ID	DWR_RD2104_01_s_2022_38				
Comment Code					
E4 : Repair the levee slope damaged by livestock and prevent large animal access.					
Inspector Comment

View of cow path down the landside slope (Spring 2022).

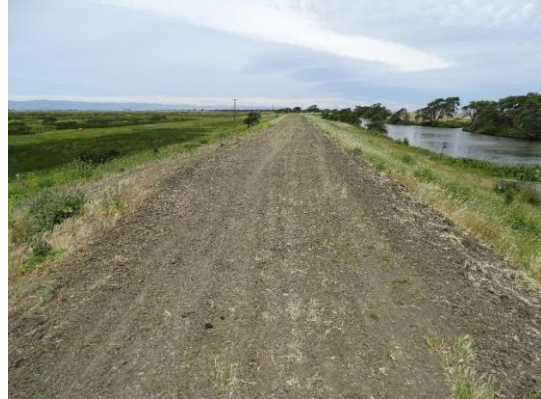
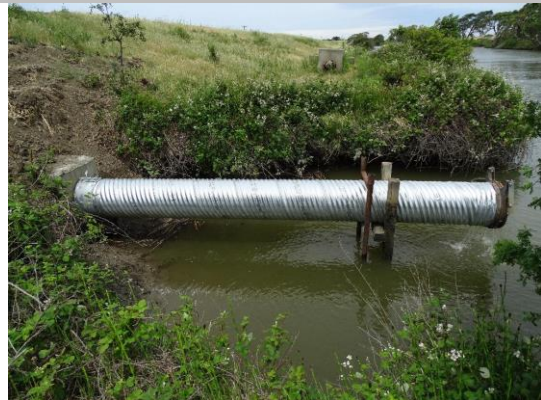
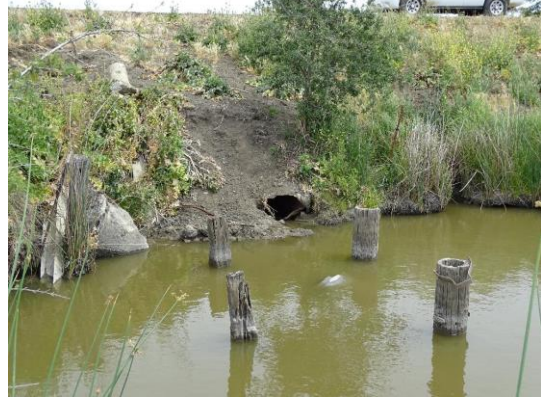
Comment Code						
Inspector Comment						
DS_ID:24705 FS_ID:75150 EP_NO: 10182 Repair Type: No Action Needed EVAL Issue: Crossing Status: Found UCIP Comments: 05/05/2022 Record remains No Action Needed. No issues observed during inspection. Riser on LS toe removed. System Feature. (D.Sanoski - DWR UCIP) 12/06/2016 Crossing has been downgraded from "Urgent" to "Non-Urgent" no signs of leaks observed along pipe alignment (limited inspection on WS toe). According to LMA representative, this crossing was replaced 6 years ago (2010) at WS concrete apron. Recommend conducting internal inspection of pipe through the levee and LS to determine pipe integrity. (O. Magana - DWR UCIP)12/04/2013 Vegetation and soil buildup throughout pipe preventing flapgate from closing. Remove vegetation to allow gate to close properly. (W. Wylie - DWR UCIP) FIELD_STRUCT_DESC: 24-inch corrugated metal drainage pipe through the levee, 15 feet below the crown. 36-inch concrete standpipe on the landside (LS) toe. Flap gate on the waterside (WS) toe. Two corrugated metal cutoff walls installed. (24-inch pipe [HLM 4.65] authorized under Automatic Board Order (ABO) issued as Permit No. 10182, 1974 - Julia Trust Machado). [Additional Reference(s): DWR Levee Log, 2006. USACE Sacramento O&M Manual 108, April 1964, (HLM 4.65), Drawing No. 50-04-3379]. FS Date: 5/5/2022 2:19:23 PM

View of levee crown.

View of pipe with flap gate out of concrete headwall on WS toe.

View of open pipe on LS slope.

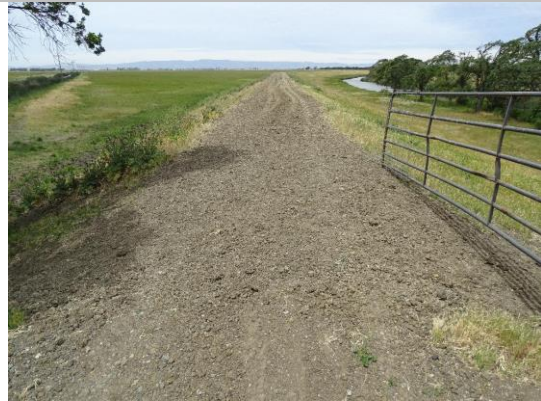
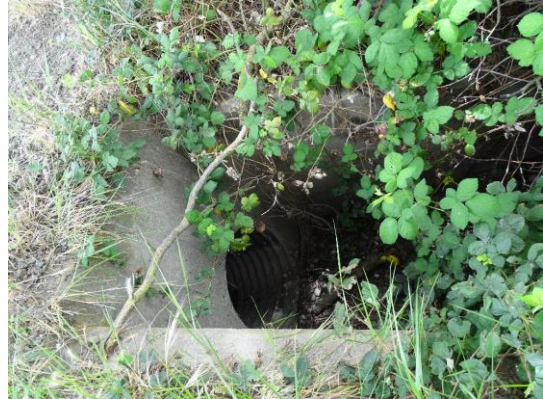
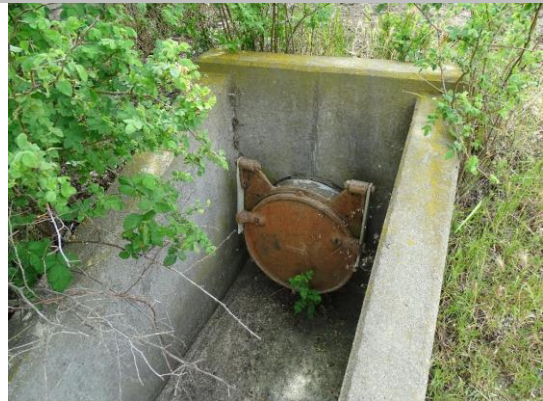
LM Start	4.72	Rating **	M	Issue No.	62
LM End	4.72	Issue Type +	En	Location *	
Category	Supplemental			GPS Latitude/Longitude	
				Start	End
Item	DWR UCIP Field Study			38.318432 °	38.318432 °
				-121.744540 °	-121.744540 °
DWR ID	24702

DS\_ID:24702  
 FS\_ID:75162  
 EP\_NO: 10182  
 Repair Type: Non-Urgent  
 EVAL Issue: 5, Pipe Damage  
 Crossing Status: Found  
 UCIP Comments: 05/05/2022 Record remains Non-Urgent. DMP internal video inspection has found pipe integrity issues. LOF of crossing is greater than or equal to 4.1 and less than 5. Crossing will be monitored until funding becomes available for rehabilitation. Unauthorized encroachment recorded in Levee Log prior to 2011. Erosion beneath WS headwall remains. (D.Sanoski - DWR UCIP) 12/04/2013 Minor erosion of base under headwall on WS toe. Heavy corrosion of pipe at WS toe. Further evaluation of pipe integrity needed. (W.Wylie - DWR UCIP)  
 FIELD\_STRUCT\_DESC: 24-inch corrugated metal drainage pipe through the levee, 13.5 feet below the crown. Concrete U-shaped headwalls on both ends. Two corrugated metal cutoff walls. Flap gate on the waterside (WS) end. (Automatic Board Order (ABO) issued as Permit No. 10182, 1974 - Julia Trust Machado). [Additional Reference(s): DWR Levee Log, 2006].

View of levee crown.

View of concrete headwall and pipe inlet on LS slope.

View of concrete headwall and flap gate on WS slope.

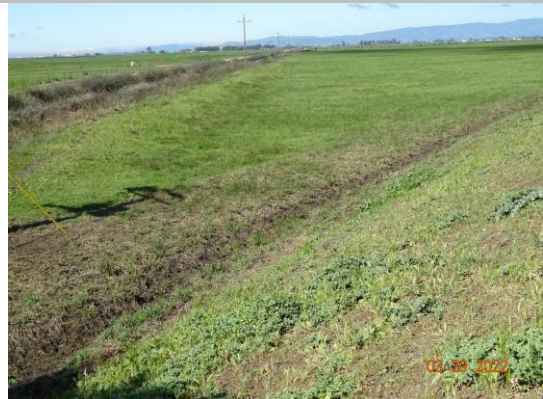
Photo 1 of 1 : FA\_2022\_RD2104\_249\_17\_20220831\_00004.jpg

LM Start	4.72	Rating **	M	Issue No.	17
LM End	4.94	Issue Type +	En	Location *	LS
Category	Earthen Levee			GPS Latitude/Longitude	
				Start	End
Item	Encroachments			38.318463 °	38.320231 °
				-121.744636 °	-121.747979 °
DWR ID	DWR_RD2104_01_s_2020_17				
Comment Code					
DT : Ditch					
Inspector Comment					
There is a small ditch at the landside toe.

View of small ditch at the landside toe (Spring 2022).

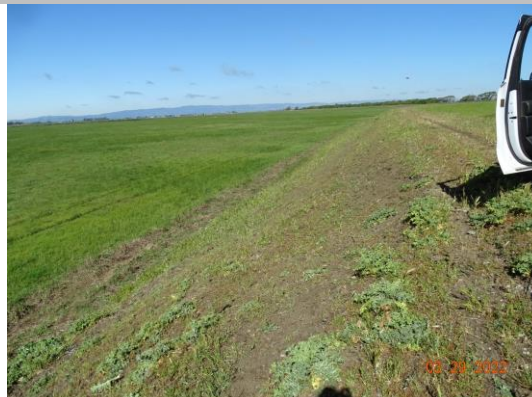
Photo 1 of 1 : FA\_2022\_RD2104\_249\_42\_20220831\_00016.jpg

LM Start	4.90	Rating **	M	Issue No.	42
LM End	4.90	Issue Type +	Ma	Location *	LS
Category	Earthen Levee			GPS Latitude/Longitude	
				Start	End
Item	Erosion / Livestock			38.319756 °	38.319756 °
				-121.747373 °	-121.747373 °
DWR ID	DWR_RD2104_01_s_2022_42				
Comment Code					
E4 : Repair the levee slope damaged by livestock and prevent large animal access.					
Inspector Comment					
Cows are digging into the top of the landside shoulder.

View looking upstream at erosion due to cows digging into the landside slope (Spring 2022).

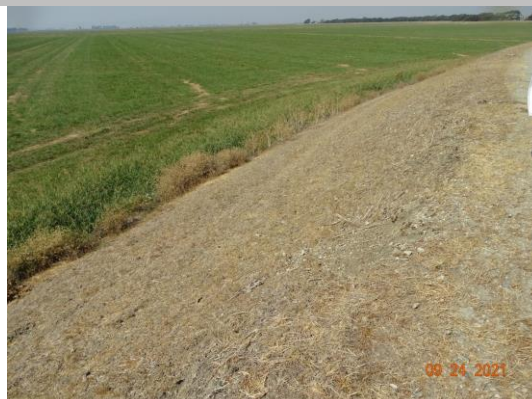
Photo 1 of 1 : FA\_2022\_RD2104\_249\_24\_20220831\_00009.jpg

LM Start	4.96	Rating **	M	Issue No.	24
LM End	4.96	Issue Type +	Ma	Location *	LS
Category	Earthen Levee			GPS Latitude/Longitude	
				Start	End
Item	Erosion / Livestock			38.320382 °	38.320382 °
				-121.748155 °	-121.748155 °
DWR ID	DWR_RD2104_01_f_2017_24				
Comment Code					
E4 : Repair the levee slope damaged by livestock and prevent large animal access.					
Inspector Comment					
Cows are digging into the top of the landside shoulder.

View looking upstream at slope instability at the landside hinge due to cows (Fall 2021).

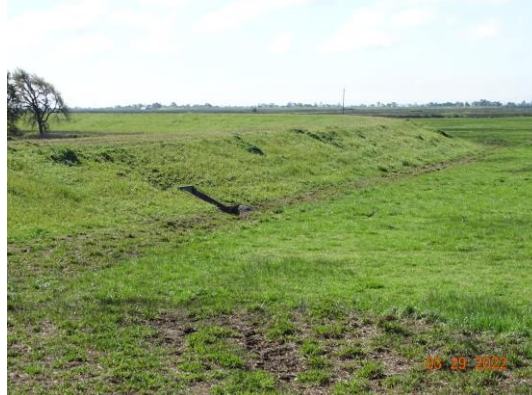
Photo 1 of 1 : FA\_2022\_RD2104\_249\_55\_20220831\_00017.jpg

LM Start	5.04	Rating **	M	Issue No.	55
LM End	5.14	Issue Type +	Ma	Location *	LS
Category	Earthen Levee			GPS Latitude/Longitude	
				Start	End
Item	Erosion / Livestock			38.321582 °	38.322872 °
				-121.748550 °	-121.748700 °
DWR ID	DWR_RD2104_01_s_2013_55				
Comment Code					
E4 : Repair the levee slope damaged by livestock and prevent large animal access.					
Inspector Comment					
Livestock have been causing erosion and slumping at landside levee shoulder.

View looking downstream at small amounts of erosion and slumping due to cows on the landside slope (Spring 2022).

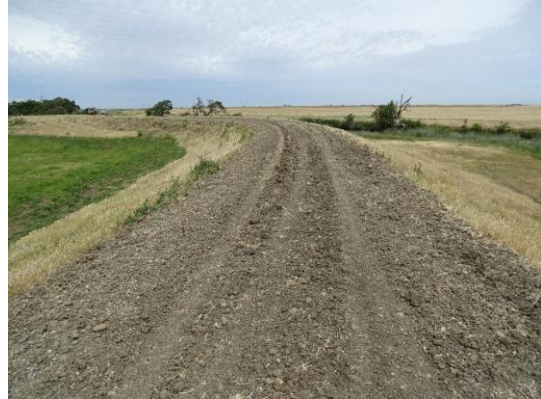
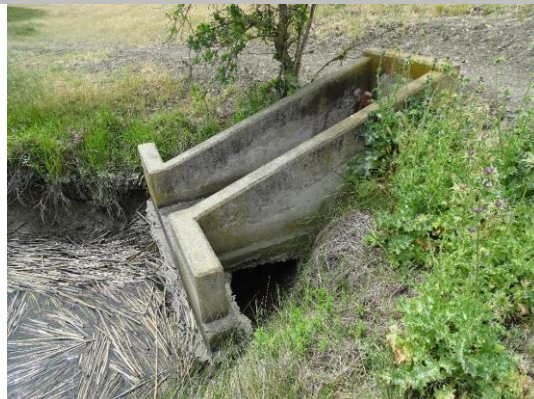
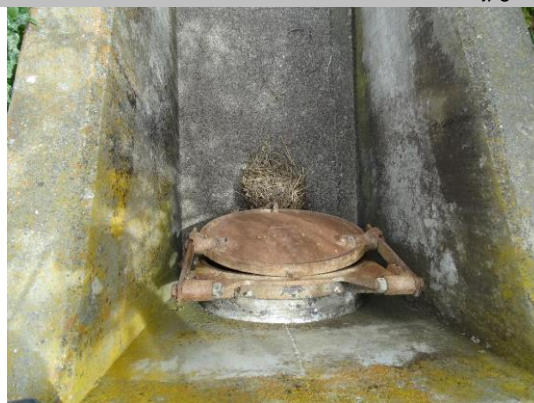
Comment Code					
Inspector Comment					
DS_ID:24701 FS_ID:75165 EP_NO: 10182 Repair Type: Urgent EVAL Issue: 1, Pipe Integrity Crossing Status: Found UCIP Comments: 05/05/2022 Record remains Urgent. DMP internal video inspection has found pipe integrity issues. LOF of crossing is between 5 and 6. Crossing will be monitored until funding becomes available to address the issues. System Feature. (D.Sanoski - DWR UCIP) 10/12/2018 Same as last inspection; concrete headwall on WS still being undermined so crossing remains Urgent (D. Sanoski - DWR UCIP).12/06/2016 same as last inspection--pipe remains "Urgent" CMP shows holes through wall and concrete headwall is undermined. Need to contact owner. Owner will need to work with the CVFPB to comply with Title 23. (O. Magana - DWR UCIP)12/04/2013 Footing under headwall on WS toe severely undermined. Pipe rusted heavily with holes at WS and may need replacement. (W. Wylie - DWR UCIP) FIELD_STRUCT_DESC: 24-inch corrugated metal drainage pipe through the levee, 13 feet below the crown. Two cutoff walls. Concrete U-shaped headwalls on both ends. Flap gate on the waterside (WS). (24-inch pipe [HLM 5.50] authorized under Automatic Board Order (ABO) issued as Permit No. 10182, 1974 - Julia Trust Machado). [Additional Reference(s): DWR Levee Log, 2006. USACE Sacramento O&M Manual 108, April 1964, (HLM 5.5), listed as a 12-inch pipe, Drawing No. 50-04-3379, listed as an 18-inch pipe]. FS Date: 5/5/2022 3:29:00 PM

View of levee crown.

View of concrete headwall with severe erosion on WS toe.

View of flap gate on pipe out of WS headwall.

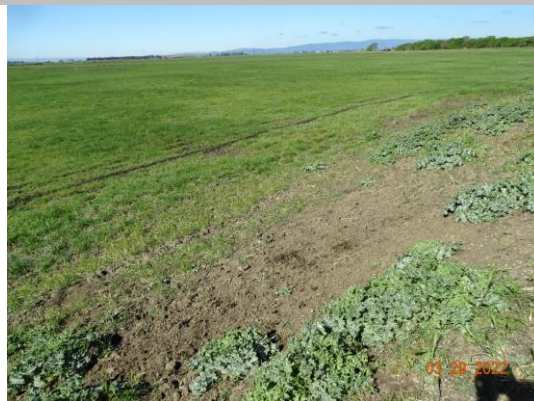
Photo 1 of 1 : FA\_2022\_RD2104\_249\_29\_20220831\_00011.jpg

LM Start	5.35	Rating **	M	Issue No.	29
LM End	5.35	Issue Type +	Ma	Location *	LS
Category	Earthen Levee			GPS Latitude/Longitude	
				Start	End
Item	Erosion / Livestock			38.323576 °	38.323576 °
				-121.752323 °	-121.752323 °
DWR ID	DWR_RD2104_01_f_2021_29				
Comment Code					
E4 : Repair the levee slope damaged by livestock and prevent large animal access.					
Inspector Comment

View of erosion due to cows digging into landside slope (Spring 2022).

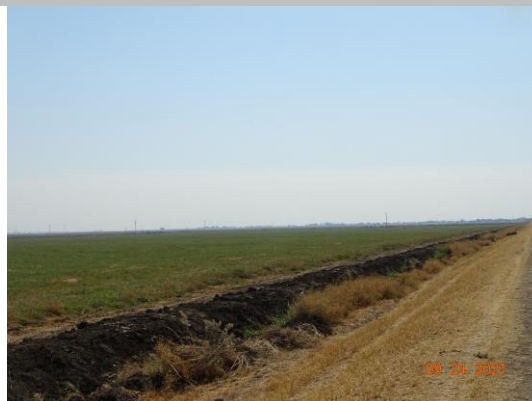
Photo 1 of 1 : FA\_2022\_RD2104\_249\_33\_20220831\_00012.jpg

View looking upstream at ditch within 15 feet of landside toe (Fall 2021).

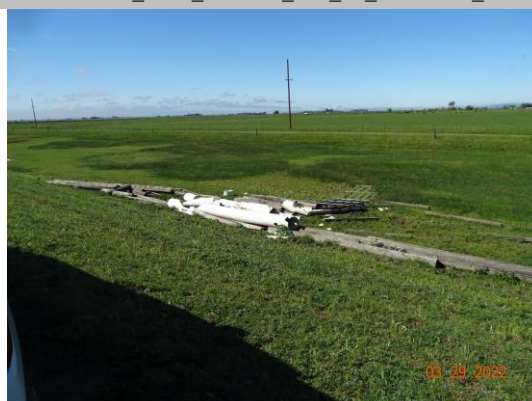
Photo 1 of 1 : FA\_2022\_RD2104\_249\_39\_20220831\_00015.jpg

View looking upstream at debris on the waterside toe (Spring 2021).
