**Flood Control Project Maintenance
Levee Inspections
Fall 2023 Levee Maintenance Deficiency Summary Report**

Sacramento River Basin

Reclamation District No. 2104 Peters Pocket Tract

Levee Inspection Report By Mile - Fall 2023

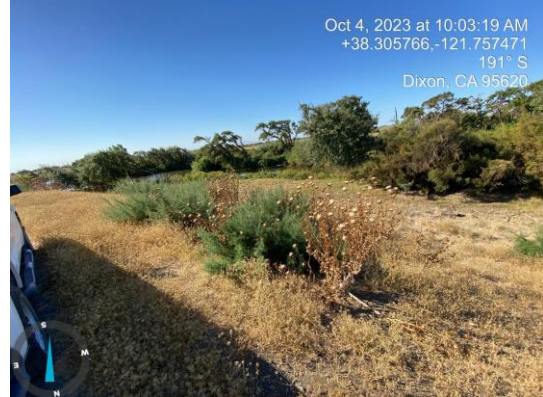
Photo 1 of 1 : FA_2023_RD2104_249_10_20231006_00036.jpg

View of vegetation on the waterside slope near the shoulder (Fall 2023).

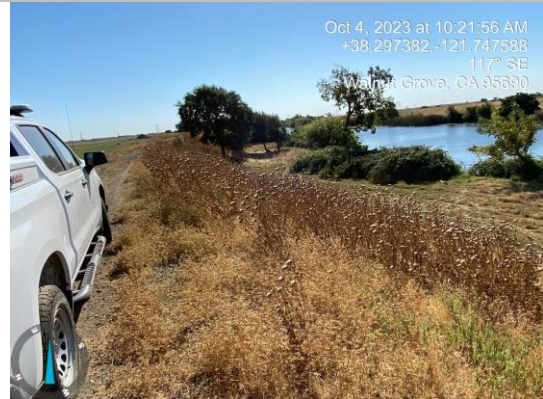
Photo 1 of 1 : FA_2023_RD2104_249_11_20231006_00034.jpg

LM Start	0.88	Rating **	U	Issue No.	11
LM End	1.12	Issue Type +	Ma	Location *	WS
Category	Earthen Levee			GPS Latitude/Longitude	
				Start	End
Item	Vegetation			38.299348°	38.297082°
				-121.749848°	-121.746752°
DWR ID	DWR_RD2104_01_f_2023_11				
Comment Code					
V1 : Control annual grass and weeds on the levee slopes and easements.					
Inspector Comment

View of vegetation on waterside slope (Fall 2023).

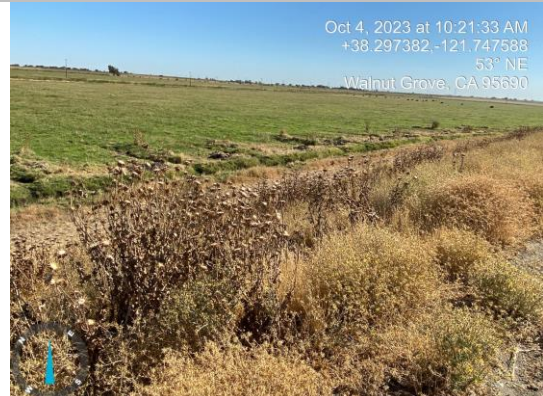
Photo 1 of 1 : FA_2023_RD2104_249_15_20231006_00033.jpg

LM Start	0.94	Rating **	U	Issue No.	15
LM End	1.10	Issue Type +	Ma	Location *	LS
Category	Earthen Levee			GPS Latitude/Longitude	
				Start	End
Item	Vegetation			38.298806°	38.297237°
				-121.748926°	-121.747078°
DWR ID	DWR_RD2104_01_f _ 2023_15				
Comment Code					
V1 : Control annual grass and weeds on the levee slopes and easements.					
Inspector Comment

View of vegetation on landside slope (Fall 2023).

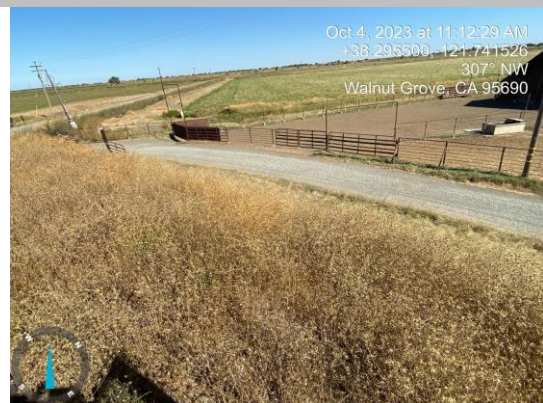
Photo 1 of 1 : FA_2023_RD2104_249_21_20231006_00041.jpg

View of vegetation on landside slope (Fall 2023).

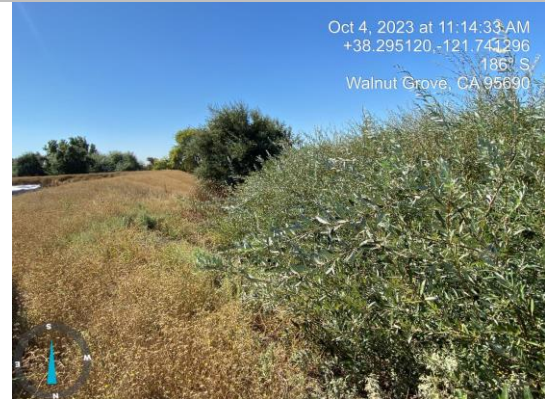
Photo 1 of 1 : FA_2023_RD2104_249_22_20231006_00040.jpg

View of vegetation on the waterside slope (Fall 2023).

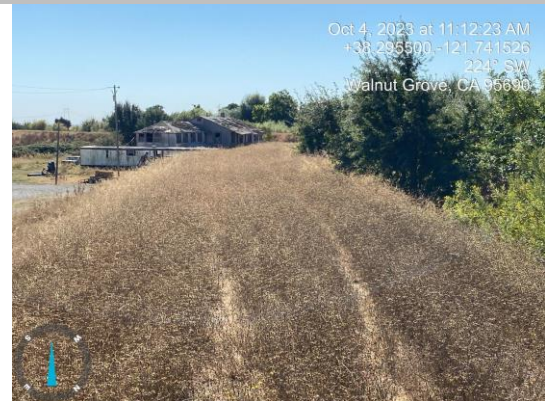
Photo 1 of 1 : FA_2023_RD2104_249_23_20231006_00035.jpg

LM Start	1.40	Rating **	U	Issue No.	23
LM End	1.57	Issue Type +	Ma	Location *	CR
Category	Earthen Levee			GPS Latitude/Longitude	
				Start	End
Item	Vegetation			38.295728°	38.294105°
				-121.742060°	-121.740402°
DWR ID	DWR_RD2104_01_f _ 2023_23				
Comment Code					
V1 : Control annual grass and weeds on the levee slopes and easements.					
Inspector Comment

View of vegetation on levee crown (Fall 2023).

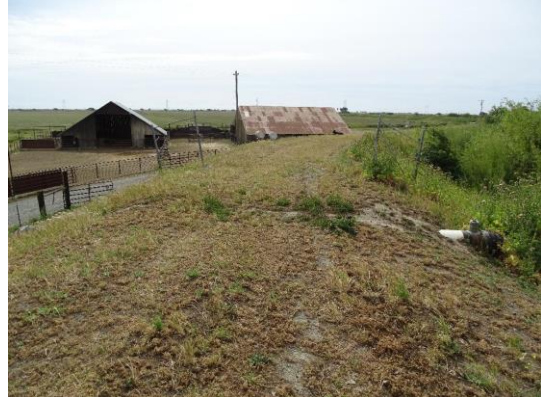
Photo 1 of 3 : UCIP_FA_2023_75136_112281.jpg

Comment Code						
Inspector Comment						
DS_ID:24711 FS_ID:75136 EP_NO: 10185 Repair Type: No Action Needed EVAL Issue: Crossing Status: Found UCIP Comments: 05/05/2022 Record remains No Action Needed. No issues observed during inspection. Running while there. System Feature. (D.Sanoski - DWR UCIP) 09/14/2017 Permit is unavailable, missing page 3 official permit documentation. (DWR UCIP - O. Magana) FIELD_STRUCT_DESC: 16-inch steel drainage pipe through the levee, 5.7 feet below the crown. Pump in an irrigation ditch on the landside (LS). Siphon breaker on the waterside (WS) slope. (Automatic Board Order (ABO) issued as Permit No. 10185, 1964 - Erwin E. and Lucy G. Vasser, limited details available electronic permit unavailable). [Additional Reference(s): DWR Levee Log, 2006. USACE Sacramento O&M Manual 108, April 1964, (HLM 1.52), Drawing Nos. 50-04-1977 and 50-04-3379]. FS Date: 5/5/2022 12:02:20 PM

View of levee crown and pipe crossing.

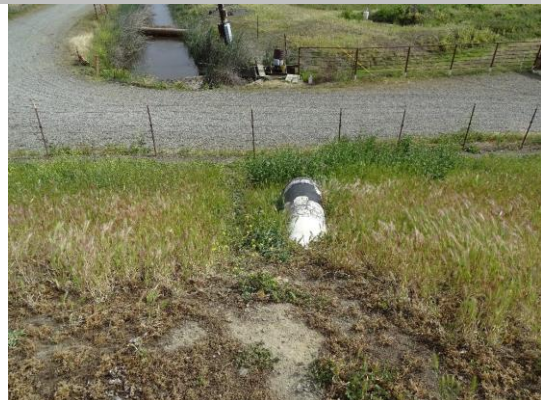
Photo 2 of 3 : UCIP_FA_2023_75136_112278.jpg

View of pipe out of LS slope.

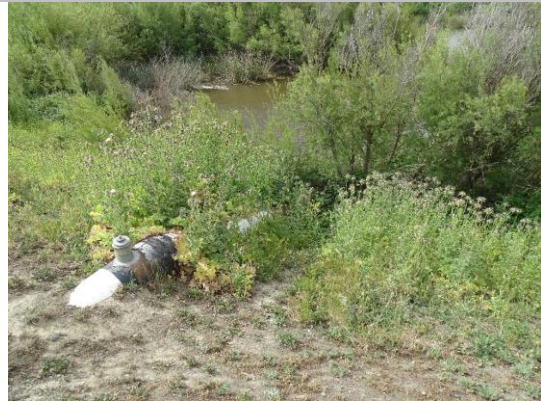
Photo 3 of 3 : UCIP_FA_2023_75136_112279.jpg

View of pipe out of WS slope.

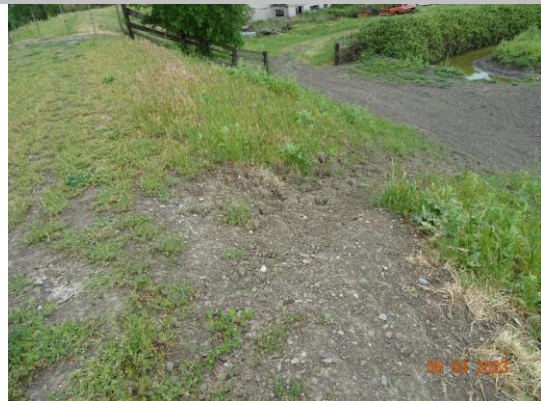
Photo 1 of 1 : FA_2023_RD2104_249_13_20231003_00001.jpg

LM Start	1.58	Rating **	M	Issue No.	13
LM End	1.58	Issue Type +	Ma	Location *	LS
Category	Earthen Levee			GPS Latitude/Longitude	
				Start	End
Item	Erosion / Livestock			38.294097°	38.294097°
				-121.740133°	-121.740133°
DWR ID	DWR_RD2104_01_f _ 2020_13				
Comment Code					
E4 : Repair the levee slope damaged by livestock and prevent large animal access.					
Inspector Comment					
There is a cow path that is digging into levee.

View of the cow path down the LS slope (Spring 2023).

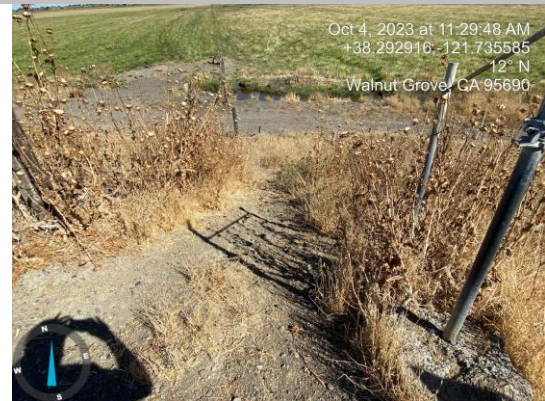
Photo 1 of 1 : FA_2023_RD2104_249_19_20231006_00042.jpg

LM Start	1.85	Rating **	M	Issue No.	19
LM End	1.85	Issue Type +	Ma	Location *	LS
Category	Earthen Levee			GPS Latitude/Longitude	
				Start	End
Item	Erosion / Livestock			38.292880 °	38.292880 °
				-121.735552 °	-121.735552 °
DWR ID	DWR_RD2104_01_f _ 2020_19				
Comment Code					
E4 : Repair the levee slope damaged by livestock and prevent large animal access.					
Inspector Comment					
There is a cow path on the landside slope.

View of cow path down the landside slope (Fall 2023).

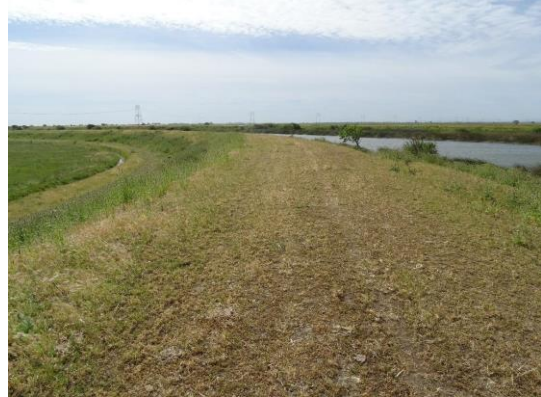
Photo 1 of 3 : UCIP_FA_2023_75140_112292.jpg

Comment Code					
Inspector Comment					
DS_ID:24721 FS_ID:75140 EP_NO: N/A Repair Type: Non-Urgent EVAL Issue: Crossing Status: Not Found UCIP Comments: 05/05/2022 Record remains Non-Urgent. Geophysical results did not confirm presence of pipe through levee. Record will remain in UCIP's inspection records until future Levee Improvement Project can confirm no crossing was found through the levee. System Feature. (D.Sanoski - DWR UCIP) FIELD_STRUCT_DESC: 16-inch drainage pipe of an unknown material through the levee, at an unknown depth. Flap gate on the waterside (WS) toe. [Additional Reference(s): USACE Sacramento O&M Manual 108, April 1964, (HLM 2.04)]. FS Date: 5/5/2022 12:06:18 PM

View of levee crown.

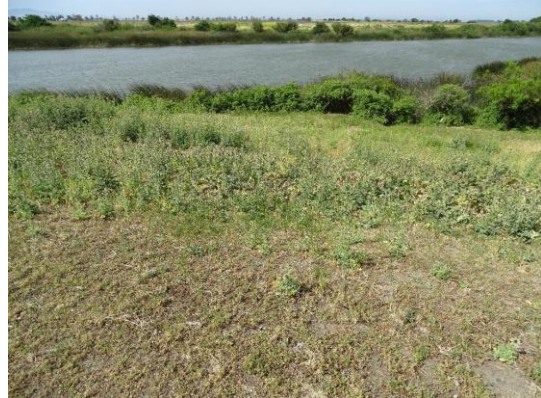
Photo 2 of 3 : UCIP_FA_2023_75140_112291.jpg

View of WS slope.

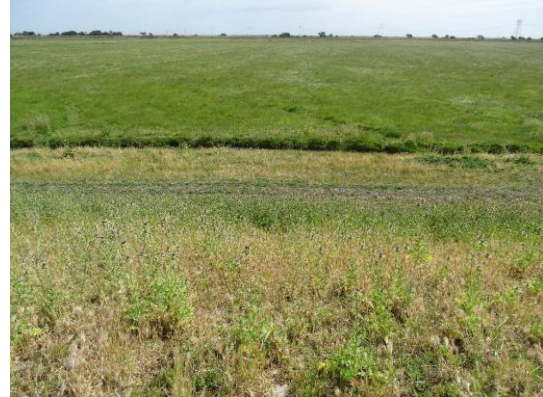
Photo 3 of 3 : UCIP_FA_2023_75140_112293.jpg

View of LS slope.

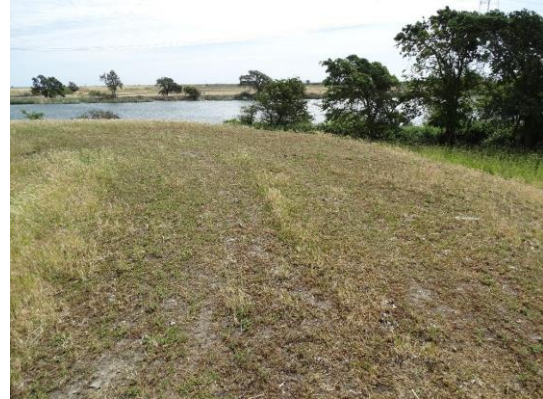
Photo 1 of 3 : UCIP_FA_2023_75141_112294.jpg

DS_ID:24726
 FS_ID:75141
 EP_NO: N/A
 Repair Type: Non-Urgent
 EVAL Issue:
 Crossing Status: Not Found
 UCIP Comments: 05/05/2022 Record remains Non-Urgent. Geophysical results did not confirm presence of pipe through levee. Record will remain in UCIP's inspection records until future Levee Improvement Project can confirm no crossing was found through the levee. No physical sign of abandoned pipe stated in last comment. System Feature. (D.Sanoski - DWR UCIP)
 12/04/2013 24-inch CMP debris on WS berm may indicate pipe was abandoned. (W.Wylie - DWR UCIP)
 FIELD_STRUCT_DESC: 24-inch corrugated metal drainage pipe through the levee, 18 feet below the crown. Flap gate on the waterside (WS) toe. [Additional Reference(s): USACE Sacramento O&M Manual 108, April 1964, (HLM 2.60)].
 FS Date: 5/5/2022 12:58:09 PM

View of levee crown.

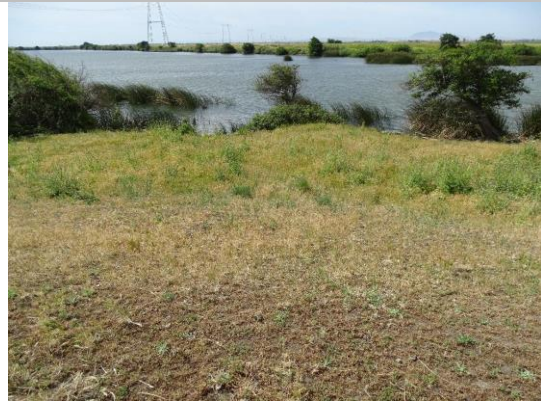
Photo 2 of 3 : UCIP_FA_2023_75141_112296.jpg

View of WS slope.

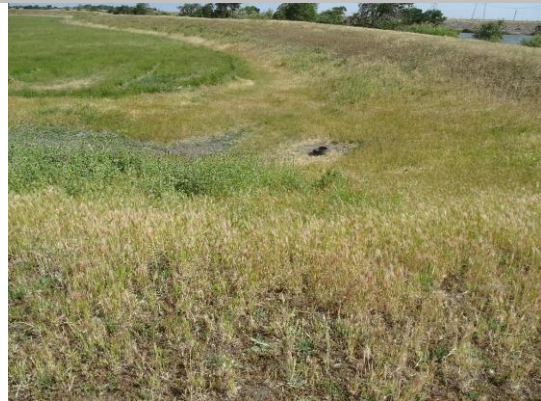
Photo 3 of 3 : UCIP_FA_2023_75141_112295.jpg

View of LS slope.

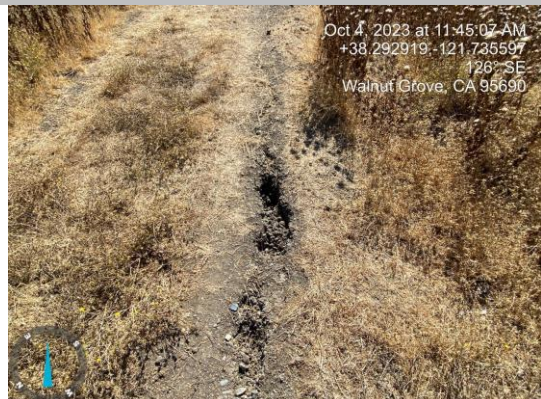
Photo 1 of 1 : FA_2023_RD2104_249_28_20231006_00039.jpg

LM Start	2.76	Rating **	M	Issue No.	28
LM End	2.76	Issue Type +	Ma	Location *	CR
Category	Earthen Levee			GPS Latitude/Longitude	
				Start	End
Item	Cracking			38.295647°	38.295647°
				-121.728749°	-121.728749°
DWR ID	DWR_RD2104_01_f_2023_28				
Comment Code					
CR1 : Monitor and have inspected by geotechnical engineer.					
Inspector Comment

View of cracking on levee crown (Fall 2023).

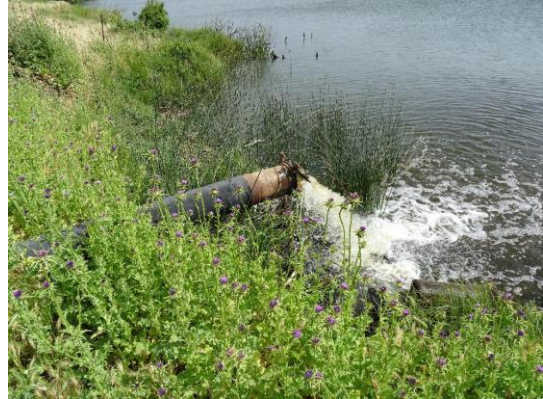
Photo 3 of 3 : UCIP_FA_2023_75142_112302.jpg

View of pipe with flap gate out of WS berm.

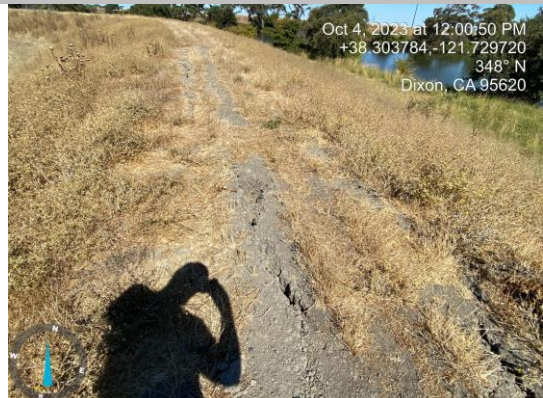
Photo 1 of 1 : FA_2023_RD2104_249_31_20231006_00038.jpg

LM Start	3.35	Rating **	M	Issue No.	31
LM End	3.38	Issue Type +	Ma	Location *	CR
Category	Earthen Levee			GPS Latitude/Longitude	
				Start	End
Item	Cracking			38.303743°	38.304106°
				-121.729675°	-121.729839°
DWR ID	DWR_RD2104_01_f_2023_31				
Comment Code					
CR1 : Monitor and have inspected by geotechnical engineer.					
Inspector Comment

View of cracking along the levee crown (Fall 2023).

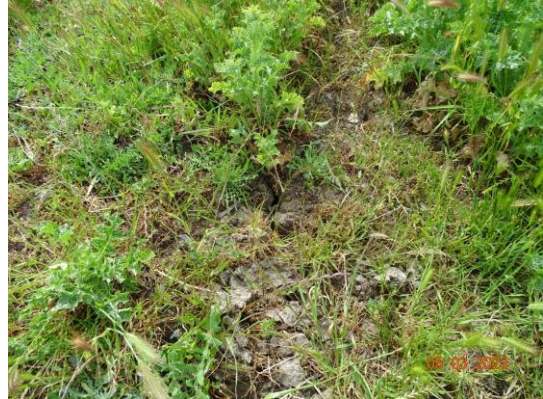
Photo 1 of 1 : FA_2023_RD2104_249_37_20231003_00007.jpg

LM Start	3.77	Rating **	M	Issue No.	37
LM End	3.77	Issue Type +	Ma	Location *	LS
Category	Earthen Levee			GPS Latitude/Longitude	
				Start	End
Item	Slope Stability			38.307897°	38.307897°
				-121.734669°	-121.734669°
DWR ID	DWR_RD2104_01_s_2022_37				
Comment Code					
S1 : Repair slope instability.					
Inspector Comment					
There is a small soil separation at top of landside slope.

View of small soil separation on LS shoulder (Spring 2023).

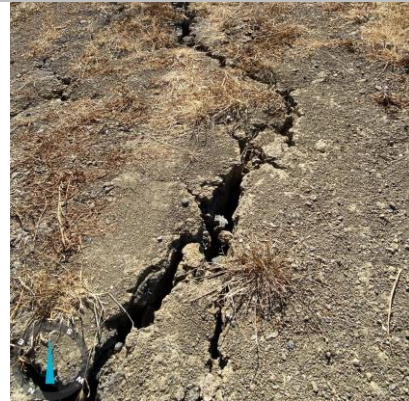
Photo 1 of 1 : FA_2023_RD2104_249_34_20231102_00043.jpg

LM Start	4.00	Rating **	U	Issue No.	34
LM End	4.00	Issue Type +	Ma	Location *	CR
Category	Earthen Levee			GPS Latitude/Longitude	
				Start	End
Item	Cracking			38.310749°	38.310749°
				-121.736170°	-121.736170°
DWR ID	DWR_RD2104_01_f_2023_34				
Comment Code					
CR1 : Monitor and have inspected by geotechnical engineer.					
Inspector Comment

View of cracking along the levee crown (Fall 2023).

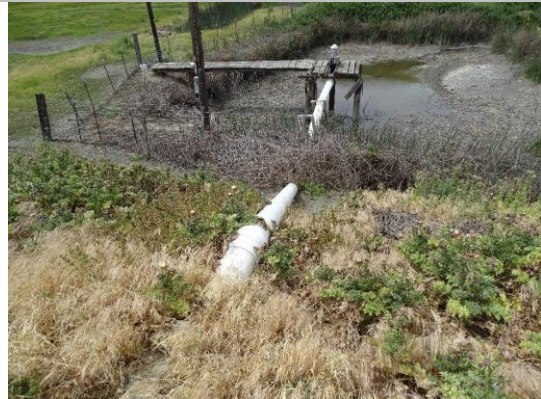
Photo 1 of 3 : UCIP_FA_2023_77169_112332.jpg

Comment Code					
Inspector Comment					
DS_ID:25763 FS_ID:77169 EP_NO: N/A Repair Type: Urgent EVAL Issue: 3b, Flood Risk Crossing Status: Found UCIP Comments: 05/05/2022 Record is Urgent. Annular space between pipes under levee crown was not grouted. No permit has been found authorizing this pipe through the levee. (D.Sanoski - DWR UCIP) FIELD_STRUCT_DESC: 10-inch PVC pipe sleeved through 12-inch CMP pipe through the levee just beneath the levee crown. Annular space not grouted. Pipe runs on the top of both levee slopes. Vertical pump on wooden pile structure in the drainage pit on landside (LS) with wooden walkway to it. Air release valve on waterside (WS) slope. FS Date: 5/5/2022

View of PVC pipe out of LS slope to pump.

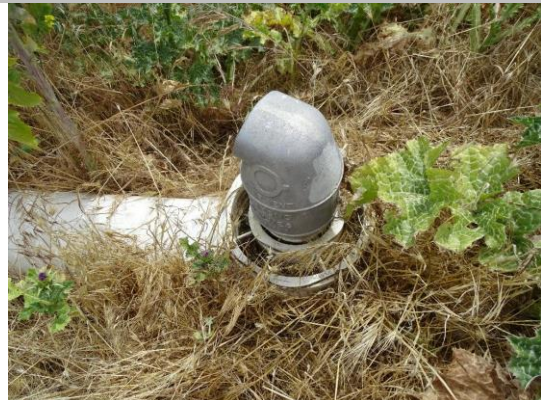
Photo 2 of 3 : UCIP_FA_2023_77169_112335.jpg

View of air release valve on WS slope.

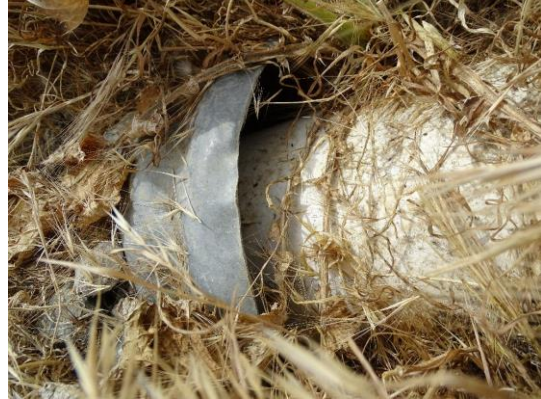
Photo 3 of 3 : UCIP_FA_2023_77169_112334.jpg

View of 10-inch PVC pipe sleeved through 12-inch CMP pipe just beneath the levee crown.

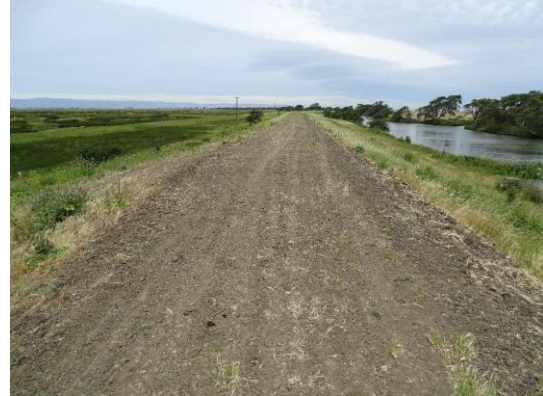
Photo 1 of 3 : UCIP_FA_2023_75150_112338.jpg

Comment Code						
Inspector Comment						
DS_ID:24705 FS_ID:75150 EP_NO: 10182 Repair Type: No Action Needed EVAL Issue: Crossing Status: Found UCIP Comments: 05/05/2022 Record remains No Action Needed. No issues observed during inspection. Riser on LS toe removed. System Feature. (D.Sanoski - DWR UCIP) 12/06/2016 Crossing has been downgraded from "Urgent" to "Non-Urgent" no signs of leaks observed along pipe alignment (limited inspection on WS toe). According to LMA representative, this crossing was replaced 6 years ago (2010) at WS concrete apron. Recommend conducting internal inspection of pipe through the levee and LS to determine pipe integrity. (O. Magana - DWR UCIP)12/04/2013 Vegetation and soil buildup throughout pipe preventing flapgate from closing. Remove vegetation to allow gate to close properly. (W. Wylie - DWR UCIP) FIELD_STRUCT_DESC: 24-inch corrugated metal drainage pipe through the levee, 15 feet below the crown. 36-inch concrete standpipe on the landside (LS) toe. Flap gate on the waterside (WS) toe. Two corrugated metal cutoff walls installed. (24-inch pipe [HLM 4.65] authorized under Automatic Board Order (ABO) issued as Permit No. 10182, 1974 - Julia Trust Machado). [Additional Reference(s): DWR Levee Log, 2006. USACE Sacramento O&M Manual 108, April 1964, (HLM 4.65), Drawing No. 50-04-3379]. FS Date: 5/5/2022 2:19:23 PM

View of levee crown.

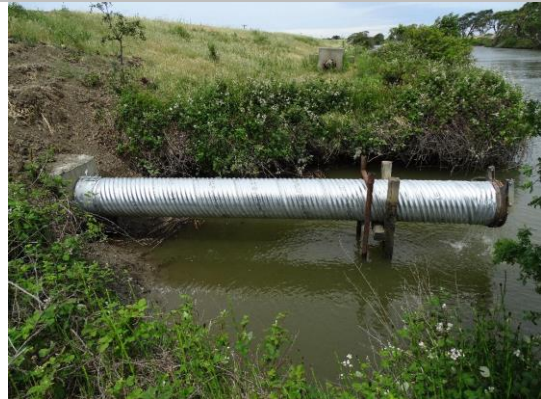
Photo 2 of 3 : UCIP_FA_2023_75150_112341.jpg

View of pipe with flap gate out of concrete headwall on WS toe.

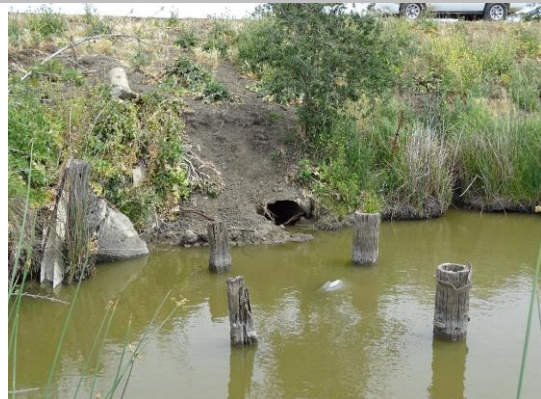
Photo 3 of 3 : UCIP_FA_2023_75150_112337.jpg

View of open pipe on LS slope.

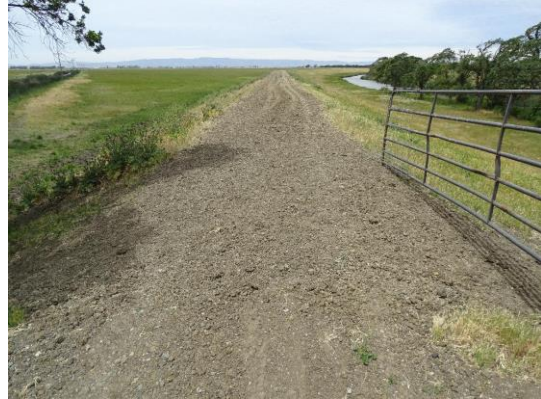
Photo 1 of 3 : UCIP_FA_2023_75162_112380.jpg

Comment Code					
Inspector Comment					
DS_ID:24702 FS_ID:75162 EP_NO: 10182 Repair Type: Non-Urgent EVAL Issue: 5, Pipe Damage Crossing Status: Found UCIP Comments: 05/05/2022 Record remains Non-Urgent. DMP internal video inspection has found pipe integrity issues. LOF of crossing is greater than or equal to 4.1 and less than 5. Crossing will be monitored until funding becomes available for rehabilitation. Erosion beneath WS headwall remains. (D.Sanoski - DWR UCIP) 12/04/2013 Minor erosion of base under headwall on WS toe. Heavy corrosion of pipe at WS toe. Further evaluation of pipe integrity needed. (W.Wylie - DWR UCIP) FIELD_STRUCT_DESC: 24-inch corrugated metal drainage pipe through the levee, 13.5 feet below the crown. Concrete U-shaped headwalls on both ends. Two corrugated metal cutoff walls. Flap gate on the waterside (WS) end. (Automatic Board Order (ABO) issued as Permit No. 10182, 1974 - Julia Trust Machado). [Additional Reference(s): DWR Levee Log, 2006. USACE As-Built Drawing No. 50-04-3379, 09 April 1964, Sheets 3 and 9, STA 195+36, listed as 10-inch steel pipe]. FS Date: 5/5/2022 2:56:07 PM

View of levee crown.

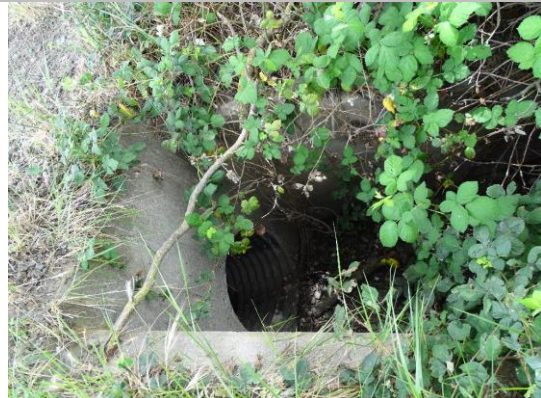
Photo 2 of 3 : UCIP_FA_2023_75162_112383.jpg

View of concrete headwall and pipe inlet on LS slope.

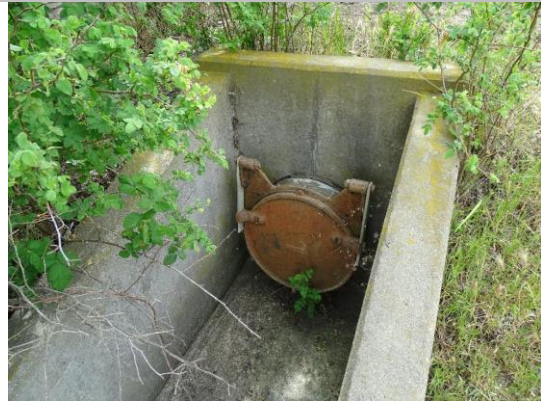
Photo 3 of 3 : UCIP_FA_2023_75162_112379.jpg

View of concrete headwall and flap gate on WS slope.

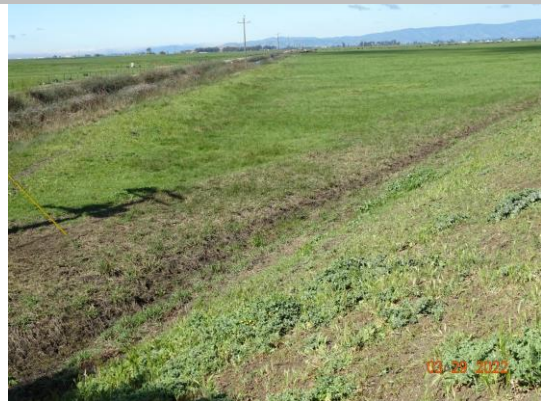
Photo 1 of 1 : FA_2023_RD2104_249_17_20231003_00002.jpg

LM Start	4.72	Rating **	M	Issue No.	17
LM End	4.94	Issue Type +	En	Location *	LS
Category	Earthen Levee			GPS Latitude/Longitude	
				Start	End
Item	Encroachments			38.318463°	38.320231°
				-121.744636°	-121.747979°
DWR ID	DWR_RD2104_01_s_2020_17				
Comment Code					
DT : Ditch					
Inspector Comment					
There is a small ditch at the landside toe.

View of small ditch at the landside toe (Spring 2022).

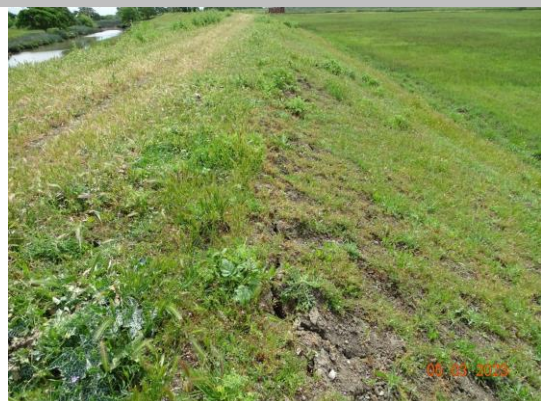
Photo 1 of 1 : FA_2023_RD2104_249_42_20231003_00008.jpg

LM Start	4.90	Rating **	M	Issue No.	42
LM End	4.90	Issue Type +	Ma	Location *	LS
Category	Earthen Levee			GPS Latitude/Longitude	
				Start	End
Item	Erosion / Livestock			38.319756°	38.319756°
				-121.747373°	-121.747373°
DWR ID	DWR_RD2104_01_s_2022_42				
Comment Code					
E4 : Repair the levee slope damaged by livestock and prevent large animal access.					
Inspector Comment					
Cows are digging into the top of the landside shoulder.

View of the erosion on the LS slope (Spring 2023).

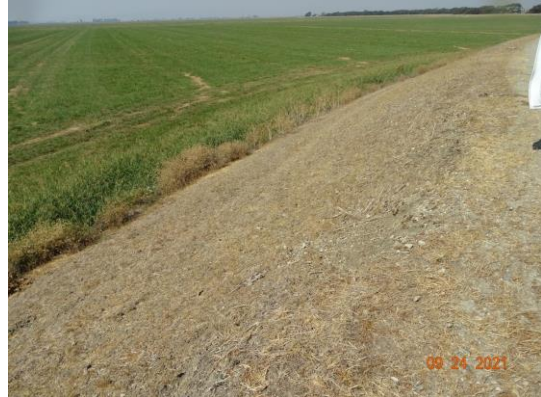
Photo 1 of 1 : FA_2023_RD2104_249_24_20231003_00004.jpg

LM Start	4.96	Rating **	M	Issue No.	24
LM End	4.96	Issue Type +	Ma	Location *	LS
Category	Earthen Levee			GPS Latitude/Longitude	
				Start	End
Item	Erosion / Livestock			38.320382°	38.320382°
				-121.748155°	-121.748155°
DWR ID	DWR_RD2104_01_f_2017_24				
Comment Code					
E4 : Repair the levee slope damaged by livestock and prevent large animal access.					
Inspector Comment					
Cows are digging into the top of the landside shoulder.

View looking upstream at livestock erosion at the landside hinge due to cows (Fall 2021).

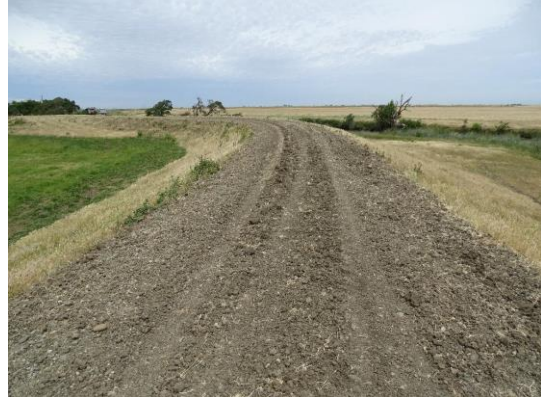
Photo 1 of 3 : UCIP_FA_2023_75165_112385.jpg

Comment Code						
Inspector Comment						
DS_ID:24701 FS_ID:75165 EP_NO: 10182 Repair Type: Urgent EVAL Issue: 1, Pipe Integrity Crossing Status: Found UCIP Comments: 05/05/2022 Record remains Urgent. DMP internal video inspection has found pipe integrity issues. LOF of crossing is between 5 and 6. Crossing will be monitored until funding becomes available to address the issues. System Feature. (D.Sanoski - DWR UCIP) 10/12/2018 Same as last inspection; concrete headwall on WS still being undermined so crossing remains Urgent (D. Sanoski - DWR UCIP).12/06/2016 same as last inspection--pipe remains "Urgent" CMP shows holes through wall and concrete headwall is undermined. Need to contact owner. Owner will need to work with the CVFPB to comply with Title 23. (O. Magana - DWR UCIP)12/04/2013 Footing under headwall on WS toe severely undermined. Pipe rusted heavily with holes at WS and may need replacement. (W. Wylie - DWR UCIP) FIELD_STRUCT_DESC: 24-inch corrugated metal drainage pipe through the levee, 13 feet below the crown. Two cutoff walls. Concrete U-shaped headwalls on both ends. Flap gate on the waterside (WS). (24-inch pipe [HLM 5.50] authorized under Automatic Board Order (ABO) issued as Permit No. 10182, 1974 - Julia Trust Machado). [Additional Reference(s): DWR Levee Log, 2006. USACE Sacramento O&M Manual 108, April 1964, (HLM 5.5), listed as a 12-inch pipe, Drawing No. 50-04-3379, listed as an 18-inch pipe]. FS Date: 5/5/2022 3:29:00 PM

View of levee crown.

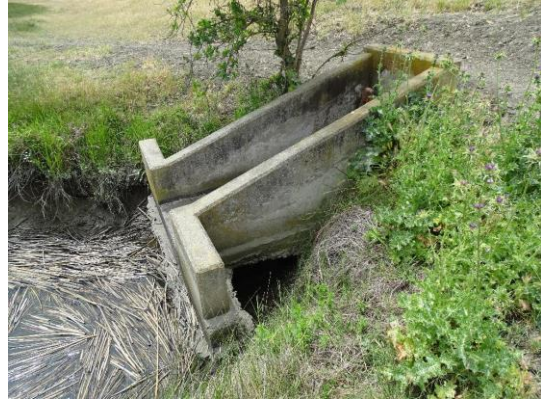
Photo 2 of 3 : UCIP_FA_2023_75165_112388.jpg

View of concrete headwall with severe erosion on WS toe.

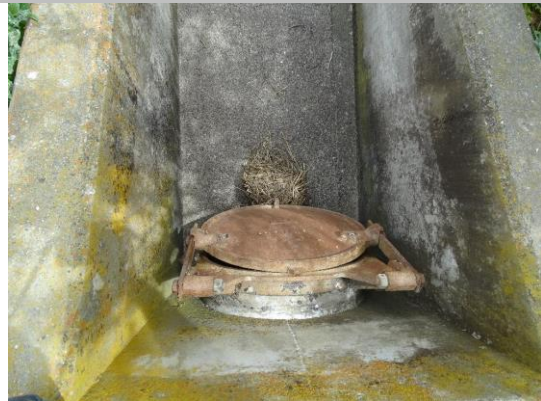
Photo 3 of 3 : UCIP_FA_2023_75165_112384.jpg

View of flap gate on pipe out of WS headwall.

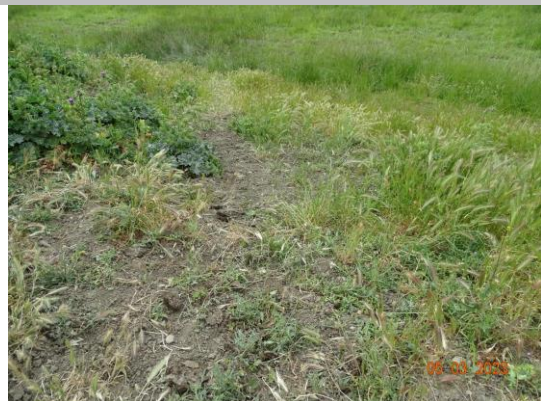
Photo 1 of 1 : FA_2023_RD2104_249_29_20231003_00005.jpg

LM Start	5.35	Rating **	M	Issue No.	29
LM End	5.35	Issue Type +	Ma	Location *	LS
Category	Earthen Levee			GPS Latitude/Longitude	
				Start	End
Item	Erosion / Livestock			38.323576°	38.323576°
				-121.752323°	-121.752323°
DWR ID	DWR_RD2104_01_f_2021_29				
Comment Code					
E4 : Repair the levee slope damaged by livestock and prevent large animal access.					
Inspector Comment

View of the erosion on the LS slope (Spring 2023).

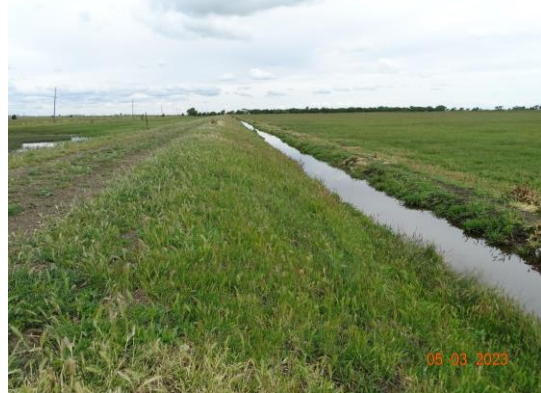
Photo 1 of 1 : FA_2023_RD2104_249_33_20231003_00006.jpg

View of the ditch along the LS toe (Spring 2023).
