Flood Control Project Maintenance Levee Inspections

Fall 2024 Levee Maintenance Deficiency Summary Report

Sacramento River Basin

Reclamation District No. 2104 Peters Pocket Tract

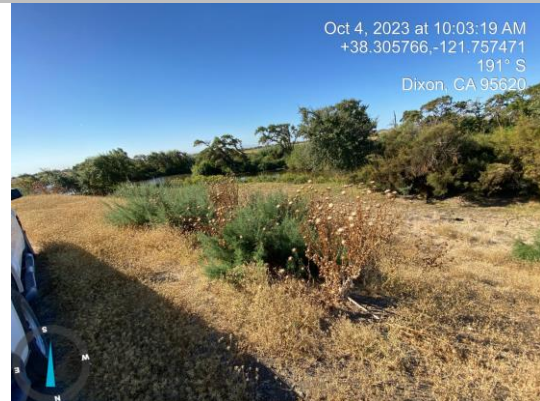
Photo 1 of 1 : FA_2024_RD2104_249_10_20241001_00001.jpg

View of vegetation on the waterside slope near the shoulder (Fall 2023).

LM Start	0.65	Rating **	C	Issue No.	38
LM End	0.66	Issue Type +	Ma	Location *	LS
Category	Earthen Levee			GPS Latitude/Longitude	
				Start	End
Item	Vegetation			38.300005°	38.299921°
				-121.754035°	-121.753823°
DWR ID	DWR_RD2104_01_s_2024_38				
Comment Code					
V2 : Remove the wild growth and woody vegetation other than native grasses from the levee slopes.					
Inspector Comment

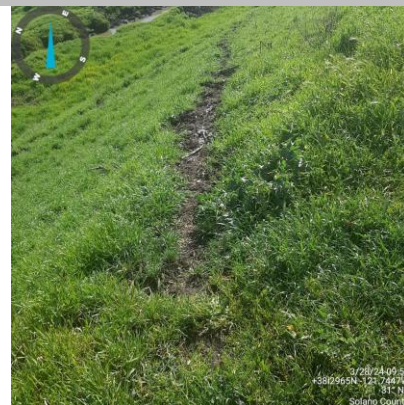
Photo 1 of 1 : FA_2024_RD2104_249_44_20241001_00016.jpg

LM Start	1.24	Rating **	A/W	Issue No.	44
LM End	1.24	Issue Type +	Ma	Location *	LS
Category	Earthen Levee			GPS Latitude/Longitude	
				Start	End
Item	Erosion / Livestock			38.296453 °	38.296453 °
				-121.744700 °	-121.744700 °
DWR ID	DWR_RD2104_01_s _ 2024_44				
Comment Code					
E4 : Repair the levee slope damaged by livestock and prevent large animal access.					
Inspector Comment					
Monitor the cow path for further damage.

View of cattle path on the LS slope. (Spring 2024)

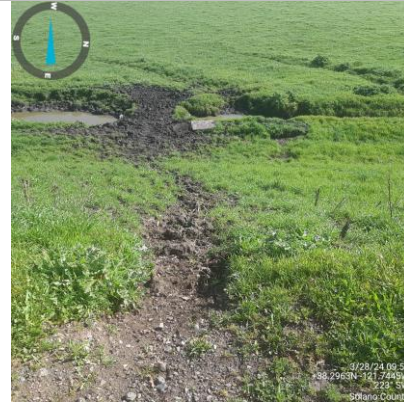
Photo 1 of 1 : FA_2024_RD2104_249_45_20241001_00017.jpg

LM Start	1.26	Rating **	M	Issue No.	45
LM End	1.26	Issue Type +	Ma	Location *	LS
Category	Earthen Levee			GPS Latitude/Longitude	
				Start	End
Item	Erosion / Livestock			38.296337 °	38.296337 °
				-121.744503 °	-121.744503 °
DWR ID	DWR_RD2104_01_s_2024_45				
Comment Code					
E4 : Repair the levee slope damaged by livestock and prevent large animal access.					
Inspector Comment

View of cattle path on the LS slope. (Spring 2024)

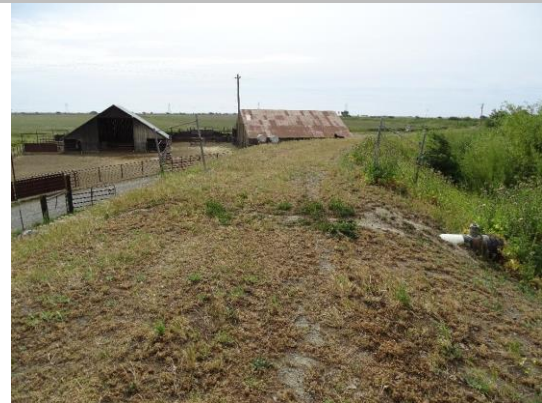
Photo 1 of 3 : UCIP_FA_2024_75136_112281.jpg

Comment Code						
Inspector Comment						
DS_ID:24711 FS_ID:75136 EP_NO: 10185 Repair Type: No Action Needed EVAL Issue: Crossing Status: Found UCIP Comments: 05/05/2022 Record remains No Action Needed. No issues observed during inspection. Running while there. System Feature. (D.Sanoski - DWR UCIP) 09/14/2017 Permit is unavailable, missing page 3 official permit documentation. (DWR UCIP - O. Magana) FIELD_STRUCT_DESC: 16-inch steel drainage pipe through the levee, 5.7 feet below the crown. Pump in an irrigation ditch on the landside (LS). Siphon breaker on the waterside (WS) slope. (16-inch pipe authorized under Automatic Board Order (ABO) issued as Permit No. 10185, 1964 - Erwin E. and Lucy G. Vassar). [Additional Reference(s): DWR Levee Log, 2006 (HLM 1.52). USACE Sacramento O&M Manual, Unit 108, April 1964, (HLM 1.52), listed as 16-inch pipe. USACE As-Built Drawing No. 50-04-3379, 22 January 1963, Sheet 5, Station 7+56]. FS Date: 5/5/2022 12:02:20 PM

View of levee crown and pipe crossing.

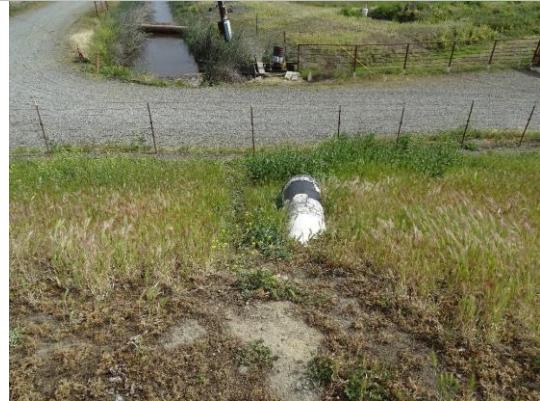
Photo 2 of 3 : UCIP_FA_2024_75136_112278.jpg

View of pipe out of LS slope.

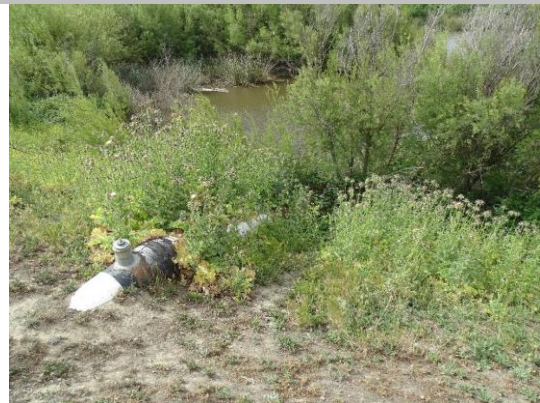
Photo 3 of 3 : UCIP_FA_2024_75136_112279.jpg

View of pipe out of WS slope.

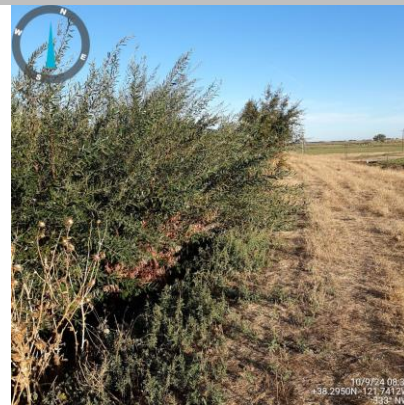
Photo 1 of 1 : FA_2024_RD2104_249_11_20241009_00048.jpg

LM Start	1.46	Rating **	M	Issue No.	11
LM End	1.48	Issue Type +	Ma	Location *	WS
Category	Earthen Levee			GPS Latitude/Longitude	
				Start	End
Item	Vegetation			38.295192 °	38.294959 °
				-121.741322 °	-121.741222 °
DWR ID	DWR_RD2104_01_f_2024_11				
Comment Code					
V2 : Remove the wild growth and woody vegetation other than native grasses from the levee slopes.					
Inspector Comment

View of overgrown shrubs on the waterside shoulder. (Fall 2024)

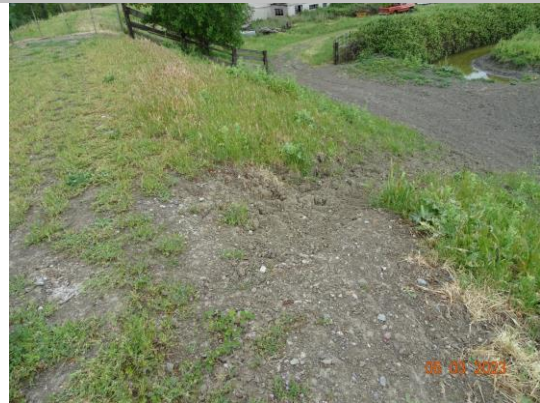
Photo 1 of 1 : FA_2024_RD2104_249_13_20241001_00002.jpg

LM Start	1.58	Rating **	M	Issue No.	13
LM End	1.58	Issue Type +	Ma	Location *	LS
Category	Earthen Levee			GPS Latitude/Longitude	
				Start	End
Item	Erosion / Livestock			38.294097 °	38.294097 °
				-121.740133 °	-121.740133 °
DWR ID	DWR_RD2104_01_f _ 2020_13				
Comment Code					
E4 : Repair the levee slope damaged by livestock and prevent large animal access.					
Inspector Comment					
There is a cow path that is digging into levee.

View of the cow path down the LS slope (Spring 2023).

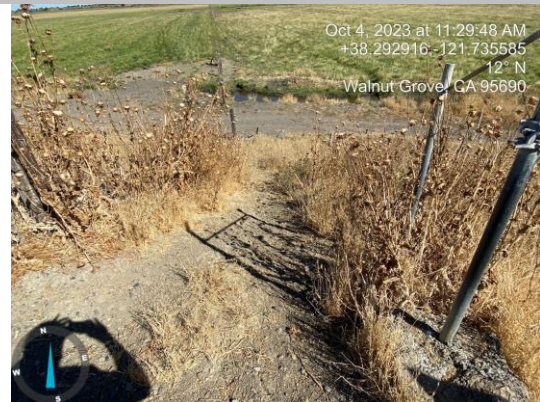
Photo 1 of 1 : FA_2024_RD2104_249_19_20241001_00004.jpg

LM Start	1.85	Rating **	M	Issue No.	19
LM End	1.85	Issue Type +	Ma	Location *	LS
Category	Earthen Levee			GPS Latitude/Longitude	
				Start	End
Item	Erosion / Livestock			38.292880 °	38.292880 °
				-121.735552 °	-121.735552 °
DWR ID	DWR_RD2104_01_f_2020_19				
Comment Code					
E4 : Repair the levee slope damaged by livestock and prevent large animal access.					
Inspector Comment					
There is a cow path on the landside slope.

View of cow path down the landside slope (Fall 2023).

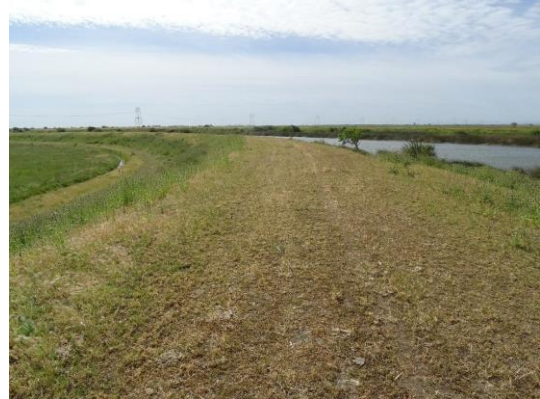
Photo 1 of 3 : UCIP_FA_2024_75140_112292.jpg

Comment Code						
Inspector Comment						
DS_ID:24721 FS_ID:75140 EP_NO: N/A Repair Type: Non-Urgent EVAL Issue: Crossing Status: Not Found UCIP Comments: 05/05/2022 Record remains Non-Urgent. Geophysical results did not confirm presence of pipe through levee. Record will remain in UCIP's inspection records until future Levee Improvement Project can confirm no crossing was found through the levee. System Feature. (D. Sanoski - DWR UCIP) FIELD_STRUCT_DESC: 16-inch drainage pipe of an unknown material through the levee, at an unknown depth. Flap gate on the waterside (WS) toe. [Additional Reference(s): USACE Sacramento O&M Manual, Unit 108, April 1964, (HLM 2.04), listed as 16-inch pipe]. FS Date: 5/5/2022 12:06:18 PM

View of levee crown.

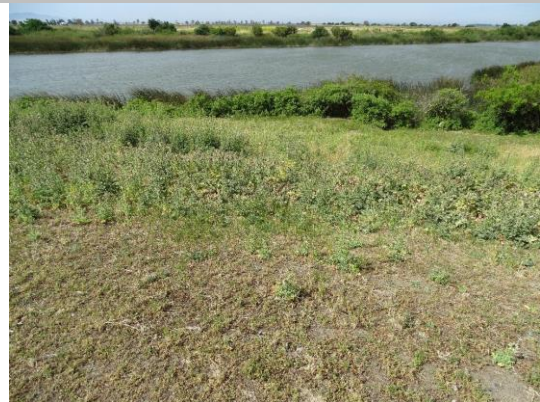
Photo 2 of 3 : UCIP_FA_2024_75140_112291.jpg

View of WS slope.

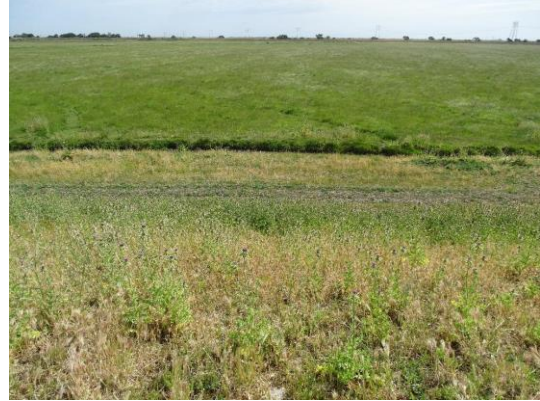
Photo 3 of 3 : UCIP_FA_2024_75140_112293.jpg

View of LS slope.

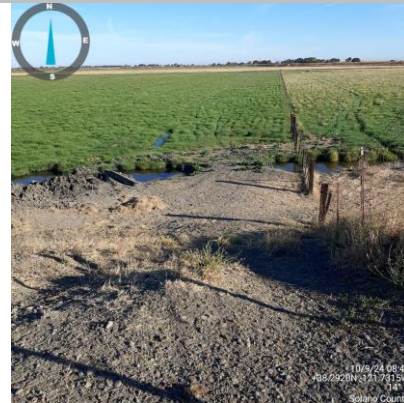
Photo 1 of 1 : FA_2024_RD2104_249_15_20241009_00049.jpg

LM Start	2.10	Rating **	M	Issue No.	15
LM End	2.10	Issue Type +	Ma	Location *	LS
Category	Earthen Levee			GPS Latitude/Longitude	
				Start	End
Item	Erosion / Livestock			38.292063 °	38.292063 °
				-121.731561 °	-121.731561 °
DWR ID	DWR_RD2104_01_f _ 2024_15				
Comment Code					
E4 : Repair the levee slope damaged by livestock and prevent large animal access.					
Inspector Comment					
Livestock path has formed on the landside slope.

View of livestock path formed on the landside slope. (Fall 2024)

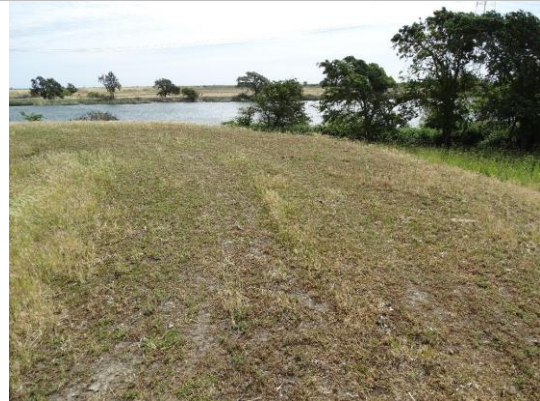
Photo 1 of 3 : UCIP_FA_2024_75141_112294.jpg

Comment Code						
Inspector Comment						
DS_ID:24726 FS_ID:75141 EP_NO: N/A Repair Type: Non-Urgent EVAL Issue: Crossing Status: Not Found UCIP Comments: 05/05/2022 Record remains Non-Urgent. Geophysical results did not confirm presence of pipe through levee. Record will remain in UCIP's inspection records until future Levee Improvement Project can confirm no crossing was found through the levee. No physical sign of abandoned pipe stated in last comment. System Feature. (D. Sanoski - DWR UCIP) 12/04/2013 24-inch CMP debris on WS berm may indicate pipe was abandoned. (W. Wylie - DWR UCIP) FIELD_STRUCT_DESC: 24-inch corrugated metal drainage pipe through the levee, 18 feet below the crown. Flap gate on the waterside (WS) toe. [Additional Reference(s): USACE Sacramento O&M Manual, Unit 108, April 1964, (HLM 2.60), listed as 24-inch pipe]. FS Date: 5/5/2022 12:58:09 PM

View of levee crown.

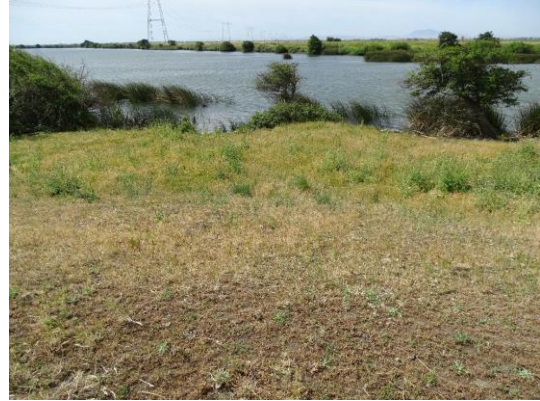
Photo 2 of 3 : UCIP_FA_2024_75141_112296.jpg

View of WS slope.

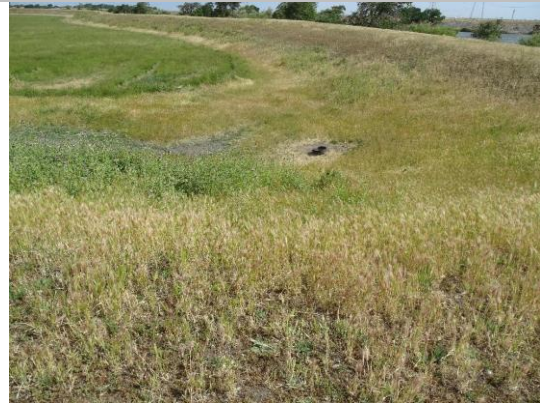
Photo 3 of 3 : UCIP_FA_2024_75141_112295.jpg

View of LS slope.

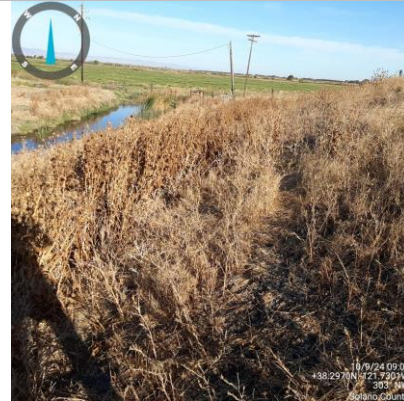
Photo 1 of 1 : FA_2024_RD2104_249_22_20241009_00050.jpg

View of tall vegetation on the landside slope. (Fall 2024)

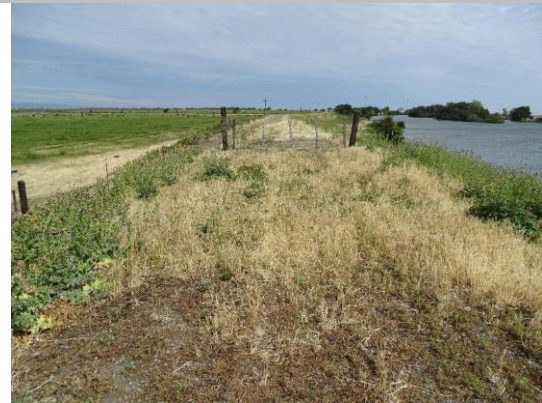
Photo 1 of 3 : UCIP_FA_2024_75142_112298.jpg

Comment Code						
Inspector Comment						
DS_ID:24708 FS_ID:75142 EP_NO: 10185 Repair Type: No Action Needed EVAL Issue: Crossing Status: Found UCIP Comments: 05/05/2022 Record remains No Action Needed. No issues observed during inspection. System Feature. (D.Sanoski - DWR UCIP) 09/14/2017 Permit is unavailable, missing page 3 official permit documentation. (DWR UCIP - O. Magana) FIELD_STRUCT_DESC: 12-inch steel drainage pipe through the levee, 4 feet below the crown. Pump on pile structure in drainage canal on the landside (LS). Siphon breaker in a 12-inch steel riser on the waterside (WS) slope. This crossing replaces 12-inch pipe (see DSID 25961). (12-inch pipe authorized under Permit No. 4412, 1963 - Mr. and Mrs. Ervin E. Vassar). FS Date: 5/5/2022 12:58:29 PM

View of levee crown.

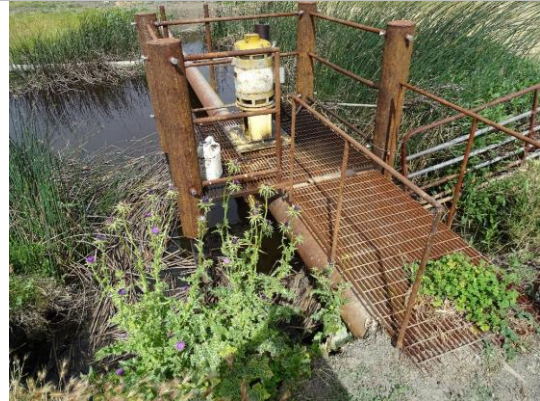
Photo 2 of 3 : UCIP_FA_2024_75142_112297.jpg

View of pump on structure off LS toe.

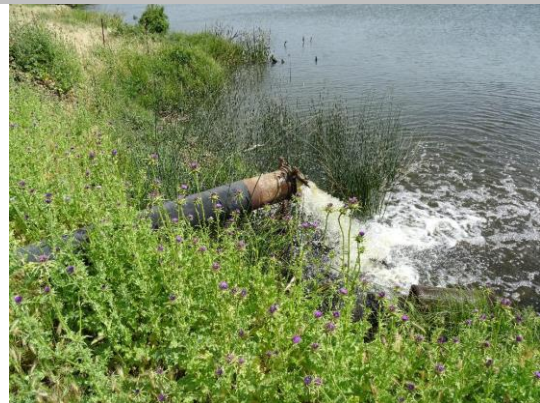
Photo 3 of 3 : UCIP_FA_2024_75142_112302.jpg

View of pipe with flap gate out of WS berm.

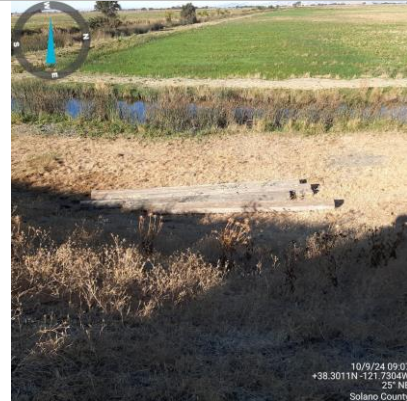
Photo 1 of 1 : FA_2024_RD2104_249_25_20241009_00051.jpg

View of wooden poles placed at the landside toe. (Fall 2024)

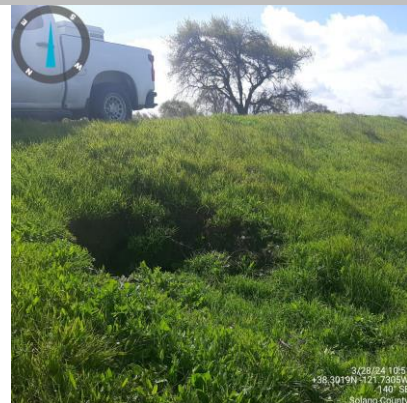
Photo 1 of 1 : FA_2024_RD2104_249_51_20241001_00018.jpg

LM Start	3.21	Rating **	U	Issue No.	51
LM End	3.21	Issue Type +	Ma	Location *	LS
Category	Earthen Levee			GPS Latitude/Longitude	
				Start	End
Item	Slope Stability			38.301804 °	38.301804 °
				-121.730454 °	-121.730454 °
DWR ID	DWR_RD2104_01_f_2024_51				
Comment Code					
S1 : Repair slope instability.					
Inspector Comment					
4'x6'x1.5' erosion/depression in LS slope needs to be repaired.

View of erosion on landside slope. (Spring 2024)

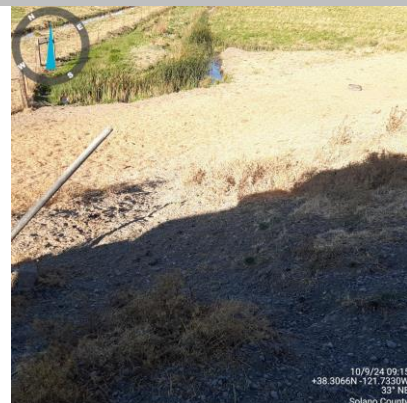
Photo 1 of 1 : FA_2024_RD2104_249_27_20241009_00052.jpg

LM Start	3.64	Rating **	U	Issue No.	27
LM End	3.64	Issue Type +	Ma	Location *	LS
Category	Earthen Levee			GPS Latitude/Longitude	
				Start	End
Item	Erosion / Livestock			38.306612°	38.306612°
				-121.733017°	-121.733017°
DWR ID	DWR_RD2104_01_f_2024_27				
Comment Code					
E4 : Repair the levee slope damaged by livestock and prevent large animal access.					
Inspector Comment					
Livestock activity has caused erosion that should be repaired by the LMA by backfilling and compacting loose material.

View of erosion caused by livestock activity on the landside slope. (Fall 2024)

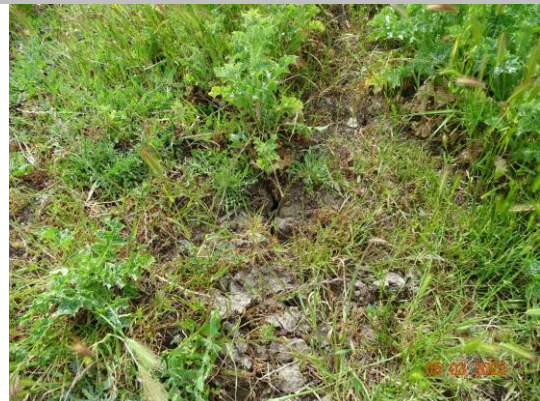
Photo 1 of 1 : FA_2024_RD2104_249_37_20241001_00012.jpg

LM Start	3.77	Rating **	M	Issue No.	37
LM End	3.77	Issue Type +	Ma	Location *	LS
Category	Earthen Levee			GPS Latitude/Longitude	
				Start	End
Item	Slope Stability			38.307897 °	38.307897 °
				-121.734669 °	-121.734669 °
DWR ID	DWR_RD2104_01_s_2022_37				
Comment Code					
S1 : Repair slope instability.					
Inspector Comment					
There is a small soil separation at top of landside slope.

View of small soil separation on LS shoulder (Spring 2023).

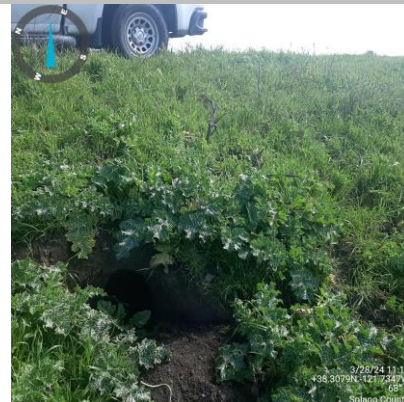
Photo 1 of 1 : FA_2024_RD2104_249_56_20241001_00019.jpg

LM Start	3.77	Rating **	U	Issue No.	56
LM End	3.77	Issue Type +	Ma	Location *	LS
Category	Earthen Levee			GPS Latitude/Longitude	
				Start	End
Item	Animal Control			38.307931 °	38.307931 °
				-121.734664 °	-121.734664 °
DWR ID	DWR_RD2104_01_s_2024_56				
Comment Code					
A3 : No rodents visible, but rodent burrows visible; need to backfill and compact or grout burrows.					
Inspector Comment					
Exterminate or relocate animal and repair burrow in LS slope.

View of animal burrow on LS slope. (Spring 2024)

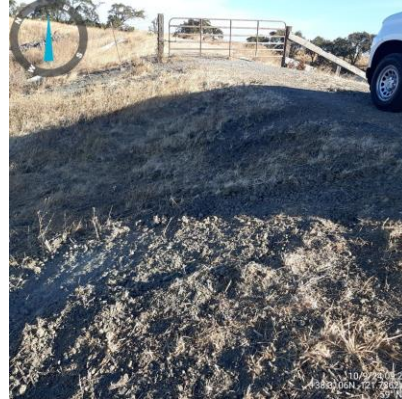
Photo 1 of 1 : FA_2024_RD2104_249_30_20241009_00053.jpg

LM Start	4.00	Rating **	M	Issue No.	30
LM End	4.00	Issue Type +	Ma	Location *	LS
Category	Earthen Levee			GPS Latitude/Longitude	
				Start	End
Item	Slope Stability			38.310672 °	38.310672 °
				-121.736185 °	-121.736185 °
DWR ID	DWR_RD2104_01_f_2024_30				
Comment Code					
S1 : Repair slope instability.					
Inspector Comment					
Repair depression in the landside slope by backfilling and compacting loose soil.

View of erosion on the landside slope. (Fall 2024)

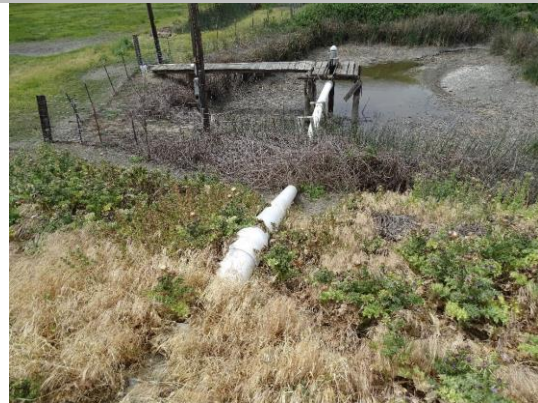
Photo 1 of 3 : UCIP_FA_2024_82597_112332.jpg

Comment Code					
Inspector Comment					
DS_ID:25763 FS_ID:82597 EP_NO: N/A Repair Type: Urgent EVAL Issue: 3b, Flood Risk Crossing Status: Found UCIP Comments: 05/05/2022 Record is Urgent. Annular space between pipes under levee crown was not grouted. No permit has been found authorizing this pipe through the levee. (D.Sanoski - DWR UCIP) FIELD_STRUCT_DESC: 10-inch PVC pipe sleeved through a 12-inch CMP pipe through the levee, just beneath the levee crown. The annular space between the two pipes are not grouted. The 10-inch PVC pipe runs on the top of both levee slopes. Vertical pump on wooden pile structure in the drainage pit on landside (LS) with wooden walkway to it. Air release valve located on waterside (WS) slope. FS Date: 5/5/2022

View of PVC pipe out of LS slope to pump.

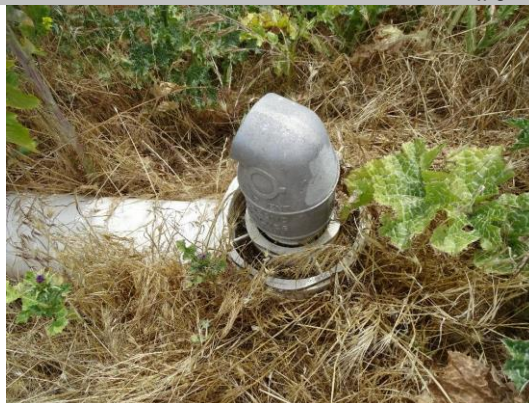
Photo 2 of 3 : UCIP_FA_2024_82597_112335.jpg

View of air release valve on WS slope.

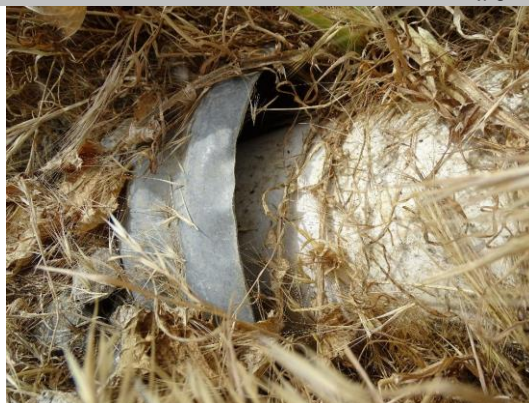
Photo 3 of 3 : UCIP_FA_2024_82597_112334.jpg

View of 10-inch PVC pipe sleeved through 12-inch CMP pipe just beneath the levee crown.

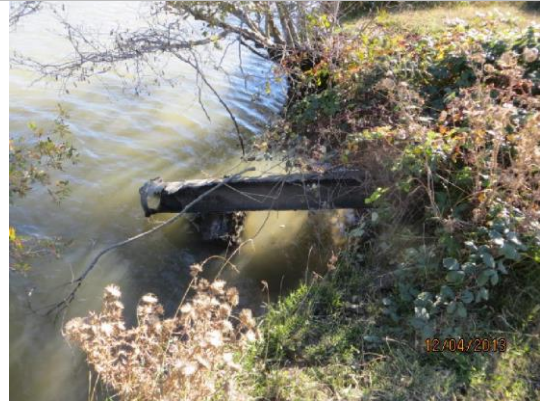
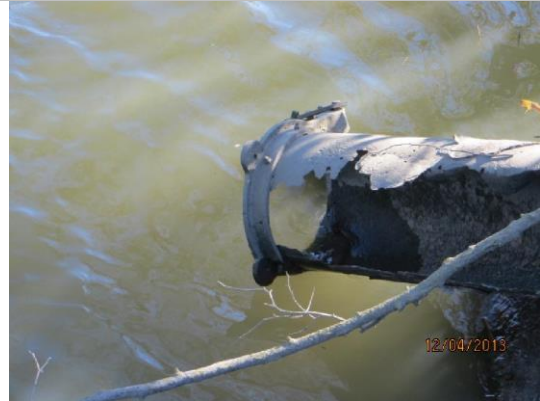
Comment Code						
Inspector Comment						
DS_ID:24706 FS_ID:75666 EP_NO: 10183 Repair Type: Non-Urgent EVAL Issue: Crossing Status: Not Found UCIP Comments: 05/05/2022 Record remains Non-Urgent. Crossing not found. Pipe was possibly removed in 2016. No permit has been identified authorizing pipe. Need to have CVFPB review ABO and determine current owner. (D. Sanoski - DWR UCIP) 12/01/2017 Pipe appears removed and replaced with PVC pipe. Refer to DSID 25763 for details on outstanding issue with new pipe, missing CVFPB permit, and construction documents. 12/06/2016 Pipe has been replaced with PVC pipe. The crossing is non-functional due to pipe not attached to new pump. Need to contact owner. Owner will need to coordinate with CVFPB regarding the modifications made to this crossing (modifications include pipe replacement, material used for pipe replacement, and debris left from construction on levees). (O. Magana - DWR UCIP) 12/04/2013 Pipe rusted through on WS berm. Siphon breaker in CMP riser blocked by riser misalignment. (W. Wylie - DWR UCIP) FIELD_STRUCT_DESC: 12-inch steel drainage pipe through the levee, 4.0 feet below the crown. Pump on pile structure in drainage ditch on the landside (LS). One corrugated metal cutoff wall and a siphon breaker in a 24-inch corrugated metal pipe (CMP) riser located on the waterside (WS) shoulder. Flap gate on the WS end. (12-inch pipe authorized under Automatic Board Order (ABO) issued as Permit No. 10183, 1974 - Harold D. and Norma L. Miller). [Additional Reference(s): DWR Levee Log, 2006 (HLM 4.32). USACE Sacramento O&M Manual, Unit 108, April 1964, (HLM 4.32), listed as 12-inch pipe. USACE As-Built Drawing No. 50-04-3379, 22 January 1963, Sheets 4 and 10, Station 232+46]. FS Date: 5/5/2022 2:08:52 PM

Pipe completely rusted through at WS berm.

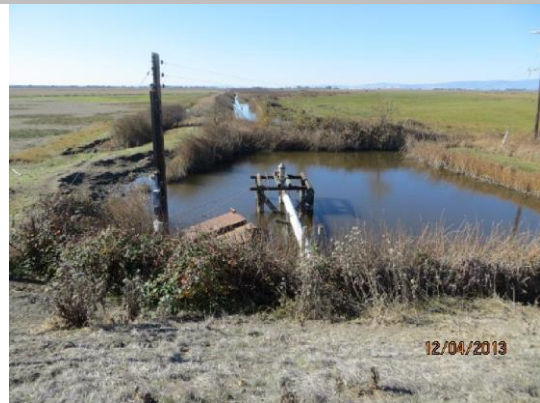
Photo 3 of 3 : UCIP_FA_2024_75666_45056.jpg

Pump on pier off LS toe at ponding area. power pole and meter on LS toe.

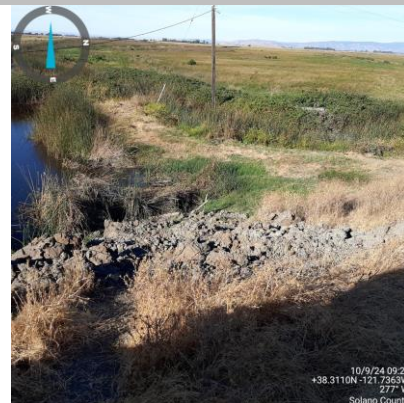
Photo 1 of 1 : FA_2024_RD2104_249_31_20241009_00054.jpg

View of loose soil located on the landside slope. (Fall 2024)

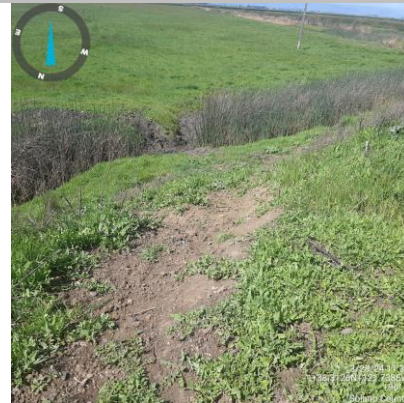
Photo 1 of 1 : FA_2024_RD2104_249_32_20241001_00008.jpg

LM Start	4.20	Rating **	U	Issue No.	32
LM End	4.20	Issue Type +	Ma	Location *	LS
Category	Earthen Levee			GPS Latitude/Longitude	
				Start	End
Item	Erosion / Livestock			38.312653 °	38.312653 °
				-121.738682 °	-121.738682 °
DWR ID	DWR_RD2104_01_f_2021_32				
Comment Code					
E4 : Repair the levee slope damaged by livestock and prevent large animal access.					
Inspector Comment					
There is a livestock path on the LS slope.

View of livestock path on LS slope. (Spring 2024)

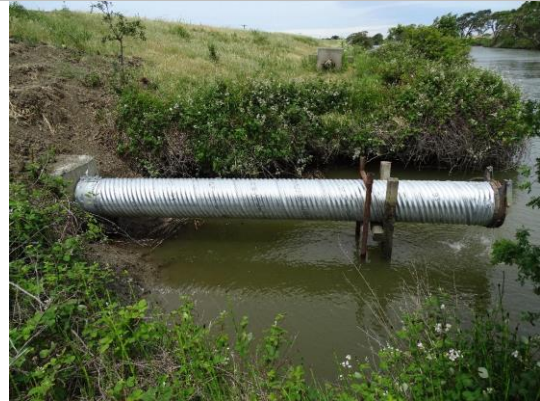
Photo 2 of 3 : UCIP_FA_2024_75150_112341.jpg

View of pipe with flap gate out of concrete headwall on WS toe.

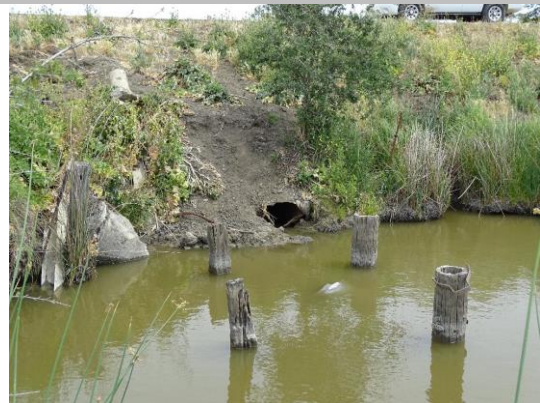
Photo 3 of 3 : UCIP_FA_2024_75150_112337.jpg

View of open pipe on LS slope.

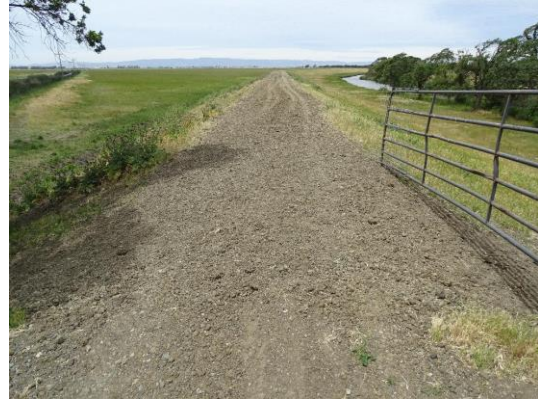
Photo 1 of 3 : UCIP_FA_2024_75162_112380.jpg

View of levee crown.

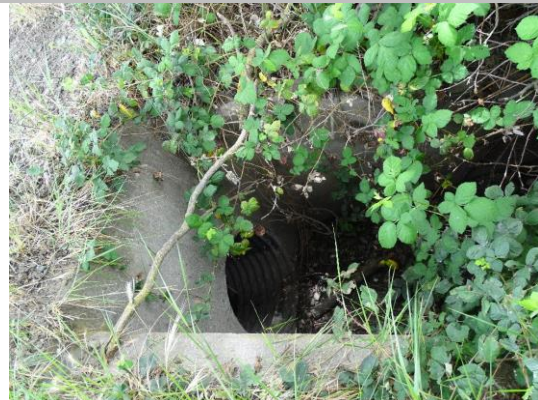
Photo 2 of 3 : UCIP_FA_2024_75162_112383.jpg

View of concrete headwall and pipe inlet on LS slope.

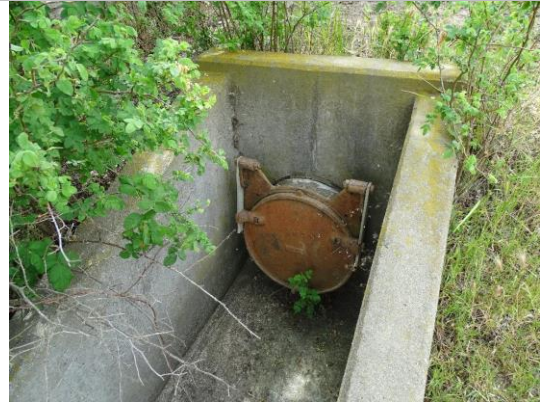
Photo 3 of 3 : UCIP_FA_2024_75162_112379.jpg

View of concrete headwall and flap gate on WS slope.

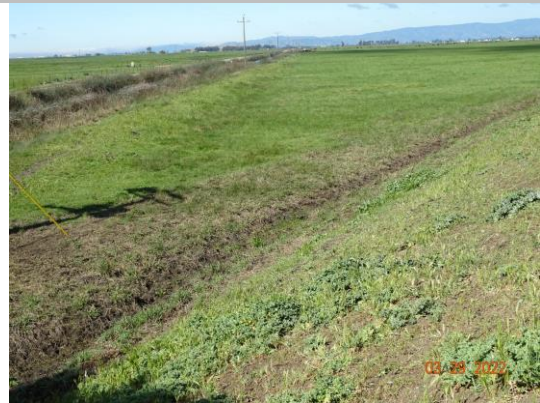
Photo 1 of 1 : FA_2024_RD2104_249_17_20241001_00003.jpg

View of small ditch at the landside toe (Spring 2022).

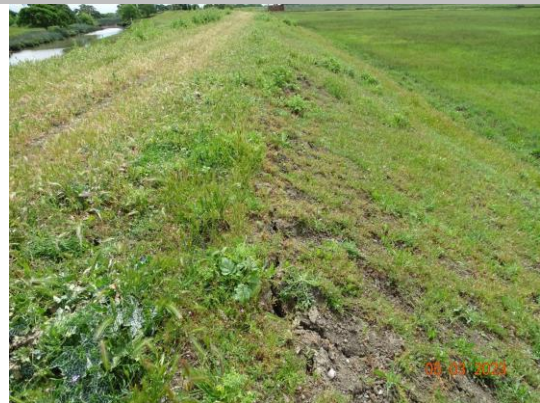
Photo 1 of 1 : FA_2024_RD2104_249_42_20241001_00014.jpg

View of the erosion on the LS slope (Spring 2023).

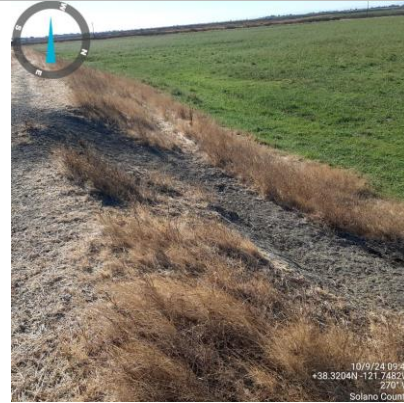
Photo 1 of 1 : FA_2024_RD2104_249_24_20241009_00055.jpg

View of livestock path on the LS slope. (Fall 2024)

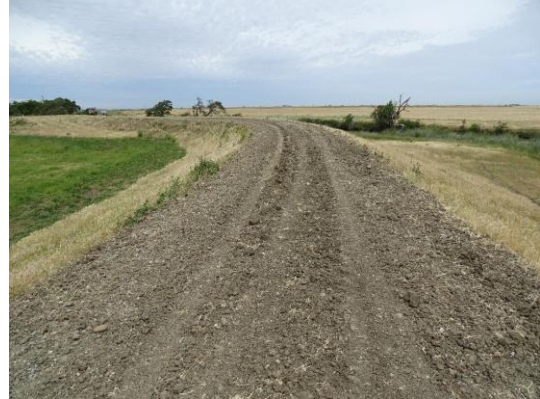
Photo 1 of 3 : UCIP_FA_2024_75165_112385.jpg

View of levee crown.

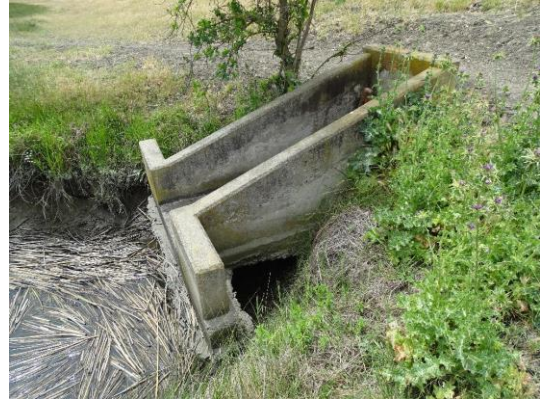
Photo 2 of 3 : UCIP_FA_2024_75165_112388.jpg

View of concrete headwall with severe erosion on WS toe.

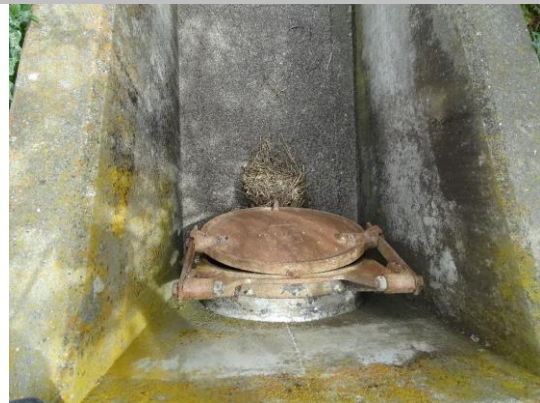
Photo 3 of 3 : UCIP_FA_2024_75165_112384.jpg

View of flap gate on pipe out of WS headwall.

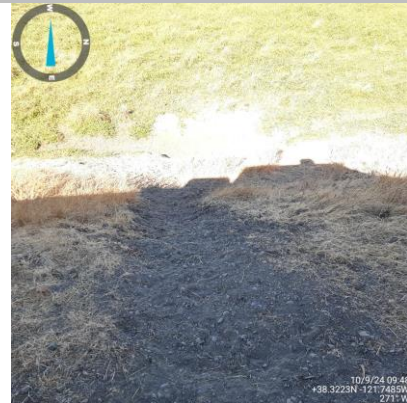
Photo 1 of 1 : FA_2024_RD2104_249_48_20241009_00056.jpg

View of livestock path and erosion on the landside slope. (Fall 2024)

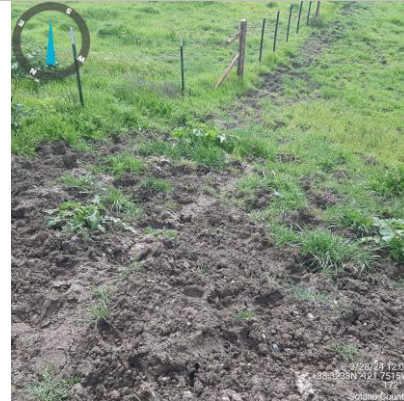
Photo 1 of 1 : FA_2024_RD2104_249_58_20241001_00020.jpg

View of livestock erosion and livestock path on LS slope. (Spring 2024)

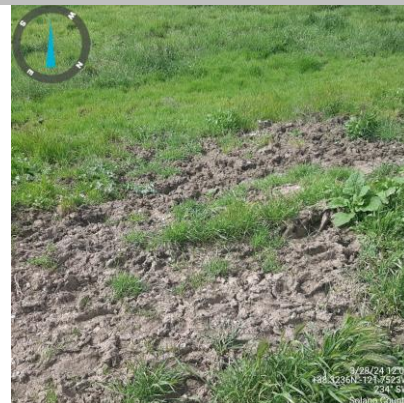
Photo 1 of 1 : FA_2024_RD2104_249_29_20241001_00006.jpg

View of livestock erosion on LS slope. (Spring 2024)

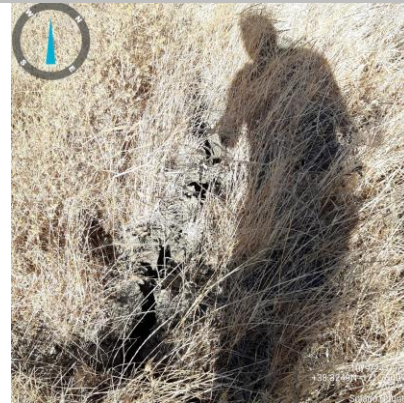
Photo 1 of 1 : FA_2024_RD2104_249_52_20241009_00059.jpg

View of soil cracking observed on the landside slope. (Fall 2024)

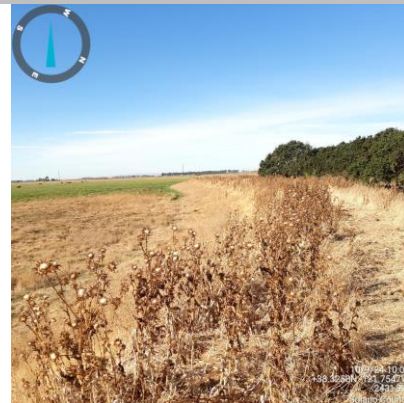
Photo 1 of 1 : FA_2024_RD2104_249_53_20241009_00057.jpg

View of tall vegetation on the landside slope.

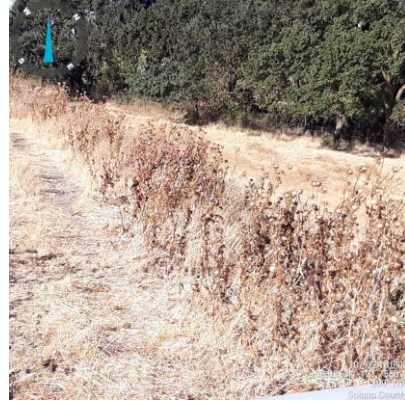
Photo 1 of 1 : FA_2024_RD2104_249_54_20241009_00058.jpg

View of vegetation on the waterside slope. (Fall 2024)

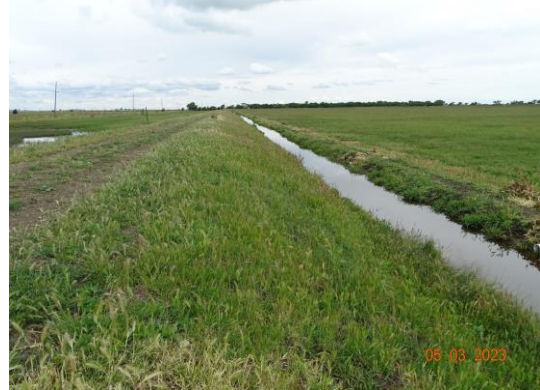
Photo 1 of 1 : FA_2024_RD2104_249_33_20241001_00009.jpg

View of the ditch along the LS toe (Spring 2023).
