**Flood Control Project Maintenance
Levee Inspections
LMA District Cover Sheet
Spring 2011 Levee Inspection Results**

Reclamation District No. 2104 Peters Pocket Tract

Levee Inspection Report By Mile - Spring 2011

Waterway			Bank	Unit Miles	Inspection Start/End	Inspector
Unit No. 01 Cache Slough			Left	7.40	04/14/2011 04/14/2011	Herman Phillips

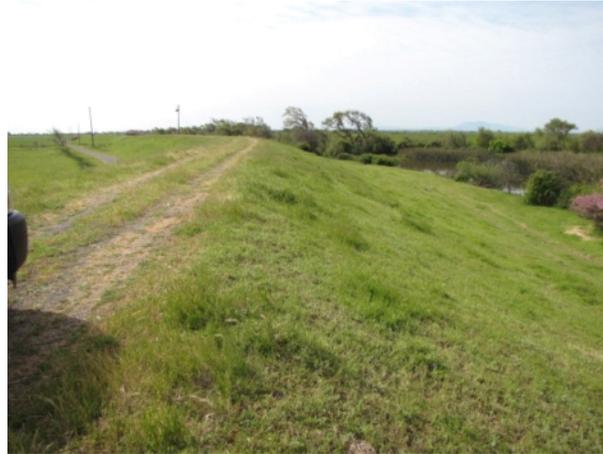
Levee Mile Report Line	1
Start Levee Mile	0.00
End Levee Mile	0.00
Location	Water Side
Category	Earthen Levee
Item	Vegetation
Looking downstream at the waterside of RD 2104 levee mile 0.00. Photo taken 4-14-2011.	
phillips_s_20110415_253.jpg

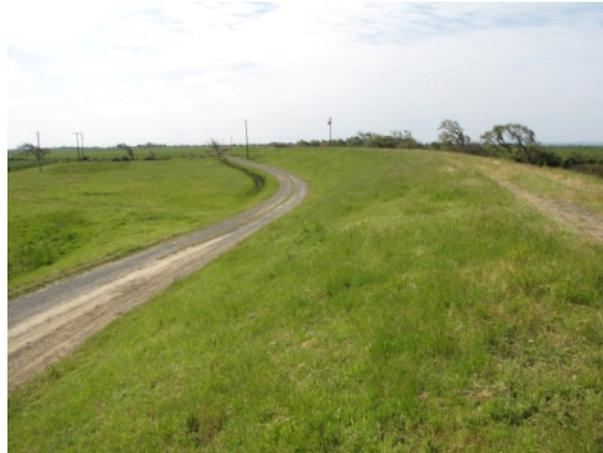
Levee Mile Report Line	2
Start Levee Mile	0.00
End Levee Mile	0.00
Location	Land Side
Category	Earthen Levee
Item	Vegetation
Looking downstream from levee mile 0.00 RD 2104 landside levee slope. Photo taken 4-14-2011.	
phillips_s_20110415_254.jpg

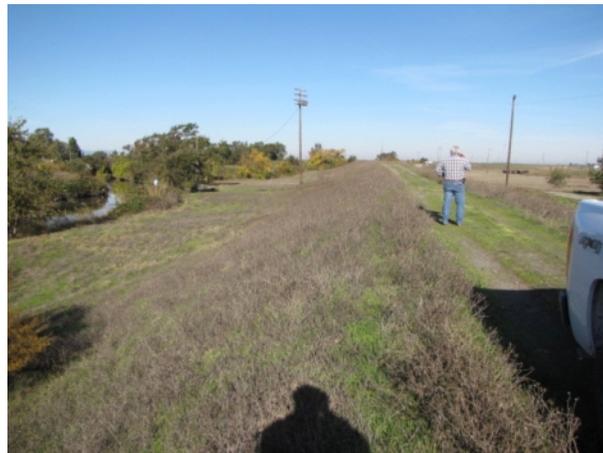
Levee Mile Report Line	3
Start Levee Mile	0.19
End Levee Mile	0.19
Location	Land Side
Category	Earthen Levee
Item	Vegetation
Levee mile 0.18 looking up stream water side levee slope. 11-17-2010	
phillips_s_20110228_142.jpg

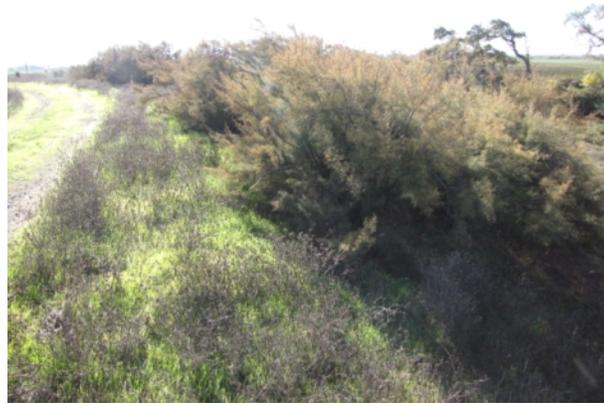
Levee Mile Report Line	4
Start Levee Mile	0.19
End Levee Mile	0.22
Location	Water Side
Category	Earthen Levee
Item	Vegetation
Looking downstream from Levee mile 0.19 Soft cedar need to be removed from levee slopes. 11-17-2010	
phillips_s_20110228_143.jpg

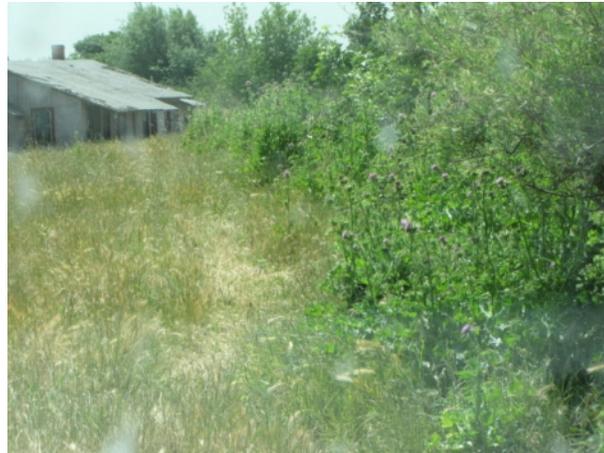
Levee Mile Report Line	15
Start Levee Mile	1.43
End Levee Mile	1.60
Location	Water Side
Category	Earthen Levee
Item	Vegetation
This photo shown here was listed with a U rating. The waterside is completely over grown from shoulder to beyond waterside toe. The crown has weeds 2-feet tall.	
phillips_s_20110228_144.jpg

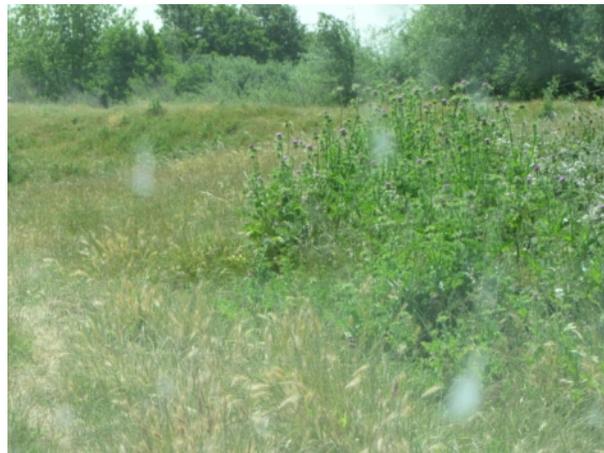
Levee Mile Report Line	15
Start Levee Mile	1.43
End Levee Mile	1.60
Location	Water Side
Category	Earthen Levee
Item	Vegetation
Standing on L/M 1.60 Looking downstream to 1.98 landward levee over grown. This levee has not had any maintenance since last inspection. Taken 11-17-2010	
phillips_s_20110228_145.jpg

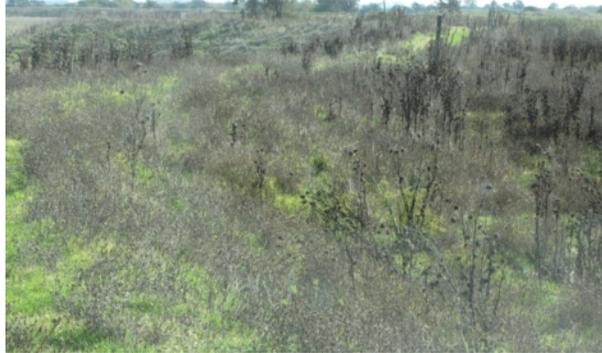
Levee Mile Report Line	15
Start Levee Mile	1.43
End Levee Mile	1.60
Location	Water Side
Category	Earthen Levee
Item	Vegetation

Standing at levee mile 1.60 looking downstream of landside wild growth remains on levee section. This section was rated unsatisfactory during the spring inspection, no change 11-17-2010.

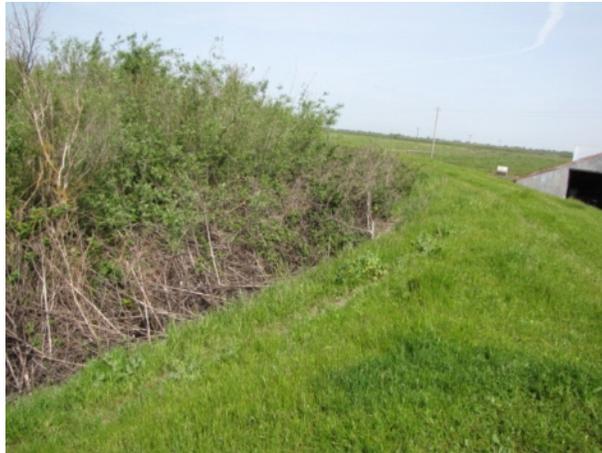
Levee Mile Report Line	15
Start Levee Mile	1.43
End Levee Mile	1.60
Location	Water Side
Category	Earthen Levee
Item	Vegetation

Looking back upstream from levee mile 1.60 waterside of RD 2104 Remain to be unsatisfactory. Photo taken 4-14-2011.

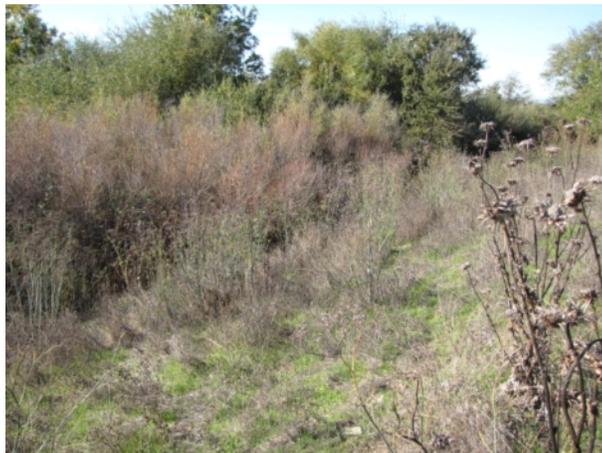
Levee Mile Report Line	16
Start Levee Mile	1.55
End Levee Mile	1.60
Location	Water Side
Category	Earthen Levee
Item	Trim / Thin Trees

Looking back downstream from levee mile 1.55 unsatisfactory wild growth remains on levee section. Photo taken 11-17-2010

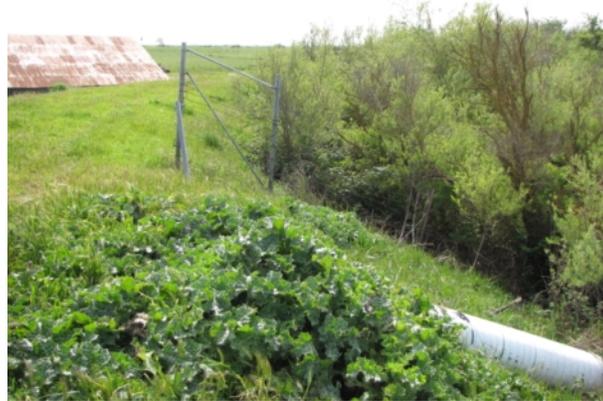
Levee Mile Report Line	16
Start Levee Mile	1.55
End Levee Mile	1.60
Location	Water Side
Category	Earthen Levee
Item	Trim / Thin Trees
<p>Looking downstream at unsatisfactory growth of trees along the water side slope levee mile 1.43. Photo taken 4-14-2011. The growth goes beyond levee mile 1.60.</p>	
<p>phillips_s_20110415_256.jpg</p>

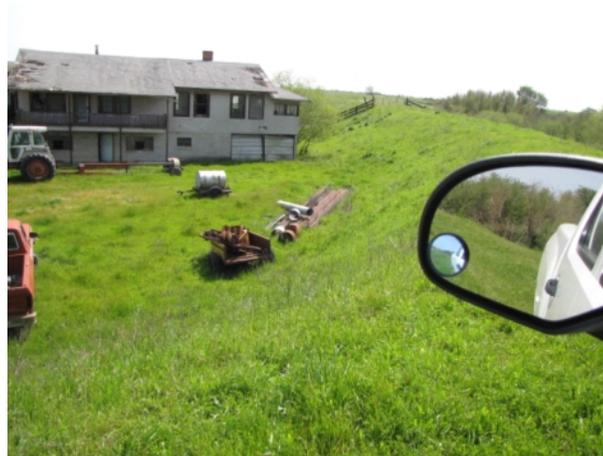
Levee Mile Report Line	18
Start Levee Mile	1.64
End Levee Mile	1.64
Location	Land Side
Category	Earthen Levee
Item	Encroachments
<p>Looking at the material within 10-foot of landward toe levee mile 1.64 RD 2104. Photo taken 4-14-2011</p>	
<p>phillips_s_20110415_258.jpg</p>

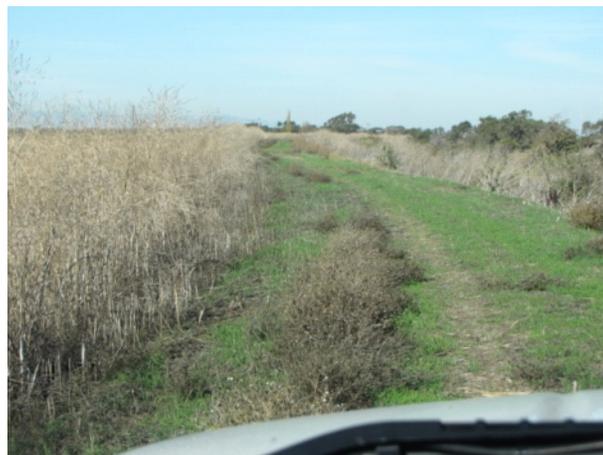
Levee Mile Report Line	19
Start Levee Mile	1.69
End Levee Mile	2.60
Location	Crown
Category	Earthen Levee
Item	Vegetation
<p>Looking downstream from levee 1.69 to 2.60 crown has not been sterilized.</p>	
<p>phillips_s_20110228_148.jpg</p>

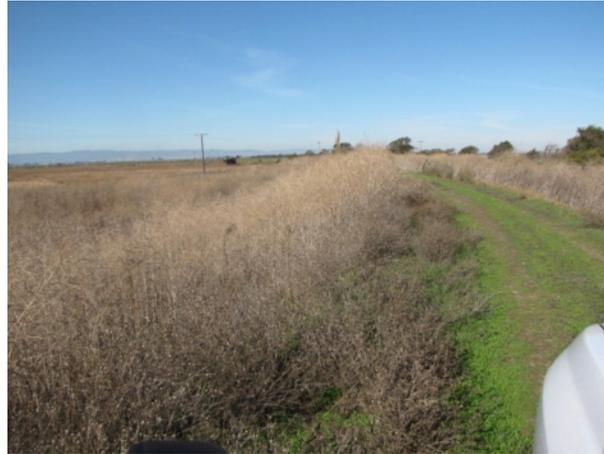
Levee Mile Report Line	22
Start Levee Mile	4.21
End Levee Mile	4.70
Location	Land Side
Category	Earthen Levee
Item	Vegetation
<p>Standing at levee mile 4.21 looking downstream to 4.70 no maintenance since last inspection wild growth on landside and waterside levee slopes. Unsatisfactory. Photo taken 11-17-2010</p>	
<p>phillips_s_20110228_149.jpg</p>

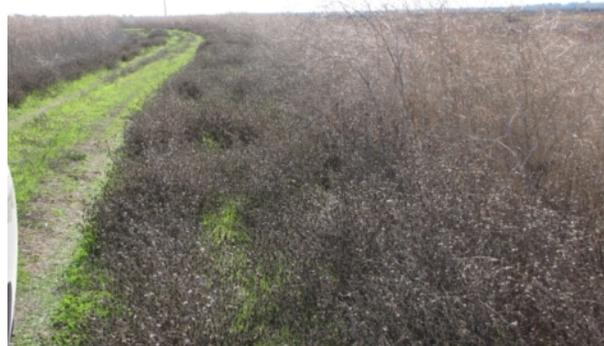
Levee Mile Report Line	22
Start Levee Mile	4.21
End Levee Mile	4.70
Location	Land Side
Category	Earthen Levee
Item	Vegetation
<p>Standing at levee mile 4.21 looking downstream waterside to levee mile 4.70 unsatisfactory growth. Photo taken 11-17-2010</p>	
<p>phillips_s_20110228_150.jpg</p>

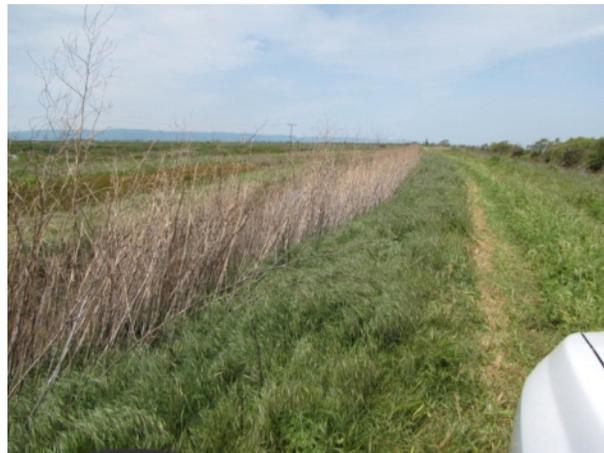
Levee Mile Report Line	22
Start Levee Mile	4.21
End Levee Mile	4.70
Location	Land Side
Category	Earthen Levee
Item	Vegetation
<p>Looking downstream landside of RD 2104 Levee mile 4.21 unsatisfactory growth slopes and crown roadway. Photo taken 4-14-2011.</p>	
<p>phillips_s_20110415_257.jpg</p>

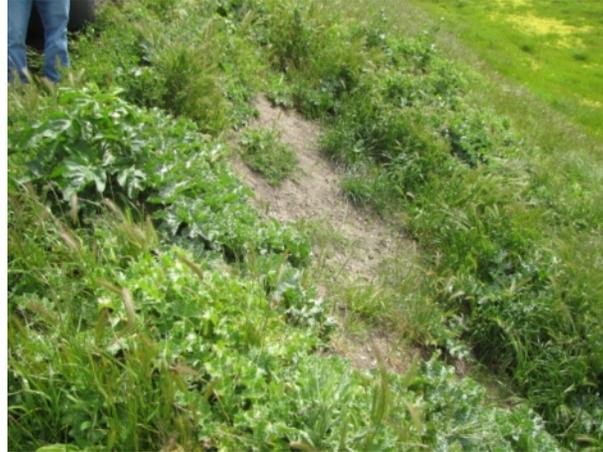
Levee Mile Report Line	24
Start Levee Mile	4.88
End Levee Mile	4.88
Location	Land Side
Category	Earthen Levee
Item	Erosion / Bank Caving
Erosion noted at levee mile 4.88 made by livestock along landside slope. Photo taken 4-14-2011.	
phillips_s_20110415_259.jpg

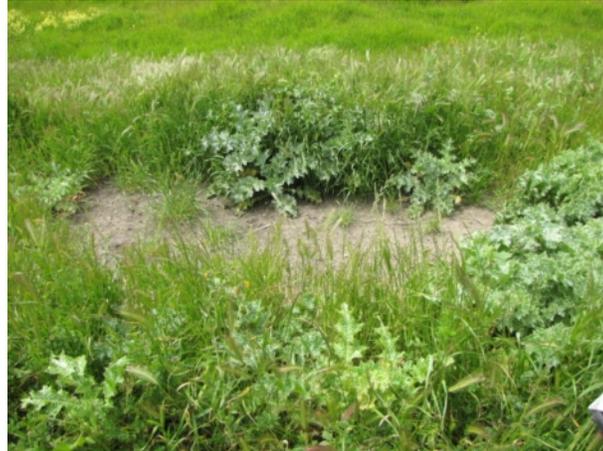
Levee Mile Report Line	25
Start Levee Mile	4.90
End Levee Mile	4.90
Location	Land Side
Category	Earthen Levee
Item	Erosion / Bank Caving
Erosion noted at levee mile 4.90 RD 2104 landside slope. Livestock caused this erosion. Photo taken 4-14-2011.	
phillips_s_20110415_260.jpg
