**Flood Control Project Maintenance
Levee Inspections**
LMA District Cover Sheet
Spring 2014 Levee Inspection Results

Reclamation District No. 2104 Peters Pocket Tract

Levee Inspection Report By Mile - Spring 2014

Waterway			Bank	Unit Miles	Inspection Start/End	Inspector
Unit No. 01 Cache Slough			Left	7.40	04/22/2014 04/22/2014	Herman Phillips

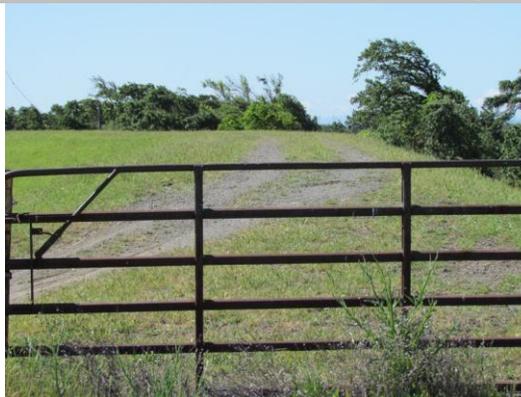
Photo 1 of 1 : phillips_s_20140603_06008.jpg

LM Start	0.00	Rating **	M	Issue No.	42
LM End	0.00	Issue Type +	Ma	Location *	LS
Category	Earthen Levee		GPS Latitude/Longitude		
			Start	End	
Item	Vegetation		38.308296 °	38.308296 °	
			-121.758594 °	-121.758594 °	
DWR ID	DWR_RD2104_01_s_2012_42				
Action/Comments					
Remove the wild growth other than native grasses from the levee slopes.

RD 2104 Levee mile 0.02 looking downstream from landward slope. Photo taken 04-22-2014.

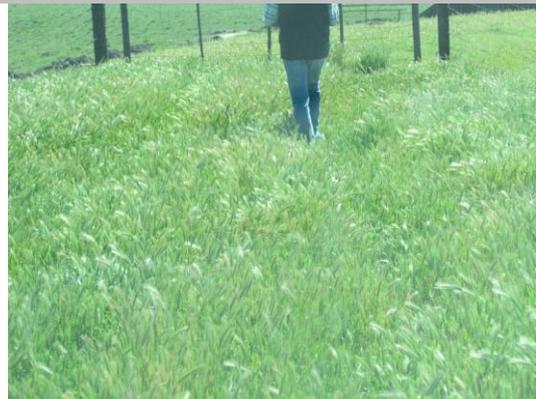
Photo 1 of 1 : phillips_s_20140603_06009.jpg

LM Start	1.38	Rating **	U	Issue No.	66
LM End	4.59	Issue Type +	Ma	Location *	CR
Category	Earthen Levee		GPS Latitude/Longitude		
			Start	End	
Item	Vegetation		38.296153 °	38.313187 °	
			-121.744238 °	-121.739071 °	
DWR ID	DWR_RD2104_01_s_2014_66				
Action/Comments					
Keep the crown roadway free of vegetation.

Crown roadway overgrown with wild weeds.

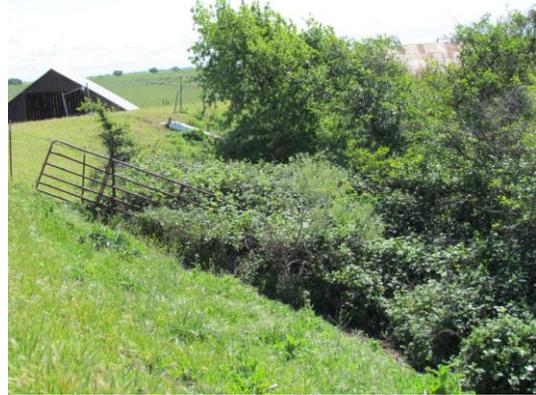
Photo 1 of 1 : phillips_s_20140603_06011.jpg

LM Start	1.50	Rating **	U	Issue No.	49
LM End	1.56	Issue Type +	Ma	Location *	WS
Category	Earthen Levee		GPS Latitude/Longitude		
			Start	End	
Item	Vegetation		38.295706 °	38.295454 °	
			-121.742451 °	-121.741529 °	
DWR ID	DWR_RD2104_01_s_2013_49				
Action/Comments					
Remove the wild growth other than native grasses from the levee slopes.

RD 2104 Levee mile 1.50 looking downstream at wild growth on water sideslope and toe.

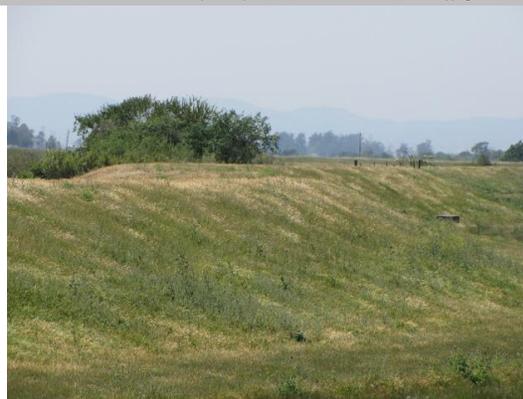
Photo 1 of 1 : phillips_s_20140414_750.jpg

LM Start	1.69	Rating **	U	Issue No.	15
LM End	2.60	Issue Type +	Ma	Location *	CR
Category	Earthen Levee		GPS Latitude/Longitude		
			Start	End	
Item	Vegetation		38.294125 °	38.294290 °	
			-121.740428 °	-121.726933 °	
DWR ID	DWR_RD2104_01_s_2012_15				
Action/Comments					
Remove the wild growth other than native grasses from the levee slopes. Inspector Comments: This unit has not improved since the last inspection, nothing has been done. 2012.

Looking back upstream from levee 2.60 back to levee mile 1.69. Landward slope and crown roadway is overgrown. Photo taken 4-26-2013.

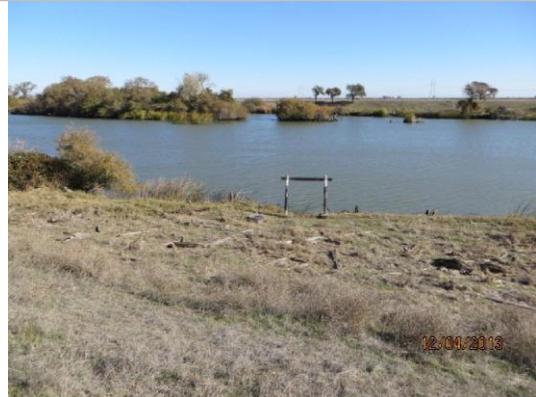
Photo 1 of 1 : UCIP_4386.jpg

LM Start	3.29	Rating **	M	Issue No.	4
LM End	3.29	Issue Type +	En	Location *	LS
Category	Supplemental		GPS Latitude/Longitude		
			Start	End	
Item	DWR UCIP Field Study		38.299447 °	38.299447 °	
			-121.730444 °	-121.730444 °	
DWR ID	DWR_RD2104_01_s_2014_4				
Action/Comments					
Inspector Comments: FS_ID:24997 EP_NO: 14184 Repair Type: Crossing Status: UCIP Comments: Signs in disrepair and need proper markings. FIELD_STRUCT_DESC: 6-inch steel gasline through the levee 3-feet below the crown. Signs on LS and WS toe. FS Date: 12/4/2013

Sign on WS berm.

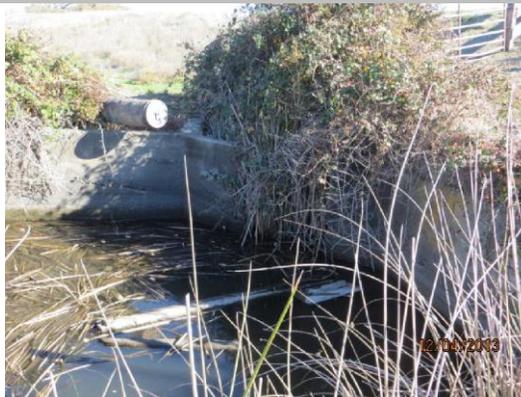
Photo 1 of 1 : UCIP_4373.jpg

LM Start	3.38	Rating **	M	Issue No.	11
LM End	3.38	Issue Type +	En	Location *	WS
Category	Supplemental		GPS Latitude/Longitude		
			Start	End	
Item	DWR UCIP Field Study		38.300605 °	38.300605 °	
			-121.730440 °	-121.730440 °	
DWR ID	DWR_RD2104_01_s_2014_11				
Action/Comments					
Inspector Comments: FS_ID:24992 EP_NO: 4412 Repair Type: Crossing Status: UCIP Comments: Heavy vegetation at concrete headwall on LS toe and at possible outlet area on WS toe. If possible, vegetation should be cleared to check if this is an accurate location. Erosion around backside of headwall at LS toe. FIELD_STRUCT_DESC: 4 x 4 concrete culvert through the levee 17.0-feet below the crown. Originally included in O+M manual, 1964. Concrete headwall on LS toe. FS Date: 12/4/2013

Vegetation covering possible location for 4X4 concrete culvert at LS toe.

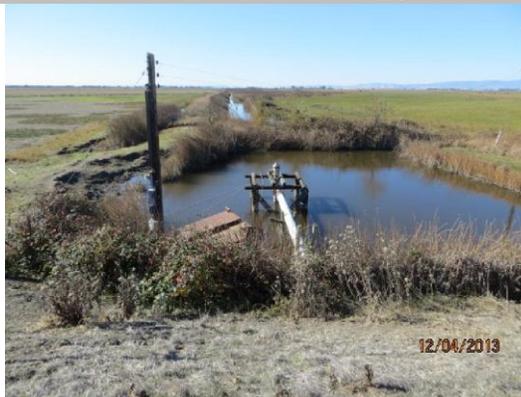
Photo 1 of 1 : UCIP_4376.jpg

LM Start	4.34	Rating **	M	Issue No.	51
LM End	4.34	Issue Type +	En	Location *	WS
Category	Supplemental		GPS Latitude/Longitude		
			Start	End	
Item	DWR UCIP Field Study		38.310873 °	38.310873 °	
			-121.736189 °	-121.736189 °	
DWR ID	DWR_RD2104_01_s_2014_51				
Action/Comments					
Inspector Comments: FS_ID:24995 EP_NO: 10183 Repair Type: Crossing Status: UCIP Comments: Pipe rusted through on WS berm. Siphon breaker in CMP riser blocked by riser misalignment. FIELD_STRUCT_DESC: 12-inch steel drainpipe through the levee 4.0-feet below the crown. Pump on pile structure in drainage ditch on landward side. One C.M. cutoff wall and a Siphon breaker in a 24-inch CMP riser on the waterward shoulder. Flap gate on waterward end. (ABO No. 10183 - Miller) Originally included in O+M manual, 1964. Asbuilt Dwg. 50-04-3379. FS Date: 12/4/2013

Pump on pier off LS toe at ponding area. power pole and meter on LS toe.

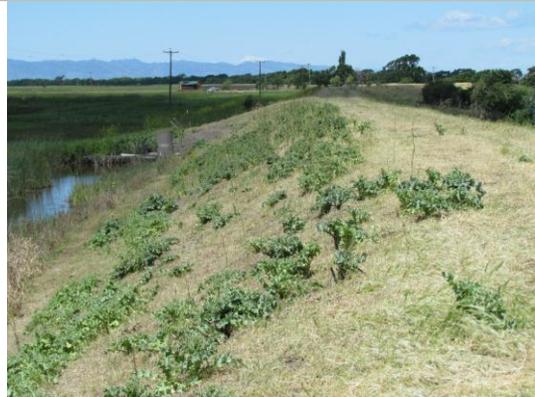
Photo 1 of 1 : phillips_s_20140603_06010.jpg

LM Start	4.58	Rating **	U	Issue No.	70
LM End	4.73	Issue Type +	Ma	Location *	LS
Category	Earthen Levee		GPS Latitude/Longitude		
			Start	End	
Item	Vegetation		38.313185 °	38.314599 °	
			-121.739070 °	-121.740574 °	
DWR ID	DWR_RD2104_01_s_2014_70				
Action/Comments					
Control annual grass and weeds on the levee slopes and easements.

Unsatisfactory growth of wild weeds on landside slope and shoulder.

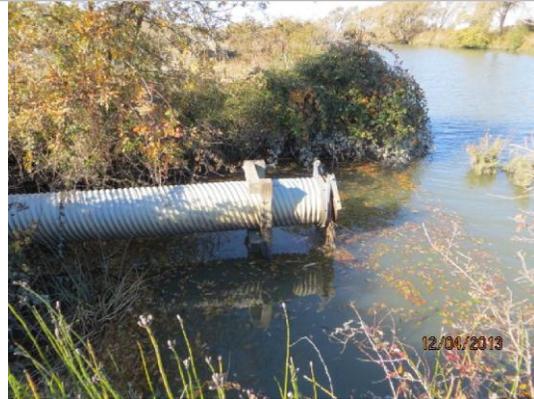
Photo 1 of 1 : UCIP_4383.jpg

LM Start	4.66	Rating **	M	Issue No.	60
LM End	4.66	Issue Type +	En	Location *	WS
Category	Supplemental		GPS Latitude/Longitude		
			Start	End	
Item	DWR UCIP Field Study		38.313955 °	38.313955 °	
			-121.739930 °	-121.739930 °	
DWR ID	DWR_RD2104_01_s_2014_60				
Action/Comments					
Inspector Comments: FS_ID:24996 EP_NO: 10182 Repair Type: Crossing Status: UCIP Comments: Vegetation and soil buildup throughout pipe preventing flapgate from closing. Remove vegetation to allow gate to close properly. FIELD_STRUCT_DESC: 24-inch CMP drainpipe through the levee 15.0-feet below the crown. 36-inch concrete standpipe on LS toe. Flapgate on WS toe. Two C.M. cut of walls. (ABO No. 10182 - Machado) Originally included in O+M manual, 1964. Asbuilt Dwg. 50-04-3379. FS Date: 12/4/2013

Vegetation at outlet preventing flapgate from closing properly.

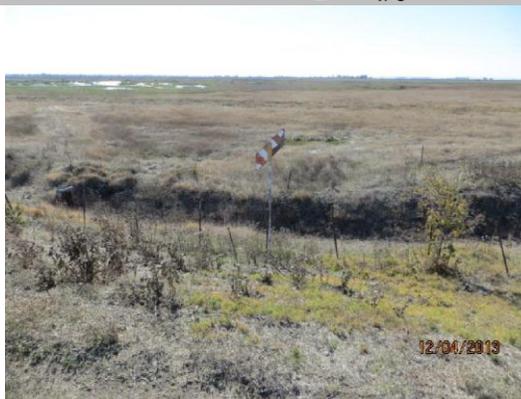
Photo 1 of 1 : UCIP_4389.jpg

LM Start	5.03	Rating **	M	Issue No.	61
LM End	5.03	Issue Type +	En	Location *	LS
Category	Supplemental			GPS Latitude/Longitude	
				Start	End
Item	DWR UCIP Field Study			38.317941 °	38.317941 °
				-121.743503 °	-121.743503 °
DWR ID	DWR_RD2104_01_s_2014_61				
Action/Comments					
Inspector Comments: FS_ID:25003 EP_NO: 10182 Repair Type: Crossing Status: UCIP Comments: Sign on WS toe needs repair. FIELD_STRUCT_DESC: 8-inch gas line through levee at high elevation. Sign on WS and LS toe. (ABO No. 10182 - Machado) Asbuilt Dwg. 50-04-3379. FS Date: 12/4/2013

Gasline marker on LS toe.

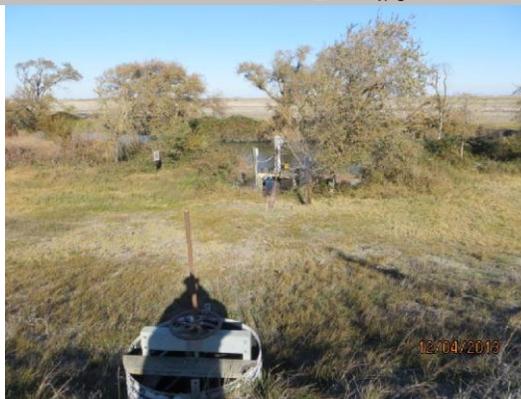
Photo 1 of 1 : UCIP_4390.jpg

LM Start	5.05	Rating **	M	Issue No.	62
LM End	5.05	Issue Type +	En	Location *	LS
Category	Supplemental			GPS Latitude/Longitude	
				Start	End
Item	DWR UCIP Field Study			38.318118 °	38.318118 °
				-121.743729 °	-121.743729 °
DWR ID	DWR_RD2104_01_s_2014_62				
Action/Comments					
Inspector Comments: FS_ID:25005 EP_NO: N/A Repair Type: Crossing Status: UCIP Comments: Good candidate for video inspection. FIELD_STRUCT_DESC: 18-inch steel irrigation pipe through the levee 13.5-feet below the crown. Pump on pile structure in stream. Slide gate in 36-inch CMP riser on waterward slope. Two cutoff walls. Concrete "U" headwall and air vent at toe of landward slope. Asbuilt Dwg. 50-04-3379. Electrical conduit through levee at same location. FS Date: 12/4/2013

Slide gate in CMP riser on WS slope with pump on pier in background.

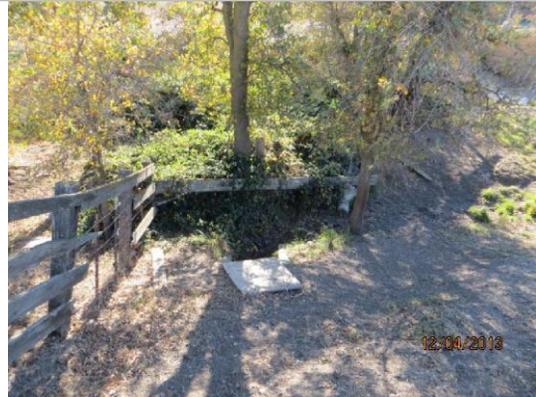
Photo 1 of 1 : UCIP_4393.jpg

LM Start	5.10	Rating **	M	Issue No.	63
LM End	5.10	Issue Type +	En	Location *	LS
Category	Supplemental			GPS Latitude/Longitude	
				Start	End
Item	DWR UCIP Field Study			38.318432 °	38.318432 °
				-121.744540 °	-121.744540 °
DWR ID	DWR_RD2104_01_s_2014_63				
Action/Comments					
Inspector Comments: FS_ID:25006 EP_NO: 10182 Repair Type: Crossing Status: UCIP Comments: Minor erosion of base under headwall on WS toe. Heavy corrosion of pipe at WS toe. Further evaluation of pipe integrity needed. FIELD_STRUCT_DESC: 24-inch CMP drain pipe through the levee 13.5-feet below the crown. Concrete "U" headwalls on both ends. Two C.M. cutoff walls. Flap gate on waterward end. (ABO No. 10182 - Machado) FS Date: 12/4/2013

Concrete U shaped headwall on LS toe.

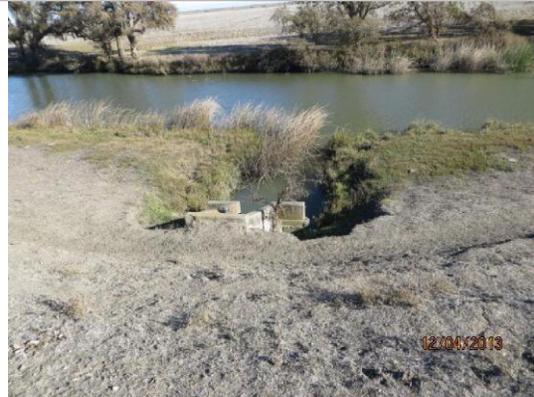
Photo 1 of 1 : UCIP_4398.jpg

LM Start	5.51	Rating **	M	Issue No.	64
LM End	5.51	Issue Type +	En	Location *	LS
Category	Supplemental		GPS Latitude/Longitude		
			Start	End	
Item	DWR UCIP Field Study		38.322215 °	38.322215 °	
			-121.748418 °	-121.748418 °	
DWR ID	DWR_RD2104_01_s_2014_64				
Action/Comments					
Inspector Comments: FS_ID:25007 EP_NO: 10182 Repair Type: Crossing Status: UCIP Comments: Footing under headwall on WS toe severely undermined. Pipe rusted heavily with holes at WS and may need replacement. FIELD_STRUCT_DESC: 24-inch CMP drain pipe through levee 13.0 feet below crown. Two cutoff walls. Concrete "U" headwalls on both ends. Flap gate on water end. (ABO No. 10182 - Machado). Asbuilt Dwg. 50-04-3379. FS Date: 12/4/2013

Concrete U-shaped headwall on WS toe. Note erosion scarp around headwall.

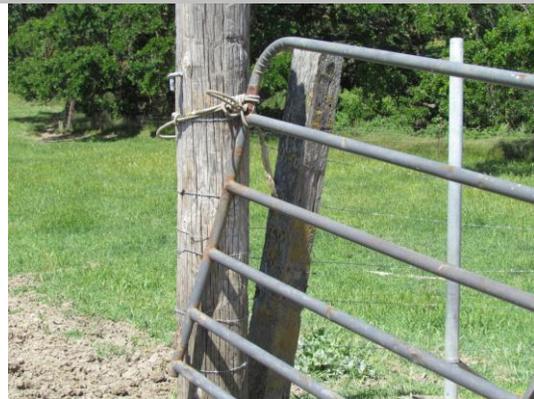
Photo 1 of 1 : phillips_s_20140603_06013.jpg

LM Start	5.72	Rating **	U	Issue No.	73
LM End	5.72	Issue Type +	Ma	Location *	CR
Category	Earthen Levee		GPS Latitude/Longitude		
			Start	End	
Item	Repair Gates		38.323281 °	38.323281 °	
			-121.751272 °	-121.751272 °	
DWR ID	DWR_RD2104_01_s_2014_73				
Action/Comments

Repair this gate at levee mile 5.72.

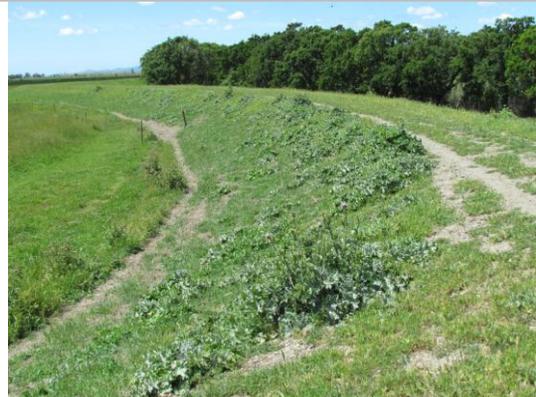
Photo 1 of 1 : phillips_s_20140603_06012.jpg

LM Start	6.01	Rating **	U	Issue No.	78
LM End	6.04	Issue Type +	Ma	Location *	LS
Category	Earthen Levee		GPS Latitude/Longitude		
			Start	End	
Item	Vegetation		38.324905 °	38.324722 °	
			-121.755241 °	-121.755701 °	
DWR ID	DWR_RD2104_01_s_2014_78				
Action/Comments					
Keep the crown roadway free of vegetation.

Unwanted broadleaf growth on the landside slope and toe.
