**Flood Control Project Maintenance
Levee Inspections**

**Fall 2014 Levee Maintenance Deficiency Summary Report
Overall LMA & Unit Ratings, including DWR Erosion Survey**

Reclamation District No. 2107 Mossdale Island

Levee Inspection Report By Mile - Fall 2014

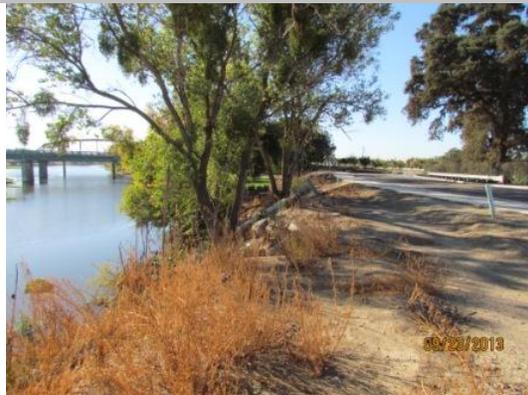
Photo 1 of 1 : FA_2014_RD2107_329_1_20141001_00001.jpg

LM Start	0.03	Rating **	N	Issue No.	1
LM End	0.03	Issue Type +	Ma	Location *	WS
Category	Earthen Levee			GPS Latitude/Longitude	
				Start	End
Item	Trim / Thin Trees			37.786993 °	37.786993 °
				-121.308694 °	-121.308694 °
DWR ID	DWR_RD2107_01_s_2012_1				
Action/Comments					
Tree stumps.

Photo of waterside slope. Stumps present from prior tree removal for access and visibility.

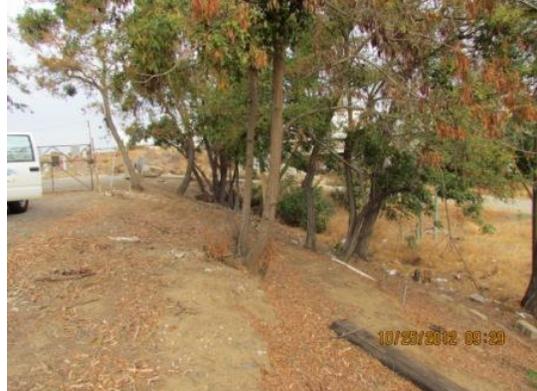
Photo 1 of 1 : FA_2014_RD2107_329_2_20141001_00002.jpg

LM Start	0.25	Rating **	N	Issue No.	2
LM End	0.25	Issue Type +	Ma	Location *	WS
Category	Earthen Levee		GPS Latitude/Longitude		
			Start	End	
Item	Trim / Thin Trees		37.784316 °	37.784316 °	
			-121.306498 °	-121.306498 °	
DWR ID	DWR_RD2107_01_s_2012_2				
Action/Comments					
Tree stumps.

Tree stumps present on slope. They were left from prior vegetation removal for access and visibility.

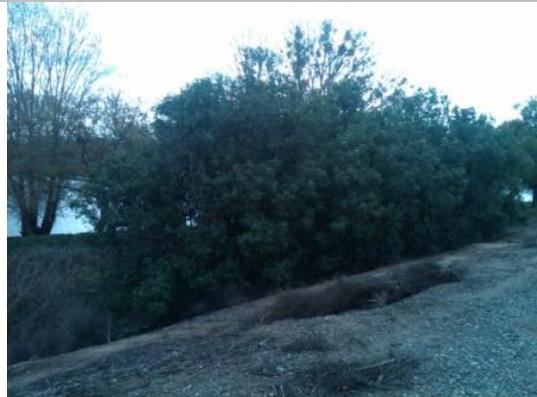
Photo 1 of 1 : FA_2014_RD2107_329_54_20141001_00006.jpg

LM Start	0.42	Rating **	M	Issue No.	54
LM End	0.42	Issue Type +	Ma	Location *	WS
Category	Earthen Levee		GPS Latitude/Longitude		
			Start	End	
Item	Vegetation		37.782737 °	37.782737 °	
			-121.304426 °	-121.304426 °	
DWR ID	DWR_RD2107_01_s_2012_54				
Action/Comments					
Elderberries are blocking visibility and flood fight capability. Inspector Comments: Large elderberry on water side slope.

03/26/2012 Large elderberry located on water side slope.

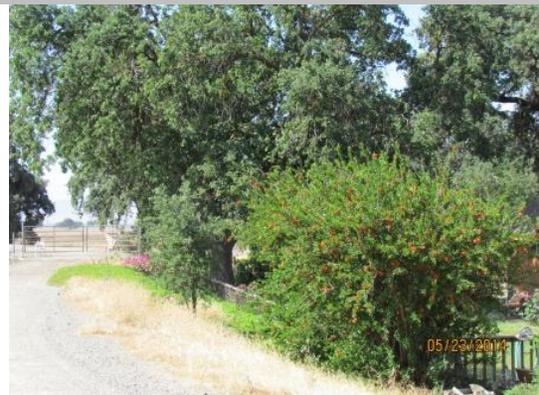
Photo 1 of 1 : FA_2014_RD2107_329_17_20141001_00005.jpg

LM Start	1.24	Rating **	M	Issue No.	17
LM End	1.24	Issue Type +	En	Location *	LS
Category	Earthen Levee		GPS Latitude/Longitude		
			Start	End	
Item	Vegetation		37.774123 °	37.774123 °	
			-121.307189 °	-121.307189 °	
DWR ID	DWR_RD2107_01_s_2012_17				
Action/Comments					
Landscaping Inspector Comments: Landscaping and fence present on levee slope.

View of landscape planting on landside levee slope and a 3-ft yard fence at the levee toe.

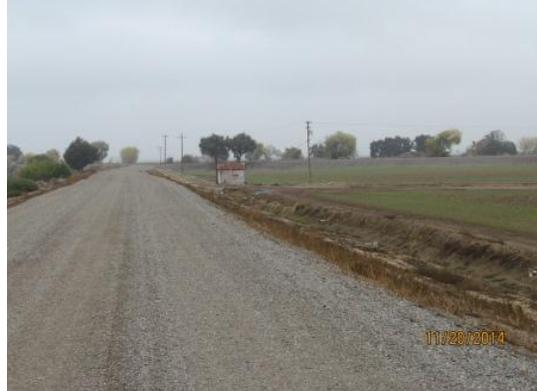
Photo 1 of 1 : FA_2014_RD2107_329_20_20141124_00013.jpg

LM Start	2.11	Rating **	A	Issue No.	20
LM End	2.11	Issue Type +	Ma	Location *	LS
Category	Earthen Levee		GPS Latitude/Longitude		
			Start	End	
Item	Vegetation		37.764236 °	37.764236 °	
			-121.309786 °	-121.309786 °	
DWR ID	DWR_RD2107_01_f_2014_20				
Action/Comments					
Control annual grass and weeds on the levee slopes and easements.

View of acceptable vegetation control.

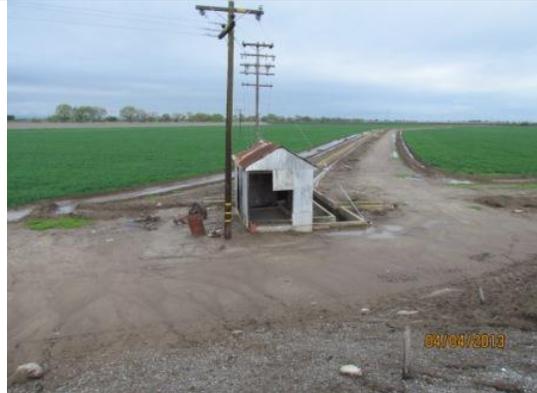
Photo 1 of 1 : FA_2014_RD2107_329_11_20141001_00004.jpg

LM Start	2.21	Rating **	A/W	Issue No.	11
LM End	2.21	Issue Type +	Ma	Location *	CR
Category	Earthen Levee		GPS Latitude/Longitude		
			Start	End	
Item	Encroachments		37.762868 °	37.762868 °	
			-121.309708 °	-121.309708 °	
DWR ID	DWR_RD2107_01_s_2012_11				
Action/Comments					
Pipe Inspector Comments: Irrigation intake pipe through levee freeboard.

View of the pipe location; alignment through levee.

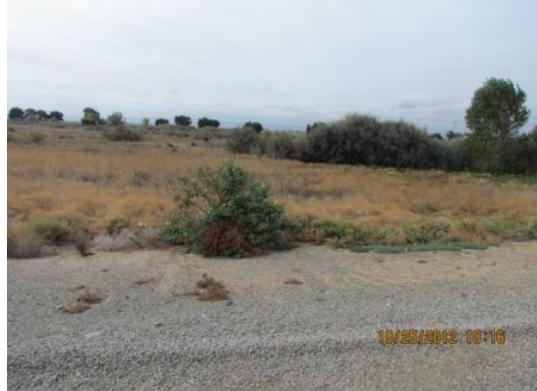
Photo 1 of 1 : FA_2014_RD2107_330_4_20141001_00003.jpg

LM Start	0.50	Rating **	M	Issue No.	4
LM End	0.50	Issue Type +	Ma	Location *	WS
Category	Earthen Levee		GPS Latitude/Longitude		
			Start	End	
Item	Vegetation		37.764780 °	37.764780 °	
			-121.316717 °	-121.316717 °	
DWR ID	DWR_RD2107_02_s_2012_4				
Action/Comments					
Elderberries are blocking visibility and flood fight capability. Inspector Comments: Elderberry bush on waterside.

Elderberry located on waterside slope.

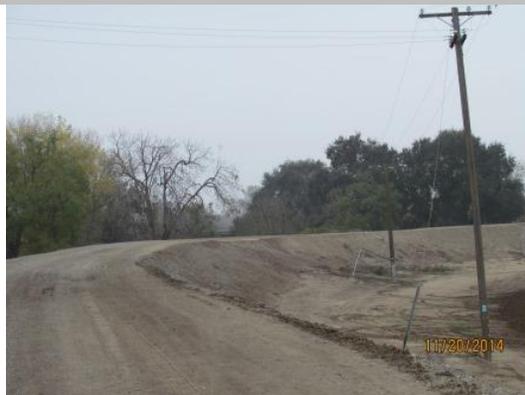
Photo 1 of 1 : FA_2014_RD2107_330_2_20141124_00009.jpg

LM Start	1.63	Rating **	A	Issue No.	2
LM End	1.63	Issue Type +	Ma	Location *	LS
Category	Earthen Levee			GPS Latitude/Longitude	
				Start	End
Item	Vegetation			37.775202 °	37.775202 °
				-121.331317 °	-121.331317 °
DWR ID	DWR_RD2107_02_f_2014_2				
Action/Comments					
Control annual grass and weeds on the levee slopes and easements.

View of acceptable vegetation control.
