**Flood Control Project Maintenance
Levee Inspections**
LMA District Cover Sheet
Spring 2014 Levee Inspection Results

Reclamation District No. 2107 Mossdale Island

Spring 2014 Levee Inspection Results

Waterway	Bank	Unit Miles
Unit No. 01 San Joaquin River	Left	2.37

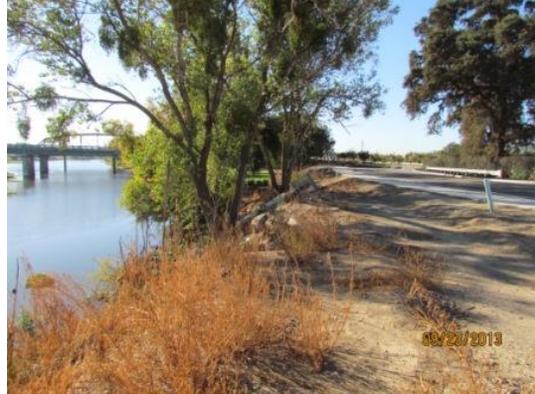
Photo 1 of 1 : mkhashch_s_20140428_00909.jpg

LM Start	0.03	Rating **	N	Issue No.	1
LM End	0.03	Issue Type +	Ma	Location *	WS
Category	Earthen Levee			GPS Latitude/Longitude	
				Start	End
Item	Trim / Thin Trees			37.786993 °	37.786993 °
				-121.308694 °	-121.308694 °
DWR ID	DWR_RD2107_01_s_2012_1				
Action/Comments					
Tree stumps.

Photo of waterside slope. Stumps present from prior tree removal for access and visibility.

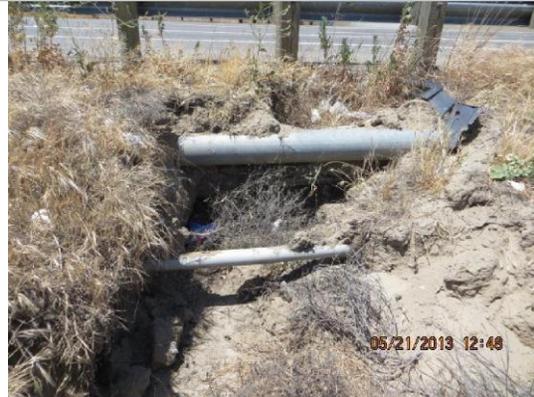
Photo 1 of 1 : UCIP_1418.jpg

LM Start	0.23	Rating **	M	Issue No.	14
LM End	0.23	Issue Type +	En	Location *	WS
Category	Supplemental			GPS Latitude/Longitude	
				Start	End
Item	DWR UCIP Field Study			37.784586 °	37.784586 °
				-121.306837 °	-121.306837 °
DWR ID	DWR_RD2107_01_s_2014_14				
Action/Comments					
Inspector Comments: FS_ID:16187 EP_NO: N/A Repair Type: Crossing Status: UCIP Comments: No permit identified. Erosion exposed pipes on LS. FIELD_STRUCT_DESC: 3-inch PVC conduit 1-foot below the road surface within roadway fill over levee crown. FS Date: 5/22/2013

Pipes visible on LS next to roadway.

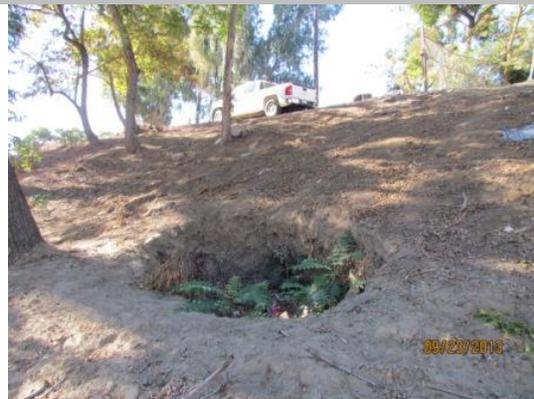
Photo 1 of 1 : mkhashch_s_20140428_00917.jpg

LM Start	0.25	Rating **	M	Issue No.	76
LM End	0.25	Issue Type +	En	Location *	WS
Category	Earthen Levee			GPS Latitude/Longitude	
				Start	End
Item	Encroachments			37.784309 °	37.784309 °
				-121.306484 °	-121.306484 °
DWR ID	DWR_RD2107_01_f_2013_76				
Action/Comments					
Ditch Inspector Comments: Dugout in the waterside levee slope about 3 feet deep by 7 feet wide by 6 feet across. Recommend to backfill and compact.

View of the ditch at the waterside levee toe.

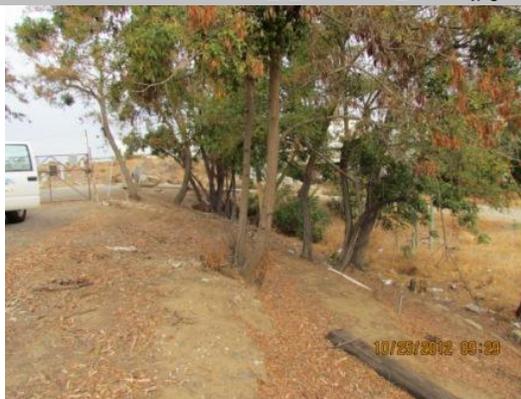
Photo 1 of 1 : mkhashch_s_20140428_00910.jpg

LM Start	0.25	Rating **	N	Issue No.	2
LM End	0.25	Issue Type +	Ma	Location *	WS
Category	Earthen Levee			GPS Latitude/Longitude	
				Start	End
Item	Trim / Thin Trees			37.784316 °	37.784316 °
				-121.306498 °	-121.306498 °
DWR ID	DWR_RD2107_01_s_2012_2				
Action/Comments					
Tree stumps.

Tree stumps present on slope. They were left from prior vegetation removal for access and visibility.

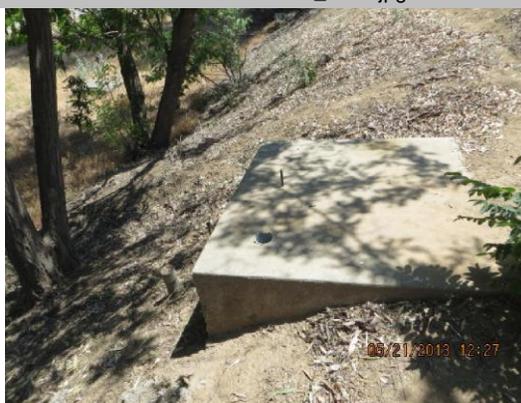
Photo 1 of 1 : UCIP_1419.jpg

LM Start	0.27	Rating **	M	Issue No.	15
LM End	0.27	Issue Type +	En	Location *	WS
Category	Supplemental			GPS Latitude/Longitude	
				Start	End
Item	DWR UCIP Field Study			37.784194 °	37.784194 °
				-121.306353 °	-121.306353 °
DWR ID	DWR_RD2107_01_s_2014_15				
Action/Comments					
Inspector Comments: FS_ID:16188 EP_NO: 12101B Repair Type: Crossing Status: UCIP Comments: Appears abandoned and should be done so properly. FIELD_STRUCT_DESC: 4" electrical conduit through the levee 2.5 feet below the crown. Distribution panel on a 5-foot by 6-foot concrete pad on the WS shoulder (Permit No 12101B, 1979). FS Date: 5/21/2013

5X5 concrete pad with exposed electrical conduit on WS shoulder.

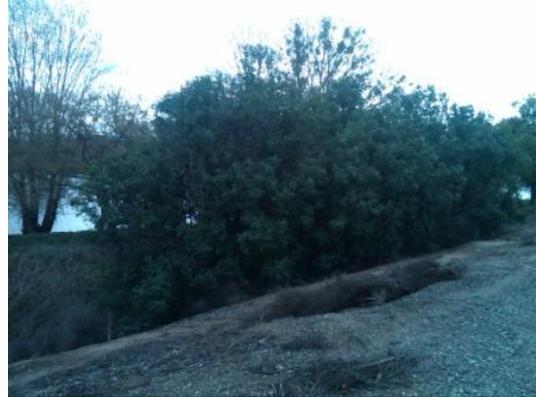
Photo 1 of 1 : mkhashch_s_20140428_00916.jpg

LM Start	0.42	Rating **	M	Issue No.	54
LM End	0.42	Issue Type +	Ma	Location *	WS
Category	Earthen Levee		GPS Latitude/Longitude		
			Start	End	
Item	Vegetation		37.782737 °	37.782737 °	
			-121.304426 °	-121.304426 °	
DWR ID	DWR_RD2107_01_s_2012_54				
Action/Comments					
Elderberries are blocking visibility and flood fight capability. Inspector Comments: Large elderberry on water side slope.

03/26/2012 Large elderberry located on water side slope.

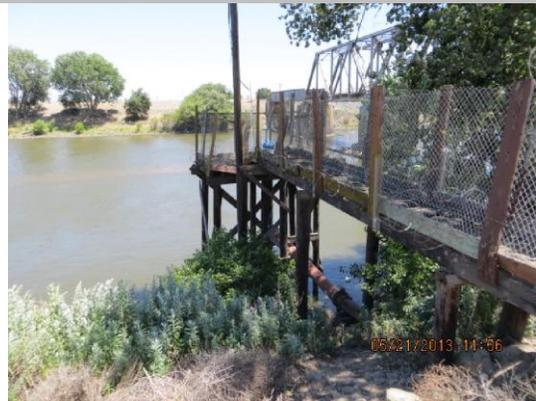
Photo 1 of 1 : UCIP_913.jpg

LM Start	0.68	Rating **	M	Issue No.	16
LM End	0.68	Issue Type +	En	Location *	WS
Category	Supplemental		GPS Latitude/Longitude		
			Start	End	
Item	DWR UCIP Field Study		37.779486 °	37.779486 °	
			-121.301960 °	-121.301960 °	
DWR ID	DWR_RD2107_01_s_2014_16				
Action/Comments					
Inspector Comments: FS_ID:13684 EP_NO: N/A Repair Type: Crossing Status: UCIP Comments: Wooden walkway to pump on platform is in disrepair and may be a hazard. FIELD_STRUCT_DESC: 1 of 2: 14-inch pipe through the levee 17.0 feet below the crown. Pump on pile structure in the stream. Walkway to pump. Slide gate in 48-inch CMP riser on WS shoulder. 36-inch concrete standpipe at the landward toe. Service pole and circuit panel on landward toe. Originally included in O&M manual, 1964. FS Date: 5/21/2013

Walkway to pump on pier at WS.

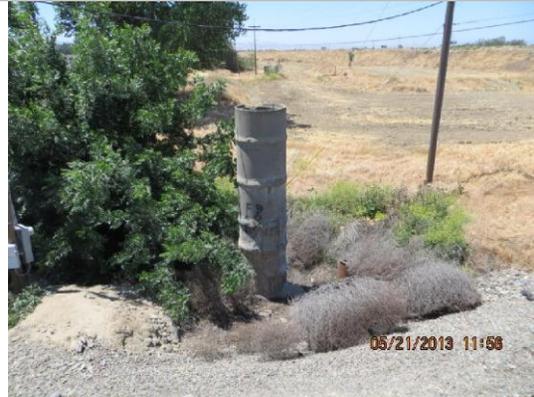
Photo 1 of 1 : UCIP_934.jpg

LM Start	0.70	Rating **	M	Issue No.	18
LM End	0.70	Issue Type +	En	Location *	WS
Category	Supplemental			GPS Latitude/Longitude	
				Start	End
Item	DWR UCIP Field Study			37.779209 °	37.779209 °
				-121.301973 °	-121.301973 °
DWR ID	DWR_RD2107_01_s_2014_18				
Action/Comments					
Inspector Comments: FS_ID:13883 EP_NO: N/A Repair Type: Crossing Status: UCIP Comments: Slide gate missing actuator inside 55-inch CMP riser. FIELD_STRUCT_DESC: 14-inch pipe through the levee, 15.0 feet below the crown. Pipe likely runs from 36-inch concrete standpipe on LS to outlet on WS toe. Portion of the discharge line from the pump at Levee Mile 0.68. 55-inch CMP riser with slide gate on LS shoulder. Originally included in O&M manual, 1964. FS Date: 5/21/2013

36-inch concrete standpipe on LS toe.

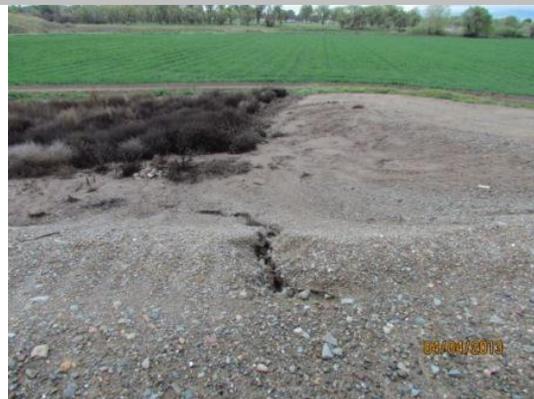
Photo 1 of 1 : mkhashch_s_20140428_00913.jpg

LM Start	0.76	Rating **	M	Issue No.	10
LM End	0.76	Issue Type +	Ma	Location *	WS
Category	Earthen Levee			GPS Latitude/Longitude	
				Start	End
Item	Erosion / Bank Caving			37.778819 °	37.778819 °
				-121.302848 °	-121.302848 °
DWR ID	DWR_RD2107_01_s_2013_10				
Action/Comments					
Note and monitor erosion site.

View of the eroding waterside levee slope.

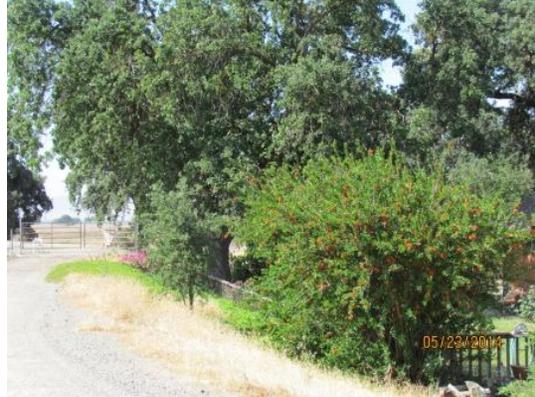
Photo 1 of 1 : mkhashch_s_20140527_01056.jpg

LM Start	1.24	Rating **	M	Issue No.	17
LM End	1.24	Issue Type +	En	Location *	LS
Category	Earthen Levee		GPS Latitude/Longitude		
			Start	End	
Item	Vegetation		37.774123 °	37.774123 °	
			-121.307189 °	-121.307189 °	
DWR ID	DWR_RD2107_01_s_2012_17				
Action/Comments					
Landscaping Inspector Comments: Landscaping and fence present on levee slope.

View of landscape planting on landside levee slope and a 3-ft yard fence at the levee toe.

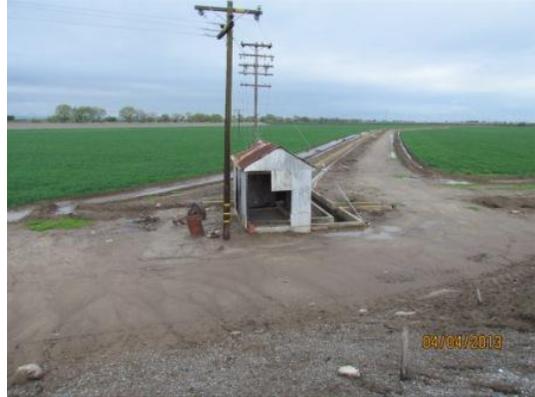
Photo 1 of 1 : mkhashch_s_20140428_00914.jpg

LM Start	2.21	Rating **	A/W	Issue No.	11
LM End	2.21	Issue Type +	Ma	Location *	CR
Category	Earthen Levee			GPS Latitude/Longitude	
				Start	End
Item	Encroachments			37.762868 °	37.762868 °
				-121.309708 °	-121.309708 °
DWR ID	DWR_RD2107_01_s_2012_11				
Action/Comments					
Pipe Inspector Comments: Irrigation intake pipe through levee freeboard.

View of the pipe location; alignment through levee.

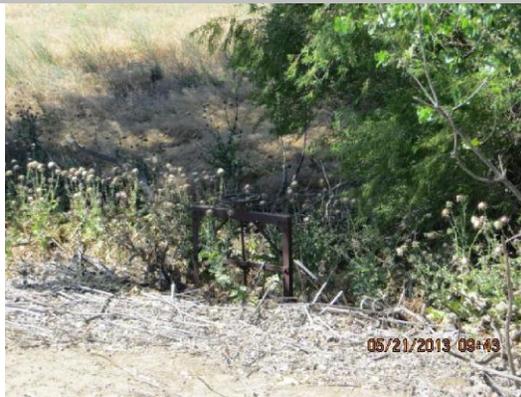
Photo 1 of 1 : UCIP_907.jpg

LM Start	0.26	Rating **	M	Issue No.	5
LM End	0.26	Issue Type +	En	Location *	LS
Category	Supplemental		GPS Latitude/Longitude		
			Start	End	
Item	DWR UCIP Field Study		37.762612 °	37.762612 °	
			-121.313480 °	-121.313480 °	
DWR ID	DWR_RD2107_02_s_2014_5				
Action/Comments					
Inspector Comments: FS_ID:13637 EP_NO: N/A Repair Type: Crossing Status: UCIP Comments: Pipe filled in with soil around outlet and not visible on LS. Appears abandoned and should be done so properly. FIELD_STRUCT_DESC: 16-inch steel storm drain pipe 16-feet below the crown with slide gate on WS toe. Originally included in O&M manual, 1964. FS Date: 5/21/2013

Slide gate visible on WS toe.

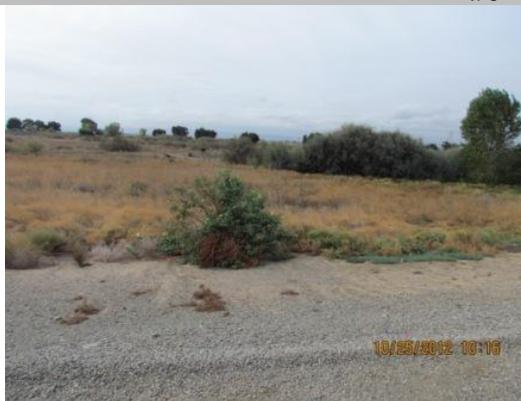
Photo 1 of 1 : mkhashch_s_20140428_00925.jpg

LM Start	0.50	Rating **	M	Issue No.	4
LM End	0.50	Issue Type +	Ma	Location *	WS
Category	Earthen Levee		GPS Latitude/Longitude		
			Start	End	
Item	Vegetation		37.764780 °	37.764780 °	
			-121.316717 °	-121.316717 °	
DWR ID	DWR_RD2107_02_s_2012_4				
Action/Comments					
Elderberries are blocking visibility and flood fight capability. Inspector Comments: Elderberry bush on waterside.

Elderberry located on waterside slope.

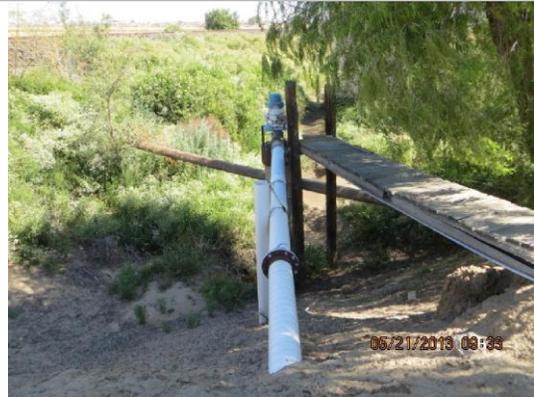
Photo 1 of 1 : UCIP_905.jpg

LM Start	0.54	Rating **	M	Issue No.	8
LM End	0.54	Issue Type +	En	Location *	WS
Category	Supplemental			GPS Latitude/Longitude	
				Start	End
Item	DWR UCIP Field Study			37.764832 °	37.764832 °
				-121.317405 °	-121.317405 °
DWR ID	DWR_RD2107_02_s_2014_8				
Action/Comments					
Inspector Comments: FS_ID:13636 EP_NO: 13161 Repair Type: Crossing Status: UCIP Comments: Some erosion along pipe alignment on WS slope. FIELD_STRUCT_DESC: 10-inch steel storm drain pipe through the levee 5-feet below the crown. Pump located on 36-inch concrete standpipe at LS toe. A PVC pipe runs parallel to waterward toe to train tracks. Air relief valve on waterward shoulder (Permit No. 13161, 1981). FS Date: 5/21/2013

Walkway, pump, and pipe on LS slope.

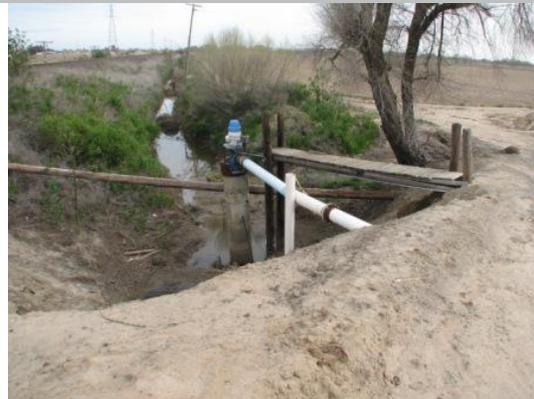
Photo 1 of 2 : mkhashch_s_20140428_00923.jpg

LM Start	0.55	Rating **	A/W	Issue No.	2
LM End	0.55	Issue Type +	Ob	Location *	CR
Category	Earthen Levee			GPS Latitude/Longitude	
				Start	End
Item	Encroachments			37.764831 °	37.764831 °
				-121.317446 °	-121.317446 °
DWR ID	DWR_RD2107_02_s_2012_2				
Action/Comments					
Pipe Inspector Comments: Drainage discharge pump and pipe through levee freeboard.

Drainage discharge pump. Steel pipe penetrates levee freeboard. No flapgate on waterside. No closure device.

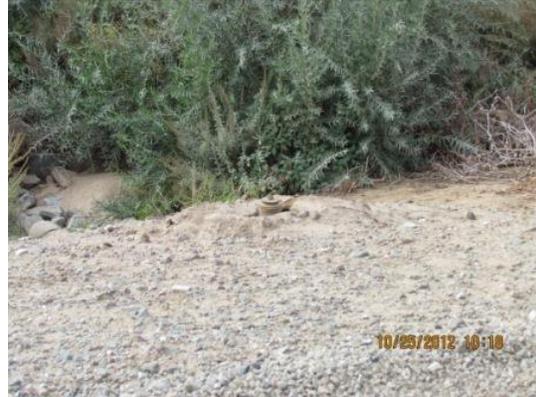
Photo 2 of 2 : mkhashch_s_20140428_00924.jpg

LM Start	0.55	Rating **	A/W	Issue No.	2 (cont)
LM End	0.55	Issue Type +	Ob	Location *	CR
Category	Earthen Levee			GPS Latitude/Longitude	
				Start	End
Item	Encroachments			37.764831 °	37.764831 °
				-121.317446 °	-121.317446 °
DWR ID	DWR_RD2107_02_s_2012_2				
Action/Comments					
Pipe Inspector Comments: Drainage discharge pump and pipe through levee freeboard.

View of siphon breaker causing some erosion on slope.

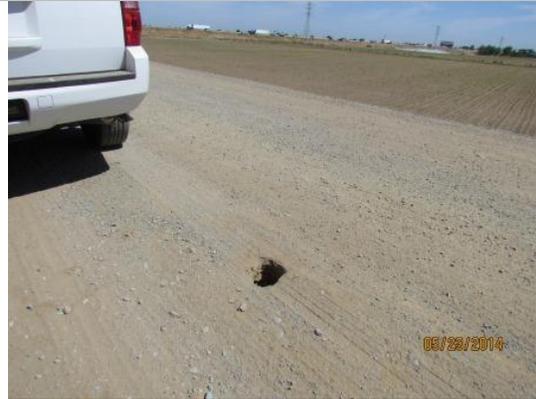
Photo 1 of 1 : mkhashch_s_20140527_01057.jpg

LM Start	1.05	Rating **	M	Issue No.	6
LM End	1.05	Issue Type +	Ma	Location *	CR
Category	Earthen Levee			GPS Latitude/Longitude	
				Start	End
Item	Animal Control			37.770171 °	37.770171 °
				-121.323161 °	-121.323161 °
DWR ID	DWR_RD2107_02_f_2012_6				
Action/Comments					
No rodents visible, but rodent burrows visible; need to backfill and compact or grout burrows. Inspector Comments: Rodent hole does not appear to be active. Recommend backfilling with grout.

View of a rodent hole on the levee crown.

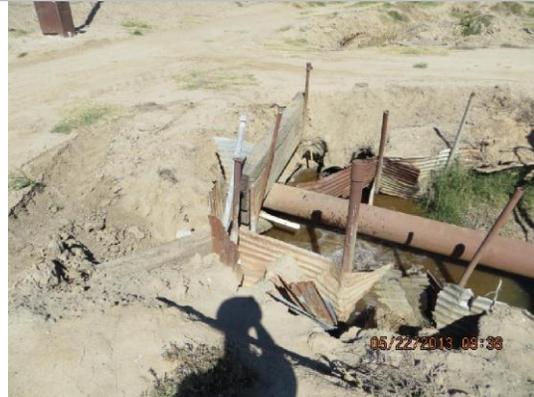
Photo 1 of 1 : UCIP_916.jpg

LM Start	1.53	Rating **	M	Issue No.	10
LM End	1.53	Issue Type +	En	Location *	CR
Category	Supplemental		GPS Latitude/Longitude		
			Start	End	
Item	DWR UCIP Field Study		37.774129 °	37.774129 °	
			-121.329896 °	-121.329896 °	
DWR ID	DWR_RD2107_02_s_2014_10				
Action/Comments					
Inspector Comments: FS_ID:13715 EP_NO: 2966 Repair Type: Crossing Status: UCIP Comments: Headwall around pipe at LS toe is failing and should be shored up. Flap gate propped open and should be returned to normal function. FIELD_STRUCT_DESC: 24-inch steel drain pipe through the levee 14 feet below the crown. Flap gate installed on the waterward end of the pipe and two standard reinforced concrete cutoff walls were placed around the pipe in line with the levee shoulders (Permit No. 2966, 1958). FS Date: 5/22/2013

Headwall failing at drainage ditch on LS toe.

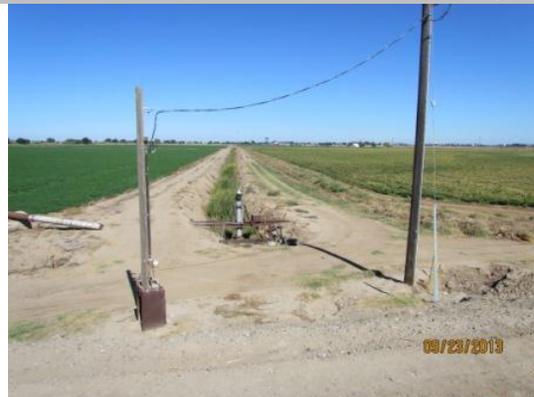
Photo 1 of 1 : mkhashch_s_20140428_00927.jpg

LM Start	1.53	Rating **	A/W	Issue No.	9
LM End	1.53	Issue Type +	Ob	Location *	LS
Category	Earthen Levee		GPS Latitude/Longitude		
			Start	End	
Item	Encroachments		37.774193 °	37.774193 °	
			-121.329967 °	-121.329967 °	
DWR ID	DWR_RD2107_02_f_2012_9				
Action/Comments					
Pipe Inspector Comments: Irrigation Pipe

View of irrigation pipe and canal.
