**Flood Control Project Maintenance  
Levee Inspections**  
**LMA District Cover Sheet**  
**Spring 2016 Levee Inspection Results**

**Reclamation District No. 2107 Mossdale Island**

**Levee Inspection Report By Mile - Spring 2016**

Waterway	Bank	Unit Miles	Inspection Start/End	Inspector
Unit No. 01 San Joaquin River	Left	2.33	03/16/2016 03/16/2016	Maksim Khashchuk

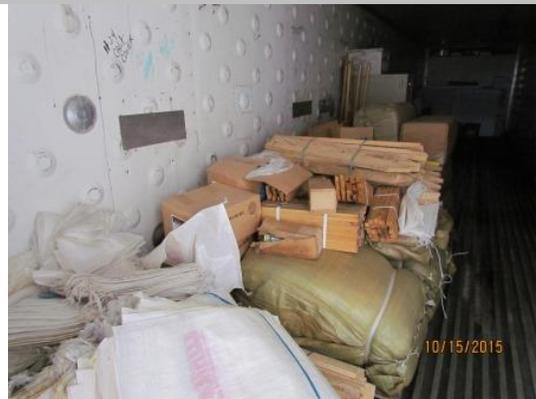
Photo 1 of 1 : SP\_2016\_RD2107\_329\_7\_20160229\_00003.jpg

LM Start		Rating **	A	Issue No.	7
LM End		Issue Type +	Ma	Location *	LS
Category	Earthen Levee		GPS Latitude/Longitude		
			Start		End
Item	Emergency Supplies & Equipment			o	o
DWR ID	DWR_RD2107_01_s_2013_7				
Comment Code					
Inspector Comment					
Flood fighting supplies are available on-site.

View of the flood fight emergency supplies.

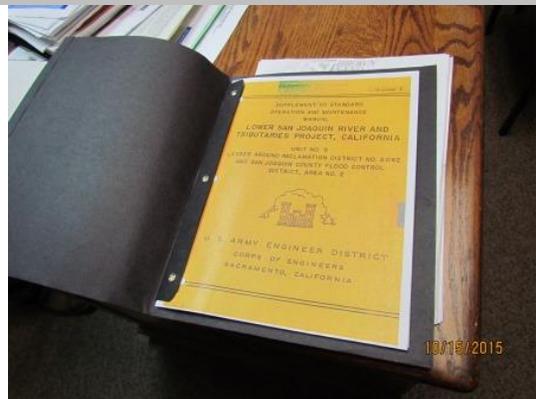
Photo 1 of 1 : SP\_2016\_RD2107\_329\_8\_20160229\_00004.jpg

LM Start		Rating **	A	Issue No.	8
LM End		Issue Type +	Ma	Location *	LS
Category	Earthen Levee		GPS Latitude/Longitude		
			Start		End
Item	Operations & Maintenance Manuals			o	o
DWR ID	DWR_RD2107_01_s_2013_8				
Comment Code					
Inspector Comment					
The O&M Manual is available at the LMA's office.

View of the O&M Manual.

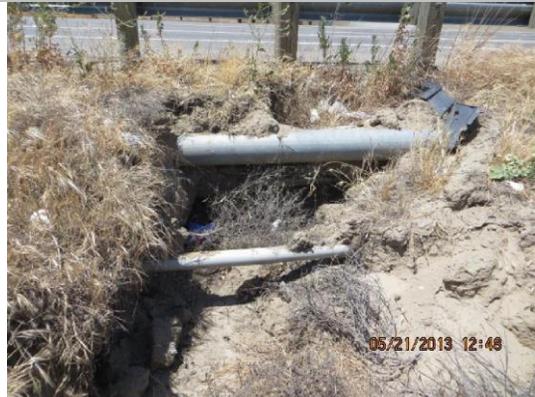
Photo 1 of 1 : UCIP\_SP\_2016\_16187\_27294.jpg

LM Start	<b>0.23</b>	Rating **	M	Issue No.	<b>58</b>
LM End	<b>0.23</b>	Issue Type +	En	Location *	WS
Category	Supplemental			GPS Latitude/Longitude	
				Start	End
Item	DWR UCIP Field Study			37.784586 °	37.784586 °
				-121.306837 °	-121.306837 °
DWR ID					
Comment Code					
Inspector Comment					
FS_ID:16187 DS_ID:23107 EP_NO: N/A Repair Type: Non-Urgent Crossing Status: Found UCIP Comments: No permit identified. Erosion exposed pipes on LS. FIELD_STRUCT_DESC: 3-inch PVC conduit 1-foot below the road surface within roadway fill over levee crown. FS Date: 5/22/2013

Pipes visible on LS next to roadway.

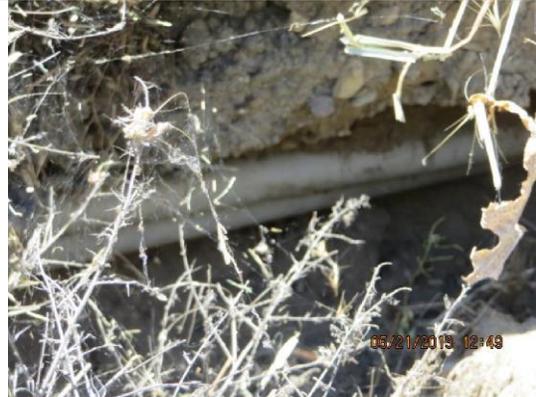
Photo 2 of 2 : UCIP\_SP\_2016\_15174\_24921.jpg

LM Start	<b>0.23</b>	Rating **	M	Issue No.	<b>65 (cont)</b>
LM End	<b>0.23</b>	Issue Type +	En	Location *	WS
Category	Supplemental			GPS Latitude/Longitude	
				Start	End
Item	DWR UCIP Field Study			37.784586 °	37.784586 °
				-121.306837 °	-121.306837 °
DWR ID					
Comment Code					
Inspector Comment					
FS_ID:15174 DS_ID:23110 EP_NO: N/A Repair Type: Non-Urgent Crossing Status: Found UCIP Comments: No permit identified for this crossing. FIELD_STRUCT_DESC: 1.5-inch PVC conduit 1-foot below the road surface within roadway fill over levee crown. FS Date: 5/22/2013

Pipes visible on LS next to roadway.

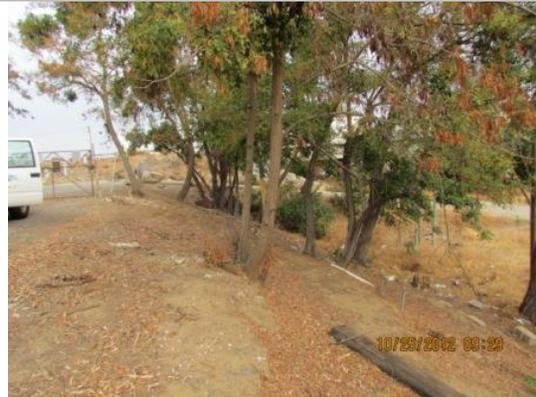
Photo 1 of 1 : SP\_2016\_RD2107\_329\_2\_20160229\_00002.jpg

LM Start	<b>0.26</b>	Rating **	N	Issue No.	<b>2</b>
LM End	<b>0.26</b>	Issue Type +	Ma	Location *	WS
Category	Earthen Levee			GPS Latitude/Longitude	
				Start	End
Item	Trim / Thin Trees			37.784316 °	37.784316 °
				-121.306498 °	-121.306498 °
DWR ID	DWR_RD2107_01_s_2012_2				
Comment Code					
T5 : Tree stumps.					
Inspector Comment

Tree stumps present on slope. They were left from prior vegetation removal for access and visibility.

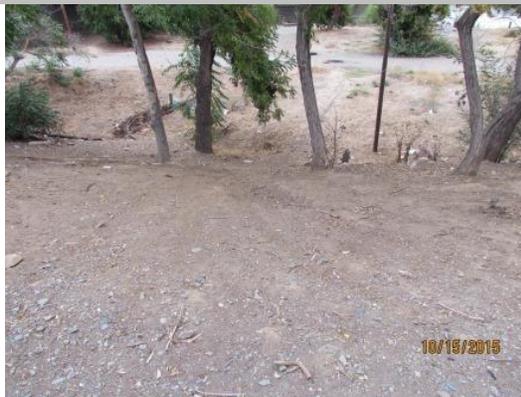
Photo 1 of 1 : SP\_2016\_RD2107\_329\_19\_20160229\_00007.jpg

LM Start	<b>0.26</b>	Rating **	A/W	Issue No.	<b>19</b>
LM End	<b>0.26</b>	Issue Type +	Ma	Location *	WS
Category	Earthen Levee		GPS Latitude/Longitude		
			Start	End	
Item	Slope Stability		37.784300 °	37.784300 °	
			-121.306488 °	-121.306488 °	
DWR ID	DWR_RD2107_01_f_2015_19				
Comment Code					
S2 : Repair the levee slope damaged by foot traffic and prevent access where possible.					
Inspector Comment

View of the tracks on the waterside levee slope.

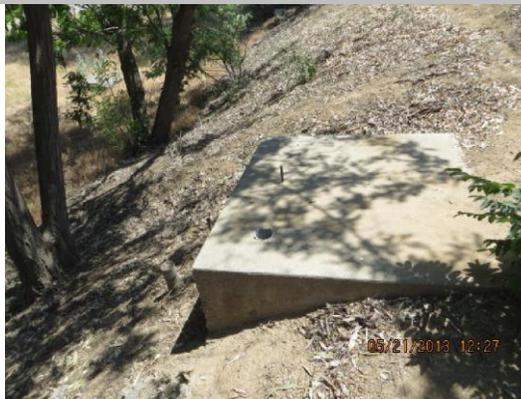
Photo 1 of 1 : UCIP\_SP\_2016\_16188\_27296.jpg

LM Start	<b>0.27</b>	Rating **	M	Issue No.	<b>59</b>
LM End	<b>0.27</b>	Issue Type +	En	Location *	WS
Category	Supplemental		GPS Latitude/Longitude		
			Start	End	
Item	DWR UCIP Field Study		37.784194 °	37.784194 °	
			-121.306353 °	-121.306353 °	
DWR ID					
Comment Code					
Inspector Comment					
FS_ID:16188 DS_ID:19055 EP_NO: 12101B Repair Type: Non-Urgent Crossing Status: Found UCIP Comments: Appears abandoned and should be done so properly. FIELD_STRUCT_DESC: 4" electrical conduit through the levee 2.5 feet below the crown. Distribution panel on a 5-foot by 6-foot concrete pad on the WS shoulder (Permit No 12101B, 1979). FS Date: 5/21/2013

5X5 concrete pad with exposed electrical conduit on WS shoulder.

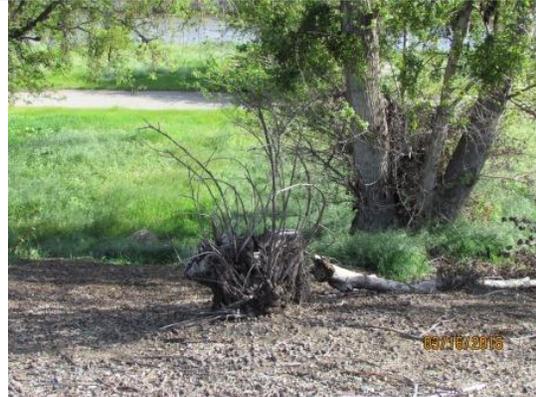
Photo 1 of 1 : SP\_2016\_RD2107\_329\_22\_20160321\_00028.jpg

LM Start	<b>0.29</b>	Rating **	N	Issue No.	<b>22</b>
LM End	<b>0.29</b>	Issue Type +	Ma	Location *	WS
Category	Earthen Levee		GPS Latitude/Longitude		
			Start	End	
Item	Trim / Thin Trees		37.783998 °	37.783998 °	
			-121.306134 °	-121.306134 °	
DWR ID	DWR_RD2107_01_s_2016_22				
Comment Code					
T5 : Tree stumps.					
Inspector Comment

View of the tree stump on the waterside levee slope.

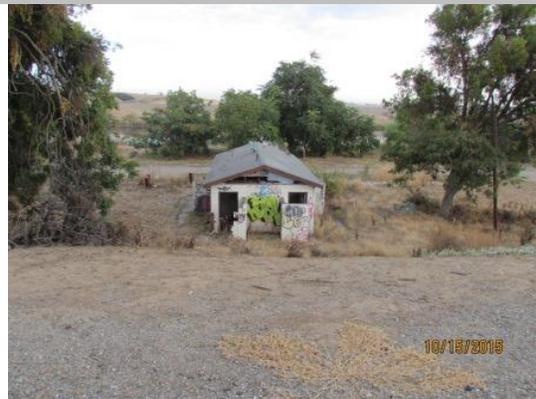
Photo 1 of 1 : SP\_2016\_RD2107\_329\_20\_20160229\_00008.jpg

LM Start	<b>0.32</b>	Rating **	M	Issue No.	<b>20</b>
LM End	<b>0.32</b>	Issue Type +	En	Location *	WS
Category	Earthen Levee		GPS Latitude/Longitude		
			Start	End	
Item	Encroachments		37.783649 °	37.783649 °	
			-121.305710 °	-121.305710 °	
DWR ID	DWR_RD2107_01_f_2015_20				
Comment Code					
BU : Building					
Inspector Comment					
Building in the floodway may impede flood flows.

View of the building in the floodway.

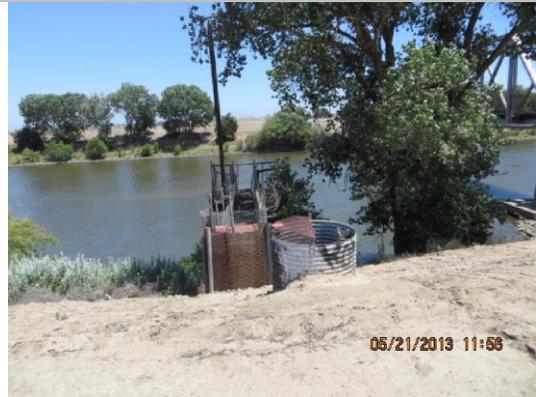
Photo 1 of 2 : UCIP\_SP\_2016\_13684\_22411.jpg

LM Start	<b>0.68</b>	Rating **	M	Issue No.	<b>63</b>
LM End	<b>0.68</b>	Issue Type +	En	Location *	WS
Category	Supplemental		GPS Latitude/Longitude		
			Start	End	
Item	DWR UCIP Field Study		37.779486 °	37.779486 °	
			-121.301961 °	-121.301961 °	
DWR ID					
Comment Code					
Inspector Comment					
FS_ID:13684 DS_ID:19036 EP_NO: N/A Repair Type: Non-Urgent Crossing Status: Found UCIP Comments: Wooden walkway to pump on platform is in disrepair and may be a hazard. FIELD_STRUCT_DESC: 1 of 2: 14-inch pipe through the levee 17.0 feet below the crown. Pump on pile structure in the stream. Walkway to pump. Slide gate in 48-inch CMP riser on WS shoulder. 36-inch concrete standpipe at the landward toe. Service pole and circuit panel on landward toe. Originally included in O&M manual, 1964. FS Date: 5/21/2013

Pier and 48-inch CMP riser on WS shoulder

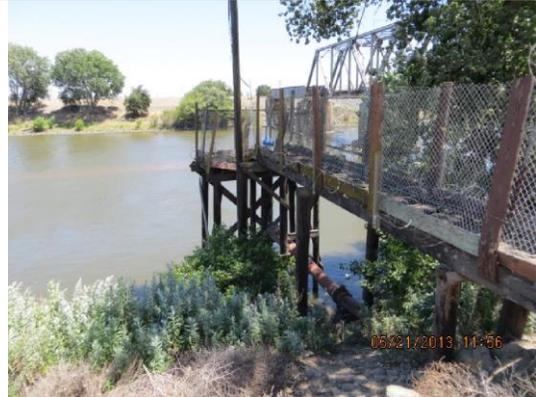
Photo 2 of 2 : UCIP\_SP\_2016\_13684\_22410.jpg

LM Start	<b>0.68</b>	Rating **	M	Issue No.	<b>63 (cont)</b>
LM End	<b>0.68</b>	Issue Type +	En	Location *	WS
Category	Supplemental			GPS Latitude/Longitude	
				Start	End
Item	DWR UCIP Field Study			37.779486°	37.779486°
				-121.301961°	-121.301961°
DWR ID					
Comment Code					
Inspector Comment					
FS_ID:13684 DS_ID:19036 EP_NO: N/A Repair Type: Non-Urgent Crossing Status: Found UCIP Comments: Wooden walkway to pump on platform is in disrepair and may be a hazard. FIELD_STRUCT_DESC: 1 of 2: 14-inch pipe through the levee 17.0 feet below the crown. Pump on pile structure in the stream. Walkway to pump. Slide gate in 48-inch CMP riser on WS shoulder. 36-inch concrete standpipe at the landward toe. Service pole and circuit panel on landward toe. Originally included in O&M manual, 1964. FS Date: 5/21/2013

Walkway to pump on pier at WS.

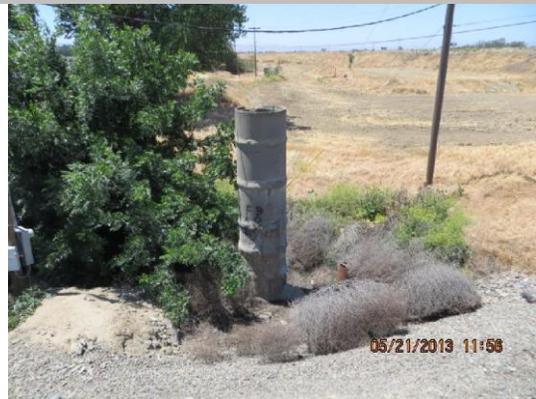
Photo 1 of 2 : UCIP\_SP\_2016\_13883\_22821.jpg

LM Start	<b>0.70</b>	Rating **	M	Issue No.	<b>60</b>
LM End	<b>0.70</b>	Issue Type +	En	Location *	WS
Category	Supplemental			GPS Latitude/Longitude	
				Start	End
Item	DWR UCIP Field Study			37.779209°	37.779209°
				-121.301973°	-121.301973°
DWR ID					
Comment Code					
Inspector Comment					
FS_ID:13883 DS_ID:19039 EP_NO: N/A Repair Type: Non-Urgent Crossing Status: Found UCIP Comments: Slide gate missing actuator inside 55-inch CMP riser. FIELD_STRUCT_DESC: 14-inch pipe through the levee, 15.0 feet below the crown. Pipe likely runs from 36-inch concrete standpipe on LS to outlet on WS toe. Portion of the discharge line from the pump at Levee Mile 0.68. 55-inch CMP riser with slide gate on LS shoulder. Originally included in O&M manual, 1964. FS Date: 5/21/2013

36-inch concrete standpipe on LS toe.

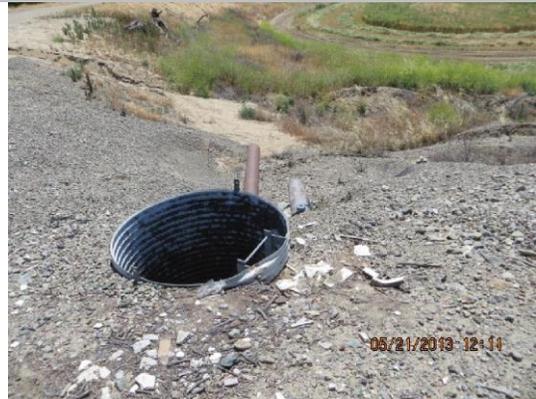
Photo 2 of 2 : UCIP\_SP\_2016\_13883\_22822.jpg

LM Start	<b>0.70</b>	Rating **	M	Issue No.	<b>60 (cont)</b>
LM End	<b>0.70</b>	Issue Type +	En	Location *	WS
Category	Supplemental			GPS Latitude/Longitude	
				Start	End
Item	DWR UCIP Field Study			37.779209 °	37.779209 °
				-121.301973 °	-121.301973 °
DWR ID					
Comment Code					
Inspector Comment					
FS_ID:13883 DS_ID:19039 EP_NO: N/A Repair Type: Non-Urgent Crossing Status: Found UCIP Comments: Slide gate missing actuator inside 55-inch CMP riser. FIELD_STRUCT_DESC: 14-inch pipe through the levee, 15.0 feet below the crown. Pipe likely runs from 36-inch concrete standpipe on LS to outlet on WS toe. Portion of the discharge line from the pump at Levee Mile 0.68. 55-inch CMP riser with slide gate on LS shoulder. Originally included in O&M manual, 1964. FS Date: 5/21/2013

55-inch CMP riser with slide gate (no handle) on LS shoulder. 14-inch and 12-inch pipe visible on LS toe.

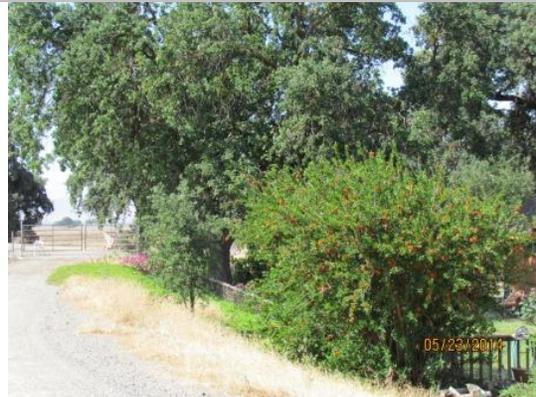
Photo 1 of 1 : SP\_2016\_RD2107\_329\_17\_20160229\_00006.jpg

LM Start	<b>1.23</b>	Rating **	M	Issue No.	<b>17</b>
LM End	<b>1.23</b>	Issue Type +	En	Location *	LS
Category	Earthen Levee		GPS Latitude/Longitude		
			Start	End	
Item	Vegetation		37.774123 °	37.774123 °	
			-121.307189 °	-121.307189 °	
DWR ID	DWR_RD2107_01_s_2012_17				
Comment Code					
V6 : Landscaping					
Inspector Comment					
Landscaping and fence present on levee slope.

View of landscape planting on landside levee slope and a 3-ft yard fence at the levee toe.

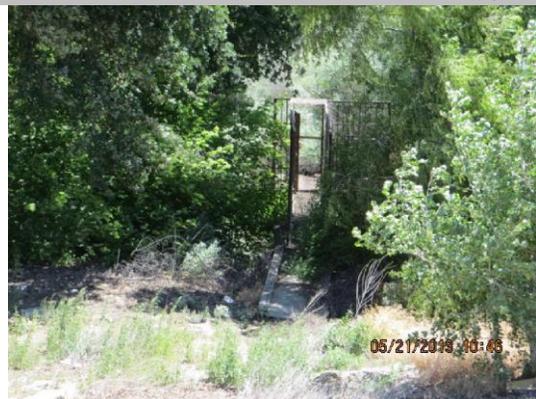
Photo 1 of 2 : UCIP\_SP\_2016\_13650\_22341.jpg

LM Start	<b>1.47</b>	Rating **	M	Issue No.	<b>61</b>
LM End	<b>1.47</b>	Issue Type +	En	Location *	LS
Category	Supplemental			GPS Latitude/Longitude	
				Start	End
Item	DWR UCIP Field Study			37.771735 °	37.771735 °
				-121.304847 °	-121.304847 °
DWR ID					
Comment Code					
Inspector Comment					
FS_ID:13650 DS_ID:19040 EP_NO: N/A Repair Type: Non-Urgent Crossing Status: Found UCIP Comments: No pump. Appears abandoned. Large hole under pipe on WS slope from animal activity. FIELD_STRUCT_DESC: 1 of 2: 18-inch PVC irrigation pipe through the levee 2.5 feet below the crown. Pump on pile structure in the stream. Walkway to the pump. Originally included O&M manual, 1964. FS Date: 5/21/2013

Pumping plant on metal pier on WS toe.

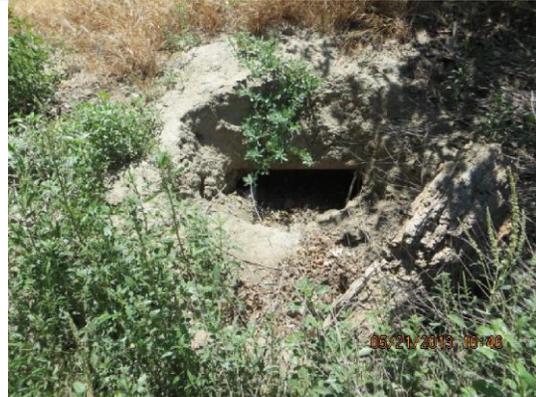
Photo 2 of 2 : UCIP\_SP\_2016\_13650\_22340.jpg

LM Start	<b>1.47</b>	Rating **	M	Issue No.	<b>61 (cont)</b>
LM End	<b>1.47</b>	Issue Type +	En	Location *	LS
Category	Supplemental			GPS Latitude/Longitude	
				Start	End
Item	DWR UCIP Field Study			37.771735 °	37.771735 °
				-121.304847 °	-121.304847 °
DWR ID					
Comment Code					
Inspector Comment					
FS_ID:13650 DS_ID:19040 EP_NO: N/A Repair Type: Non-Urgent Crossing Status: Found UCIP Comments: No pump. Appears abandoned. Large hole under pipe on WS slope from animal activity. FIELD_STRUCT_DESC: 1 of 2: 18-inch PVC irrigation pipe through the levee 2.5 feet below the crown. Pump on pile structure in the stream. Walkway to the pump. Originally included O&M manual, 1964. FS Date: 5/21/2013

Large hole under pipe on WS slope.

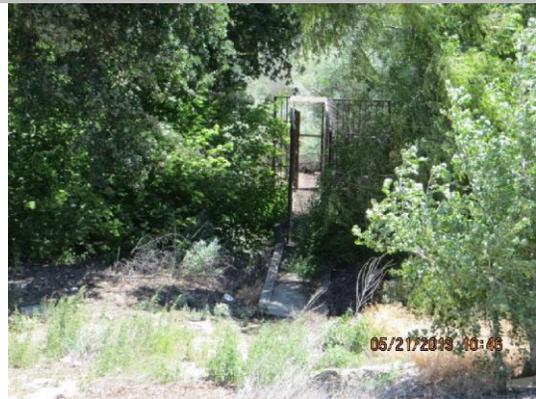
Photo 1 of 2 : UCIP\_SP\_2016\_15179\_24935.jpg

LM Start	<b>1.47</b>	Rating **	M	Issue No.	<b>67</b>
LM End	<b>1.47</b>	Issue Type +	En	Location *	LS
Category	Supplemental			GPS Latitude/Longitude	
				Start	End
Item	DWR UCIP Field Study			37.771735 °	37.771735 °
				-121.304847 °	-121.304847 °
DWR ID					
Comment Code					
Inspector Comment					
FS_ID:15179 DS_ID:23106 EP_NO: N/A Repair Type: Non-Urgent Crossing Status: Found UCIP Comments: Pipe open on WS toe at the pump on pier. Pipe abandoned and should be done so properly. FIELD_STRUCT_DESC: 16-inch steel irrigation pipe through the levee 2.5 feet below the crown. Pump on pile structure in the stream. Walkway to the pump. FS Date: 5/21/2013

Metal pier on WS slope.

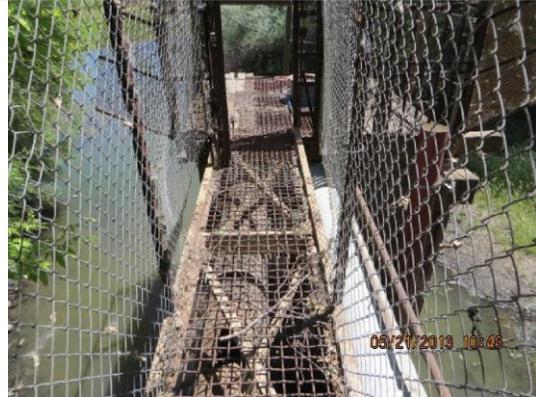
Photo 2 of 2 : UCIP\_SP\_2016\_15179\_24934.jpg

LM Start	<b>1.47</b>	Rating **	M	Issue No.	<b>67 (cont)</b>
LM End	<b>1.47</b>	Issue Type +	En	Location *	LS
Category	Supplemental			GPS Latitude/Longitude	
				Start	End
Item	DWR UCIP Field Study			37.771735 °	37.771735 °
				-121.304847 °	-121.304847 °
DWR ID					
Comment Code					
Inspector Comment					
FS_ID:15179 DS_ID:23106 EP_NO: N/A Repair Type: Non-Urgent Crossing Status: Found UCIP Comments: Pipe open on WS toe at the pump on pier. Pipe abandoned and should be done so properly. FIELD_STRUCT_DESC: 16-inch steel irrigation pipe through the levee 2.5 feet below the crown. Pump on pile structure in the stream. Walkway to the pump. FS Date: 5/21/2013

Pipe visible under metal walkway on WS slope.

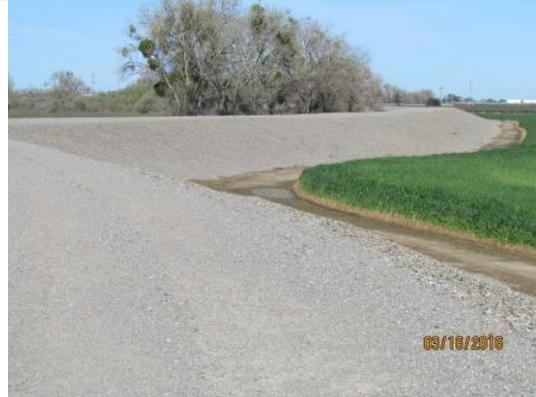
Photo 1 of 1 : SP\_2016\_RD2107\_330\_8\_20160321\_00011.jpg

View of the acceptable vegetation maintenance on the landside levee slope.

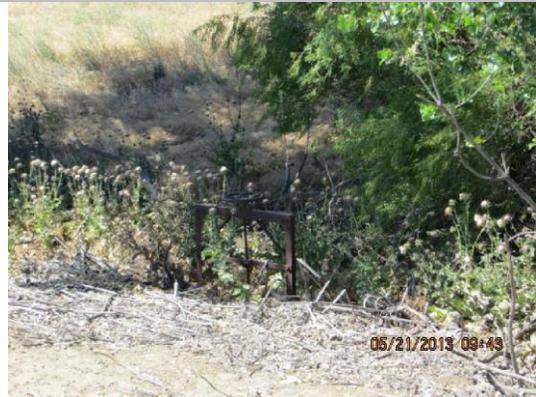
Photo 1 of 2 : UCIP\_SP\_2016\_13637\_22299.jpg

LM Start	<b>0.27</b>	Rating **	M	Issue No.	<b>12</b>
LM End	<b>0.27</b>	Issue Type +	En	Location *	LS
Category	Supplemental		GPS Latitude/Longitude		
			Start	End	
Item	DWR UCIP Field Study		37.762613 °	37.762613 °	
			-121.313480 °	-121.313480 °	
DWR ID					
Comment Code					
Inspector Comment					
FS_ID:13637 DS_ID:19057 EP_NO: N/A Repair Type: Non-Urgent Crossing Status: Found UCIP Comments: Pipe filled in with soil around outlet and not visible on LS. Appears abandoned and should be done so properly. FIELD_STRUCT_DESC: 16-inch steel storm drain pipe 16-feet below the crown with slide gate on WS toe. Originally included in O&M manual, 1964. FS Date: 5/21/2013

Slide gate visible on WS toe.

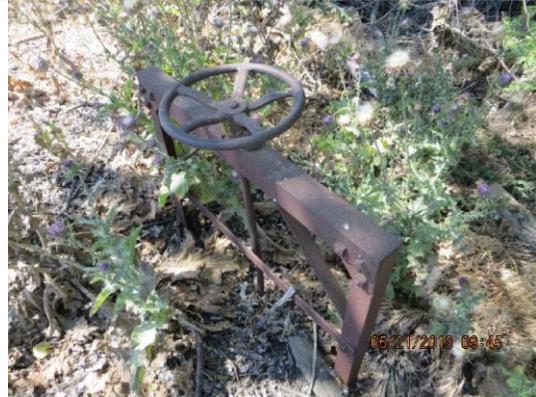
Photo 2 of 2 : UCIP\_SP\_2016\_13637\_22298.jpg

LM Start	<b>0.27</b>	Rating **	M	Issue No.	<b>12 (cont)</b>
LM End	<b>0.27</b>	Issue Type +	En	Location *	LS
Category	Supplemental			GPS Latitude/Longitude	
				Start	End
Item	DWR UCIP Field Study			37.762613 °	37.762613 °
				-121.313480 °	-121.313480 °
DWR ID					
Comment Code					
Inspector Comment					
FS_ID:13637 DS_ID:19057 EP_NO: N/A Repair Type: Non-Urgent Crossing Status: Found UCIP Comments: Pipe filled in with soil around outlet and not visible on LS. Appears abandoned and should be done so properly. FIELD_STRUCT_DESC: 16-inch steel storm drain pipe 16-feet below the crown with slide gate on WS toe. Originally included in O&M manual, 1964. FS Date: 5/21/2013

Slide gate visible on WS toe.

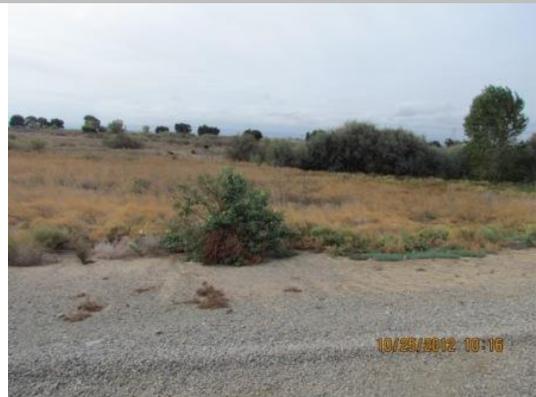
Photo 1 of 1 : SP\_2016\_RD2107\_330\_4\_20160229\_00001.jpg

LM Start	<b>0.51</b>	Rating **	A/W	Issue No.	<b>4</b>
LM End	<b>0.51</b>	Issue Type +	Ma	Location *	WS
Category	Earthen Levee			GPS Latitude/Longitude	
				Start	End
Item	Vegetation			37.764780 °	37.764780 °
				-121.316717 °	-121.316717 °
DWR ID	DWR_RD2107_02_s_2012_4				
Comment Code					
V4 : Elderberries are blocking visibility and flood fight capability.					
Inspector Comment					
Elderberry bush on waterside.

Elderberry located on waterside slope.

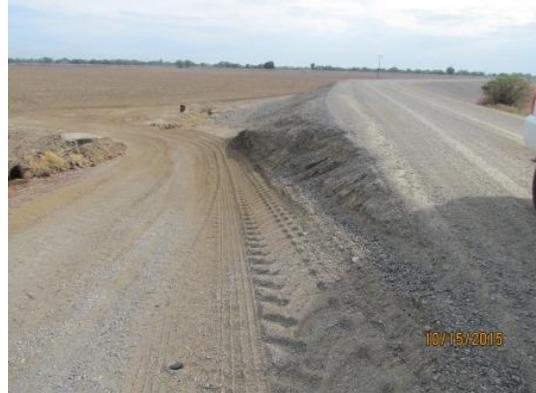
Photo 1 of 1 : SP\_2016\_RD2107\_330\_9\_20160229\_00002.jpg

LM Start	<b>0.54</b>	Rating **	M	Issue No.	<b>9</b>
LM End	<b>0.54</b>	Issue Type +	Ma	Location *	LS
Category	Earthen Levee		GPS Latitude/Longitude		
			Start	End	
Item	Slope Stability		37.764838 °	37.764838 °	
			-121.317318 °	-121.317318 °	
DWR ID	DWR_RD2107_02_f_2015_9				
Comment Code					
S1 : Repair slope instability.					
Inspector Comment					
Add appropriate fill and compact the slope.

View of the vertical cut on the landside levee slope.

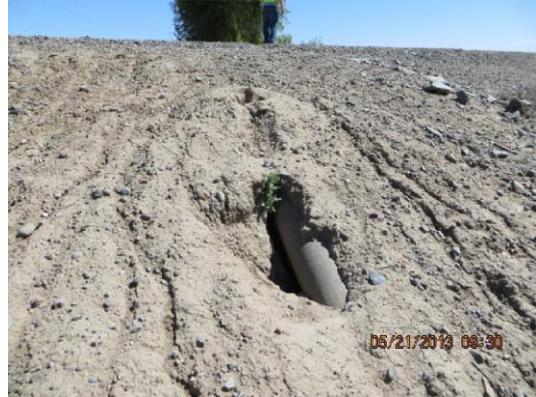
Photo 1 of 2 : UCIP\_SP\_2016\_13636\_22296.jpg

LM Start	<b>0.54</b>	Rating **	M	Issue No.	<b>11</b>
LM End	<b>0.54</b>	Issue Type +	En	Location *	LS
Category	Supplemental		GPS Latitude/Longitude		
			Start	End	
Item	DWR UCIP Field Study		37.764832 °	37.764832 °	
			-121.317405 °	-121.317405 °	
DWR ID					
Comment Code					
Inspector Comment					
FS_ID:13636 DS_ID:19058 EP_NO: 13161 Repair Type: Non-Urgent Crossing Status: Found UCIP Comments: Some erosion along pipe alignment on WS slope. FIELD_STRUCT_DESC: 10-inch steel storm drain pipe through the levee 5-feet below the crown. Pump located on 36-inch concrete standpipe at LS toe. A PVC pipe runs parallel to waterward toe to train tracks. Air relief valve on waterward shoulder (Permit No. 13161, 1981). FS Date: 5/21/2013

Erosion along pipe alignment on WS slope.

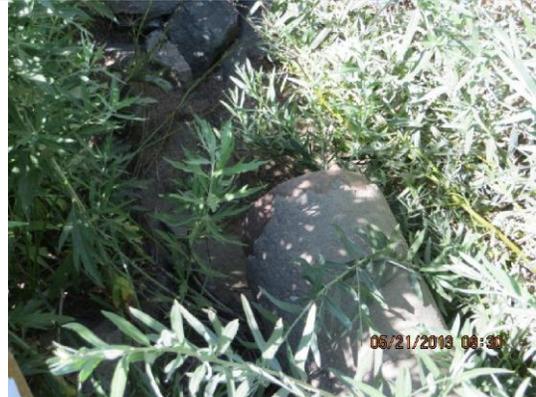
Photo 2 of 2 : UCIP\_SP\_2016\_13636\_22295.jpg

LM Start	<b>0.54</b>	Rating **	M	Issue No.	<b>11 (cont)</b>
LM End	<b>0.54</b>	Issue Type +	En	Location *	LS
Category	Supplemental			GPS Latitude/Longitude	
				Start	End
Item	DWR UCIP Field Study			37.764832 °	37.764832 °
				-121.317405 °	-121.317405 °
DWR ID					
Comment Code					
Inspector Comment					
FS_ID:13636 DS_ID:19058 EP_NO: 13161 Repair Type: Non-Urgent Crossing Status: Found UCIP Comments: Some erosion along pipe alignment on WS slope. FIELD_STRUCT_DESC: 10-inch steel storm drain pipe through the levee 5-feet below the crown. Pump located on 36-inch concrete standpipe at LS toe. A PVC pipe runs parallel to waterward toe to train tracks. Air relief valve on waterward shoulder (Permit No. 13161, 1981). FS Date: 5/21/2013

Pipe at outlet.

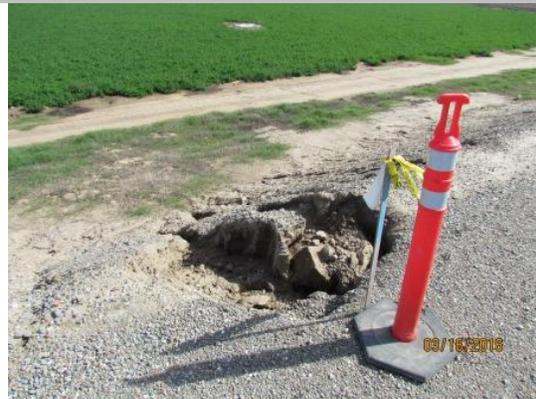
Photo 1 of 1 : SP\_2016\_RD2107\_330\_10\_20160321\_00012.jpg

LM Start	<b>1.32</b>	Rating **	M	Issue No.	<b>10</b>
LM End	<b>1.32</b>	Issue Type +	Ma	Location *	LS
Category	Earthen Levee			GPS Latitude/Longitude	
				Start	End
Item	Erosion / Bank Caving			37.772432 °	37.772432 °
				-121.327275 °	-121.327275 °
DWR ID	DWR_RD2107_02_s_2016_10				
Comment Code					
E2 : Schedule repair of erosion site prior to the next inspection.					
Inspector Comment

View of the erosion on the landside levee slope.

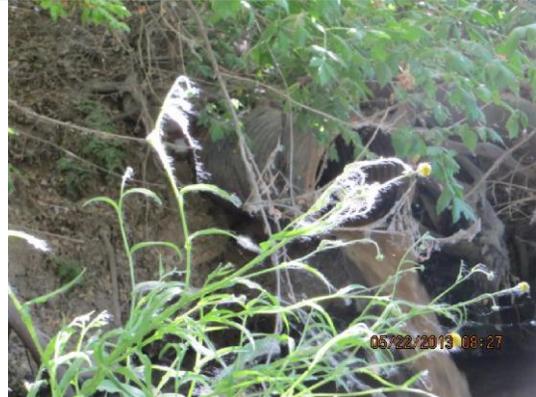
Photo 1 of 2 : UCIP\_SP\_2016\_43097\_22441.jpg

LM Start	<b>1.51</b>	Rating **	U	Issue No.	<b>13</b>
LM End	<b>1.51</b>	Issue Type +	En	Location *	LS
Category	Supplemental			GPS Latitude/Longitude	
				Start	End
Item	DWR UCIP Field Study			37.774130 °	37.774130 °
				-121.329896 °	-121.329896 °
DWR ID					
Comment Code					
Inspector Comment					
FS_ID:43097 DS_ID:19056 EP_NO: 2966 Repair Type: Urgent Crossing Status: Found UCIP Comments: Headwall around pipe at LS toe is failing and should be shored up. Flap gate propped open and should be returned to normal function. FIELD_STRUCT_DESC: 24-inch steel drain pipe through the levee 14 feet below the crown. Flap gate installed on the waterward end of the pipe and two standard reinforced concrete cutoff walls were placed around the pipe in line with the levee shoulders (Permit No. 2966, 1958). FS Date: 5/22/2013

Pipe visible on WS toe with Flap gate open.

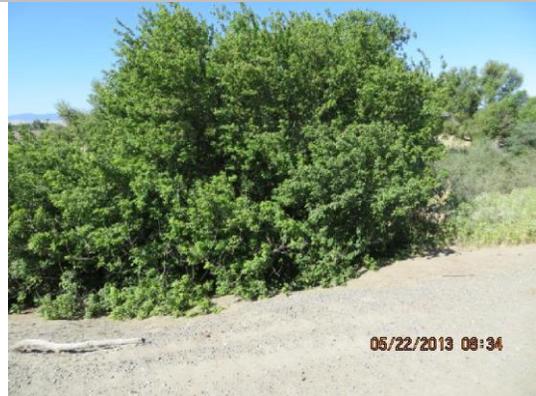
Photo 2 of 2 : UCIP\_SP\_2016\_43097\_22440.jpg

LM Start	<b>1.51</b>	Rating **	U	Issue No.	<b>13 (cont)</b>
LM End	<b>1.51</b>	Issue Type +	En	Location *	LS

Pipes visible under foliage on WS toe.
