**Flood Control Project Maintenance
Levee Inspections**

Maintenance Issue Types Only, Levee Inspection Report By Mile - Fall 2015

Reclamation District No. 2107 Mossdale Island

Waterway	Bank	Unit Miles	Inspection Start/End	Inspector
Unit No. 01 San Joaquin River	Left	2.33	10/15/2015 10/15/2015	Maksim Khashchuk

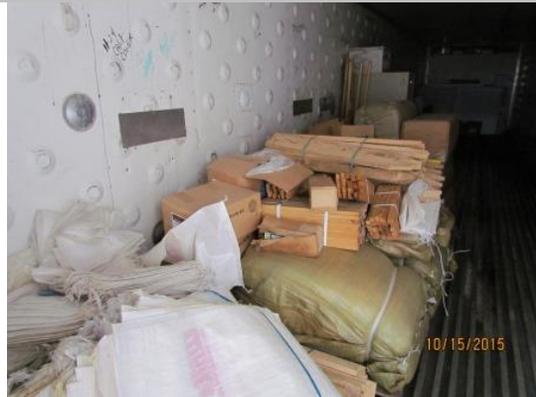
Photo 1 of 1 : FA_2015_RD2107_329_7_20151026_00015.jpg

LM Start		Rating **	A	Issue No.	7
LM End		Issue Type +	Ma	Location *	CR
Category	Earthen Levee		GPS Latitude/Longitude		
			Start		End
Item	Emergency Supplies & Equipment			o	o
DWR ID	DWR_RD2107_01_s_2013_7				
Action/Comments					
Inspector Comments: Flood fighting supplies are available on-site.

View of the flood fight emergency supplies.

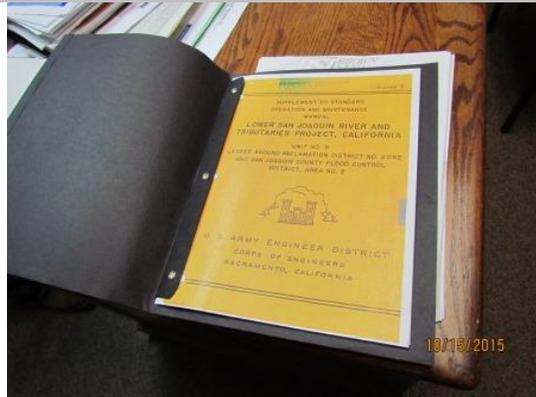
Photo 1 of 1 : FA_2015_RD2107_329_8_20151026_00016.jpg

LM Start		Rating **	A	Issue No.	8
LM End		Issue Type +	Ma	Location *	CR
Category	Earthen Levee		GPS Latitude/Longitude		
			Start		End
Item	Operations & Maintenance Manuals			o	o
DWR ID	DWR_RD2107_01_s_2013_8				
Action/Comments					
Inspector Comments: The O&M Manual is available at the LMA's office.

View of the O&M Manual.

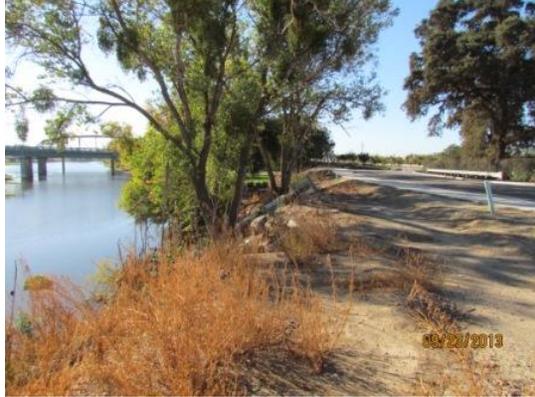
Photo 1 of 1 : FA_2015_RD2107_329_1_20150910_00001.jpg

LM Start	0.03	Rating **	N	Issue No.	1
LM End	0.03	Issue Type +	Ma	Location *	WS
Category	Earthen Levee		GPS Latitude/Longitude		
			Start	End	
Item	Trim / Thin Trees		37.786993 °	37.786993 °	
			-121.308694 °	-121.308694 °	
DWR ID	DWR_RD2107_01_s_2012_1				
Action/Comments					
Tree stumps.

Photo of waterside slope. Stumps present from prior tree removal for access and visibility.

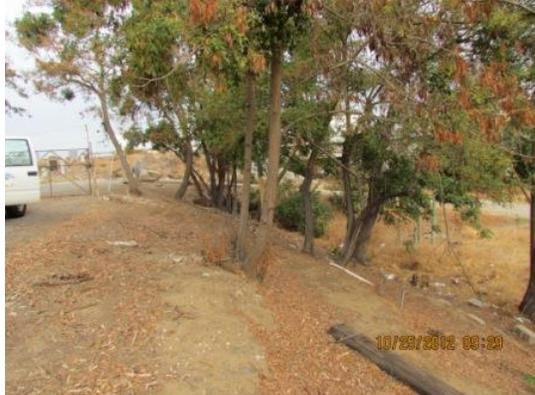
Photo 1 of 1 : FA_2015_RD2107_329_2_20150910_00002.jpg

LM Start	0.26	Rating **	N	Issue No.	2
LM End	0.26	Issue Type +	Ma	Location *	WS
Category	Earthen Levee		GPS Latitude/Longitude		
			Start	End	
Item	Trim / Thin Trees		37.784316 °	37.784316 °	
			-121.306498 °	-121.306498 °	
DWR ID	DWR_RD2107_01_s_2012_2				
Action/Comments					
Tree stumps.

Tree stumps present on slope. They were left from prior vegetation removal for access and visibility.

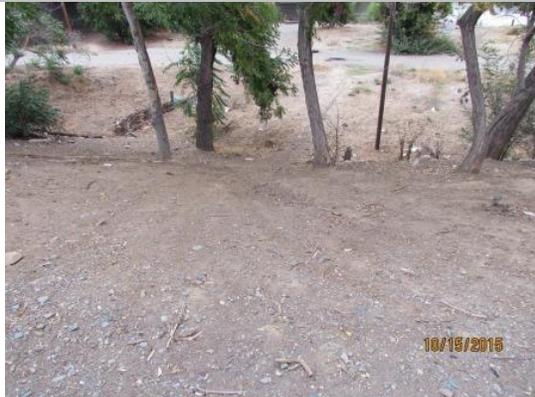
Photo 1 of 1 : FA_2015_RD2107_329_19_20151026_00011.jpg

View of the tracks on the waterside levee slope.

LM Start	0.26	Rating **	M	Issue No.	19
LM End	0.26	Issue Type +	Ma	Location *	WS
Category	Earthen Levee		GPS Latitude/Longitude		
			Start	End	
Item	Slope Stability		37.784300 °	37.784300 °	
			-121.306488 °	-121.306488 °	
DWR ID	DWR_RD2107_01_f_2015_19				
Action/Comments					
Repair the levee slope damaged by foot traffic and prevent access where possible.

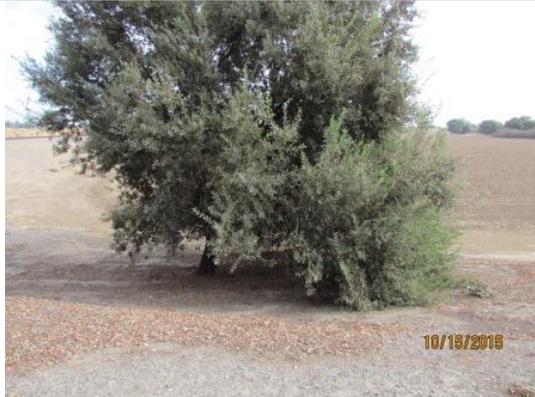
Photo 1 of 1 : FA_2015_RD2107_329_21_20151026_00013.jpg

View of the overgrown tree on the waterside levee slope obstructing visibility.

LM Start	1.14	Rating **	M	Issue No.	21
LM End	1.14	Issue Type +	Ma	Location *	WS
Category	Earthen Levee		GPS Latitude/Longitude		
			Start	End	
Item	Trim / Thin Trees		37.775324 °	37.775324 °	
			-121.307685 °	-121.307685 °	
DWR ID	DWR_RD2107_01_f_2015_21				
Action/Comments					
Trim trees to at least five feet above ground level. Inspector Comments: Trim up limbs blocking visibility.

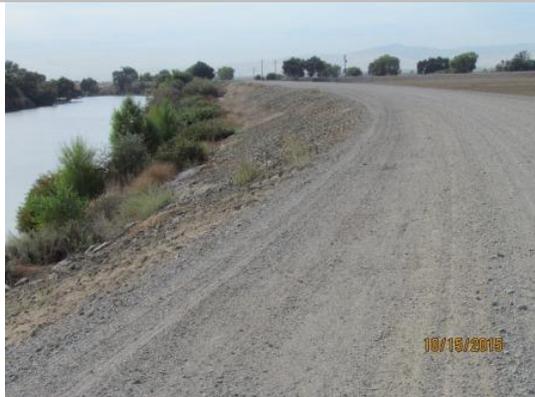
Photo 1 of 1 : FA_2015_RD2107_329_22_20151026_00014.jpg

View of the acceptable vegetation on the waterside levee slope.

LM Start	2.00	Rating **	A	Issue No.	22
LM End	2.00	Issue Type +	Ma	Location *	WS
Category	Earthen Levee		GPS Latitude/Longitude		
			Start	End	
Item	Vegetation		37.765571 °	37.765571 °	
			-121.309613 °	-121.309613 °	
DWR ID	DWR_RD2107_01_f_2015_22				
Action/Comments					
Control annual grass and weeds on the levee slopes and easements.

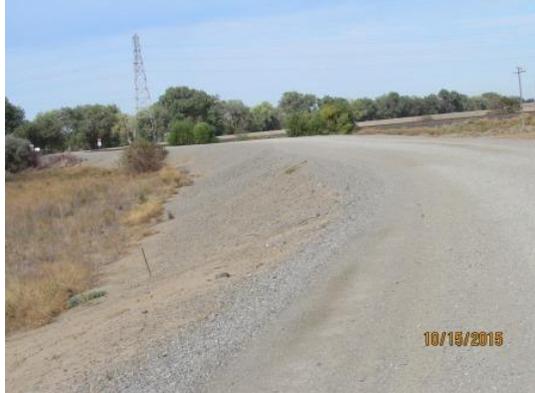
Photo 1 of 1 : FA_2015_RD2107_330_8_20151026_00005.jpg

View of the acceptable vegetation control on the waterside levee slope.

LM Start	0.42	Rating **	A	Issue No.	8
LM End	0.42	Issue Type +	Ma	Location *	WS
Category	Earthen Levee		GPS Latitude/Longitude		
			Start	End	
Item	Vegetation		37.764171 °	37.764171 °	
			-121.315377 °	-121.315377 °	
DWR ID	DWR_RD2107_02_f_2015_8				
Action/Comments					
Control annual grass and weeds on the levee slopes and easements.

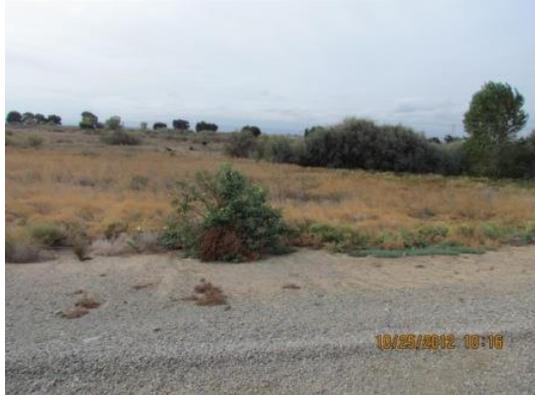
Photo 1 of 1 : FA_2015_RD2107_330_4_20150910_00001.jpg

LM Start	0.51	Rating **	M	Issue No.	4
LM End	0.51	Issue Type +	Ma	Location *	WS
Category	Earthen Levee		GPS Latitude/Longitude		
			Start	End	
Item	Vegetation		37.764780 °	37.764780 °	
			-121.316717 °	-121.316717 °	
DWR ID	DWR_RD2107_02_s_2012_4				
Action/Comments					
Elderberries are blocking visibility and flood fight capability. Inspector Comments: Elderberry bush on waterside.

Elderberry located on waterside slope.

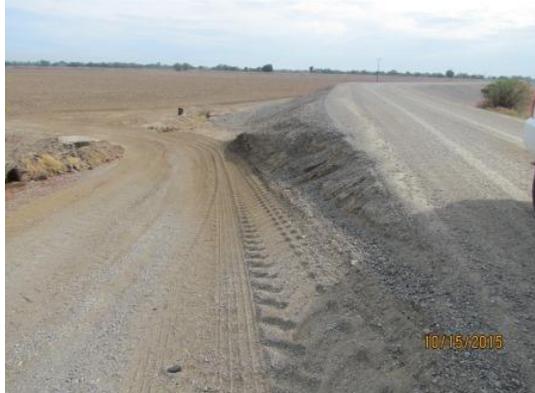
Photo 1 of 1 : FA_2015_RD2107_330_9_20151026_00006.jpg

View of the vertical cut on the landside levee slope.

LM Start	0.54	Rating **	M	Issue No.	9
LM End	0.54	Issue Type +	Ma	Location *	LS
Category	Earthen Levee		GPS Latitude/Longitude		
			Start	End	
Item	Slope Stability		37.764838 °	37.764838 °	
			-121.317318 °	-121.317318 °	
DWR ID	DWR_RD2107_02_f_2015_9				
Action/Comments					
Repair slope instability. Inspector Comments: Add appropriate fill and compact the slope.

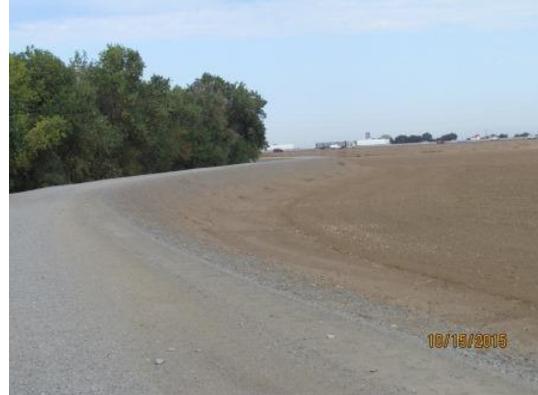
Photo 1 of 1 : FA_2015_RD2107_330_10_20151026_00007.jpg

View of the acceptable vegetation control on the landside levee slope.

LM Start	0.75	Rating **	A	Issue No.	10
LM End	0.75	Issue Type +	Ma	Location *	LS
Category	Earthen Levee		GPS Latitude/Longitude		
			Start	End	
Item	Vegetation		37.766621 °	37.766621 °	
			-121.320149 °	-121.320149 °	
DWR ID	DWR_RD2107_02_f_2015_10				
Action/Comments					
Control annual grass and weeds on the levee slopes and easements.
