**Flood Control Project Maintenance
Levee Inspections**

Maintenance Issue Types Only, Levee Inspection Report By Mile - Spring 2015

Reclamation District No. 2107 Mossdale Island

Waterway	Bank	Unit Miles	Inspection Start/End	Inspector
Unit No. 01 San Joaquin River	Left	2.33	05/06/2015 05/06/2015	Maksim Khashchuk

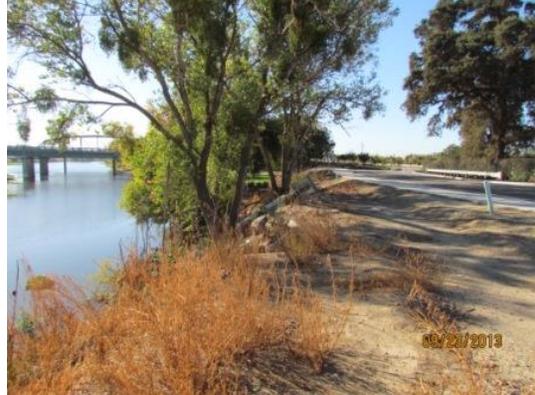
Photo 1 of 1 : SP_2015_RD2107_329_1_20150317_00001.jpg

LM Start	0.03	Rating **	N	Issue No.	1
LM End	0.03	Issue Type +	Ma	Location *	WS
Category	Earthen Levee			GPS Latitude/Longitude	
				Start	End
Item	Trim / Thin Trees			37.786993 °	37.786993 °
				-121.308694 °	-121.308694 °
DWR ID	DWR_RD2107_01_s_2012_1				
Action/Comments					
Tree stumps.

Photo of waterside slope. Stumps present from prior tree removal for access and visibility.

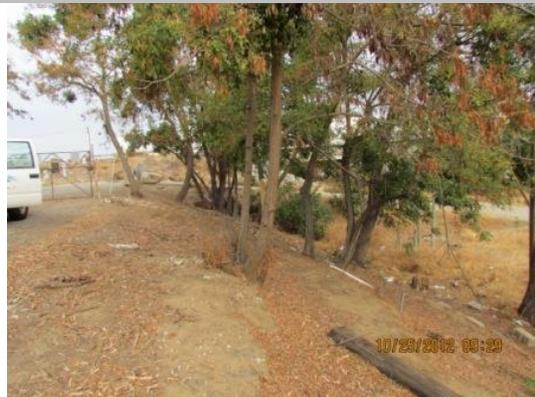
Photo 1 of 1 : SP_2015_RD2107_329_2_20150317_00002.jpg

LM Start	0.26	Rating **	N	Issue No.	2
LM End	0.26	Issue Type +	Ma	Location *	WS
Category	Earthen Levee			GPS Latitude/Longitude	
				Start	End
Item	Trim / Thin Trees			37.784316 °	37.784316 °
				-121.306498 °	-121.306498 °
DWR ID	DWR_RD2107_01_s_2012_2				
Action/Comments					
Tree stumps.

Tree stumps present on slope. They were left from prior vegetation removal for access and visibility.

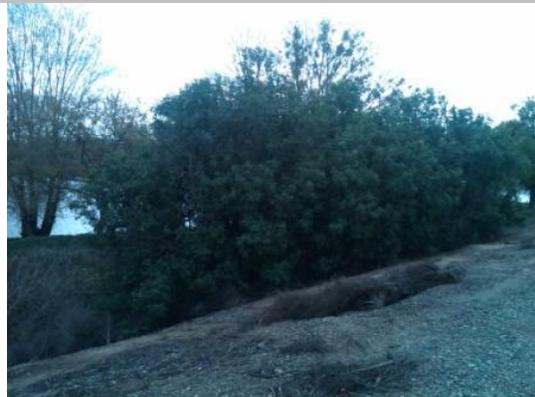
Photo 1 of 1 : SP_2015_RD2107_329_54_20150317_00005.jpg

LM Start	0.41	Rating **	M	Issue No.	54
LM End	0.41	Issue Type +	Ma	Location *	WS
Category	Earthen Levee			GPS Latitude/Longitude	
				Start	End
Item	Vegetation			37.782737 °	37.782737 °
				-121.304426 °	-121.304426 °
DWR ID	DWR_RD2107_01_s_2012_54				
Action/Comments					
Elderberries are blocking visibility and flood fight capability. Inspector Comments: Large elderberry on water side slope.

03/26/2012 Large elderberry located on water side slope.

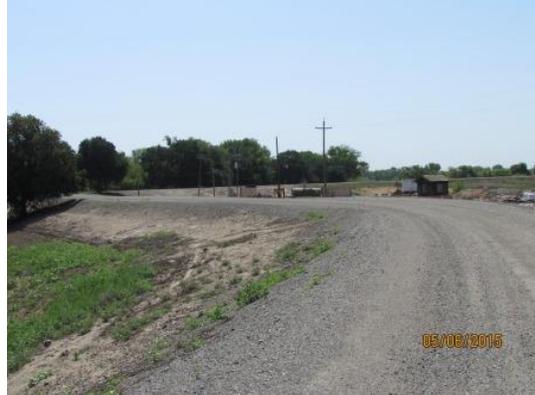
Photo 1 of 1 : SP_2015_RD2107_329_19_20150511_00011.jpg

LM Start	1.34	Rating **	A	Issue No.	19
LM End	1.34	Issue Type +	Ma	Location *	WS
Category	Earthen Levee		GPS Latitude/Longitude		
			Start	End	
Item	Vegetation		37.772616 °	37.772616 °	
			-121.306718 °	-121.306718 °	
DWR ID	DWR_RD2107_01_s_2015_19				
Action/Comments					
Control annual grass and weeds on the levee slopes and easements.

View of the acceptable vegetation control on the landside levee slope.

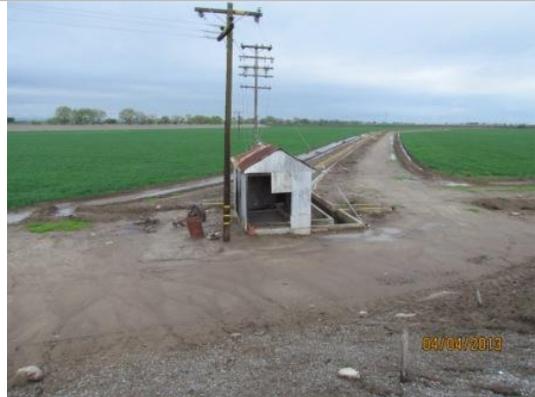
Photo 1 of 1 : SP_2015_RD2107_329_11_20150317_00003.jpg

LM Start	2.19	Rating **	A/W	Issue No.	11
LM End	2.19	Issue Type +	Ma	Location *	CR
Category	Earthen Levee		GPS Latitude/Longitude		
			Start	End	
Item	Encroachments		37.762868 °	37.762868 °	
			-121.309708 °	-121.309708 °	
DWR ID	DWR_RD2107_01_s_2012_11				
Action/Comments					
Pipe Inspector Comments: Irrigation intake pipe through levee freeboard.

View of the pipe location; alignment through levee.

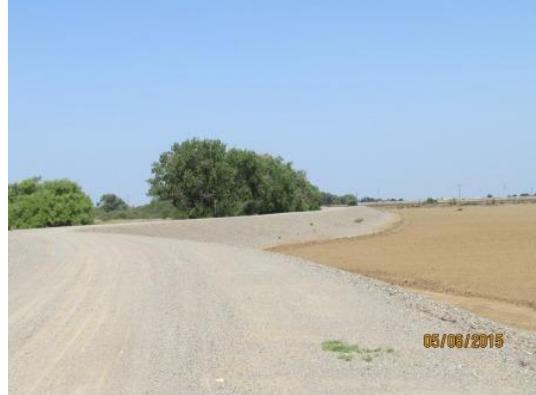
Photo 1 of 1 : SP_2015_RD2107_330_8_20150511_00005.jpg

LM Start	0.14	Rating **	A	Issue No.	8
LM End	0.14	Issue Type +	Ma	Location *	LS
Category	Earthen Levee		GPS Latitude/Longitude		
			Start	End	
Item	Vegetation		37.761487 °	37.761487 °	
			-121.311772 °	-121.311772 °	
DWR ID	DWR_RD2107_02_s_2015_8				
Action/Comments					
Control annual grass and weeds on the levee slopes and easements.

View of the acceptable vegetation control on the landside levee slope.

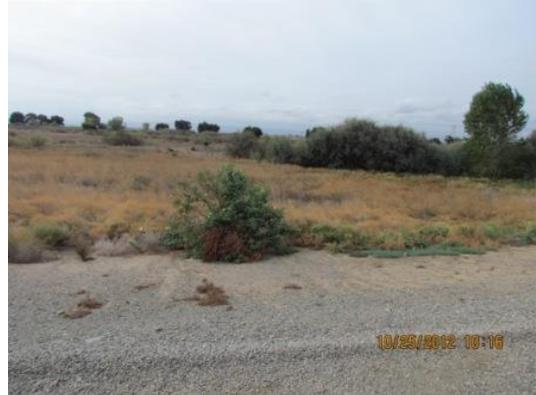
Photo 1 of 1 : SP_2015_RD2107_330_4_20150317_00001.jpg

LM Start	0.51	Rating **	M	Issue No.	4
LM End	0.51	Issue Type +	Ma	Location *	WS
Category	Earthen Levee		GPS Latitude/Longitude		
			Start	End	
Item	Vegetation		37.764780 °	37.764780 °	
			-121.316717 °	-121.316717 °	
DWR ID	DWR_RD2107_02_s_2012_4				
Action/Comments					
Elderberries are blocking visibility and flood fight capability. Inspector Comments: Elderberry bush on waterside.

Elderberry located on waterside slope.
