**Flood Control Project Maintenance  
Levee Inspections  
LMA District Cover Sheet  
Spring 2012 Levee Inspection Results**

**Reclamation District No. 2107 Mossdale Island**

**Spring 2012 Levee Inspection Results**

Waterway	Bank	Unit Miles
Unit No. 01 San Joaquin River	Left	2.37

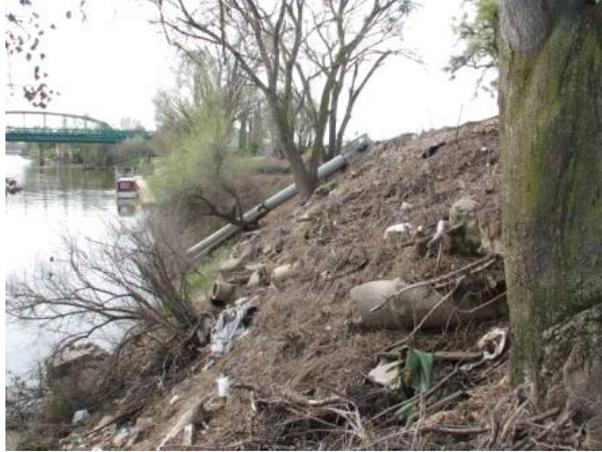
Levee Mile Report Line	4
Start Levee Mile	0.03
End Levee Mile	0.03
Location	Water Side
Category	Earthen Levee
Item	Trim / Thin Trees
<p>Photo of waterside slope. Stumps present from prior tree removal for access and visibility.</p>	
<p>jeto_s_20120309_555.jpg</p>

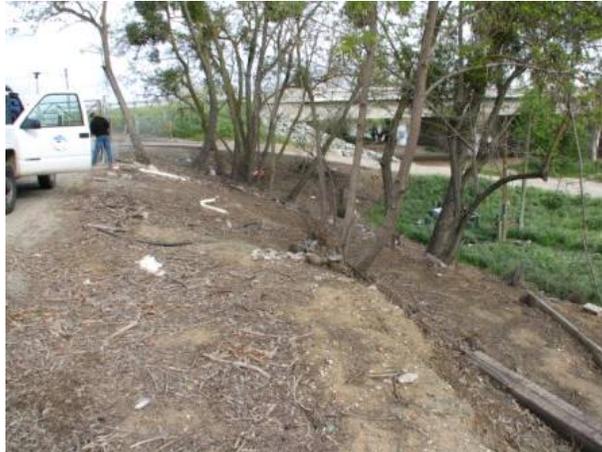
Levee Mile Report Line	5
Start Levee Mile	0.25
End Levee Mile	0.25
Location	Water Side
Category	Earthen Levee
Item	Trim / Thin Trees
<p>Tree stumps present on slope. They were left from prior vegetation removal for access and visibility.</p>	
<p>jeto_s_20120309_556.jpg</p>

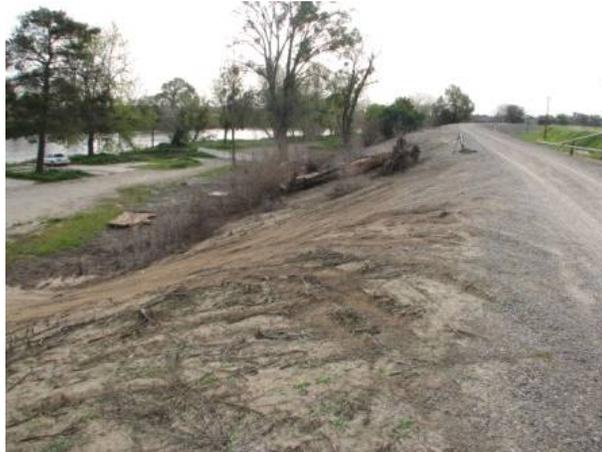
Levee Mile Report Line	6
Start Levee Mile	0.37
End Levee Mile	0.37
Location	Water Side
Category	Earthen Levee
Item	Trim / Thin Trees
<p>Tree stumps and trunks on levee slope. Vehicle traffic on levee slope is an ongoing problem at this location due to the abandoned trailer park, access should be restricted.</p>	
<p>jeto_s_20120309_557.jpg</p>

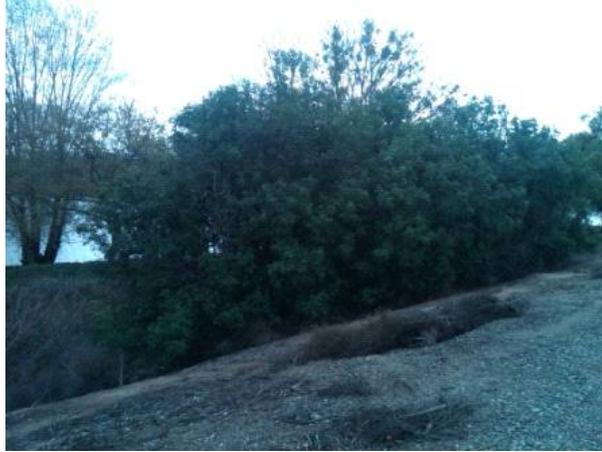
Levee Mile Report Line	7
Start Levee Mile	0.42
End Levee Mile	0.42
Location	Water Side
Category	Earthen Levee
Item	Vegetation
03/26/2012 Large elderberry located on water side slope.	
jeto_s_20120326_718.jpg

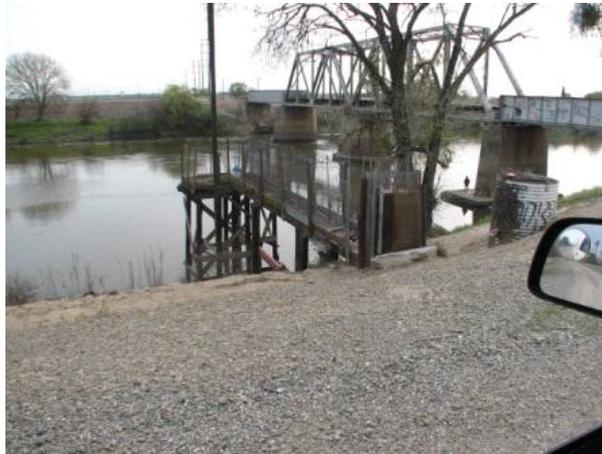
Levee Mile Report Line	8
Start Levee Mile	0.68
End Levee Mile	0.68
Location	Crown
Category	Earthen Levee
Item	Encroachments
Irrigation intake pipe runs through the base of the levee. Stand pipes on waterside and landside. A butterfly valve is located near waterside slope.	
jeto_s_20120309_558.jpg

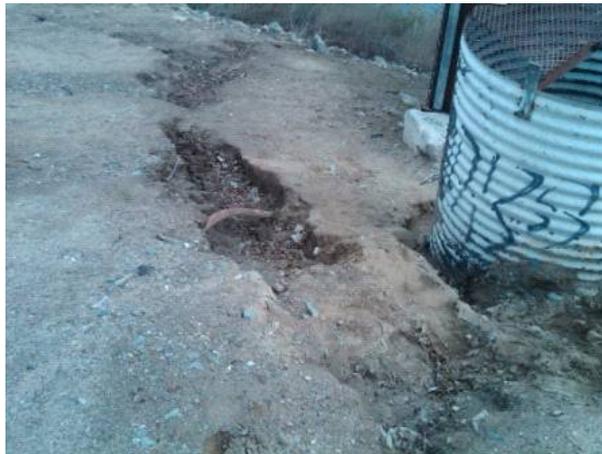
Levee Mile Report Line	9
Start Levee Mile	0.68
End Levee Mile	0.68
Location	Water Side
Category	Earthen Levee
Item	Erosion / Bank Caving
03/26/2012 Erosion noted at pump location.	
jeto_s_20120326_719.jpg

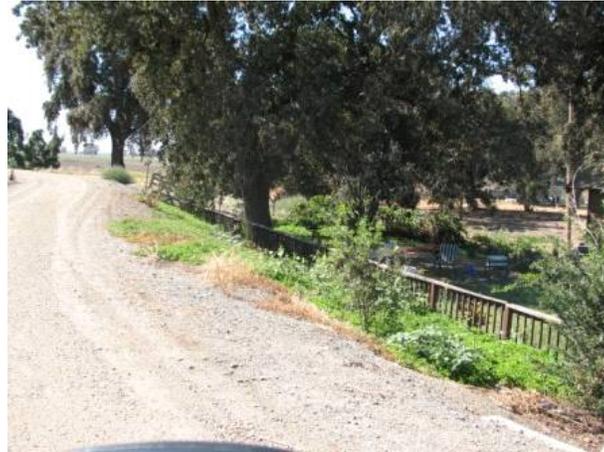
Levee Mile Report Line	10
Start Levee Mile	1.24
End Levee Mile	1.24
Location	Land Side
Category	Earthen Levee
Item	Vegetation
Fall 2009 photo of landscape planting on landside levee slope and a 3-ft yard fence at the levee toe.	
jeto_s_20120309_560.jpg

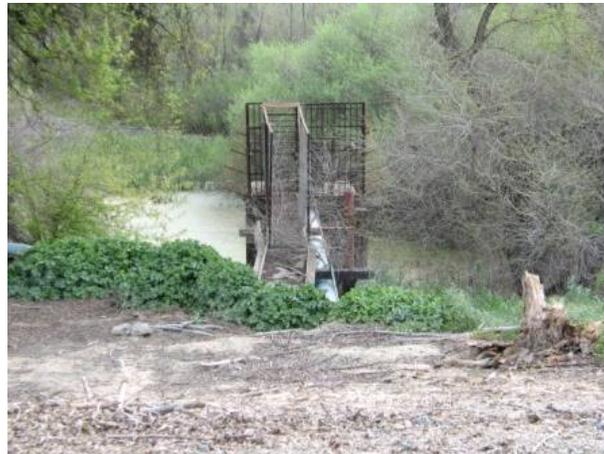
Levee Mile Report Line	11
Start Levee Mile	1.49
End Levee Mile	1.49
Location	Crown
Category	Earthen Levee
Item	Encroachments
Irrigation intake pipe through levee freeboard.	
jeto_s_20120309_559.jpg

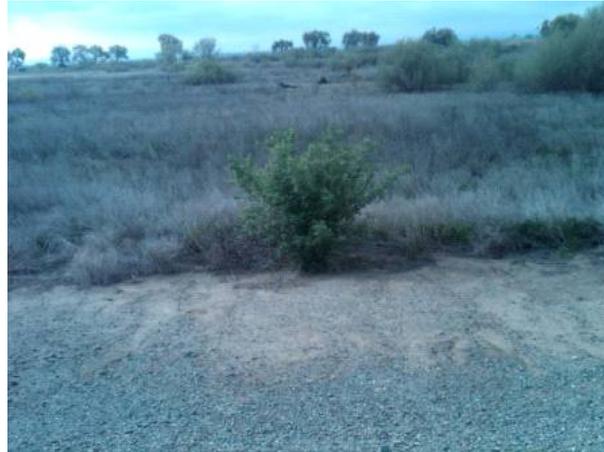
Levee Mile Report Line	1
Start Levee Mile	0.50
End Levee Mile	0.50
Location	Water Side
Category	Earthen Levee
Item	Vegetation
03/26/2012 Elderberry located on water side slope.	
jeto_s_20120326_720.jpg

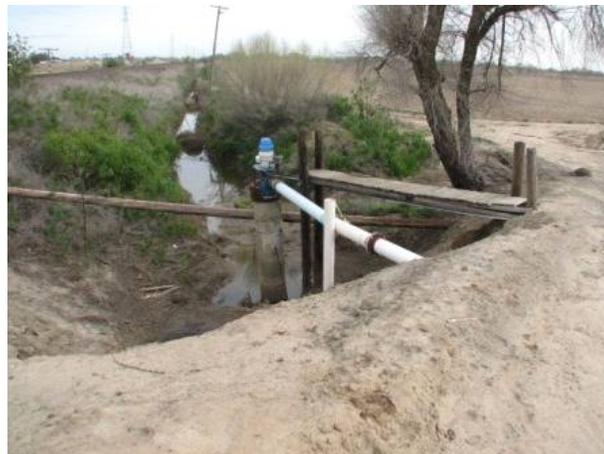
Levee Mile Report Line	2
Start Levee Mile	0.55
End Levee Mile	0.55
Location	Crown
Category	Earthen Levee
Item	Encroachments
Drainage discharge pump. Steel pipe penetrates levee freeboard. No flapgate on waterside. No closure device.	
jeto_s_20120309_561.jpg

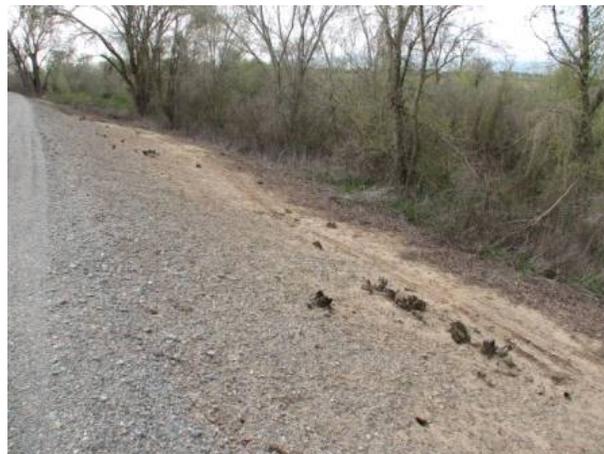
Levee Mile Report Line	3
Start Levee Mile	0.84
End Levee Mile	0.84
Location	Water Side
Category	Earthen Levee
Item	Trim / Thin Trees
Tree stumps on levee slope.	
jeto_s_20120309_562.jpg
