**Flood Control Project Maintenance
Levee Inspections
LMA District Cover Sheet
Spring 2013 Levee Inspection Results**

Reclamation District No. 2107 Mossdale Island

Levee Inspection Report By Mile - Spring 2013

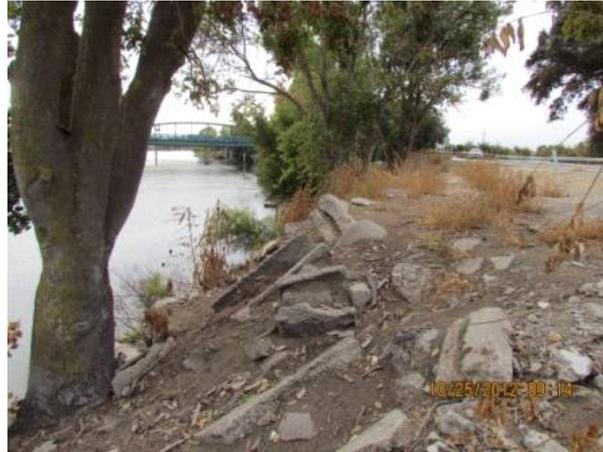
Levee Mile Report Line	4
Start Levee Mile	0.03
End Levee Mile	0.03
Location	Water Side
Category	
Item	Trim / Thin Trees
Photo of waterside slope. Stumps present from prior tree removal for access and visibility.	
mkhashch_s_20130225_627.JPG

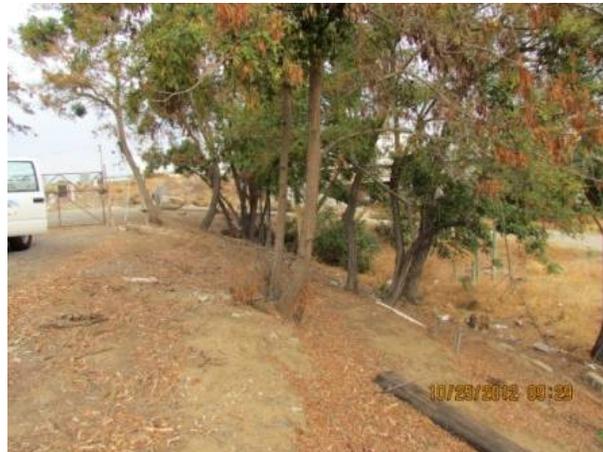
Levee Mile Report Line	5
Start Levee Mile	0.25
End Levee Mile	0.25
Location	Water Side
Category	
Item	Trim / Thin Trees
Tree stumps present on slope. They were left from prior vegetation removal for access and visibility.	
mkhashch_s_20130225_628.JPG

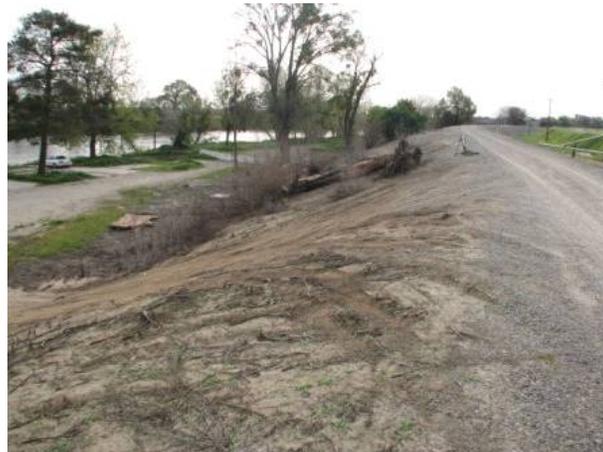
Levee Mile Report Line	6
Start Levee Mile	0.37
End Levee Mile	0.37
Location	Water Side
Category	
Item	Trim / Thin Trees
Tree stumps and trunks on levee slope. Vehicle traffic on levee slope is an ongoing problem at this location due to the abandoned trailer park, access should be restricted.	
mkhashch_s_20130225_630.jpg

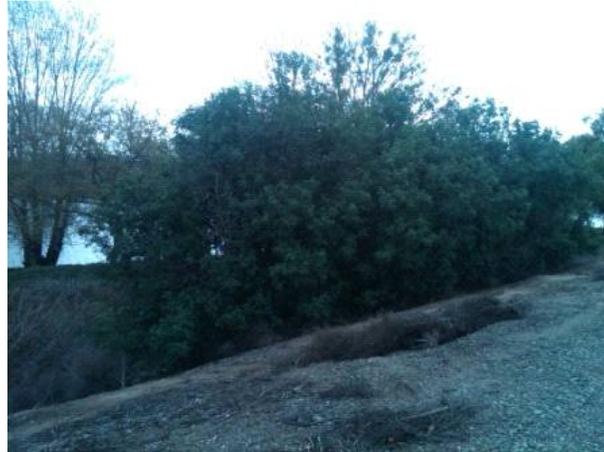
DWR ID: DWR_RD2107_01_f_2012_3										
8	0.42	0.42		Vegetation	WS	M Ma	V4 : Elderberries are blocking visibility and flood fight capability. Inspector Comments: Large elderberry on water side slope.	37.782737 ° -121.304426 °	37.782737 ° -121.304426 °	54 Y
DWR ID: DWR_RD2107_01_s_2012_54										
9	0.68	0.68		Encroachments	CRA/W	En	PI : Pipe Inspector Comments: Irrigation intake pump. Steel pipe runs through base of levee.	37.779550 ° -121.301987 °	37.779550 ° -121.301987 °	6 Y
DWR ID: DWR_RD2107_01_s_2012_6										
10	0.76	0.76		Erosion / Bank Caving	WS	M Ma	E1 : Note and monitor erosion site.	37.778819 ° -121.302848 °	37.778819 ° -121.302848 °	10 Y
DWR ID: DWR_RD2107_01_s_2013_10										
11	1.24	1.24		Vegetation	LS	M En	V6 : Landscaping Inspector Comments: Landscaping and fence present on levee slope.	37.774123 ° -121.307189 °	37.774123 ° -121.307189 °	17 Y
DWR ID: DWR_RD2107_01_s_2012_17

Levee Mile Report Line	8
Start Levee Mile	0.42
End Levee Mile	0.42
Location	Water Side
Category	
Item	Vegetation
03/26/2012 Large elderberry located on water side slope.	
mkhashch_s_20130225_634.jpg

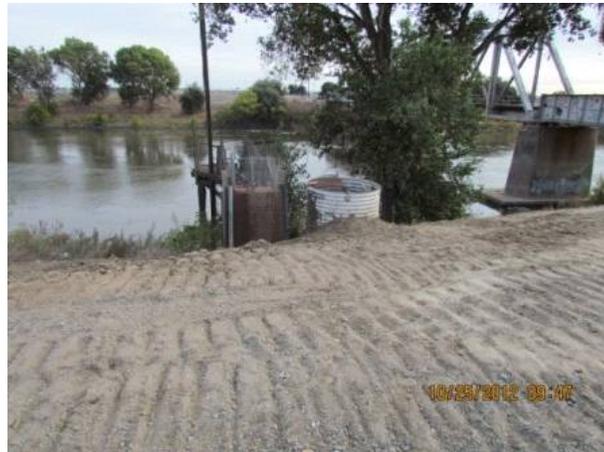
Levee Mile Report Line	9
Start Levee Mile	0.68
End Levee Mile	0.68
Location	Crown
Category	
Item	Encroachments
Irrigation intake pipe runs through the base of the levee. Stand pipes on waterside and landside. A butterfly valve is located near waterside slope.	
mkhashch_s_20130225_631.JPG

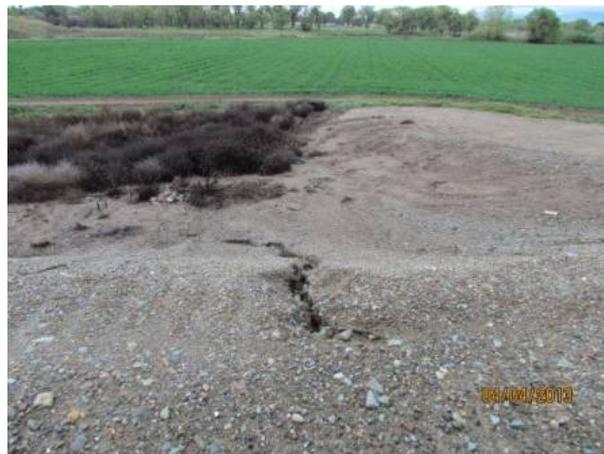
Levee Mile Report Line	10
Start Levee Mile	0.76
End Levee Mile	0.76
Location	Water Side
Category	
Item	Erosion / Bank Caving
View of the eroding waterside levee slope.	
mkhashch_s_20130410_701.JPG

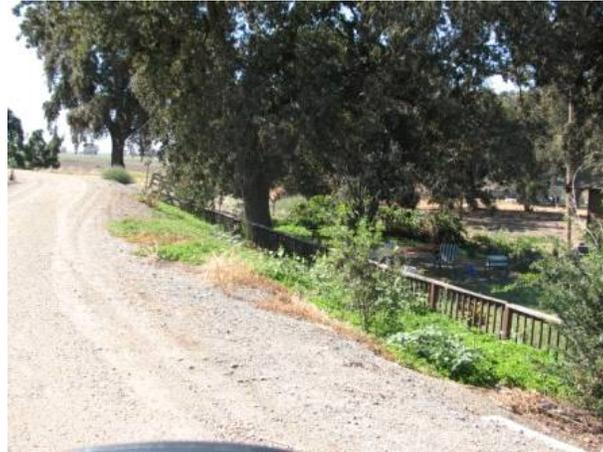
Levee Mile Report Line	11
Start Levee Mile	1.24
End Levee Mile	1.24
Location	Land Side
Category	
Item	Vegetation
Fall 2009 photo of landscape planting on landside levee slope and a 3-ft yard fence at the levee toe.	
mkhashch_s_20130225_633.jpg

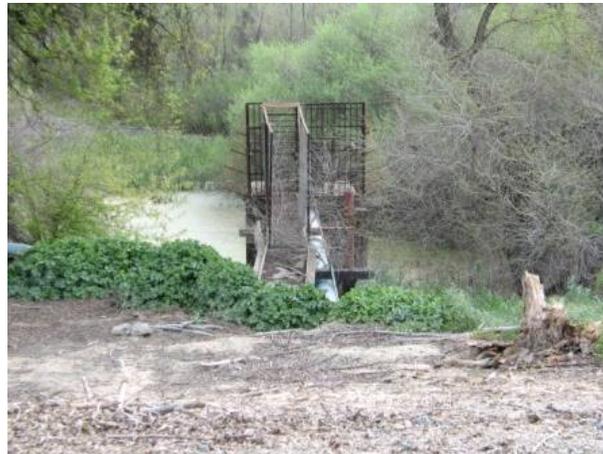
12	1.49	1.49		Encroachments	CRA/W	En	PI : Pipe Inspector Comments: Irrigation intake pump. Unable to locate closure valve/gate.	37.771636 ° -121.304773 °	37.771636 ° -121.304773 °	9 Y
DWR ID: DWR_RD2107_01_s_2012_9										
13	2.21	2.21		Encroachments	CRA/W	En	PI : Pipe Inspector Comments: Irrigation intake pipe through levee freeboard.	37.762868 ° -121.309708 °	37.762868 ° -121.309708 °	11 Y
DWR ID: DWR_RD2107_01_s_2012_11

Levee Mile Report Line	12
Start Levee Mile	1.49
End Levee Mile	1.49
Location	Crown
Category	
Item	Encroachments
Irrigation intake pipe through levee freeboard.	
mkhashch_s_20130225_632.jpg

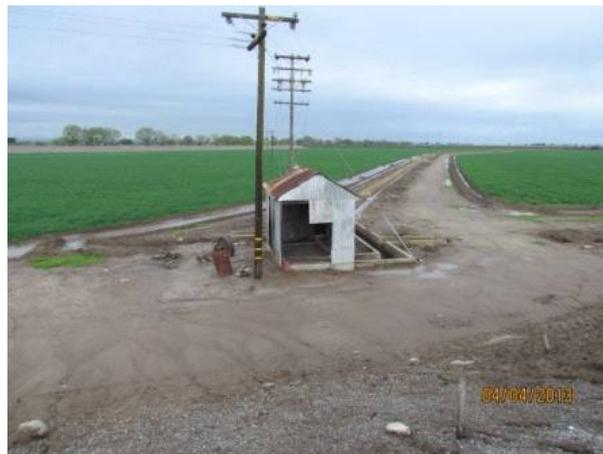
Levee Mile Report Line	13
Start Levee Mile	2.21
End Levee Mile	2.21
Location	Crown
Category	
Item	Encroachments
View of the pipe location; alignment through levee.	
mkhashch_s_20130410_702.JPG

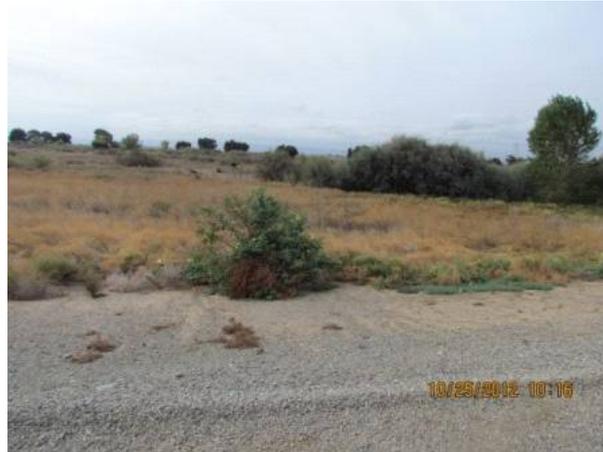
Levee Mile Report Line	1
Start Levee Mile	0.50
End Levee Mile	0.50
Location	Water Side
Category	
Item	Vegetation
Elderberry located on waterside slope.	
mkhashch_s_20130225_637.JPG

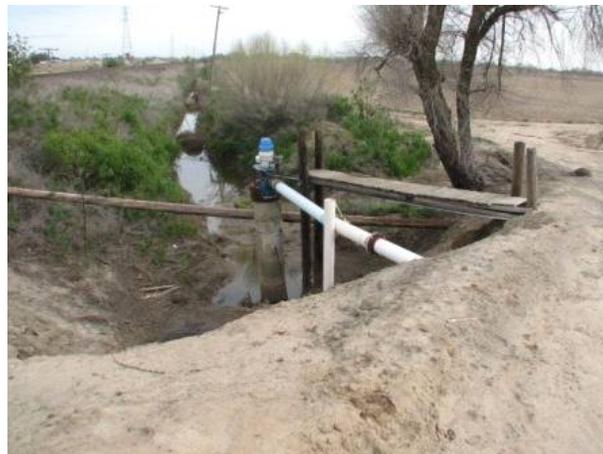
Levee Mile Report Line	2
Start Levee Mile	0.55
End Levee Mile	0.55
Location	Crown
Category	
Item	Encroachments
Drainage discharge pump. Steel pipe penetrates levee freeboard. No flapgate on waterside. No closure device.	
mkhashch_s_20130225_635.jpg

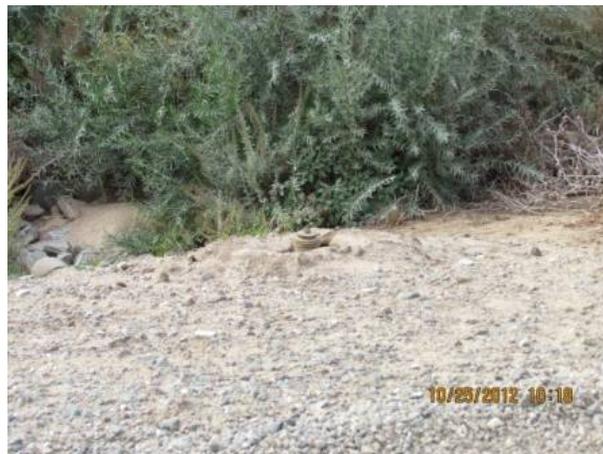
Levee Mile Report Line	2
Start Levee Mile	0.55
End Levee Mile	0.55
Location	Crown
Category	
Item	Encroachments
View of siphon breaker causing some erosion on slope.	
mkhashch_s_20130225_636.JPG

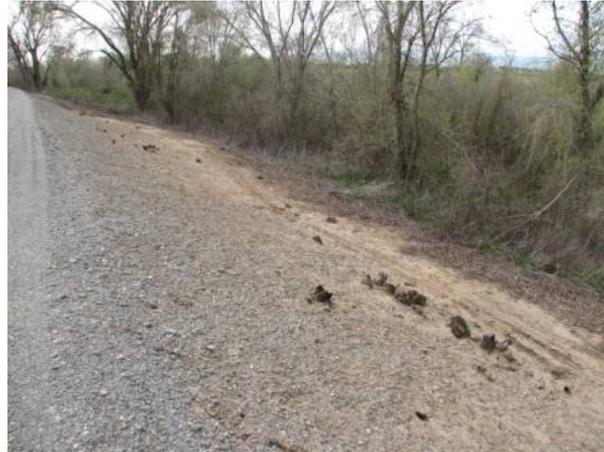
Levee Mile Report Line	3
Start Levee Mile	0.84
End Levee Mile	0.84
Location	Water Side
Category	
Item	Trim / Thin Trees
Tree stumps on levee slope.	
mkhashch_s_20130225_638.jpg

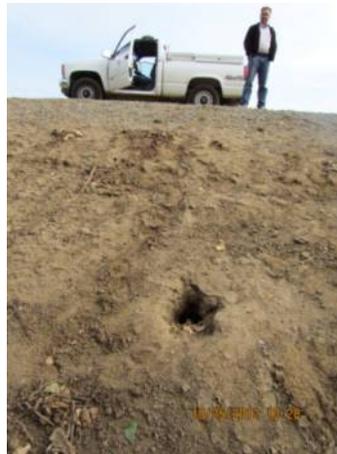
Levee Mile Report Line	4
Start Levee Mile	1.06
End Levee Mile	1.06
Location	Water Side
Category	
Item	Animal Control
View of large burrow on waterside slope.	
mkhashch_s_20130225_639.JPG

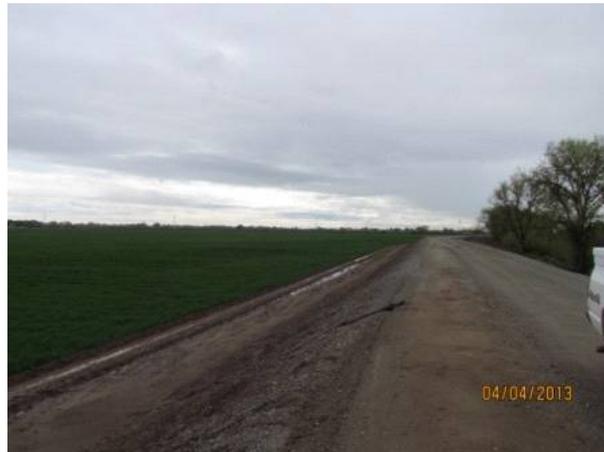
Levee Mile Report Line	5
Start Levee Mile	1.07
End Levee Mile	1.07
Location	Land Side
Category	
Item	Vegetation
View of acceptable vegetation management.	
mkhashch_s_20130410_703.JPG

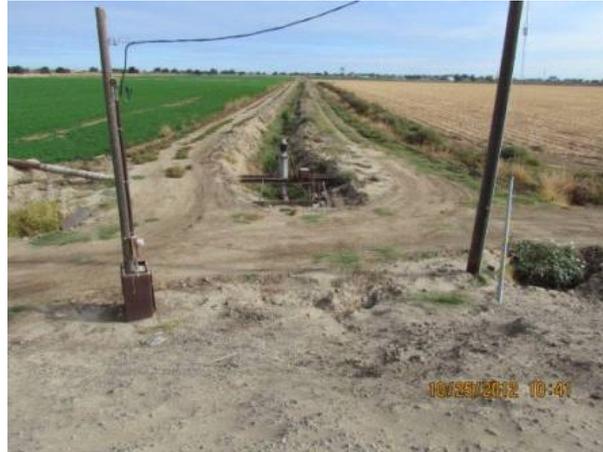
Levee Mile Report Line	7
Start Levee Mile	1.54
End Levee Mile	1.54
Location	Land Side
Category	
Item	Encroachments
View of irrigation pipe and canal.	
mkhashch_s_20130225_641.JPG
