**Flood Control Project Maintenance  
Levee Inspections**

**Fall 2009 Levee Maintenance Deficiency Summary Report**

**Sacramento River Basin**

**Sacramento Maintenance Yard Cache Creek**

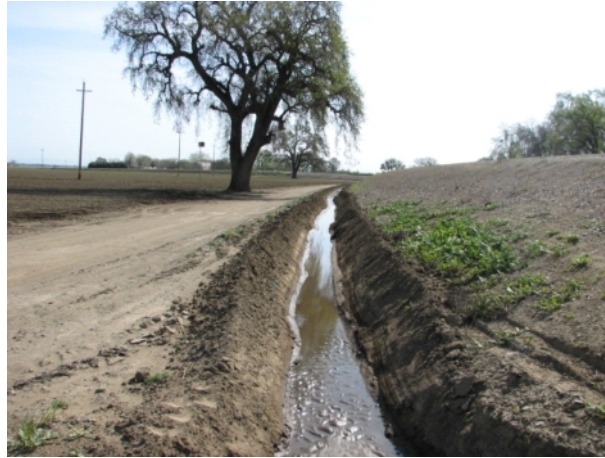
Levee Mile Report Line	30
Start Levee Mile	6.94
End Levee Mile	7.23
Location	Land Side
Category	Earthen Levee
Item	Encroachments

new ditch this spring

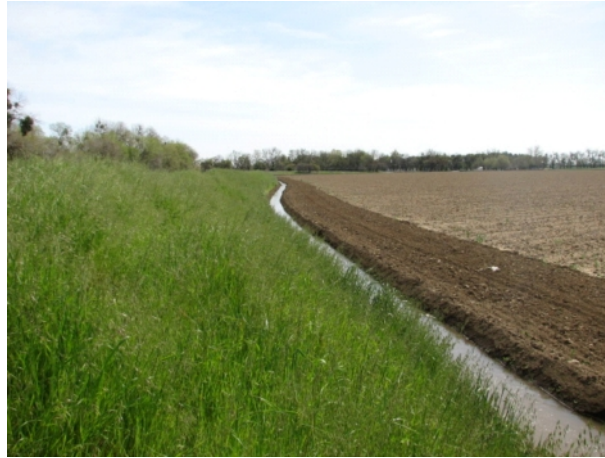
Levee Mile Report Line	8
Start Levee Mile	2.60
End Levee Mile	3.00
Location	Land Side
Category	Earthen Levee
Item	Encroachments

ditch along toe new
