**Flood Control Project Maintenance
Levee Inspections**

Fall 2010 Levee Maintenance Deficiency Summary Report

Sacramento Maintenance Yard Cache Creek

Levee Inspection Report By Mile - Fall 2010

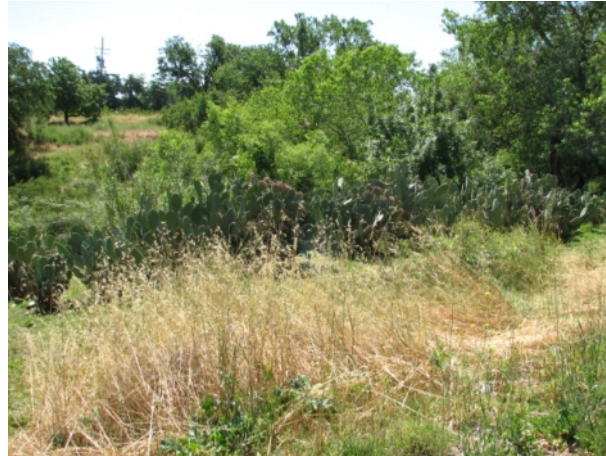
Levee Mile Report Line	4
Start Levee Mile	1.96
End Levee Mile	1.99
Location	Water Side
Category	Earthen Levee
Item	Encroachments
cactus garden	
rduffey_f_20101007_202.jpg

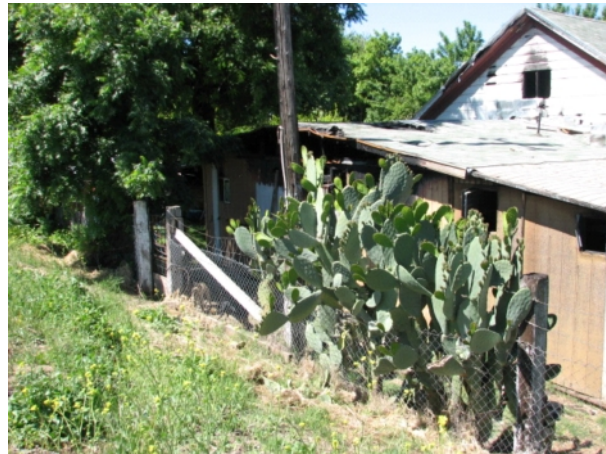
Levee Mile Report Line	6
Start Levee Mile	1.98
End Levee Mile	1.98
Location	Land Side
Category	Earthen Levee
Item	Encroachments
building and catus landside, town of Yolo	
rduffey_f_20101007_203.jpg

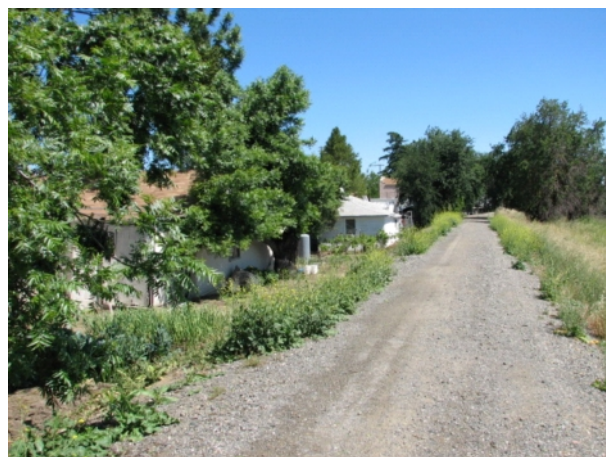
Levee Mile Report Line	7
Start Levee Mile	2.01
End Levee Mile	2.01
Location	Land Side
Category	Earthen Levee
Item	Encroachments
general photo of homes in the town of Yolo	
rduffey_f_20101007_204.jpg

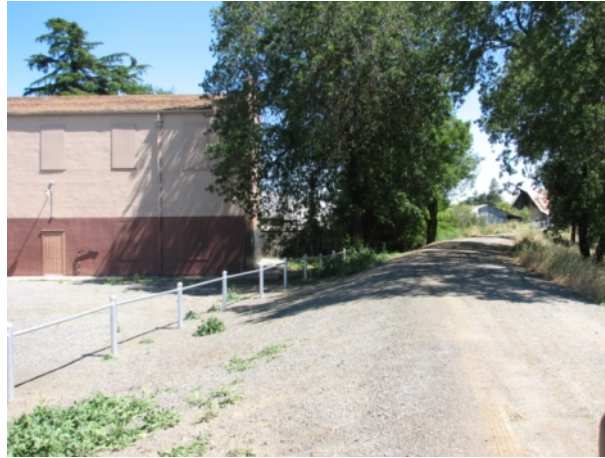
Levee Mile Report Line	10
Start Levee Mile	2.05
End Levee Mile	2.05
Location	Land Side
Category	Earthen Levee
Item	Encroachments

building close to toe

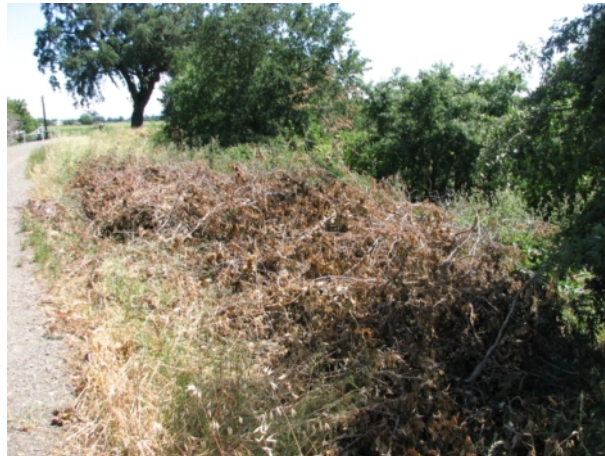
Levee Mile Report Line	14
Start Levee Mile	2.12
End Levee Mile	2.15
Location	Water Side
Category	Earthen Levee
Item	Encroachments

pile of prunings on waterside shoulder

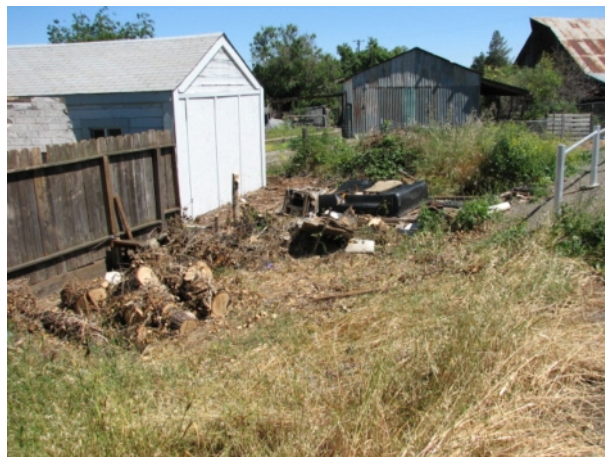
Levee Mile Report Line	15
Start Levee Mile	2.12
End Levee Mile	2.12
Location	Land Side
Category	Earthen Levee
Item	Encroachments

tree cut down and debris behind home

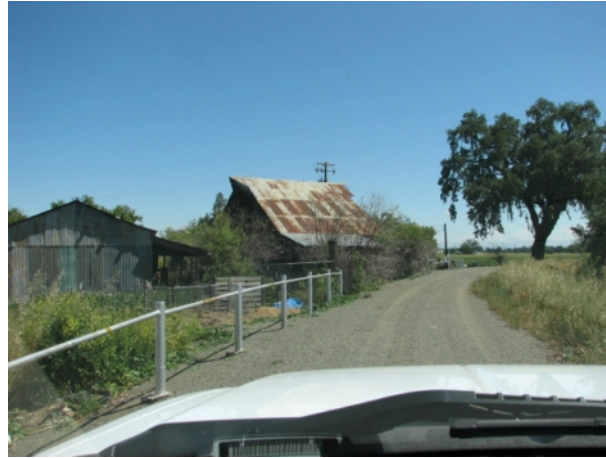
Levee Mile Report Line	16
Start Levee Mile	2.15
End Levee Mile	2.15
Location	Land Side
Category	Earthen Levee
Item	Encroachments

horse barn and corral

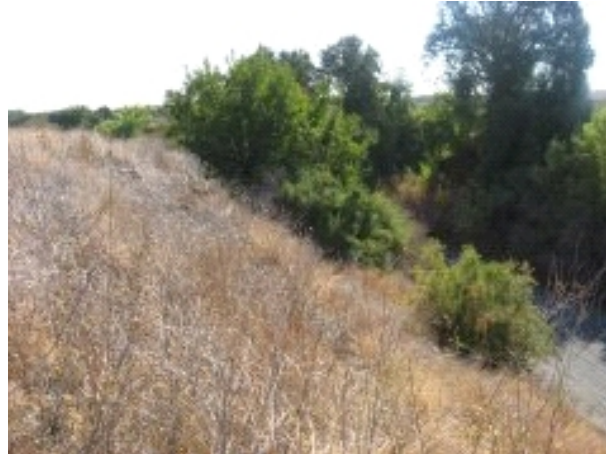
Levee Mile Report Line	17
Start Levee Mile	2.54
End Levee Mile	2.58
Location	Water Side
Category	Supplemental
Item	USACE Erosion Survey

2009: 15 ft berm, 1.5:1 slope, tree hazards, holes, and slumping, sands and silts, 4 ft/s [2009 SiteID:CHC_2-4_L]

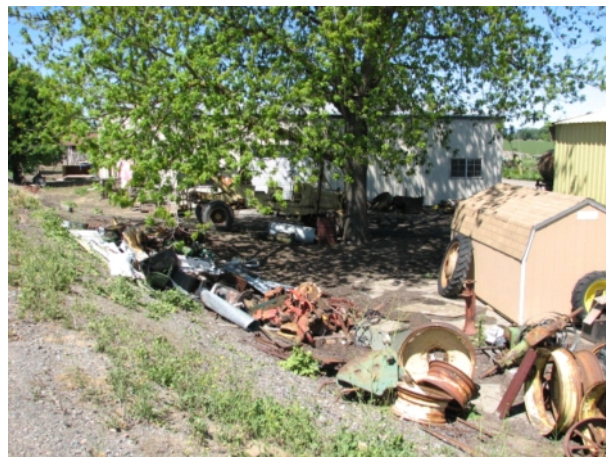
Levee Mile Report Line	18
Start Levee Mile	2.60
End Levee Mile	2.60
Location	Land Side
Category	Earthen Levee
Item	Encroachments

building and parts of tractors

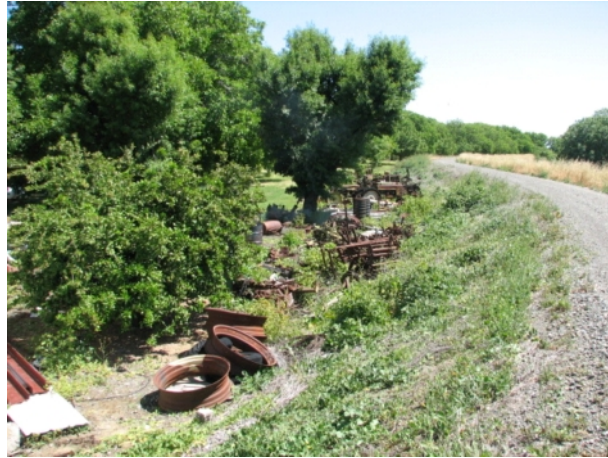
Levee Mile Report Line	20
Start Levee Mile	2.65
End Levee Mile	2.70
Location	Land Side
Category	Earthen Levee
Item	Encroachments

equipment and parts

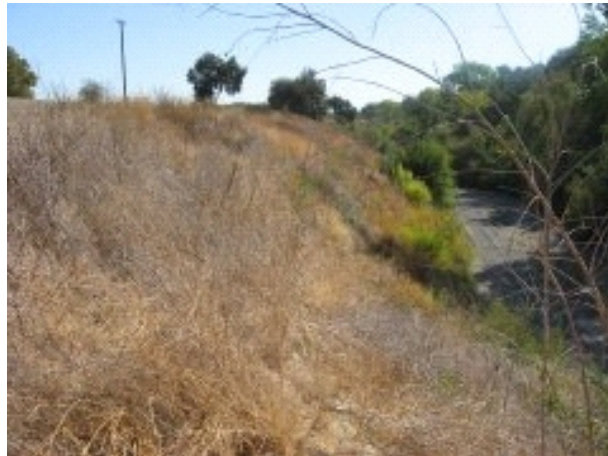
Levee Mile Report Line	22
Start Levee Mile	2.79
End Levee Mile	2.83
Location	Water Side
Category	Supplemental
Item	USACE Erosion Survey

2009: 15 ft berm, 1:1 slope, slumping, sands and silts, 5.89 ft/s [2009 SiteID:CHC_2-8_L]

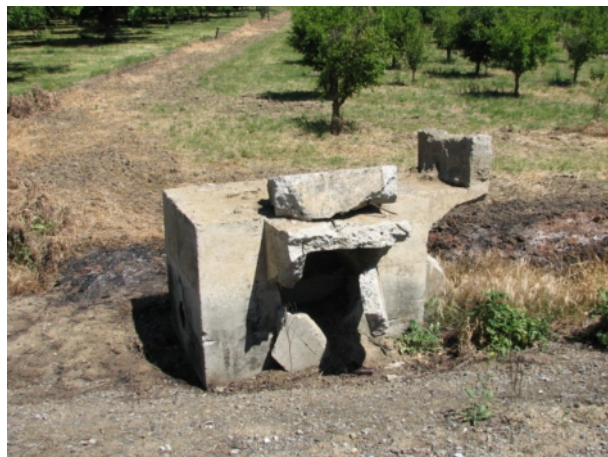
Levee Mile Report Line	23
Start Levee Mile	2.86
End Levee Mile	2.86
Location	Land Side
Category	Earthen Levee
Item	Encroachments

concrete debris

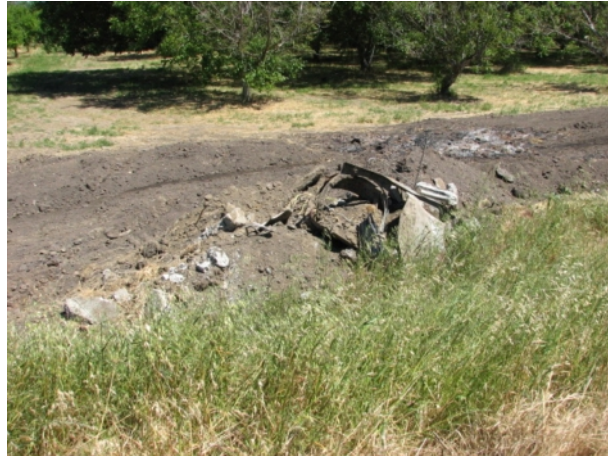
Levee Mile Report Line	24
Start Levee Mile	3.06
End Levee Mile	3.06
Location	Land Side
Category	Earthen Levee
Item	Encroachments
old burn pile left over debris	
rduffey_f_20101007_211.jpg

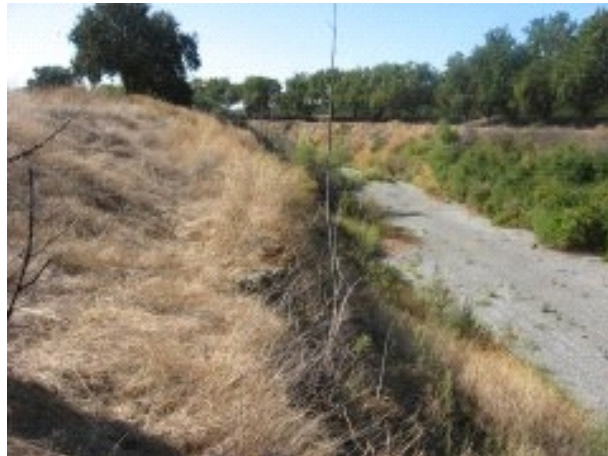
Levee Mile Report Line	25
Start Levee Mile	3.46
End Levee Mile	3.52
Location	Water Side
Category	Supplemental
Item	USACE Erosion Survey
2009: 15 ft berm, 1:1 slope, holes and slumping, sands and silts, 6.5 ft/s [2009 SiteID:CHC_3-4_L]	
rduffey_f_20101007_216.JPG

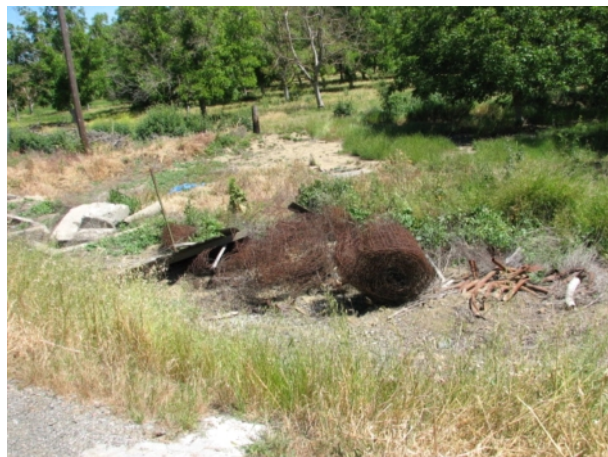
Levee Mile Report Line	26
Start Levee Mile	3.64
End Levee Mile	3.64
Location	Land Side
Category	Earthen Levee
Item	Encroachments
Trash dumped	
rduffey_f_20101007_212.jpg

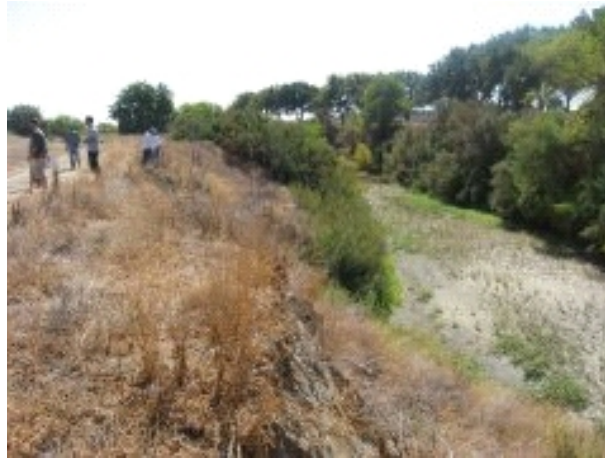
Levee Mile Report Line	27
Start Levee Mile	3.86
End Levee Mile	3.94
Location	Water Side
Category	Supplemental
Item	USACE Erosion Survey
2009: 10 ft berm, 1:1 slope, tree hazards and holes, sands and silts, 6 ft/s [2009 SiteID:CHC_3-9_L]	
rduffey_f_20101007_217.JPG

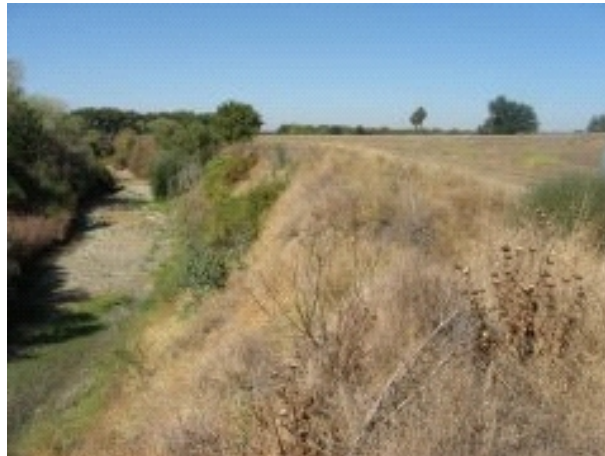
Levee Mile Report Line	28
Start Levee Mile	4.13
End Levee Mile	4.27
Location	Water Side
Category	Supplemental
Item	USACE Erosion Survey
2009: 3 ft berm, 1.5:1 slope, tree hazards and holes, sands and silts, 4 ft/s [2009 SiteID:CHC_4-2_L]	
rduffey_f_20101007_220.JPG

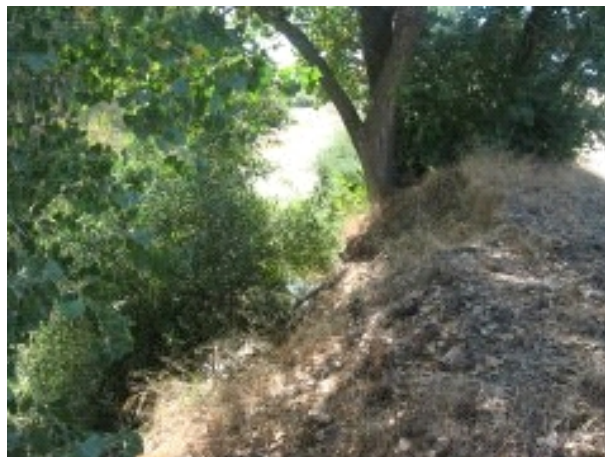
Levee Mile Report Line	31
Start Levee Mile	5.33
End Levee Mile	5.37
Location	Water Side
Category	Supplemental
Item	USACE Erosion Survey
2009: 15 ft berm, vertical slope, tree hazards, holes, and slumping, sands and silts, 9.39 ft/s [2009 SiteID:CHC_5-4_L]	
rduffey_f_20101007_221.JPG

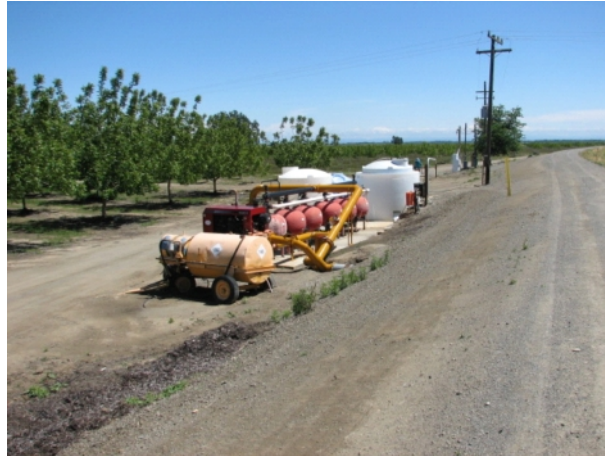
Levee Mile Report Line	33
Start Levee Mile	6.31
End Levee Mile	6.31
Location	Land Side
Category	Earthen Levee
Item	Encroachments
pipe trough levee filter and fertilizer tanks	
rduffey_f_20101007_213.jpg

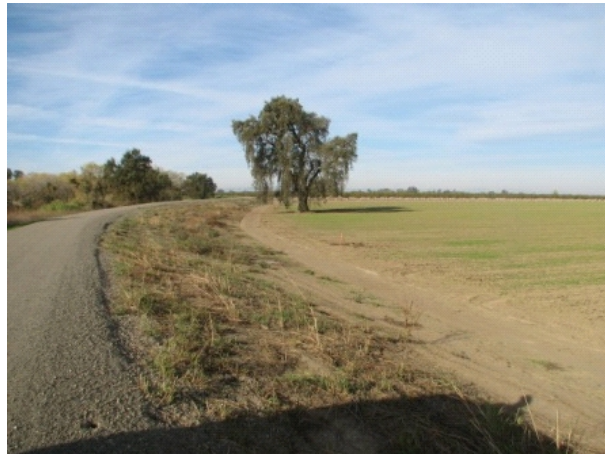
Levee Mile Report Line	35
Start Levee Mile	6.36
End Levee Mile	6.70
Location	Land Side
Category	Earthen Levee
Item	Encroachments
View of the fill in v - ditch along the toe.	
dpesaven_f_20101202_329.jpg

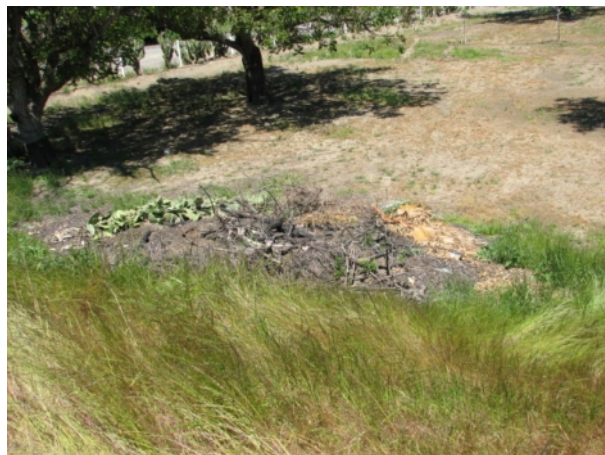
Levee Mile Report Line	37
Start Levee Mile	7.29
End Levee Mile	7.29
Location	Land Side
Category	Earthen Levee
Item	Encroachments
trash and burn pile	
rduffey_f_20101007_224.jpg

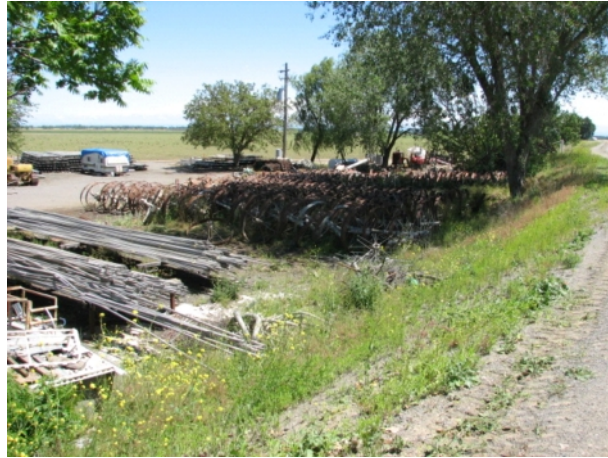
Levee Mile Report Line	38
Start Levee Mile	7.33
End Levee Mile	7.38
Location	Land Side
Category	Earthen Levee
Item	Encroachments
irrigation equipment	
rduffey_f_20101007_219.jpg

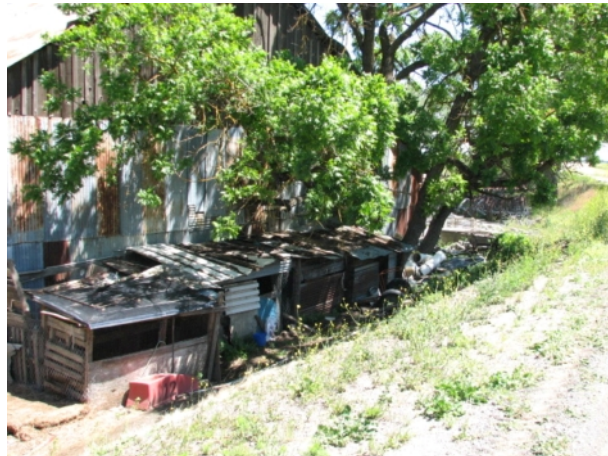
Levee Mile Report Line	39
Start Levee Mile	7.33
End Levee Mile	7.33
Location	Land Side
Category	Earthen Levee
Item	Encroachments
barn and livestock pens	
rduffey_f_20101007_218.jpg

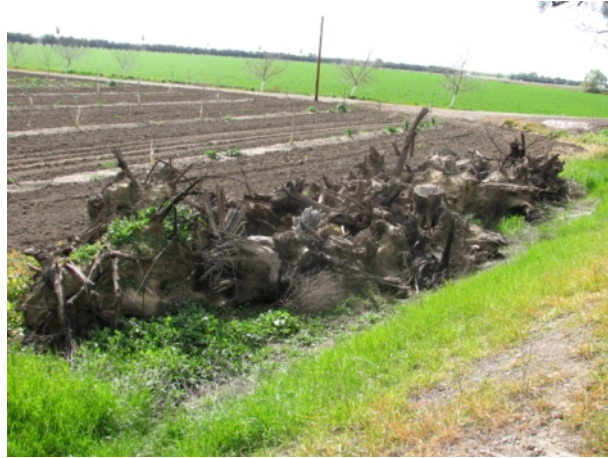
Levee Mile Report Line	1
Start Levee Mile	0.18
End Levee Mile	0.18
Location	Land Side
Category	Earthen Levee
Item	Encroachments

stumps against levee toe

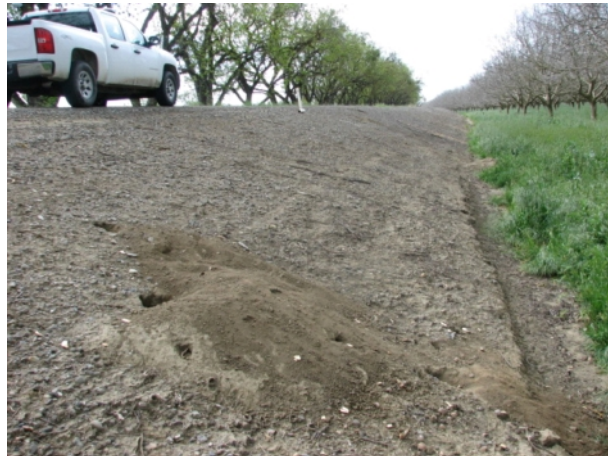
Levee Mile Report Line	4
Start Levee Mile	1.45
End Levee Mile	1.45
Location	Land Side
Category	Earthen Levee
Item	Animal Control

rodent activity

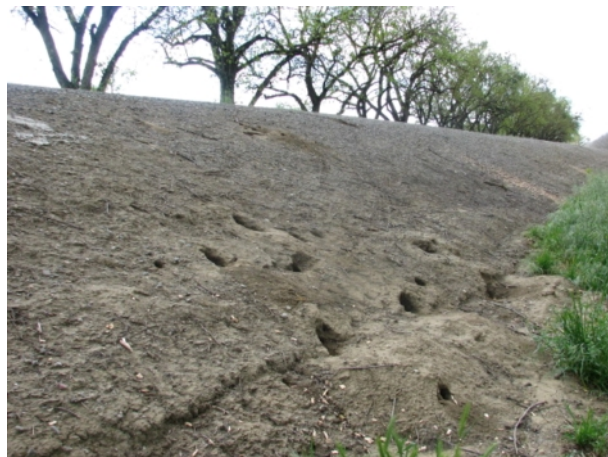
Levee Mile Report Line	4
Start Levee Mile	1.45
End Levee Mile	1.45
Location	Land Side
Category	Earthen Levee
Item	Animal Control

more holes bait station is in place

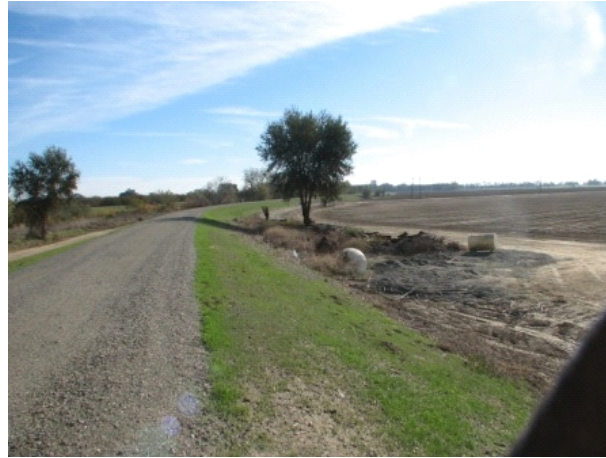
Levee Mile Report Line	8
Start Levee Mile	2.41
End Levee Mile	2.41
Location	Land Side
Category	Earthen Levee
Item	Encroachments

View of removed equipment that was next to toe.

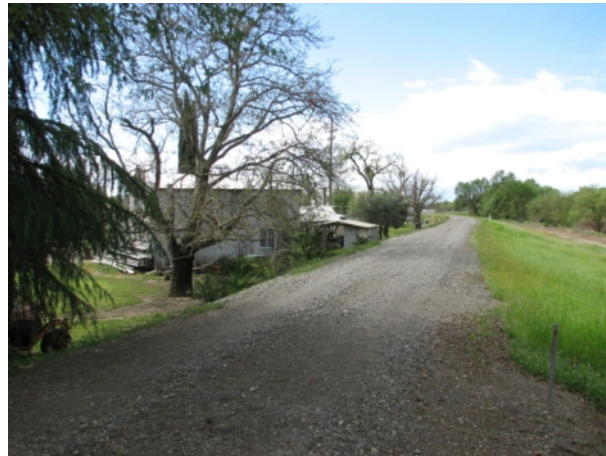
Levee Mile Report Line	12
Start Levee Mile	4.00
End Levee Mile	4.04
Location	Land Side
Category	Earthen Levee
Item	Encroachments

out building at toe

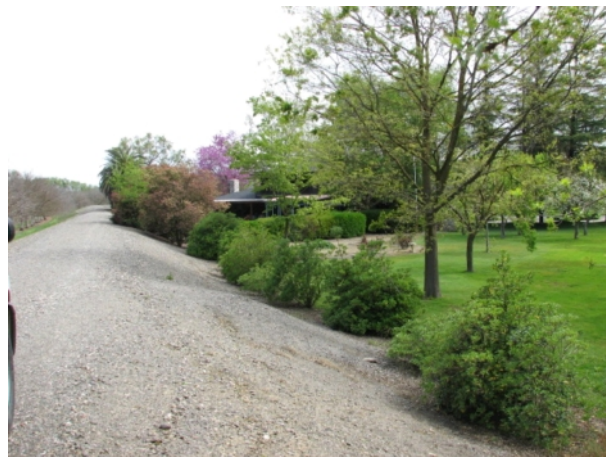
Levee Mile Report Line	13
Start Levee Mile	4.04
End Levee Mile	4.13
Location	Land Side
Category	Earthen Levee
Item	Encroachments

landscape

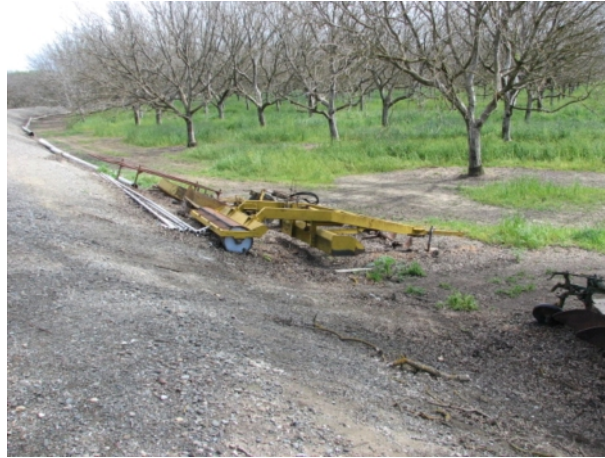
Levee Mile Report Line	14
Start Levee Mile	4.15
End Levee Mile	4.15
Location	Land Side
Category	Earthen Levee
Item	Encroachments

pipe run on toe along oorchard

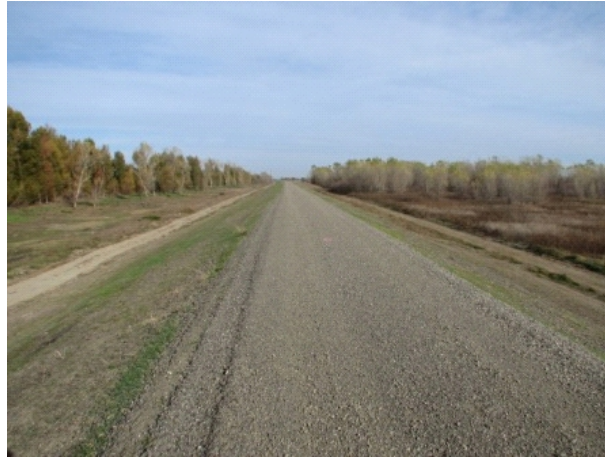
Levee Mile Report Line	1
Start Levee Mile	1.51
End Levee Mile	1.51
Location	Land Side
Category	Earthen Levee
Item	Crown Surface / Depressions / Rutting
View of the crown roadway & both slope clear of vegetation.	
rduffey_f_20101123_329.jpg
