**Flood Control Project Maintenance
Levee Inspections**

Fall 2011 Levee Maintenance Deficiency Summary Report

Sacramento River Basin

Sacramento Maintenance Yard Cache Creek

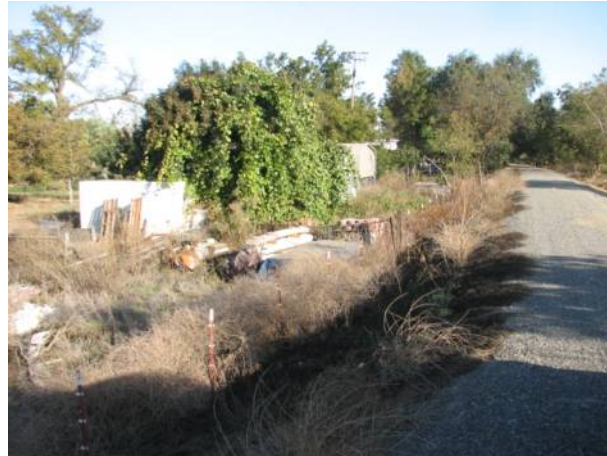
Levee Mile Report Line	1
Start Levee Mile	1.83
End Levee Mile	1.83
Location	Land Side
Category	Earthen Levee
Item	Encroachments
The owner has a lot of building material stored within the easement. Fall 2011	
johngw_f_20111102_450.jpg

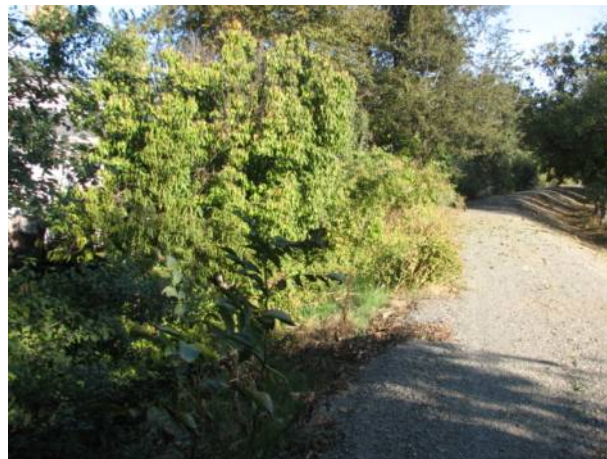
Levee Mile Report Line	2
Start Levee Mile	1.86
End Levee Mile	1.96
Location	Land Side
Category	Earthen Levee
Item	Encroachments
The landscape vegetation needs to be trimmed for visibility of the levee slope. Fall 2011	
johngw_f_20111102_451.jpg

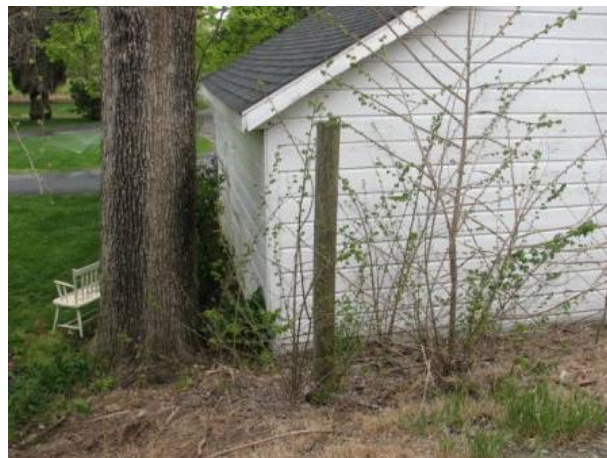
Levee Mile Report Line	3
Start Levee Mile	1.91
End Levee Mile	1.91
Location	Land Side
Category	Earthen Levee
Item	Encroachments
The building backs up to the landside levee toe of the levee.	
johngw_f_20110923_729.jpg

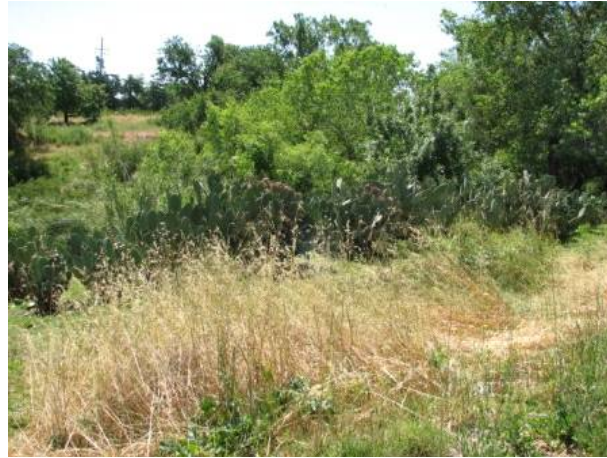
Levee Mile Report Line	4
Start Levee Mile	1.96
End Levee Mile	1.99
Location	Water Side
Category	Earthen Levee
Item	Encroachments
A cactus garden is planted on the waterside of the levee. There is some planted on the landside also.	
johngw_f_20110923_730.jpg

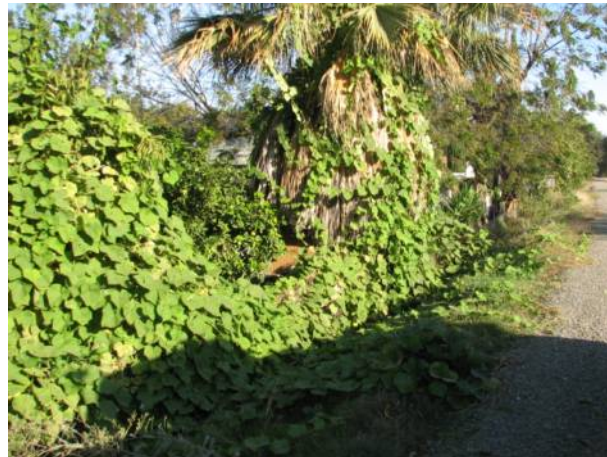
Levee Mile Report Line	5
Start Levee Mile	1.96
End Levee Mile	1.99
Location	Land Side
Category	Earthen Levee
Item	Encroachments
Wild grape and other plants are obstructing the view for inspection. Fall 2011	
johngw_f_20111102_452.jpg

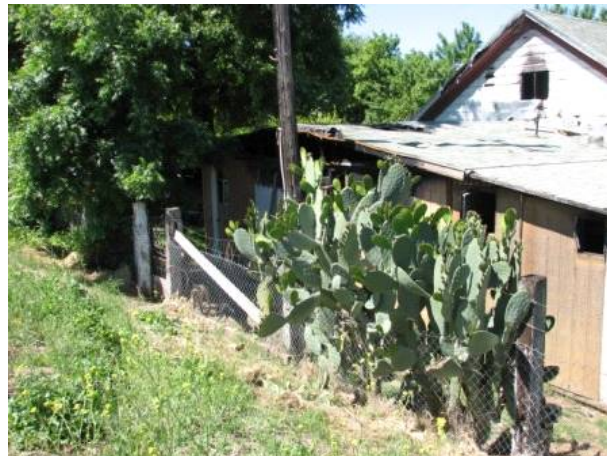
Levee Mile Report Line	6
Start Levee Mile	1.98
End Levee Mile	1.98
Location	Land Side
Category	Earthen Levee
Item	Encroachments
Building and catus landside, town of Yolo	
johngw_f_20110923_731.jpg

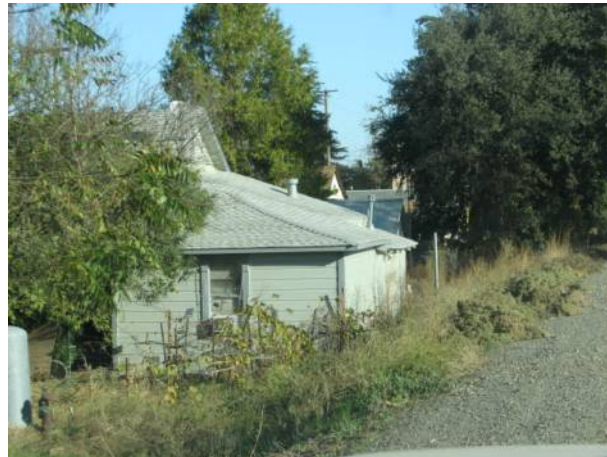
Levee Mile Report Line	8
Start Levee Mile	2.03
End Levee Mile	2.03
Location	Land Side
Category	Earthen Levee
Item	Encroachments

The house is too close to the levee toe. Fall 2011

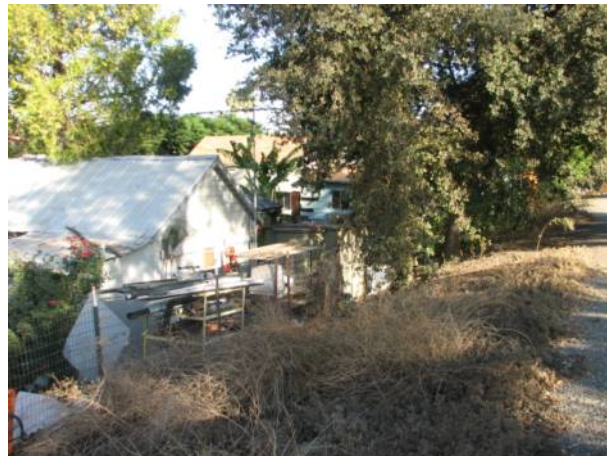
Levee Mile Report Line	9
Start Levee Mile	2.04
End Levee Mile	2.04
Location	Land Side
Category	Earthen Levee
Item	Encroachments

The building and backyard is at the toe of the levee. Fall 2011

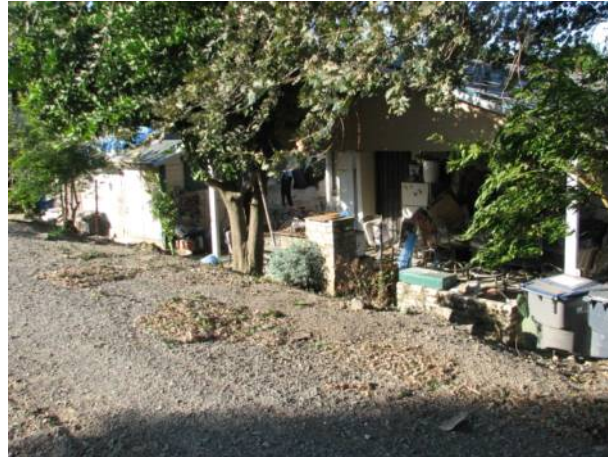
Levee Mile Report Line	10
Start Levee Mile	2.06
End Levee Mile	2.06
Location	Land Side
Category	Earthen Levee
Item	Encroachments

The patio is at the toe of the levee Fall 2011

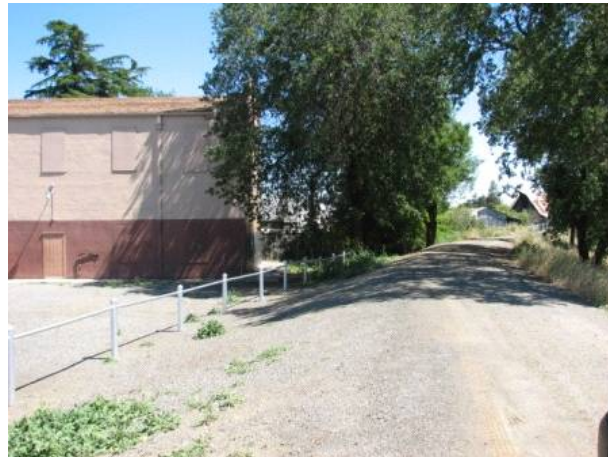
Levee Mile Report Line	11
Start Levee Mile	2.09
End Levee Mile	2.09
Location	Land Side
Category	Earthen Levee
Item	Encroachments

The building is close to the toe of the levee.

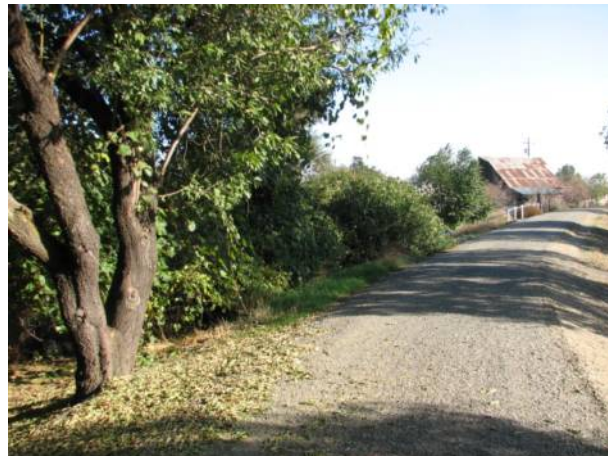
Levee Mile Report Line	12
Start Levee Mile	2.10
End Levee Mile	2.11
Location	Land Side
Category	Earthen Levee
Item	Encroachments

The shrubs block visibility of the levee slope. Fall 2011

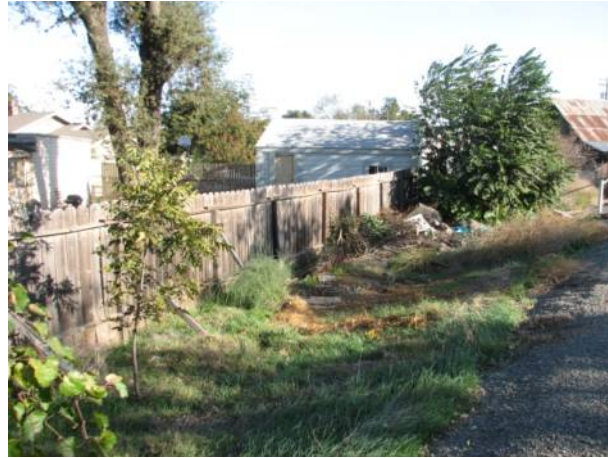
Levee Mile Report Line	13
Start Levee Mile	2.11
End Levee Mile	2.13
Location	Land Side
Category	Earthen Levee
Item	Encroachments
The fence blocks the visibility of the levee. Fall 2011	
johngw_f_20111102_458.jpg

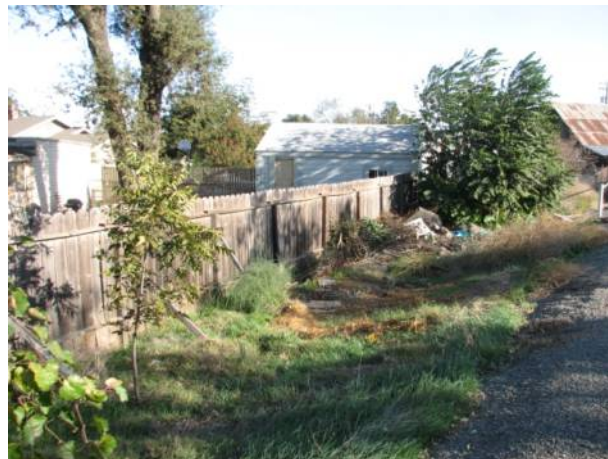
Levee Mile Report Line	14
Start Levee Mile	2.12
End Levee Mile	2.12
Location	Land Side
Category	Earthen Levee
Item	Encroachments
This is the same photo but shows the debris pile on the levee. Fall 2011	
johngw_f_20111102_459.jpg

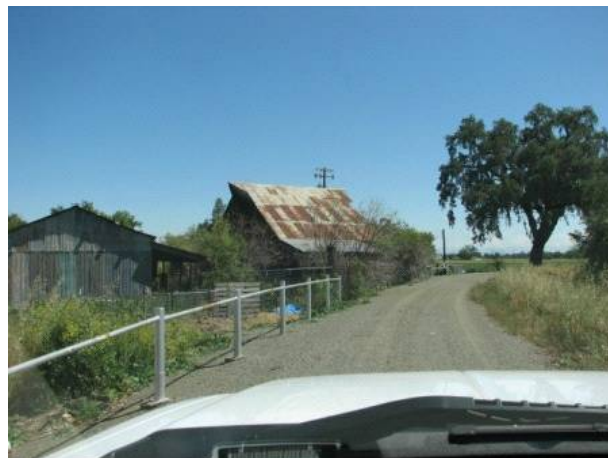
Levee Mile Report Line	15
Start Levee Mile	2.15
End Levee Mile	2.15
Location	Land Side
Category	Earthen Levee
Item	Encroachments
Horse barn and corral	
johngw_f_20110923_734.jpg

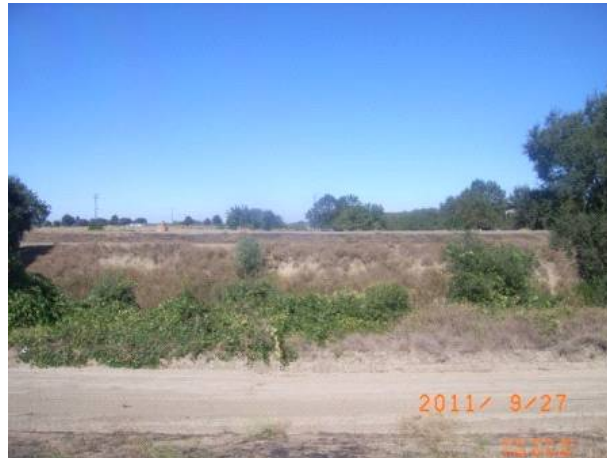
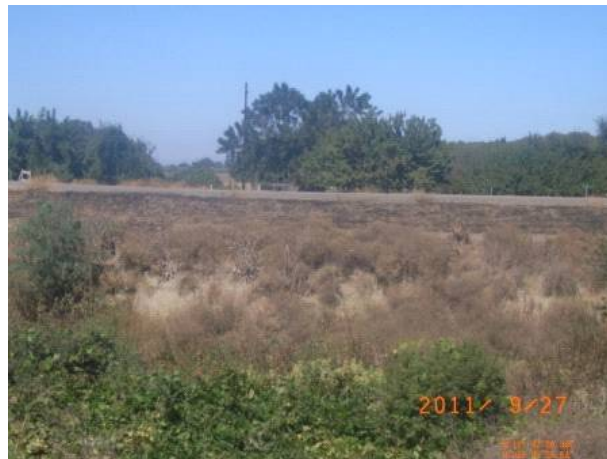
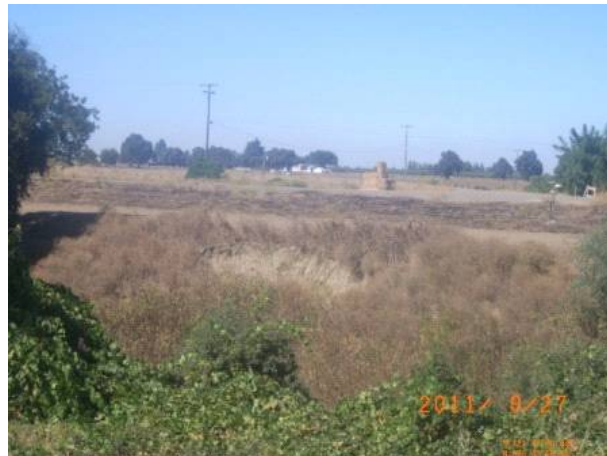
Levee Mile Report Line	16
Start Levee Mile	2.42
End Levee Mile	2.51
Location	Water Side
Category	Supplemental
Item	USACE Erosion Survey

16	2.42	2.51	Supplemental Survey	USACE Erosion Survey	WS	U	Inspector Comments: Site identified as CRITICAL in 2002. 2006 - Currently constructing a setback levee. New failures present and extensive. Downstream end of the setback levee did not extend far enough. Upstream end was repaired. 2007 - DWR repaired with a setback levee, but the levee did not go far enough downstream. 2011: No observed change. [2011 Site ID: CHC_2-4_L]	38.732836 ° -121.797893 °	38.732685 ° -121.797154 °	18 Y
17	2.60	2.60	Earthen Levee	Encroachments	LS	PO	Buildings	38.732850 ° -121.796798 °	38.732850 ° -121.796798 °	17 Y

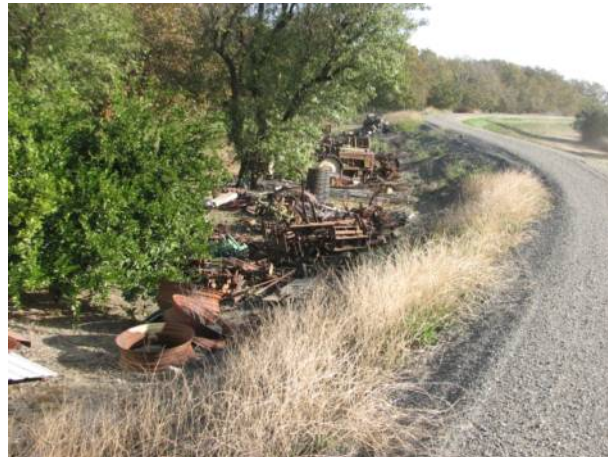
Levee Mile Report Line	18
Start Levee Mile	2.65
End Levee Mile	2.70
Location	Land Side
Category	Earthen Levee
Item	Encroachments

The equipment is stored at the toe of the levee.
Fall 2011

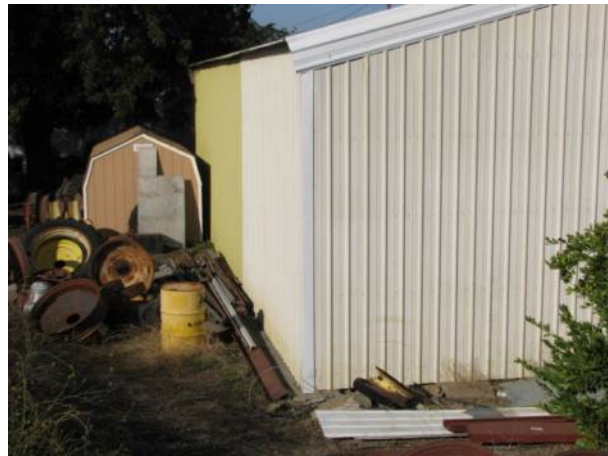
Levee Mile Report Line	19
Start Levee Mile	2.66
End Levee Mile	2.66
Location	Land Side
Category	Earthen Levee
Item	Encroachments

The corner of the shop is within the easement of
the levee. Fall 2011

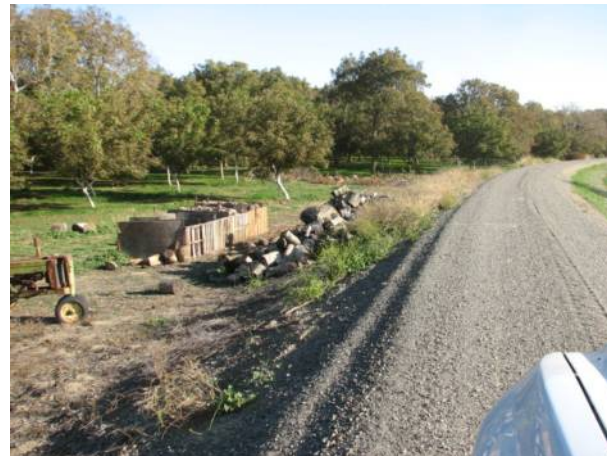
Levee Mile Report Line	22
Start Levee Mile	2.70
End Levee Mile	2.70
Location	Land Side
Category	Earthen Levee
Item	Encroachments

Firewood is stockpiled on the levee slope. Fall 2011

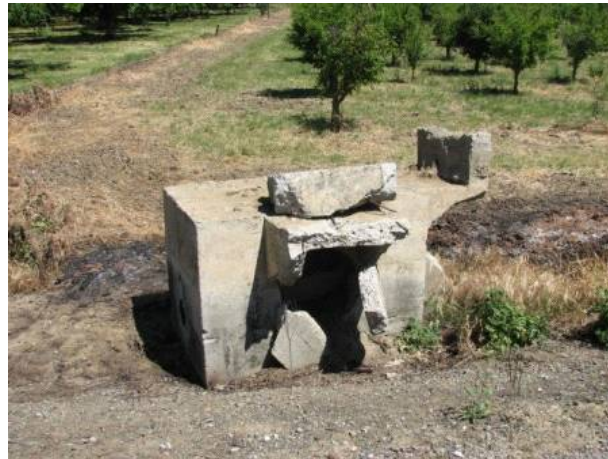
Levee Mile Report Line	24
Start Levee Mile	2.86
End Levee Mile	2.86
Location	Land Side
Category	Earthen Levee
Item	Encroachments

Concrete debris

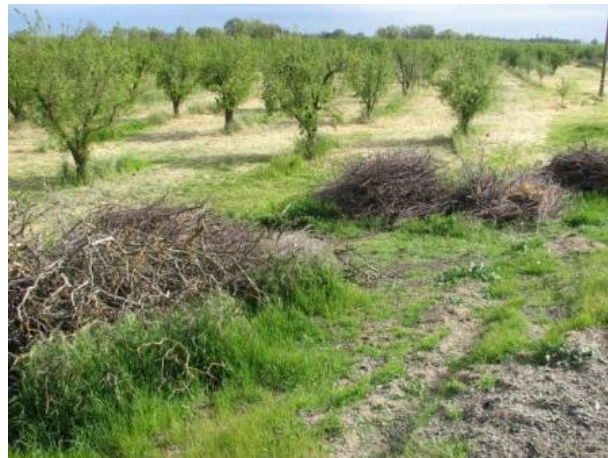
Levee Mile Report Line	26
Start Levee Mile	3.22
End Levee Mile	3.22
Location	Land Side
Category	Earthen Levee
Item	Encroachments

This seasons prunings have been piled up against the toe of the landside levee.

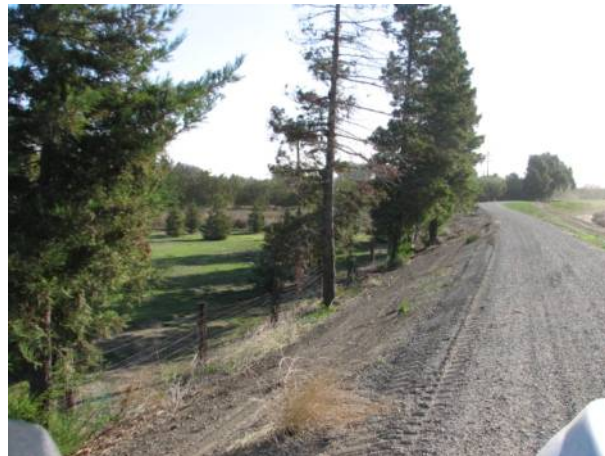
Levee Mile Report Line	30
Start Levee Mile	4.27
End Levee Mile	4.42
Location	Land Side
Category	Earthen Levee
Item	Encroachments

Landscape trees are planted along the levee to and on the slope. Some of the trees are trimmed up for visibility. Fall 2011

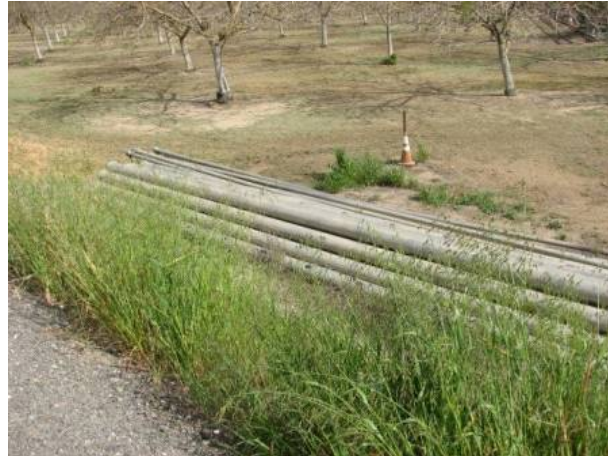
Levee Mile Report Line	31
Start Levee Mile	4.76
End Levee Mile	4.76
Location	Land Side
Category	Earthen Levee
Item	Encroachments
Aluminum irrigation pipe is placed along the landside levee toe.	
johngw_f_20110923_739.jpg

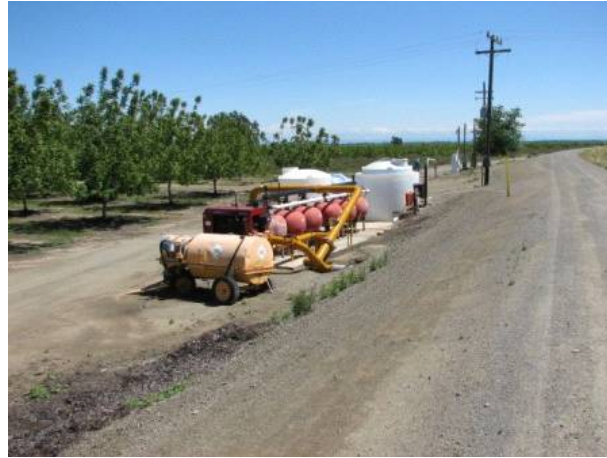
Levee Mile Report Line	34
Start Levee Mile	6.31
End Levee Mile	6.31
Location	Land Side
Category	Earthen Levee
Item	Encroachments
Pipe through levee filter and fertilizer tanks	
johngw_f_20110923_742.jpg

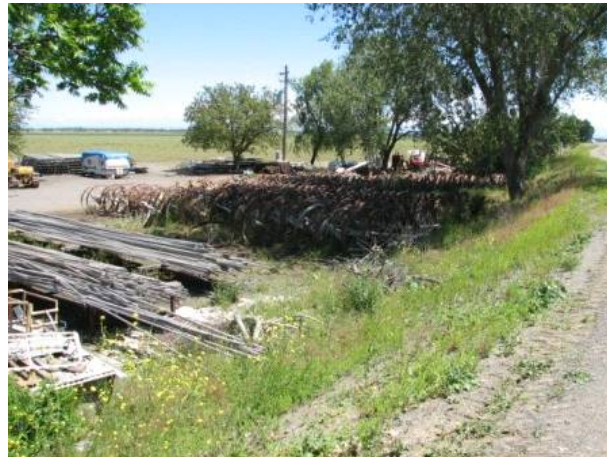
Levee Mile Report Line	37
Start Levee Mile	7.33
End Levee Mile	7.38
Location	Land Side
Category	Earthen Levee
Item	Encroachments
Irrigation equipment	
johngw_f_20110923_748.jpg

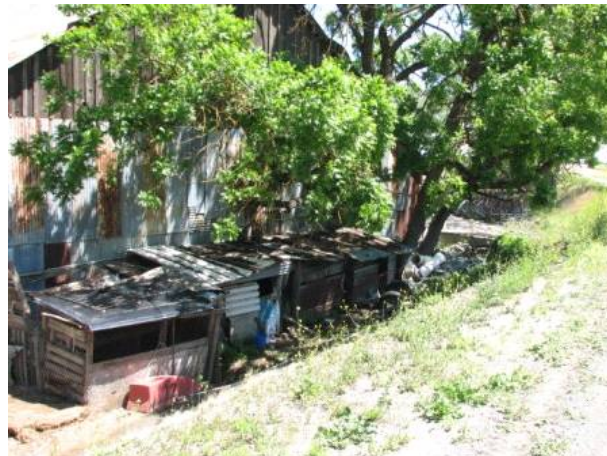
Levee Mile Report Line	38
Start Levee Mile	7.33
End Levee Mile	7.33
Location	Land Side
Category	Earthen Levee
Item	Encroachments
Barn and livestock pens	
johngw_f_20110923_747.jpg

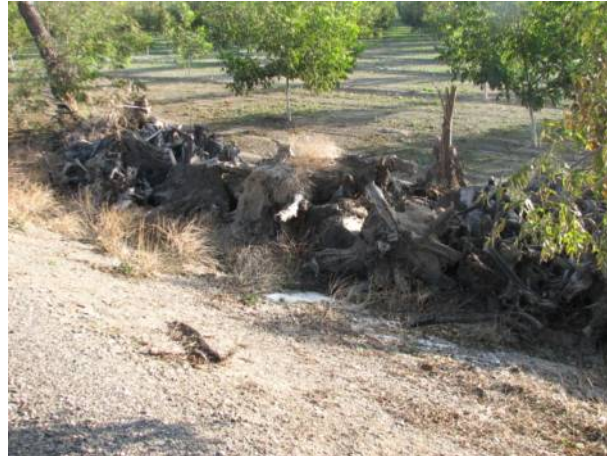
The stumps have not been removed or burned along the toe of the levee. Fall 2011

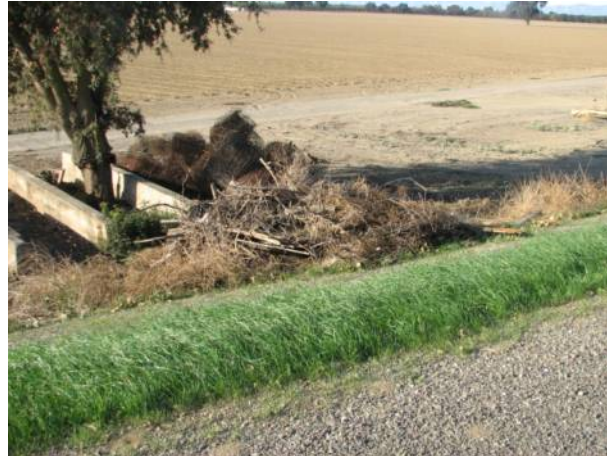
Levee Mile Report Line	7
Start Levee Mile	2.42
End Levee Mile	2.42
Location	Land Side
Category	Earthen Levee
Item	Encroachments
There is prunings piled at the toe of the levee. Fall 2011	
johngw_f_20111107_471.jpg

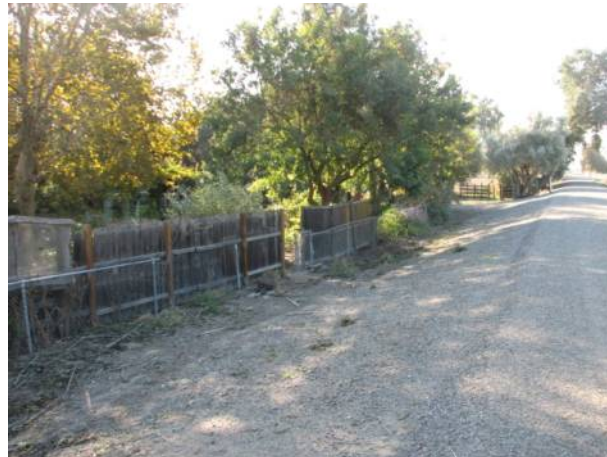
Levee Mile Report Line	8
Start Levee Mile	3.48
End Levee Mile	3.57
Location	Land Side
Category	Earthen Levee
Item	Encroachments
The landscaping and fence are obstructive to viewing the levee toe. Fall 2011	
johngw_f_20111107_472.jpg

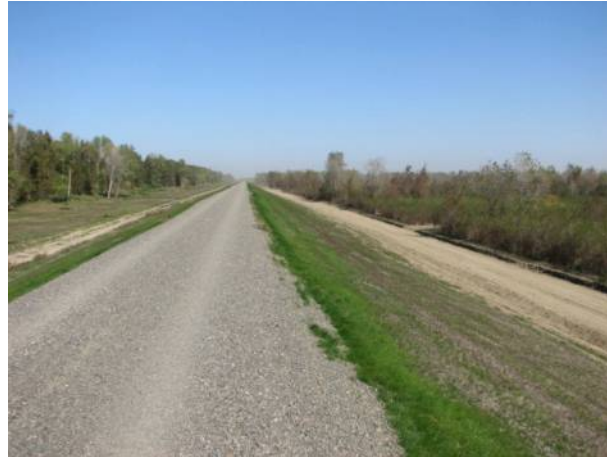
Levee Mile Report Line	1
Start Levee Mile	
End Levee Mile	
Location	Land Side
Category	Earthen Levee
Item	Vegetation
The levee slope is clean of all brush and has at least 50% grasses. Fall 2011	
johngw_f_20111102_449.jpg

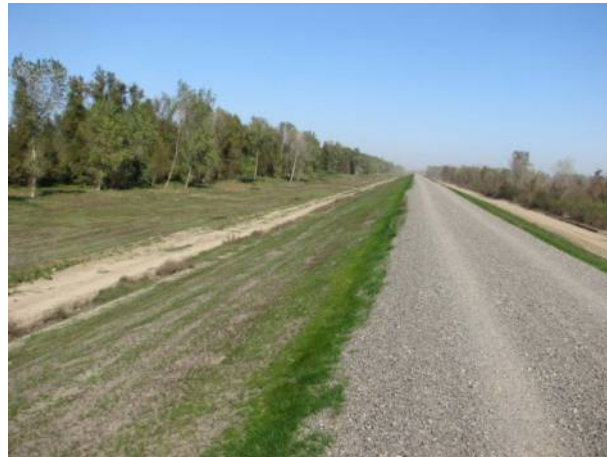
Levee Mile Report Line	2
Start Levee Mile	
End Levee Mile	
Location	Water Side
Category	Earthen Levee
Item	Vegetation
The levee slope is clean of all brush and has at least 50% grasses. Fall 2011	
johngw_f_20111102_448.jpg
