**Flood Control Project Maintenance
Levee Inspections**

Fall 2012 Levee Maintenance Deficiency Summary Report

Sacramento River Basin

Sacramento Maintenance Yard Cache Creek

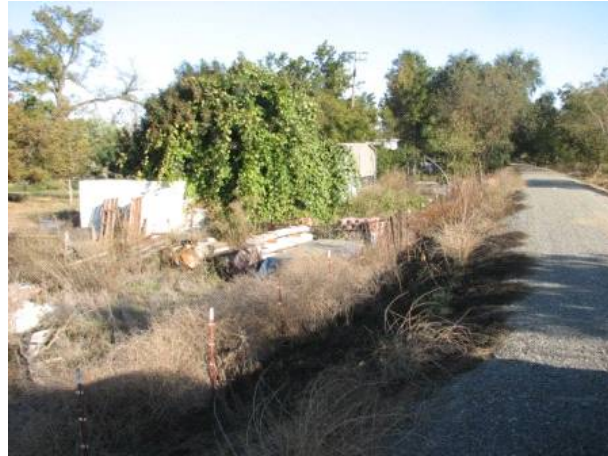
| The owner has a lot of building material stored within the easement. Fall 2011 | |

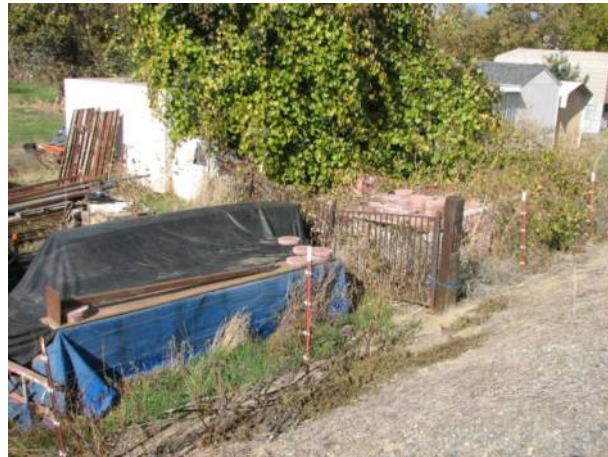
| Building materials stacked along landside toe. Fall 2012 | |

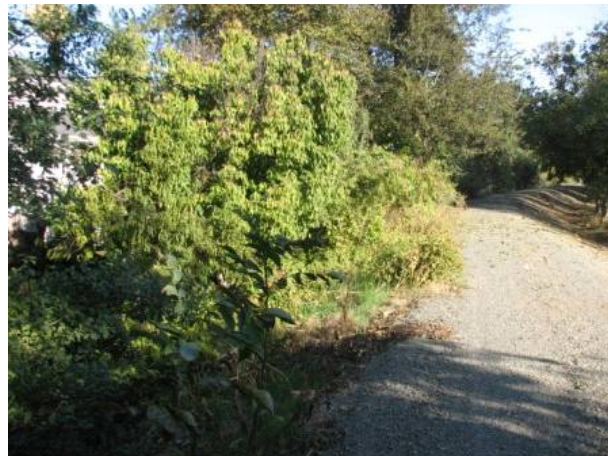
| The landscape vegetation needs to be trimmed for visibility of the levee slope. Fall 2011 | |

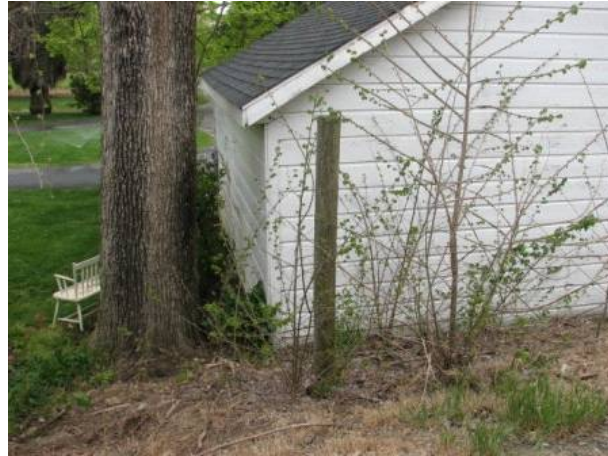
The building backs up to the landside levee toe of the levee.

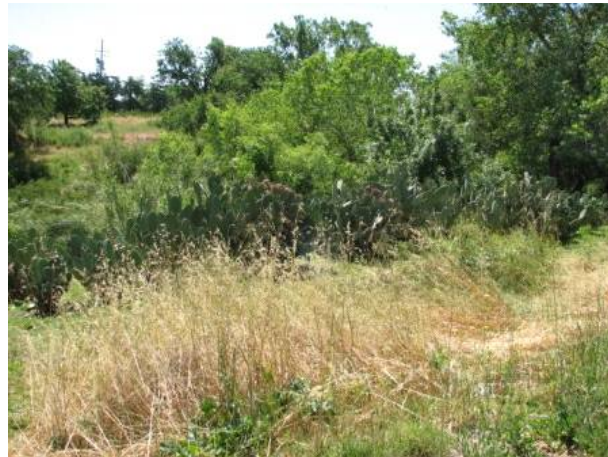
A cactus garden is planted on the waterside of the levee. There is some planted on the landside also.

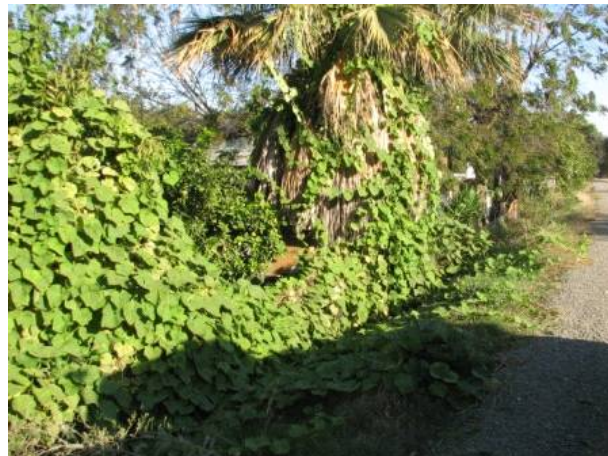
Wild grape and other plants are obstructing the view for inspection. Fall 2011

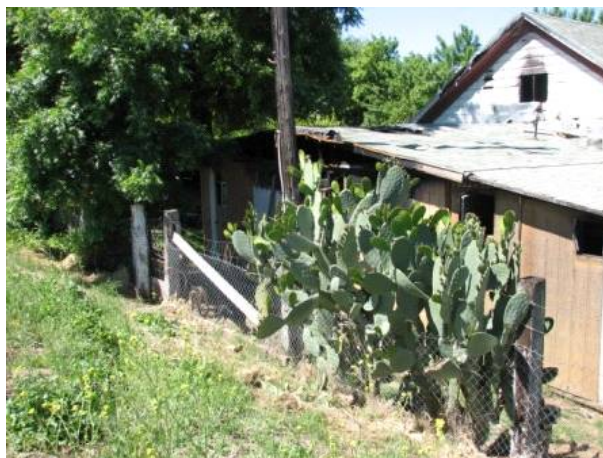
Building and catus landside, town of Yolo

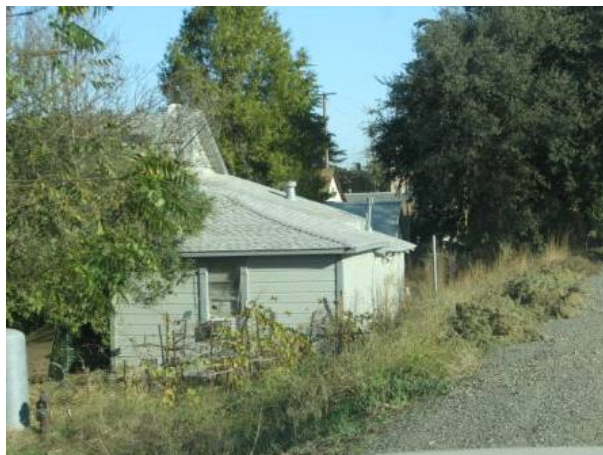
The house is too close to the levee toe. Fall 2011

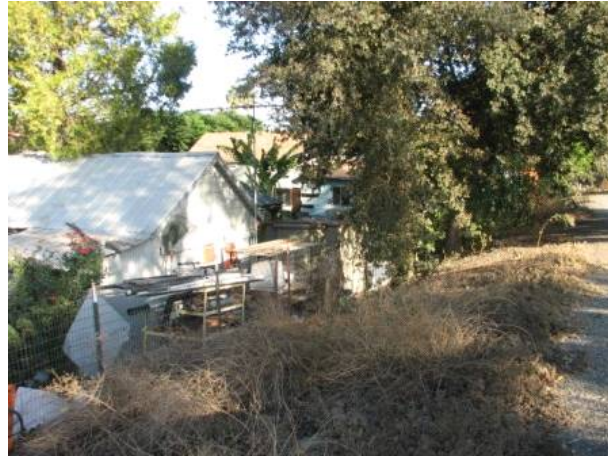
The building and backyard is at the toe of the levee. Fall 2011

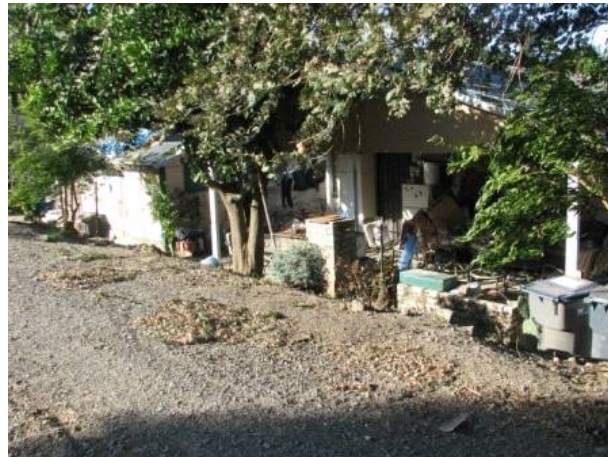
The patio is at the toe of the levee Fall 2011

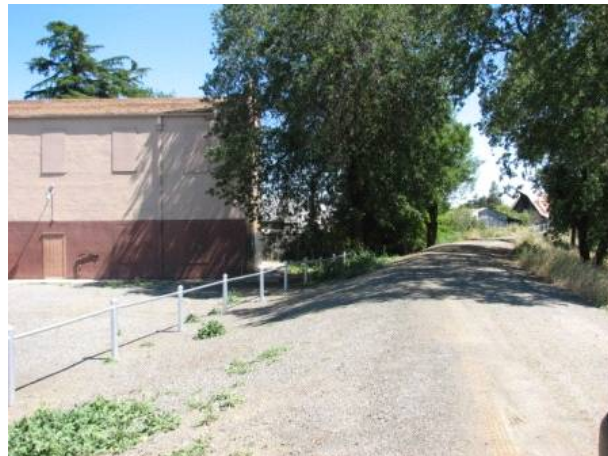
The building is close to the toe of the levee.

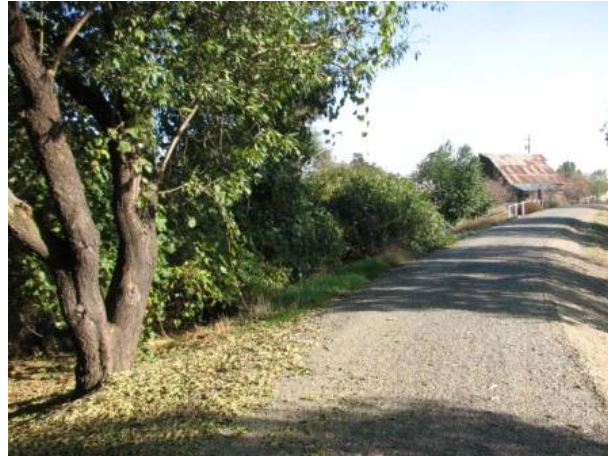
The shrubs block visibility of the levee slope. Fall 2011

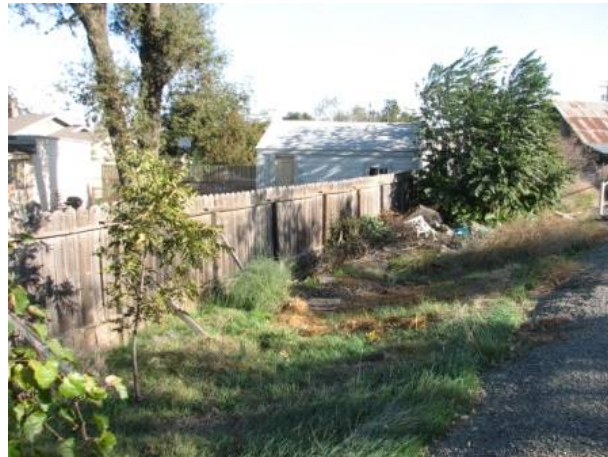
The fence blocks the visibility of the levee. Fall 2011

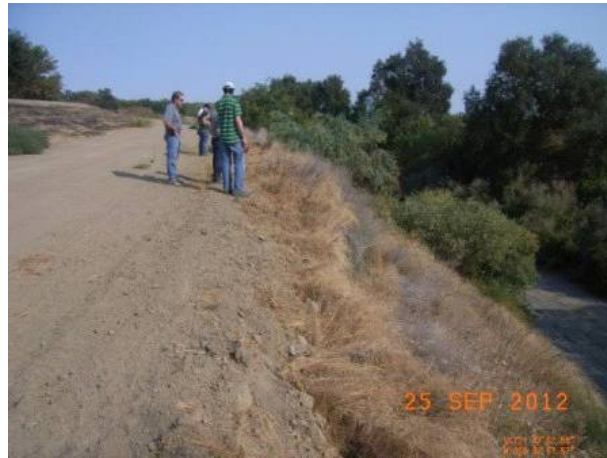
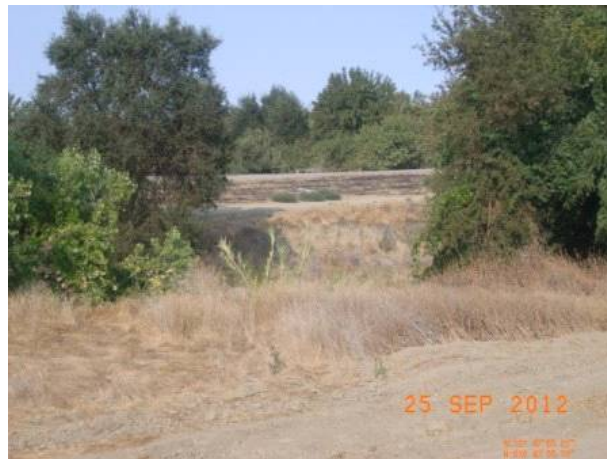
| LMR No. | Levee Mile | | Category | Item | Location | Rating | Action/Comment | GPS Latitude/Longitude | | Issue No. Photo |
|---|---|---|---|---|---|---|---|---|---|---|
| 18 | 2.42 | 2.51 | Supplemental | USACE Erosion Survey | WS | U Ma | Inspector Comments: Site identified as CRITICAL in 2002. 2006 - Currently constructing a setback levee. New failures present and extensive. Downstream end of the setback levee did not extend far enough. Upstream end was repaired. 2007 - DWR repaired with a setback levee, but the levee did not go far enough downstream. 2012: No observed change. [2012 Site ID: CHC_2-4_L] | 38.732836 ° -121.797893 ° | 38.732685 ° -121.797154 ° | 18 Y |

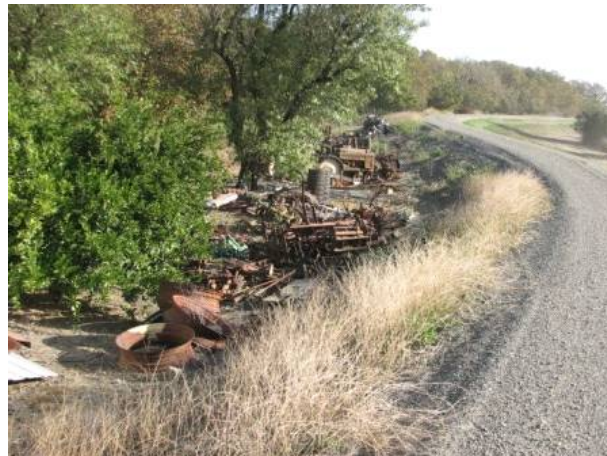
The equipment is stored at the toe of the levee.
Fall 2011

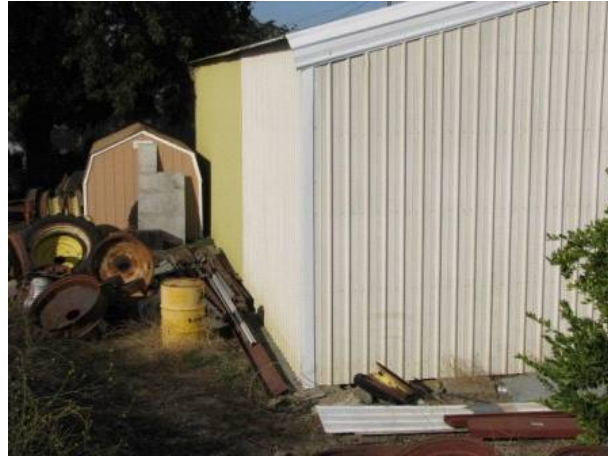
The corner of the shop is within the easement of the levee. Fall 2011

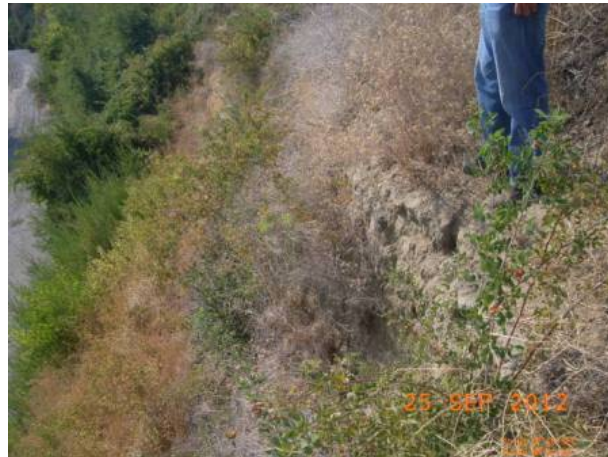
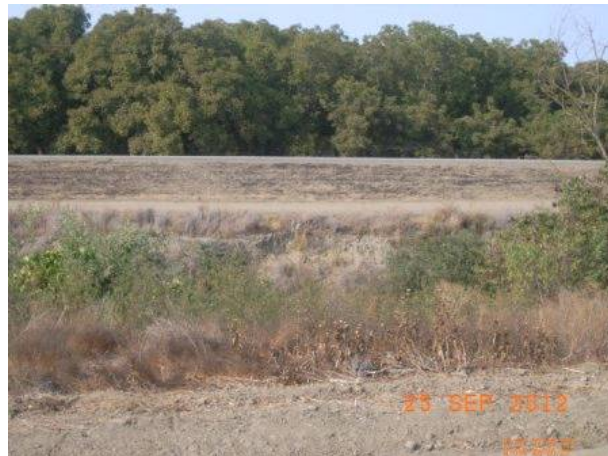
| LMR No. | Levee Mile | | Category | Item | Location | Rating | Action/Comment | GPS Latitude/Longitude | | Issue No. Photo |
|---|---|---|---|---|---|---|---|---|---|---|
| 22 | 2.79 | 2.83 | Supplemental | USACE Erosion Survey | WS | M Ma | Inspector Comments: 2006 - Large new failure. 2008 - Plans for repair currently in the design phase. 2010 - Planned setback levee by CA DWR, 60% design complete, construction planned for 2012. 2011 - Construction delayed to 2013. 2012: Construction planned for 2013 - 2014. [2012 Site ID: CHC_2-8_L] | 38.734067 ° -121.793713 ° | 38.734171 ° -121.792992 ° | 25 Y |

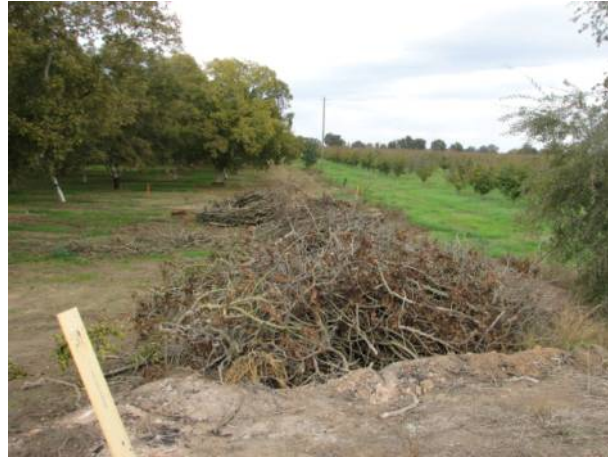
A fence made out of pruning debris stacked at the toe of the levee, Fall 2012

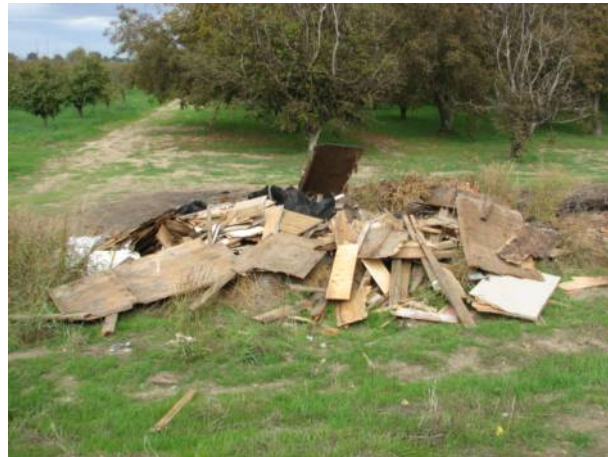
A debris pile of plywood and wood scrapes. Fall 2012

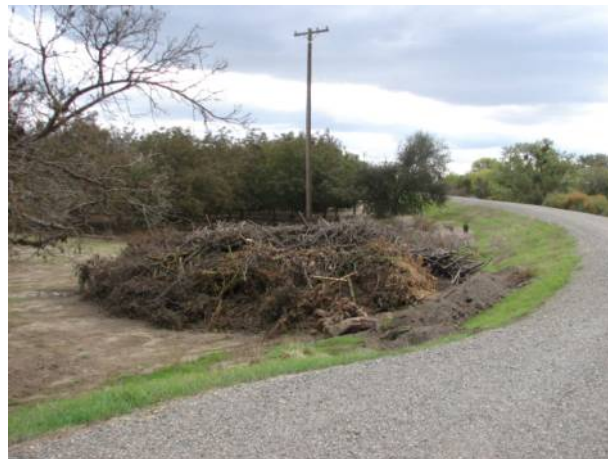
A very large pruning pile under the power lines at the levee toe. Fall 2012

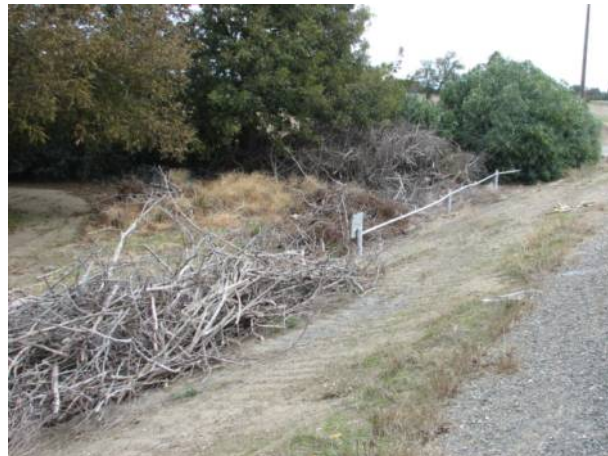
Pruning piles stacked on the toe of the levee. Fall 2012

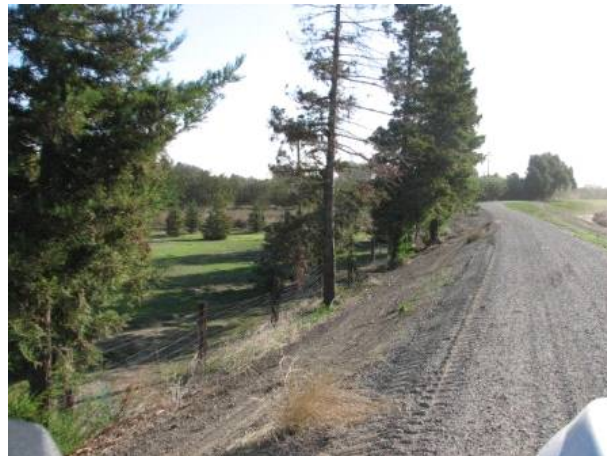
Landscape trees are planted along the levee to and on the slope. Some of the trees are trimmed up for visibility. Fall 2011

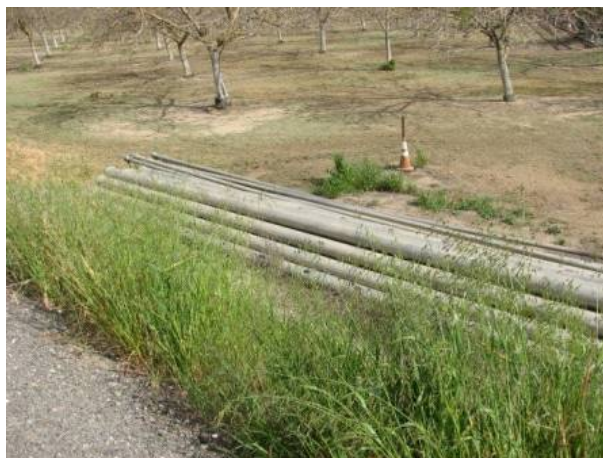
Aluminum irrigation pipe is placed along the landside levee toe.

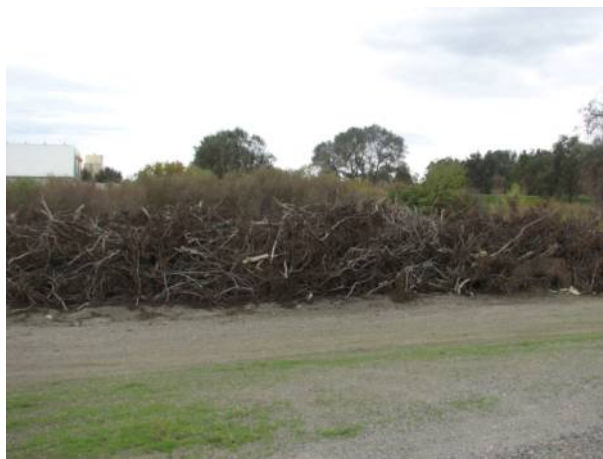
A very large pruning pile on the waterside berm.
Fall 2012

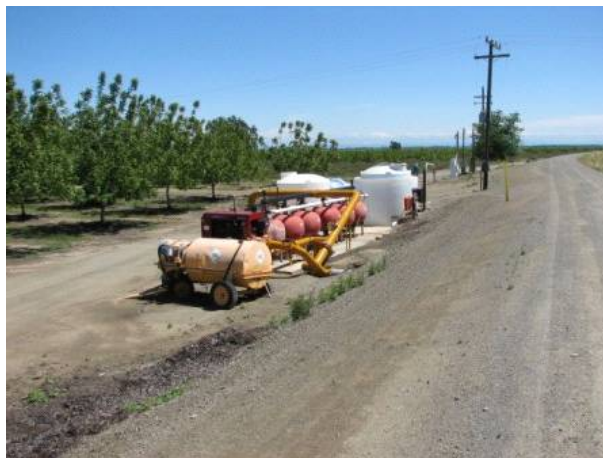
Pipe through levee filter and fertilizer tanks

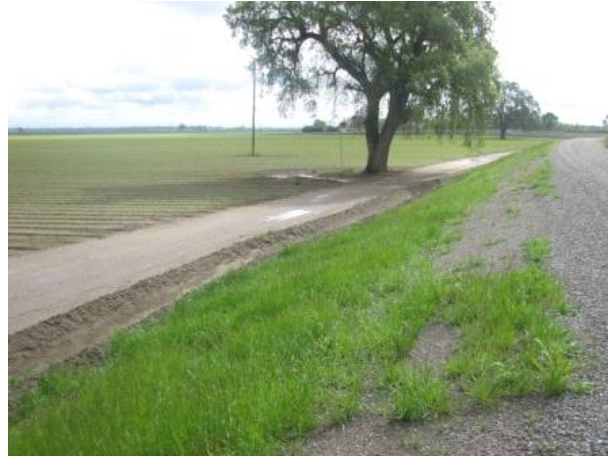
The farmer cuts an ag-ditch along the landside toe, photo taken spring 2012.

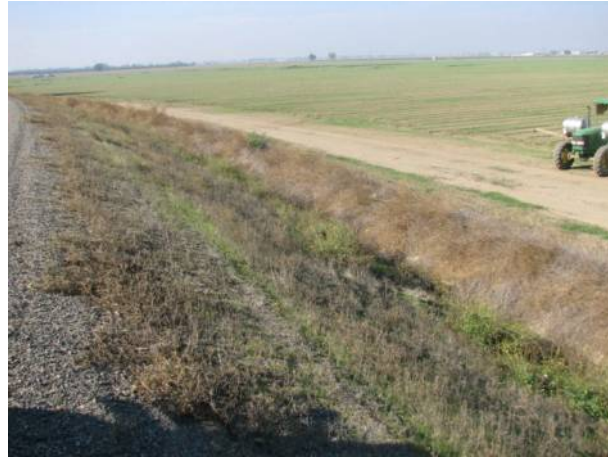
An old concrete lined ditch is at the landside toe.
Fall 2012

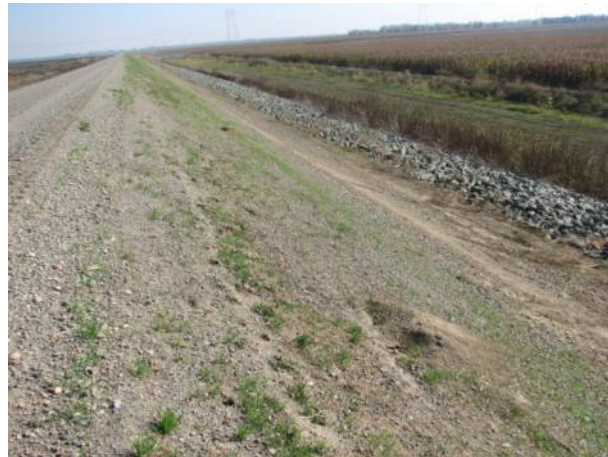
Rodent hole on the waterside levee slope. Fall
2012

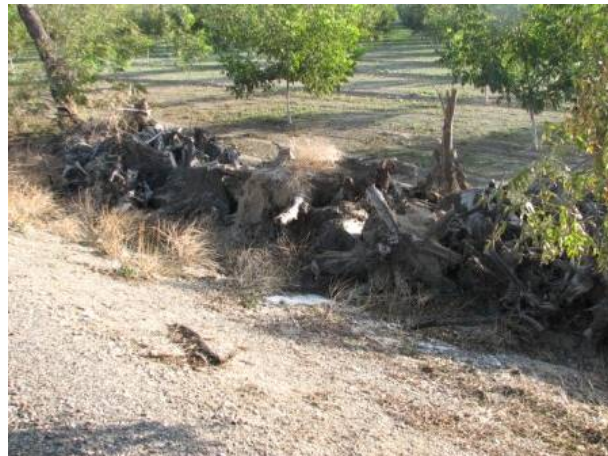
The stumps have not been removed or burned
along the toe of the levee. Fall 2011

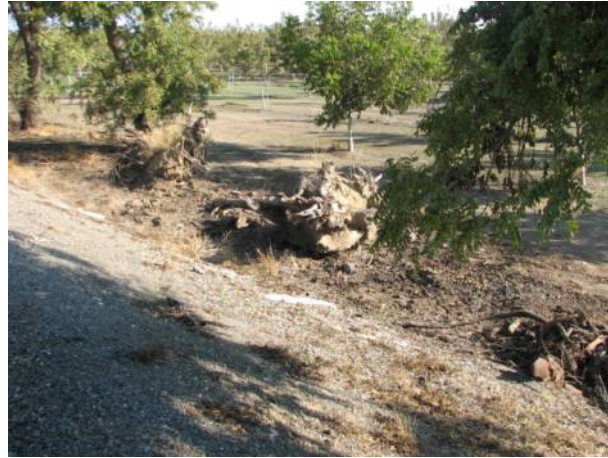
Only two stumps left and the rest of the pruning's are burnt. Fall 2012

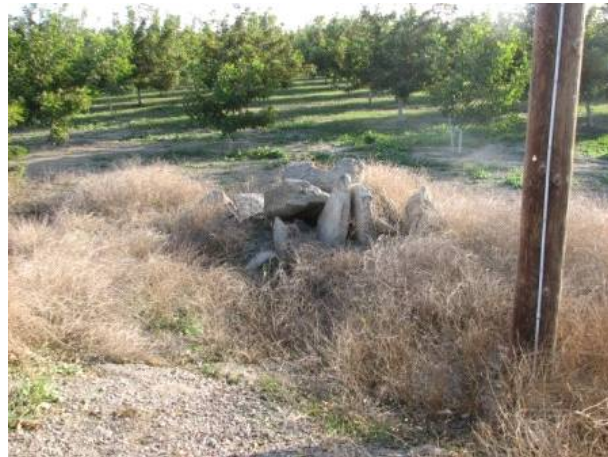
A pile of concrete debris is on the landside toe. Fall 2011

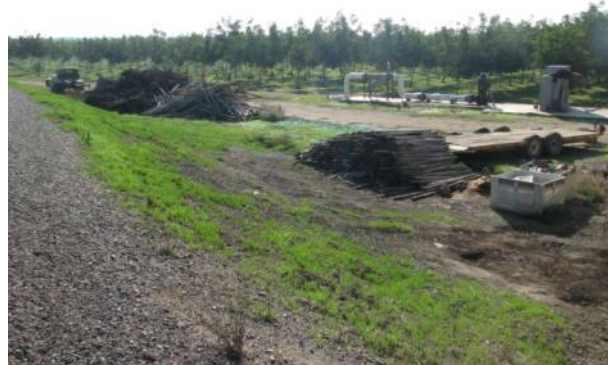
Tree stakes and pruning debris are piled next to the levee toe. Fall 2012

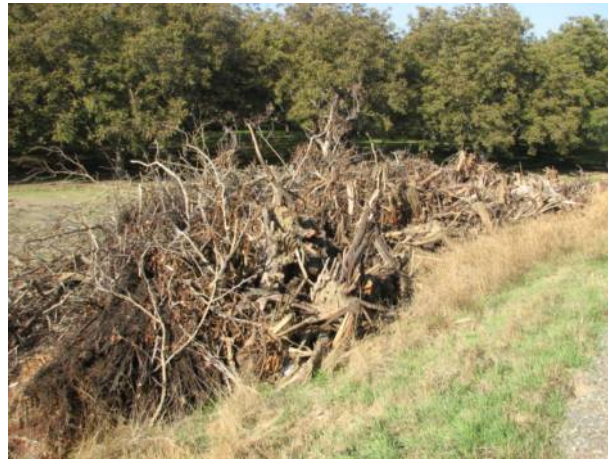
A pruning pile stacked against the levee. Fall 2012

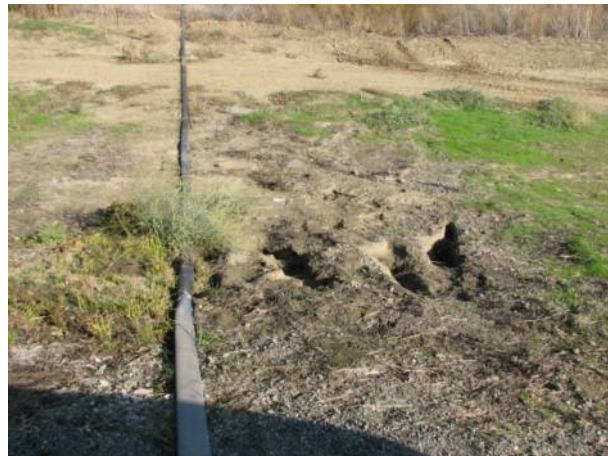
Some erosion has occurred from the overflow hose leaking. Fall 2012

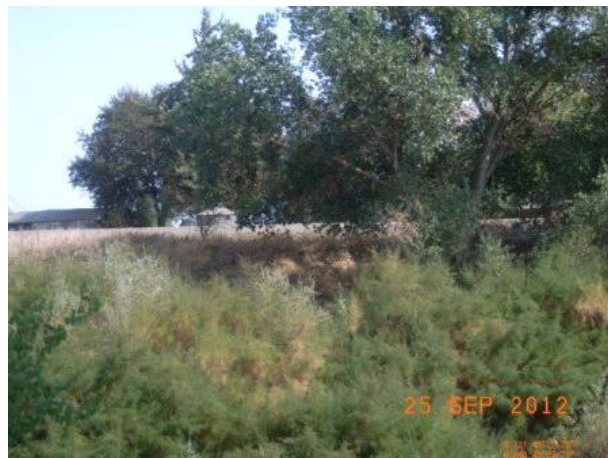
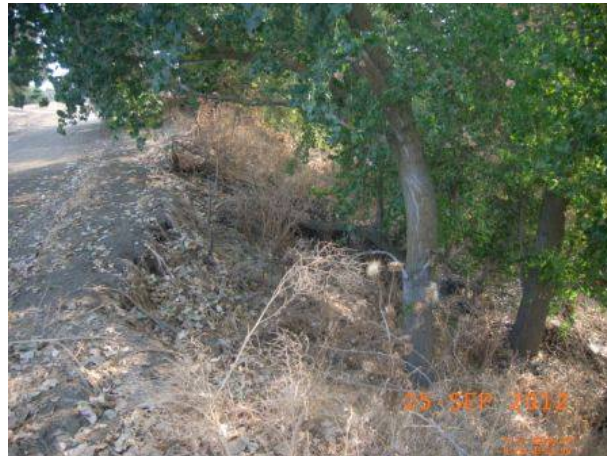
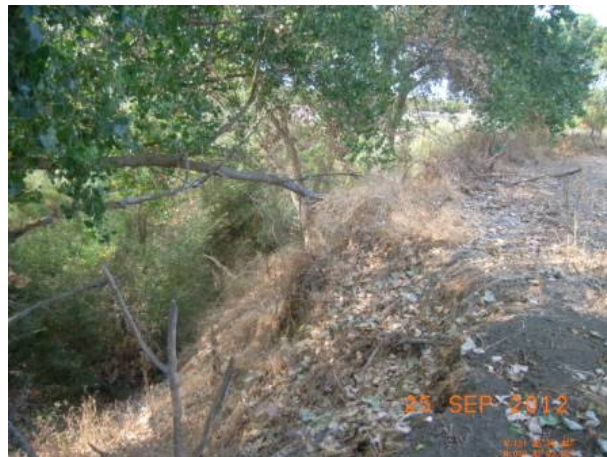
| Waterway | | | | | | | Bank | Unit Miles | Inspection Start/End | Inspector |
|---|---|---|---|---|---|---|--|---|---|---|
| 11 | 3.53 | 3.61 | Supplemental | USACE Erosion Survey | WS | M Ma | Inspector Comments: 2010 - Large slump on the upper berm, a tree has recently slid down the slope. 2011 - Large slump and new erosion. 2012: No observed change. [2012 Site ID: CHC_3-5_R] | 38.722138 ° -121.759736 ° | 38.723294 ° -121.759588 ° | 14 Y |

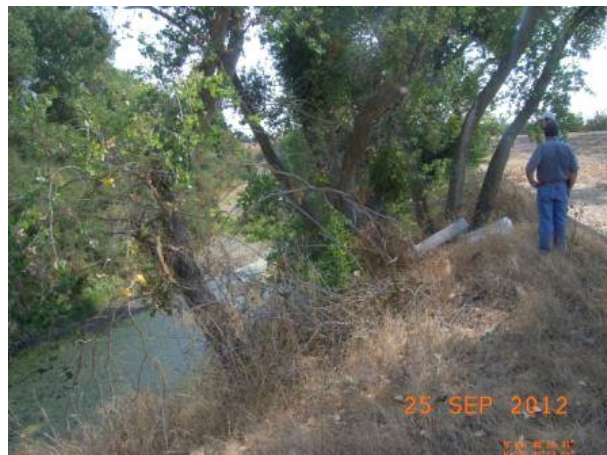
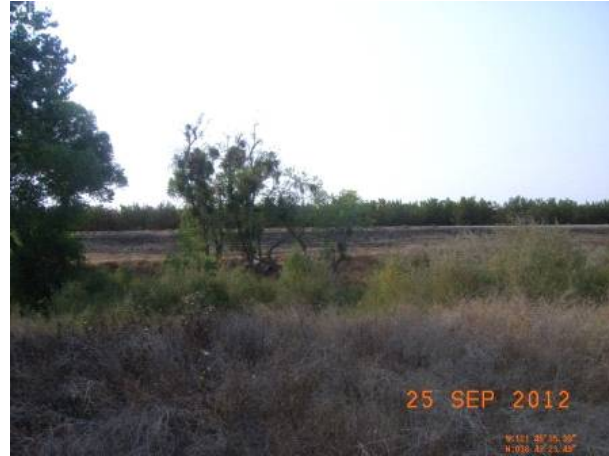
| Waterway | | | | | | | Bank | Unit Miles | Inspection Start/End | Inspector |
|---|---|---|---|---|---|---|--|---|---|---|
| 12 | 3.58 | 3.59 | Supplemental | USACE Erosion Survey | WS | M Ma | Inspector Comments: 2009 - Erosion into the levee slope. 2010 - Minor new erosion. 2011 - New erosion and a freshly fallen tree. 2012: No observed change. [2012 Site ID: CHC_5-4_L] | 38.722933 ° -121.760561 ° | 38.723467 ° -121.760436 ° | 20 Y |
