**Flood Control Project Maintenance  
Levee Inspections**

**Fall 2013 Levee Maintenance Deficiency Summary Report**

**Sacramento Maintenance Yard Cache Creek**

**Levee Inspection Report By Mile - Fall 2013**

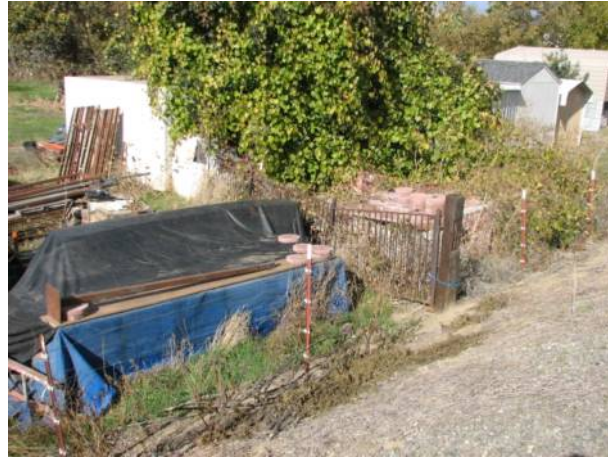
Levee Mile Report Line	6
Start Levee Mile	1.83
End Levee Mile	1.83
Location	Land Side
Category	Earthen Levee
Item	Encroachments
Building materials stacked along landside toe. Fall 2012	
johngw_f_20131021_757.jpg

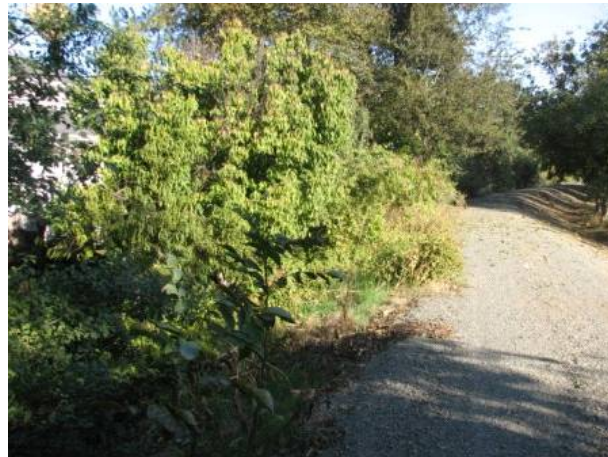
Levee Mile Report Line	7
Start Levee Mile	1.86
End Levee Mile	1.96
Location	Land Side
Category	Earthen Levee
Item	Vegetation
The landscape vegetation needs to be trimmed for visibility of the levee slope. Fall 2011	
johngw_f_20131021_758.jpg

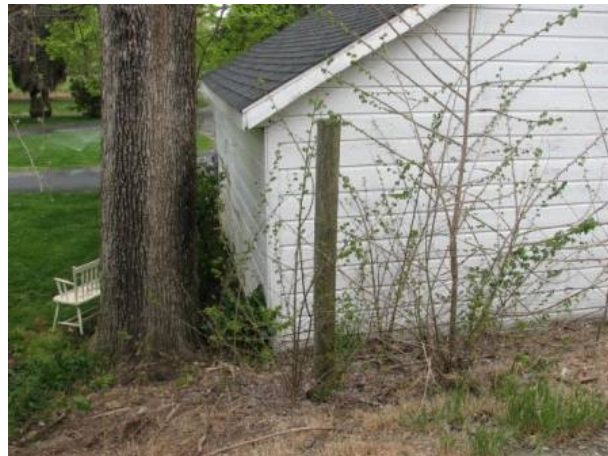
Levee Mile Report Line	8
Start Levee Mile	1.91
End Levee Mile	1.91
Location	Land Side
Category	Earthen Levee
Item	Encroachments
The building backs up to the landside levee toe of the levee.	
johngw_f_20131021_759.jpg

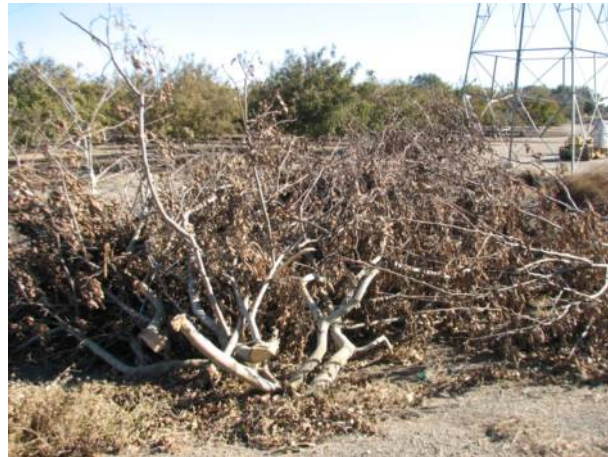
Levee Mile Report Line	41
Start Levee Mile	5.65
End Levee Mile	5.65
Location	Land Side
Category	Earthen Levee
Item	Encroachments
A large pruning pile is at the toe of the levee. Fall 2013	
johngw_f_20131112_297.JPG

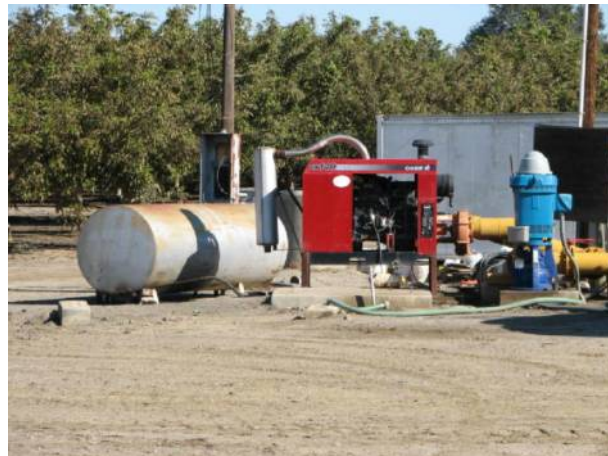
Levee Mile Report Line	43
Start Levee Mile	5.73
End Levee Mile	5.73
Location	Land Side
Category	Supplemental
Item	DWR UCIP Field Study
Landside view: pumping plant	
UCIP_3753.jpg

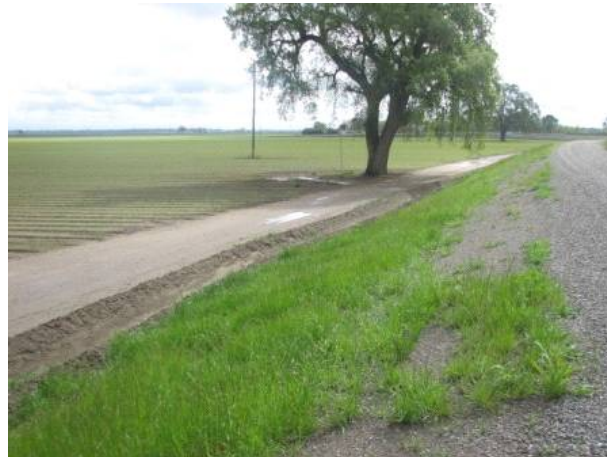
Levee Mile Report Line	46
Start Levee Mile	6.94
End Levee Mile	7.24
Location	Land Side
Category	Earthen Levee
Item	Encroachments
The farmer cuts an ag-ditch along the landside toe, photo taken spring 2012.	
johngw_f_20131021_789.jpg

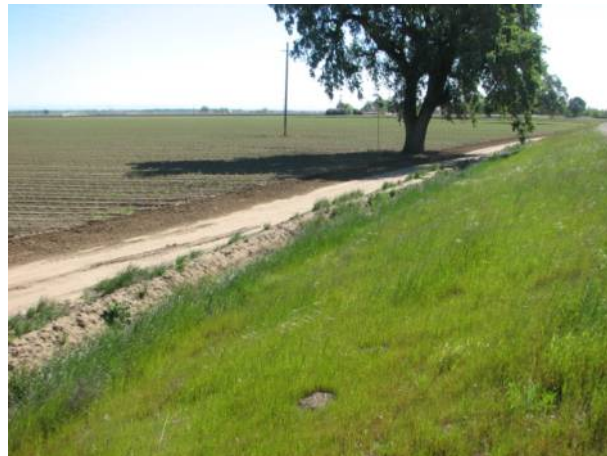
Levee Mile Report Line	46
Start Levee Mile	6.94
End Levee Mile	7.24
Location	Land Side
Category	Earthen Levee
Item	Encroachments
The farmer continues to v-ditch the toe of the levee. Spring 2013	
johngw_f_20131021_790.JPG

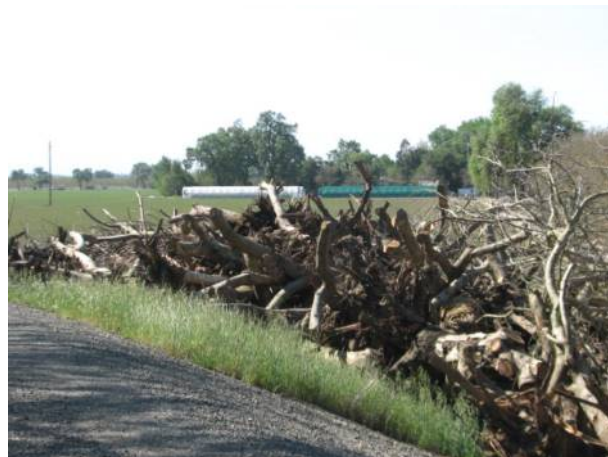
Levee Mile Report Line	9
Start Levee Mile	1.65
End Levee Mile	1.65
Location	Land Side
Category	Earthen Levee
Item	Encroachments
The pruning pile at the toe continues to grow. Spring 2013	
johngw_f_20131021_806.JPG

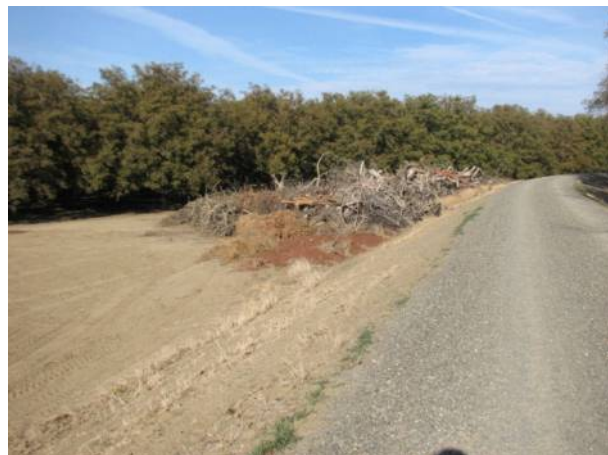
Levee Mile Report Line	9
Start Levee Mile	1.65
End Levee Mile	1.65
Location	Land Side
Category	Earthen Levee
Item	Encroachments
The never ending pruning pile is at the toe of the levee. Fall 2013	
johngw_f_20131112_305.JPG
