**Flood Control Project Maintenance
Levee Inspections**

Fall 2014 Levee Maintenance Deficiency Summary Report

Sacramento Maintenance Yard Cache Creek

Levee Inspection Report By Mile - Fall 2014

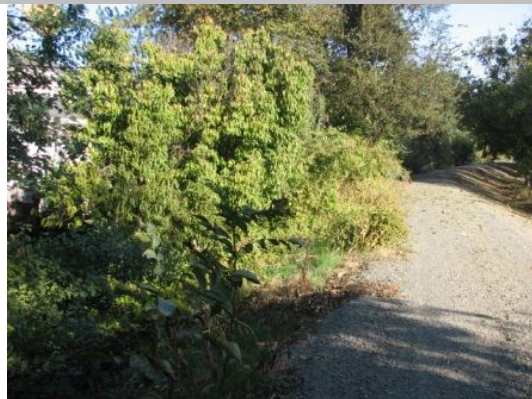
Photo 1 of 2 : FA_2014_ST0001_259_3_20141014_00004.jpg

LM Start	1.86	Rating **	M	Issue No.	3
LM End	1.96	Issue Type +	En	Location *	LS
Category	Earthen Levee			GPS Latitude/Longitude	
				Start	End
Item	Vegetation			38.729828 °	38.731143 °
				-121.806532 °	-121.806255 °
DWR ID	DWR_ST0001_01_s_2012_3				
Action/Comments					
Landscaping

The landscape vegetation needs to be trimmed for visibility of the levee slope. Fall 2011

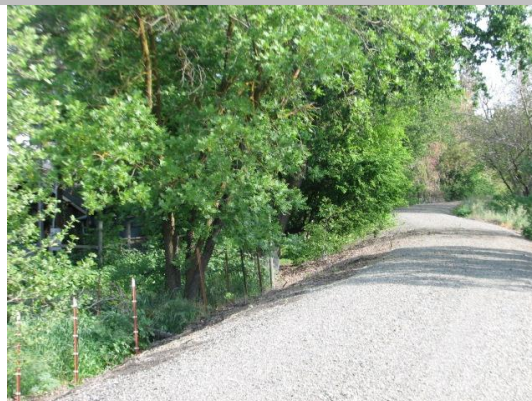
Photo 2 of 2 : FA_2014_ST0001_259_3_20141014_00005.jpg

The landscape needs to be trimmed up. Spring 2014

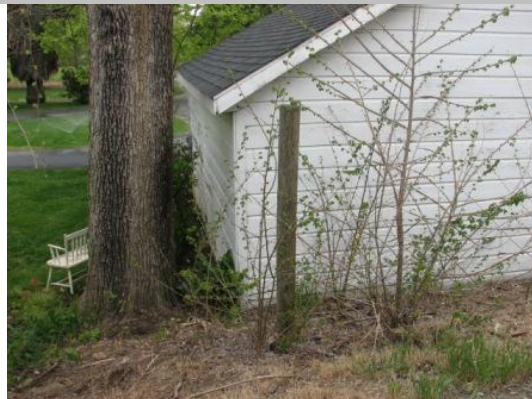
Photo 1 of 1 : FA_2014_ST0001_259_4_20141014_00006.jpg

LM Start	1.91	Rating **	M	Issue No.	4
LM End	1.91	Issue Type +	En	Location *	LS
Category	Earthen Levee			GPS Latitude/Longitude	
				Start	End
Item	Encroachments			38.730528 °	38.730528 °
				-121.806485 °	-121.806485 °
DWR ID	DWR_ST0001_01_s_2012_4				
Action/Comments					
Building

The building backs up to the landside levee toe of the levee.

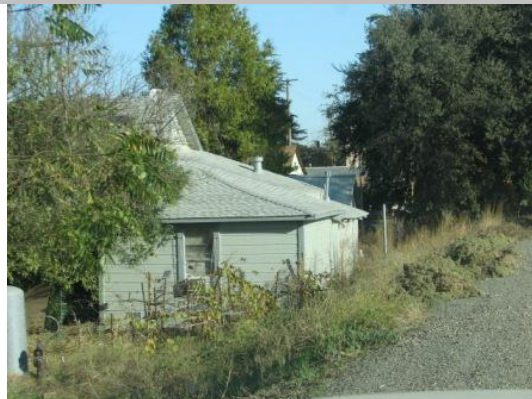
Photo 1 of 1 : FA_2014_ST0001_259_10_20141014_00012.jpg

LM Start	2.03	Rating **	M	Issue No.	10
LM End	2.03	Issue Type +	En	Location *	LS
Category	Earthen Levee			GPS Latitude/Longitude	
				Start	End
Item	Encroachments			38.732162 °	38.732162 °
				-121.805895 °	-121.805895 °
DWR ID	DWR_ST0001_01_s_2012_10				
Action/Comments					
Building

The house is in the easement of the levee toe. Fall 2011

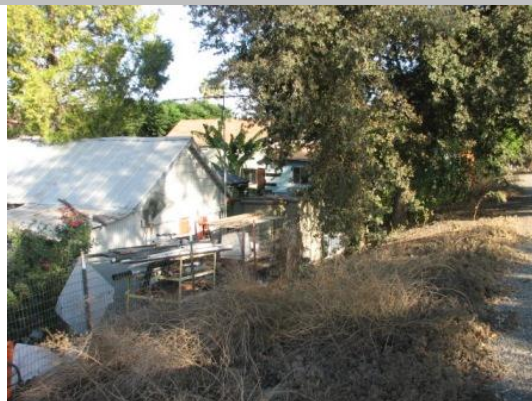
Photo 1 of 1 : FA_2014_ST0001_259_11_20141014_00013.jpg

LM Start	2.04	Rating **	M	Issue No.	11
LM End	2.04	Issue Type +	En	Location *	LS
Category	Earthen Levee			GPS Latitude/Longitude	
				Start	End
Item	Encroachments			38.732268 °	38.732268 °
				-121.805832 °	-121.805832 °
DWR ID	DWR_ST0001_01_s_2012_11				
Action/Comments					
Building

The building is in the easement of the levee. Fall 2011

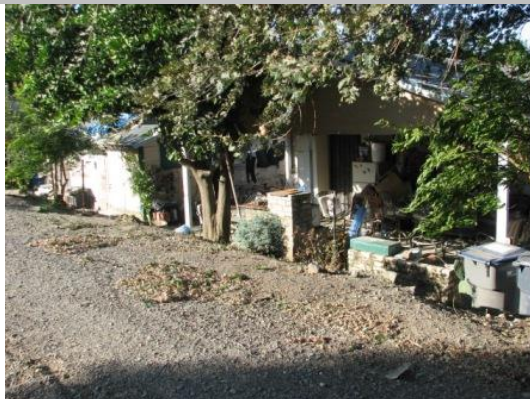
Photo 1 of 1 : FA_2014_ST0001_259_13_20141014_00015.jpg

LM Start	2.06	Rating **	M	Issue No.	13
LM End	2.06	Issue Type +	En	Location *	LS
Category	Earthen Levee			GPS Latitude/Longitude	
				Start	End
Item	Encroachments			38.732537 °	38.732537 °
				-121.805708 °	-121.805708 °
DWR ID	DWR_ST0001_01_s_ 2012_13				
Action/Comments					
Building

The building is in the easement of the levee. Fall 2011

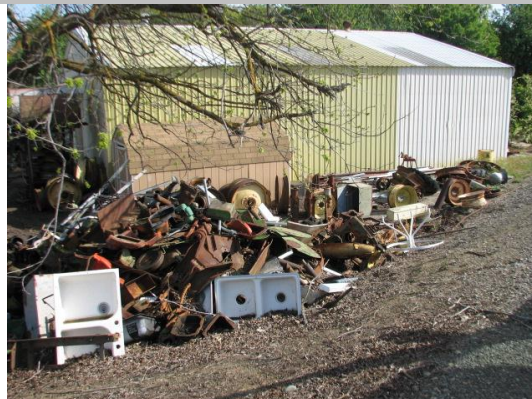
Photo 2 of 2 : FA_2014_ST0001_259_19_20141014_00021.jpg

LM Start	2.65	Rating **	M	Issue No.	19 (cont)
LM End	2.70	Issue Type +	Ma	Location *	LS
Category	Earthen Levee			GPS Latitude/Longitude	
				Start	End
Item	Encroachments			38.733080 °	38.733492 °
				-121.796013 °	-121.795293 °
DWR ID	DWR_ST0001_01_s_2012_19				
Action/Comments					
Equipment

Equipment and parts stacked along the levee toe and slope. Spring 2014

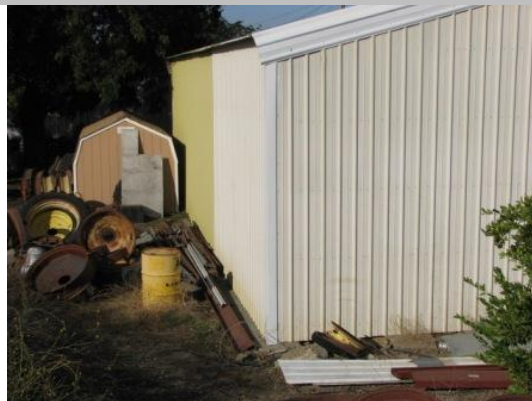
Photo 1 of 1 : FA_2014_ST0001_259_20_20141014_00022.jpg

LM Start	2.66	Rating **	M	Issue No.	20
LM End	2.66	Issue Type +	En	Location *	LS
Category	Earthen Levee			GPS Latitude/Longitude	
				Start	End
Item	Encroachments			38.733132 °	38.733132 °
				-121.795890 °	-121.795890 °
DWR ID	DWR_ST0001_01_s_2012_20				
Action/Comments					
Building

The corner of the shop is within the easement of the levee. Fall 2011

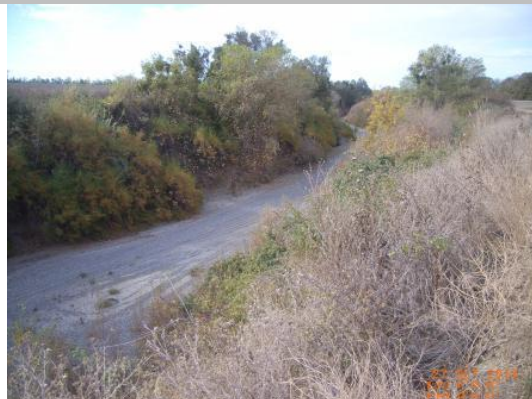
Photo 1 of 1 : FA_2014_ST0001_259_30_20141014_00028.jpg

LM Start	2.79	Rating **	M	Issue No.	30
LM End	2.83	Issue Type +	Ma	Location *	WS
Category	Supplemental			GPS Latitude/Longitude	
				Start	End
Item	USACE Erosion Survey			38.734067 °	38.734171 °
				-121.793713 °	-121.792992 °
DWR ID	DWR_ST0001_01_f_2014_30				
Action/Comments					
Inspector Comments: 2006 - Large new failure. 2008 - Plans for repair currently in the design phase. 2010 - Planned setback levee by CA DWR, 60% design complete, construction planned for 2012. 2011 - Construction delayed to 2013 - 2014. 2013: No observed changes. [2013 Site ID: CHC_2-8_L]

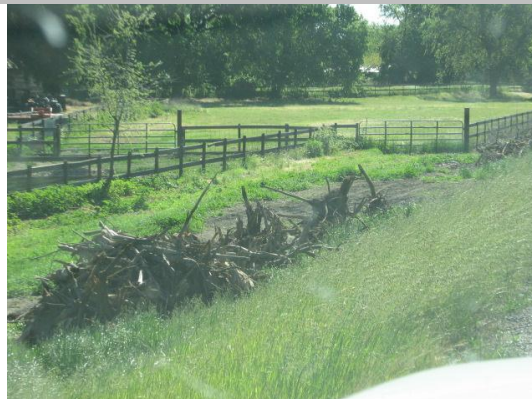
Photo 1 of 1 : FA_2014_ST0001_259_32_20141014_00030.jpg

LM Start	4.80	Rating **	M	Issue No.	32
LM End	4.80	Issue Type +	En	Location *	LS
Category	Earthen Levee			GPS Latitude/Longitude	
				Start	End
Item	Encroachments			38.722384 °	38.722384 °
				-121.766882 °	-121.766882 °
DWR ID	DWR_ST0001_01_s_2013_32				
Action/Comments					
Prunings

Prunings and root balls at the toe of the levee. Spring 2013

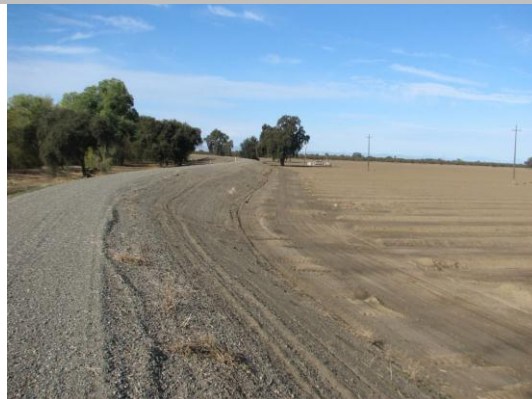
Photo 1 of 1 : FA_2014_ST0001_259_570_20141106_00833.jpg

LM Start	6.94	Rating **	A	Issue No.	570
LM End	7.24	Issue Type +	En	Location *	LS
Category	Earthen Levee			GPS Latitude/Longitude	
				Start	End
Item	Encroachments				°
					°
DWR ID	DWR_ST0001_01_f_2014_570				
Action/Comments					
Ditch

Levee mile 7.14, agricultural ditch has been removed. Fall 2014.

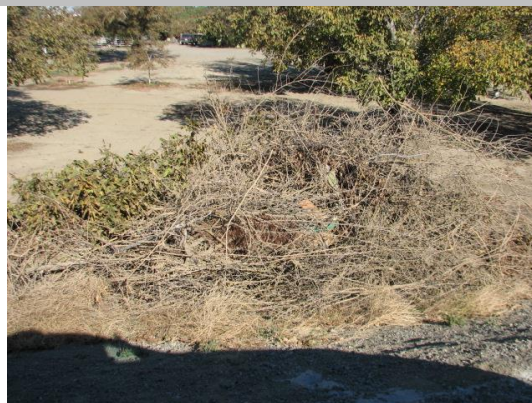
Photo 1 of 2 : FA_2014_ST0001_259_41_20141014_00036.jpg

LM Start	7.29	Rating **	M	Issue No.	41
LM End	7.29	Issue Type +	En	Location *	LS
Category	Earthen Levee			GPS Latitude/Longitude	
				Start	End
Item	Encroachments			38.727747 °	38.727747 °
				-121.729290 °	-121.729290 °
DWR ID	DWR_ST0001_01_s_2013_41				
Action/Comments					
Prunings

A pruning pile is at the toe of the levee. Fall 2013

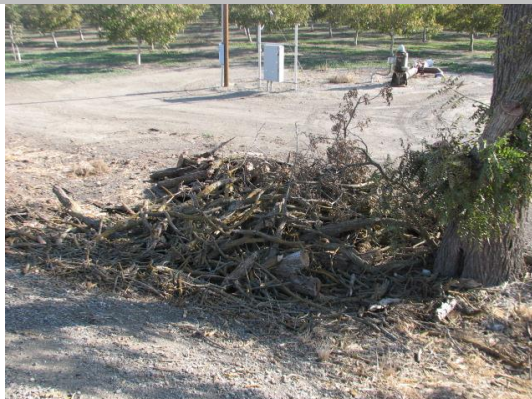
Photo 1 of 2 : FA_2014_ST0001_260_17_20141014_00013.jpg

LM Start	0.26	Rating **	M	Issue No.	17
LM End	0.26	Issue Type +	En	Location *	LS
Category	Earthen Levee			GPS Latitude/Longitude	
				Start	End
Item	Encroachments			38.730715 °	38.730715 °
				-121.804958 °	-121.804958 °
DWR ID	DWR_ST0001_02_f_2013_17				
Action/Comments					
Prunings

A pruning pile is within the easement of the levee. Fall 2013

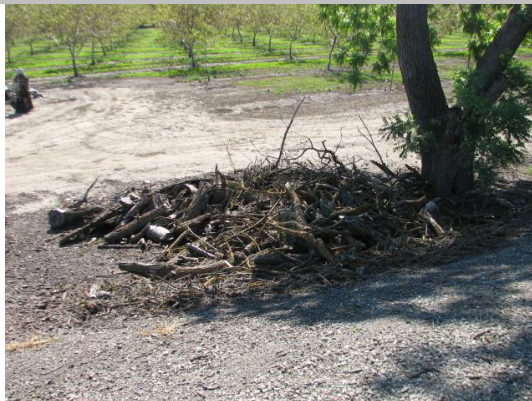
Photo 2 of 2 : FA_2014_ST0001_260_17_20141014_00014.jpg

A pruning pile is at the toe of the levee. Spring 2014

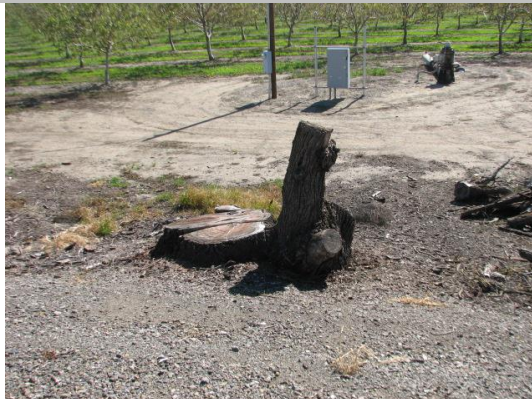
Photo 1 of 1 : FA_2014_ST0001_260_6_20141014_00004.jpg

LM Start	0.26	Rating **	N	Issue No.	6
LM End	0.26	Issue Type +	Ma	Location *	LS
Category	Earthen Levee			GPS Latitude/Longitude	
				Start	End
Item	Trim / Thin Trees			38.730723 °	38.730723 °
				-121.804972 °	-121.804972 °
DWR ID	DWR_ST0001_02_s_2014_6				
Action/Comments					
Tree stumps.

A large black walnut tree stump is at the toe of the levee. Spring 2014

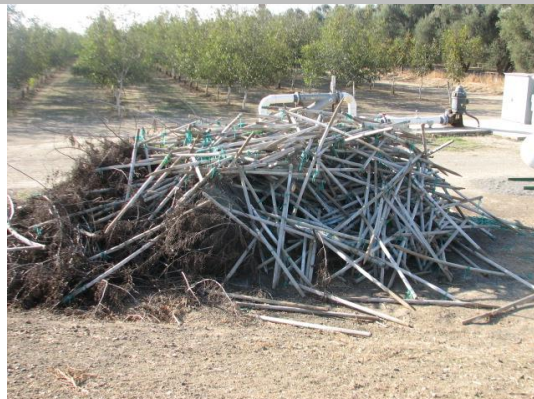
Photo 1 of 1 : FA_2014_ST0001_260_1_20141014_00001.jpg

LM Start	0.68	Rating **	M	Issue No.	1
LM End	0.68	Issue Type +	En	Location *	LS
Category	Earthen Levee			GPS Latitude/Longitude	
				Start	End
Item	Encroachments			38.732229 °	38.732229 °
				-121.798922 °	-121.798922 °
DWR ID	DWR_ST0001_02_s_ 2012_1				
Action/Comments					
Debris

Tree stakes and pruning's are at the toe of the levee. Fall 2013

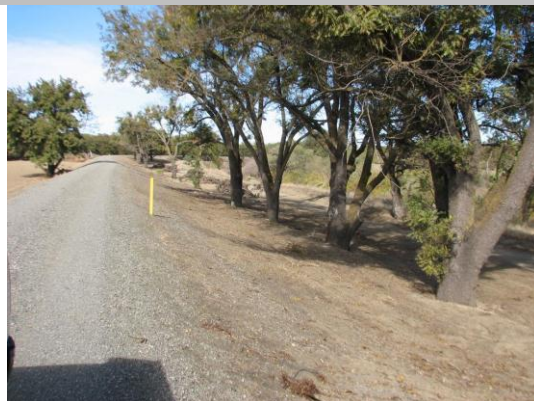
Photo 1 of 1 : FA_2014_ST0001_260_434_20141106_00614.jpg

LM Start	1.05	Rating **	M	Issue No.	434
LM End	1.80	Issue Type +	En	Location *	WS
Category	Earthen Levee			GPS Latitude/Longitude	
				Start	End
Item	Encroachments				38.728650
					-121.784523
DWR ID	DWR_ST0001_02_f_ 2014_434				
Action/Comments					
Prunings

Levee mile 1.80, pruning piles at water side toe. Fall 2014.

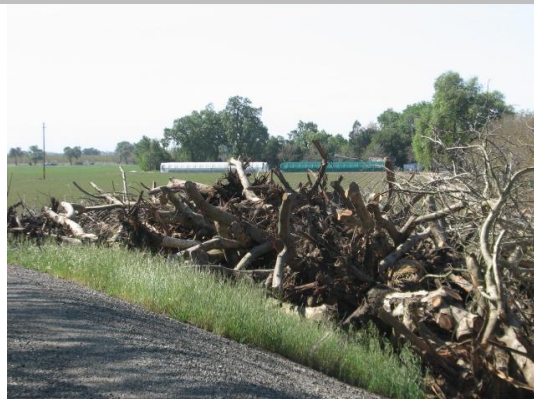
Photo 1 of 3 : FA_2014_ST0001_260_12_20141014_00008.jpg

LM Start	1.64	Rating **	M	Issue No.	12
LM End	1.64	Issue Type +	En	Location *	LS
Category	Earthen Levee			GPS Latitude/Longitude	
				Start	End
Item	Encroachments			38.730624 °	38.730624 °
				-121.786050 °	-121.786050 °
DWR ID	DWR_ST0001_02_f_ 2012_12				
Action/Comments					
Prunings

The pruning pile at the toe continues to grow. Spring 2013

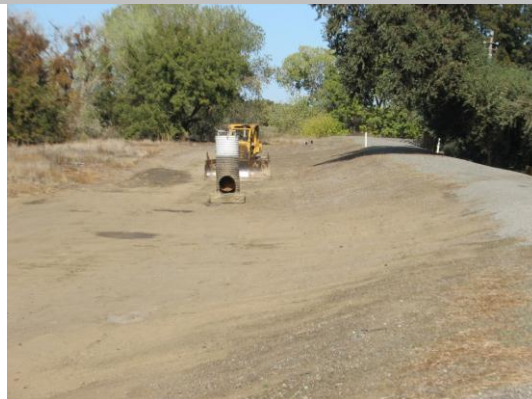
Photo 1 of 1 : FA_2014_ST0001_260_433_20141106_00616.jpg

LM Start	3.42	Rating **	M	Issue No.	433
LM End	3.42	Issue Type +	En	Location *	LS
Category	Supplemental			GPS Latitude/Longitude	
				Start	End
Item	DWR UCIP Field Study			38.721348 °	38.721348 °
				-121.759503 °	-121.759503 °
DWR ID	DWR_ST0001_02_f_2014_433				
Action/Comments					
Inspector Comments: FS_ID:33306					
EP_NO: 10223					
Repair Type: Non-Urgent					
Crossing Status: Found					
UCIP Comments: 18-inch steel pipe in 36-inch concrete pipe distribution box on LS. 18-inch steel riser on WS. An abandoned foundation of a pump house on waterside of the levee.					
FIELD_STRUCT_DESC: 24-inch CMP through levee 6.0 feet below crown. Pump house foundation on waterward slope. Slide gate in riser on waterward shoulder. (ABO No. 10223 - Lawley)					
FS Date: 4/10/2014 2:05:43 PM

Levee mile 3.42, pipe has been removed. Fall 2014.

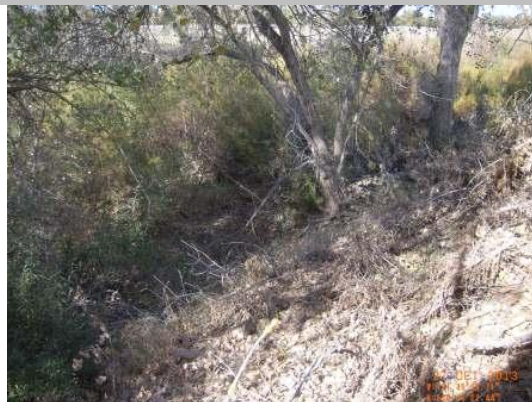
Photo 1 of 1 : FA_2014_ST0001_260_13_20141014_00011.jpg

LM Start	3.48	Rating **	M	Issue No.	13
LM End	3.56	Issue Type +	Ma	Location *	WS
Category	Supplemental			GPS Latitude/Longitude	
				Start	End
Item	USACE Erosion Survey			38.722138 °	38.723294 °
				-121.759736 °	-121.759588 °
DWR ID	DWR_ST0001_02_f_2014_13				
Action/Comments					
Inspector Comments: 2010 - Large slump on the upper berm, a tree has recently slid down the slope. 2011 - Large slump and new erosion. 2012 - Slightly steeper slopes and cracks observed. 2013: No observed changes. [2013 Site ID: CHC_3-5_R]

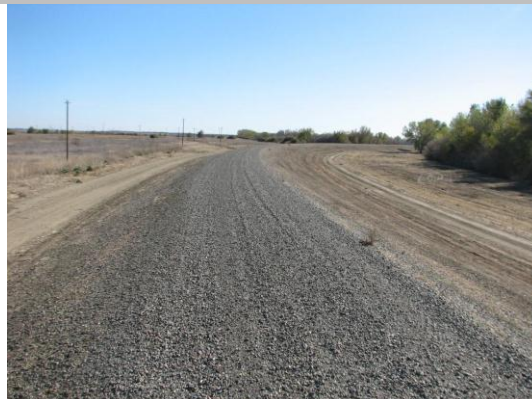
Photo 1 of 1 : FA_2014_ST0001_261_50_20141106_00094.jpg

LM Start	0.00	Rating **	A	Issue No.	50
LM End	2.28	Issue Type +	Ma	Location *	LS
Category	Earthen Levee			GPS Latitude/Longitude	
				Start	End
Item	Vegetation				°
					°
DWR ID	DWR_ST0001_04_f_2014_50				
Action/Comments					
Control annual grass and weeds on the levee slopes and easements.

Levee mile 0.17, vegetation controlled on levee slopes and crown. Fall 2014.
